The Fukushima Daiichi Accident

Technical Volume 2/5 Safety Assessment

THE FUKUSHIMA DAIICHI ACCIDENT

TECHNICAL VOLUME 2 SAFETY ASSESSMENT

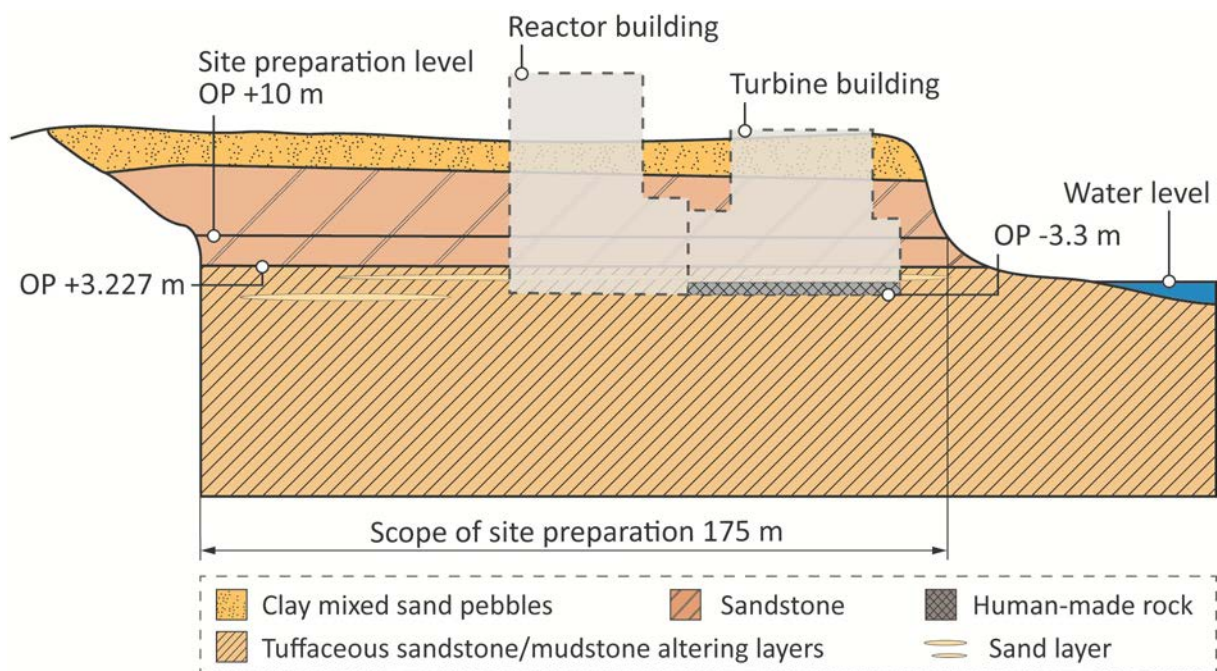
In the civil construction of the plant, TEPCO considered these factors, as indicated in the TEPCO Fukushima Nuclear Accident Analysis Report [10], through interviews with former employees who were involved in this work [10]. Although the topography provided a natural ground level of OP +30–35 m, TEPCO decided to build the plant at OP +10.00 m, i.e. much closer to the sea water level. This decision entailed the removal of soil and rock layers with a thickness of more than 20 m over a large area.

FIG. 2.1–1. Cross-section of the Fukushima Daiichi construction site showing soil characteristics (all levels are above mean sea level) [3].

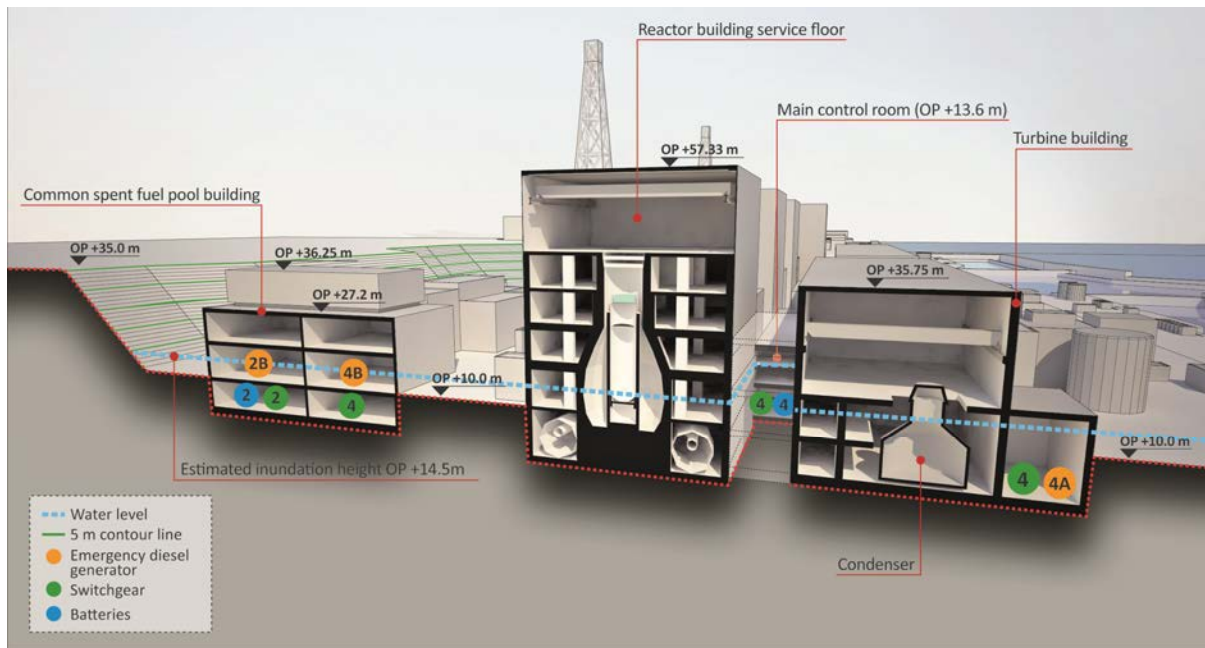
Figure 2.1–2 shows a typical cross-section of the main buildings of Unit 1, illustrating the location of the grade level at OP +10.00 m and the relationship with the layout of the buildings.

The TEPCO report on the accident [10] indicated that the main plant grade level was defined in accordance with the information available from the historical records on tsunamis in the Fukushima Daiichi region and the topographical and bathymetric conditions of the shoreline in the area. In terms of construction costs, it would have been preferable not to excavate to a low level, though on the other hand, the lower level provided access advantages for water intakes and loading wharfs as well as significantly lower installation (i.e. required pump power) and operating costs for pumping cooling water. The report [10] also listed economic factors. These included the total excavation cost to develop the power station site area, including road access and the work area required, as well as the need to remove the clay and sandstone upper layers to reach the stable strata to obtain firm foundation soil where the major buildings were founded.

FIG. 2.1–2. Cross-section of the main buildings at Unit 1 of the Fukushima Daiichi NPP [3].

Thus, the main reason for the decision on the main plant grade level would have been the economics of water cooling supply (i.e. installation cost during the construction stage and transport energy cost during the operational life of the installation) based on the assumption that the external flooding levels would not impose a risk according to recent historical records in this area [10].

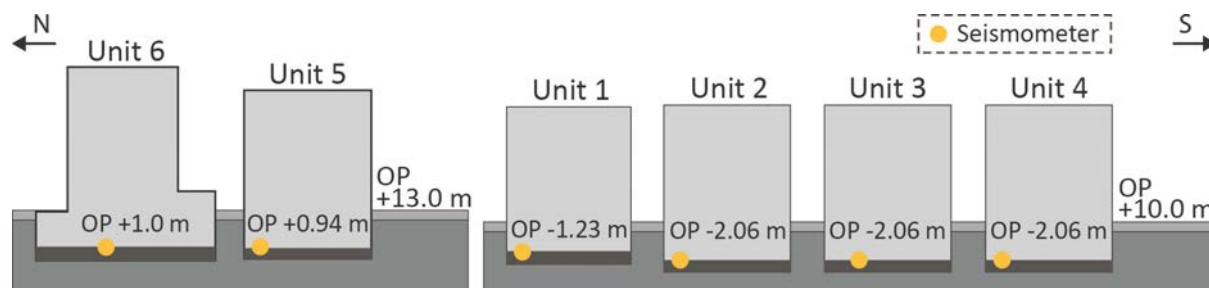
Figure 2.1–3 illustrates the location of the measurement points for the measurements shown in Table 2.1–1 for Fukushima Daiichi NPP units [6].

FIG. 2.1–3. Maximum acceleration values observed at Units 1–6 of the Fukushima Daiichi NPP, and comparison with the original design basis values and re-evaluation values [6].

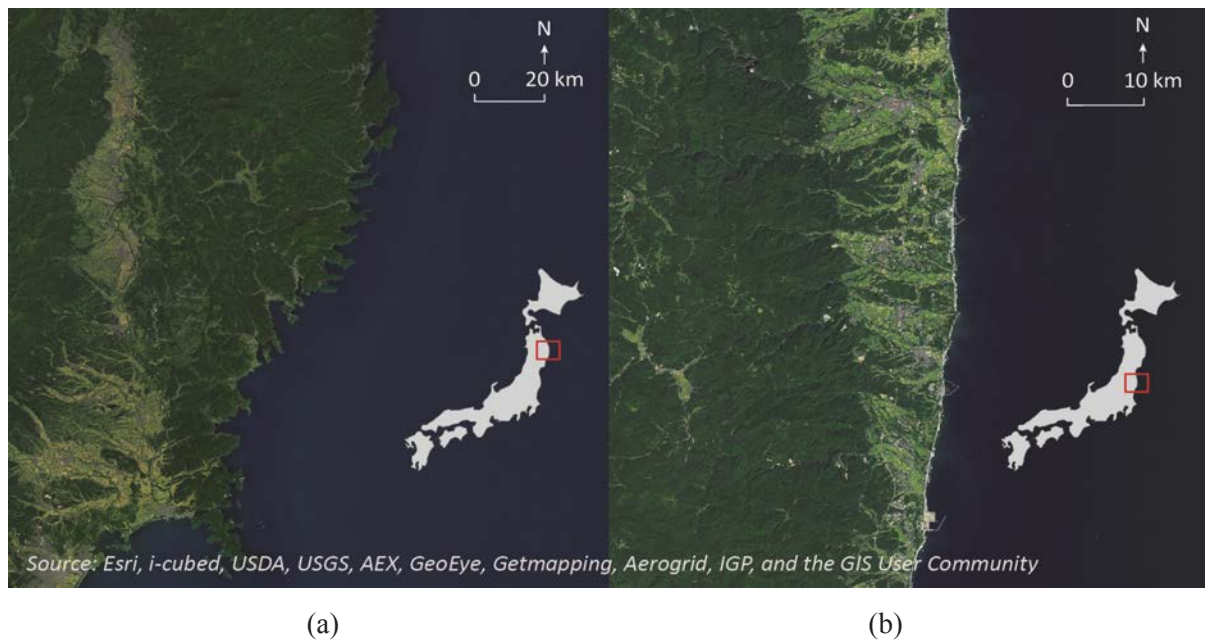
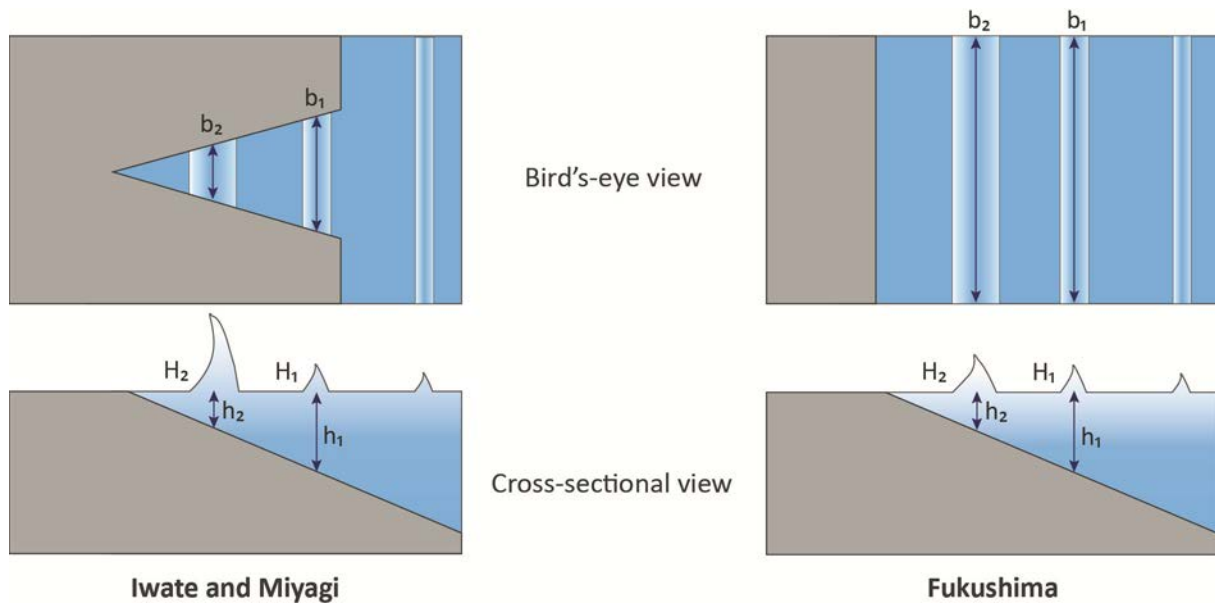
Using the same approach as in the Fukushima Daiichi NPP design basis, the maximum level adopted for the flood design event for Unit 1 of the Onagawa NPP site in 1970 was OP +2.00–3.00 m, as indicated in its Establishment Permit. This level corresponds to values obtained from the literature survey. Later, for Unit 2, in 1987, the highest flood level was determined at OP +9.10 m using numerical simulation techniques. However, the main plant grade level of the Onagawa NPP site is OP +14.80 m. Another reason for the increased level of tsunami runup historically recorded at the north of the Fukushima Daiichi NPP site, in the region of Miyagi and Iwate Prefectures, is the influence of the coastal topography and bathymetry. The Fukushima Daiichi site is located along a rectilinear coastline, while at the Onagawa NPP site, the coastline is a ria (a coastal inlet) with a V shape that would significantly amplify the wave heights of tsunamis. Figures 2.1–7 and 2.1–8, illustrate these issues [33].

FIG. 2.1–7. (a) Aerial view of Iwate and Miyagi Prefectures; and (b) Fukushima Prefecture.

FIG. 2.1-8. Influence of topography and bathymetry in Iwate and Miyagi Prefectures in comparison with Fukushima Prefecture [33].

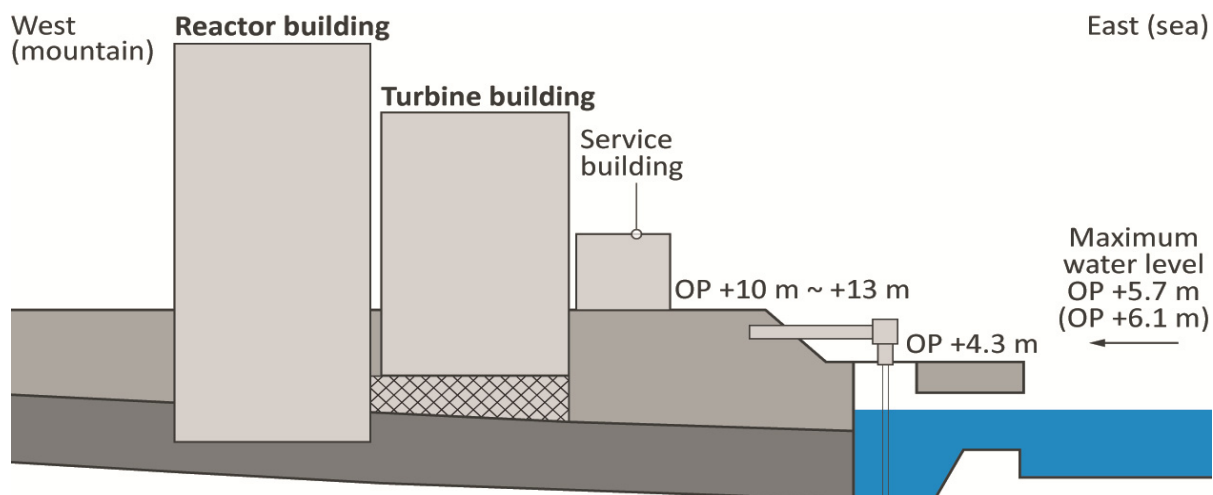
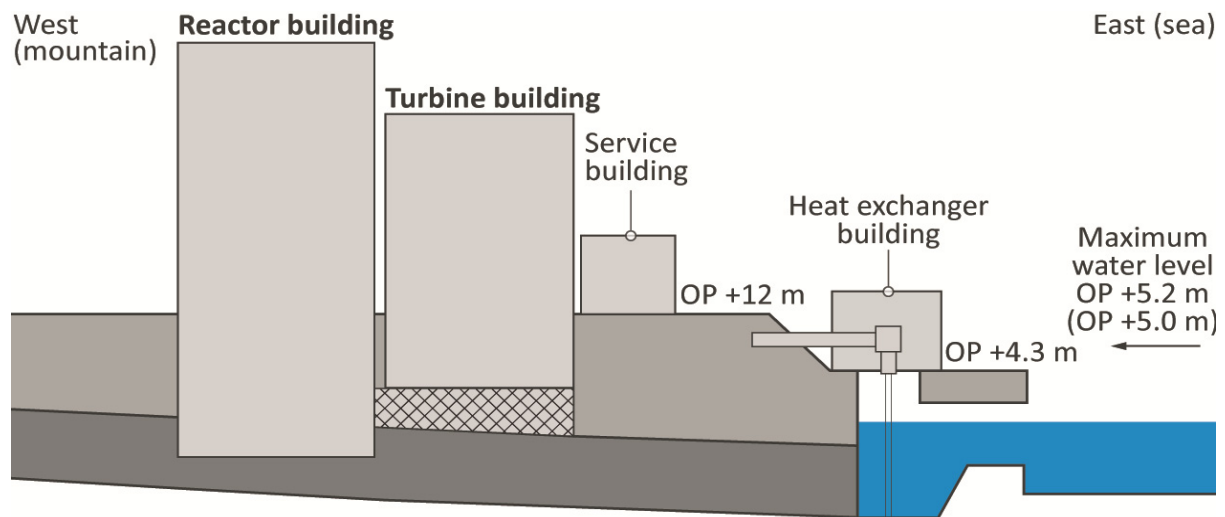
Later, in 2009, with more precise topography (onshore), bathymetry (offshore) and tidal data of the Fukushima Daiichi NPP site, TEPCO again performed this evaluation using the JSCE source models, and obtained the maximum water level of OP +6.10 m. Figures 2.1–13 and 2.1–14 illustrate the results obtained by TEPCO of the tsunami re-evaluations performed between 2002 and 2009 for the Fukushima Daiichi and Daini NPPs.

FIG. 2.1–13. Summary of 2002 and 2009 tsunami re-evaluations of the Fukushima Daiichi NPP using the JSCE methodology (topography and tide data were revised in 2009) [33].

FIG. 2.1–14. Summary of 2002 and 2009 tsunami re-evaluations of the Fukushima Daiichi NPP using the JSCE methodology (topography and tide data were revised in 2009) [33].
