SPENT FUEL STORAGE CORROSION MANAGEMENT

G.R. SUNARYO, SRIYONO
PTRKN-BATAN,
Serpong,
Indonesia

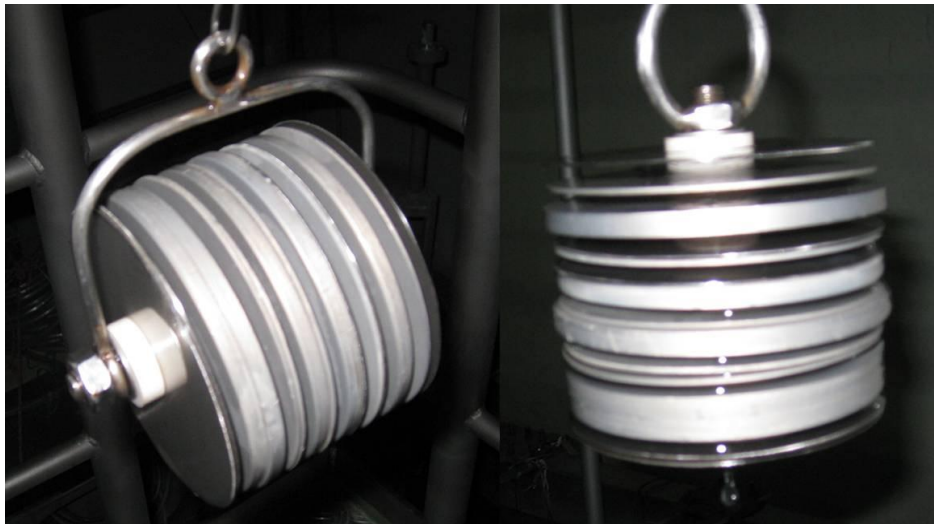
Withdrawn both coupons are shown in Figure 1. There is no color change observed. It can be understood that the general corrosion is not the main corrosion process for both position even after three years exposing duration. After dismantling, it can be seen that there is white debris on the surface on horizontally coupon (Figure 2). The dismantling process was difficult, because of corrosion, both discs are being stucked together.

Fig. 1. Coupon after 3 years exposing, vertically and horizontally.

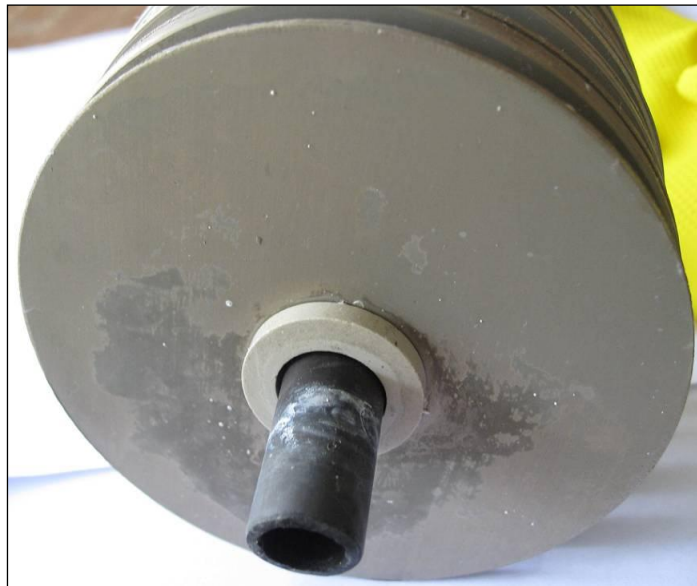
Fig. 2. White debris on the surface of horizontally coupon.

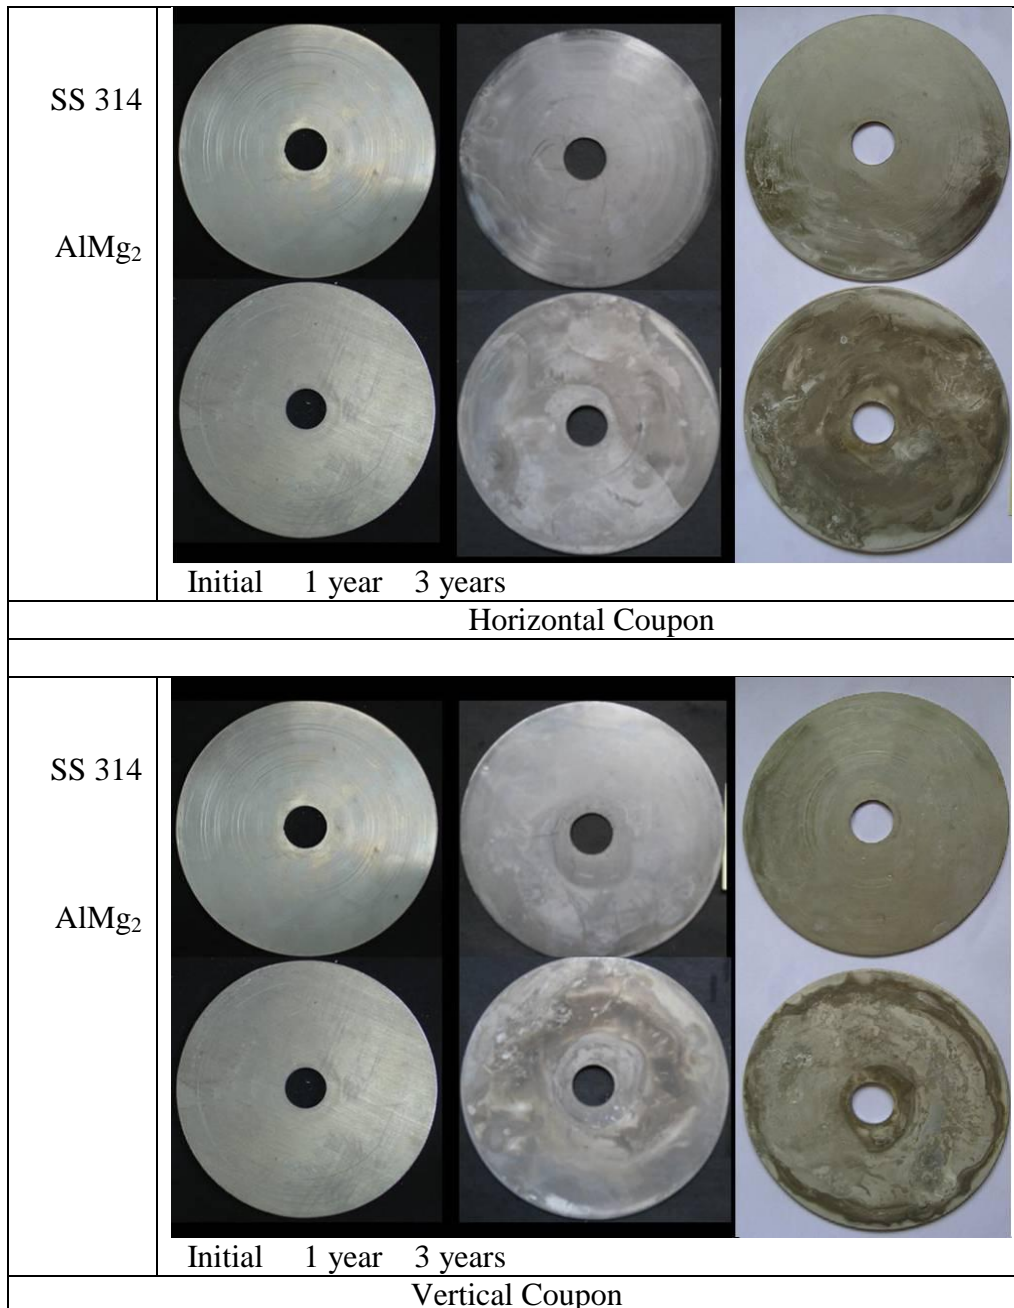
The galvanic pair discs are being dismantled and each pair are being documented and can be seen as upper for SS 314 and lower row for AlMg₂ in Figure 3. Similar pair for galvanic objects are being compared for each exposing duration, as zero, a year and three years [4]. From Figure 3, it can be understood that the Galvanic corrosion occurs clearly for both pair of SS314–AlMg₂ and SS314–Al₂Mg₃ (Figure 3.). The level of galvanic corrosion becomes worse due to the length of exposing time. The three years exposing time shows darker than the shorter exposing time a year. However, the aluminium coupons show more sacrificed than the SS coupon. Coupons from the vertically rack shows more severe galvanic corrosion occur. It can be considered that the trapped water in vertically racks seem to be stand longer than the horizontally racks, even there is no significant pH difference for both vertically and horizontally racks. From this results, it can be understood that the wet storage water flow rate doesn't fast enough to suppress the corrosion process for material which is being closed together, as experiment.

The white precipitation that mostly appears on the aluminium surface as Al₂O₃, has made those both galvanic pair becomes difficult to be separated by hands, because of stucked each other. The white precipitate is formed because of potential different between both

material that initiated the galvanic corrosion. From the weight measurement, there is only less than 1 μg weight difference for both before and after exposing coupons into the storage pool water, therefore becoming undetected well. The longer exposing duration of 3 years does not increase significantly the weight of white precipitation formed.

Fig. 3. Galvanic Corrosion between SS and AlMg₂ at various exposing time up to 3 years.

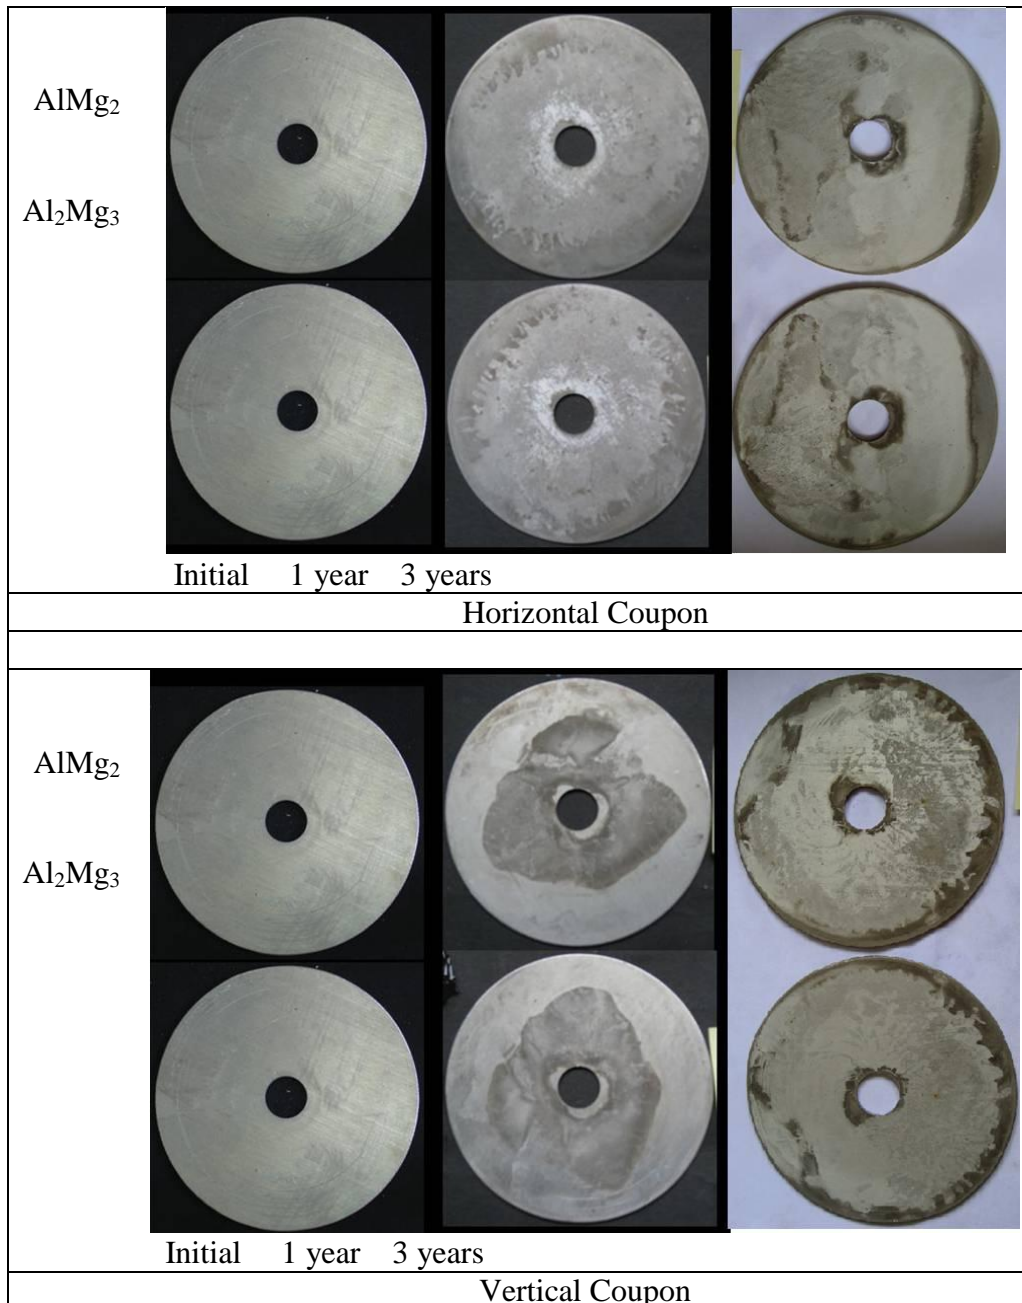
Crevice corrosion either is clearly being observed from AlMg₂ and Al₂Mg₃. The white precipitation appears more clear than galvanic corrosion in scale range of less than 10 μg with deviation error of 20%. Longer exposing duration of 3 years gives more precipitation visually, but still can not be measured quantitatively. Pair of aluminium from different number of magnesium gives white precipitation either. In this case the corrosion process of galvanic and crevice are mix. Visually gives similar white precipitation on both surfaces. Bio-corrosion does not occur and observe in these experimental results. Pitting corrosion also does not detected.

Fig. 4. Crevice Corrosion between $AlMg_2$ and $AlMg_3$ at various exposing time up to 3 years.
