# **Repair of the NRU Reactor Vessel: Technical Challenges and Lesson Learned**

David S. Cox

Atomic Energy of Canada Limited

**International Conference on Research Reactors:  
Safe Management and Effective Utilization**

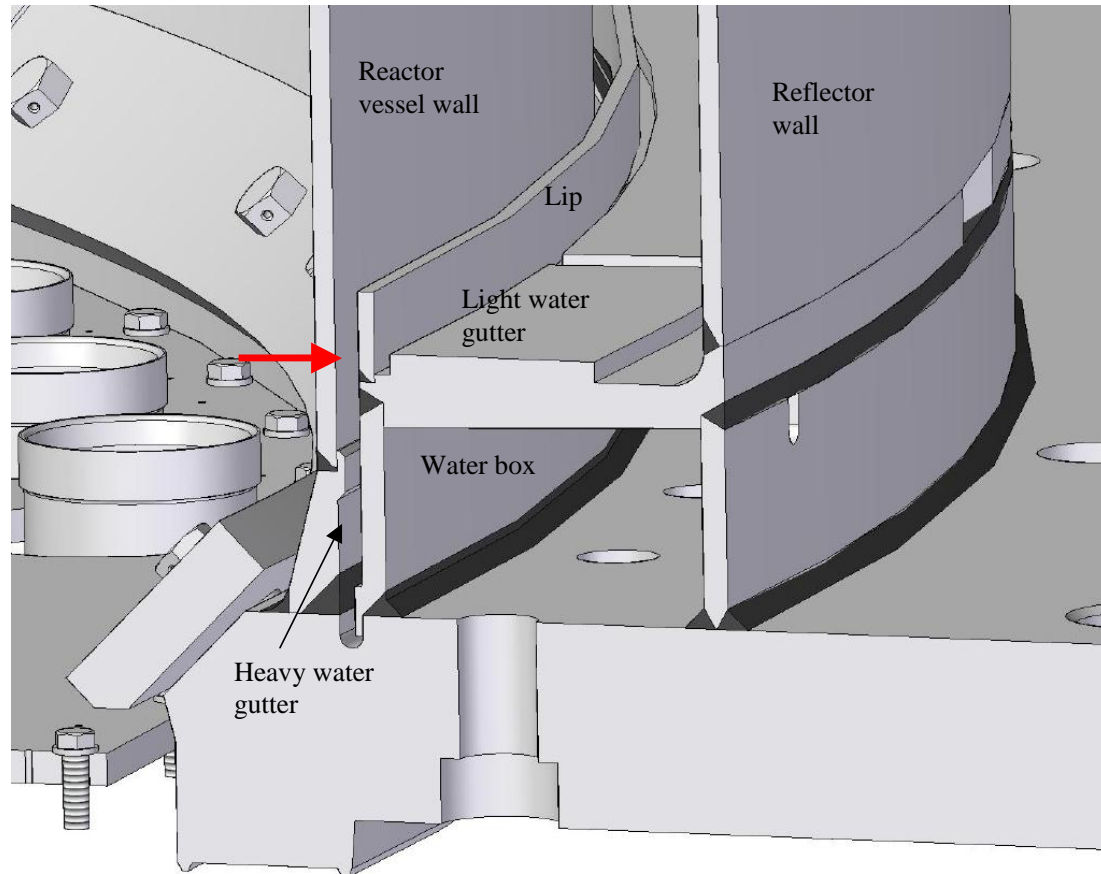
# Leak Site

- Detailed non-destructive examination of lower vessel wall performed
  - Leak location determined accurately
  - Widespread corrosion identified in the lower portion of the J-rod annulus

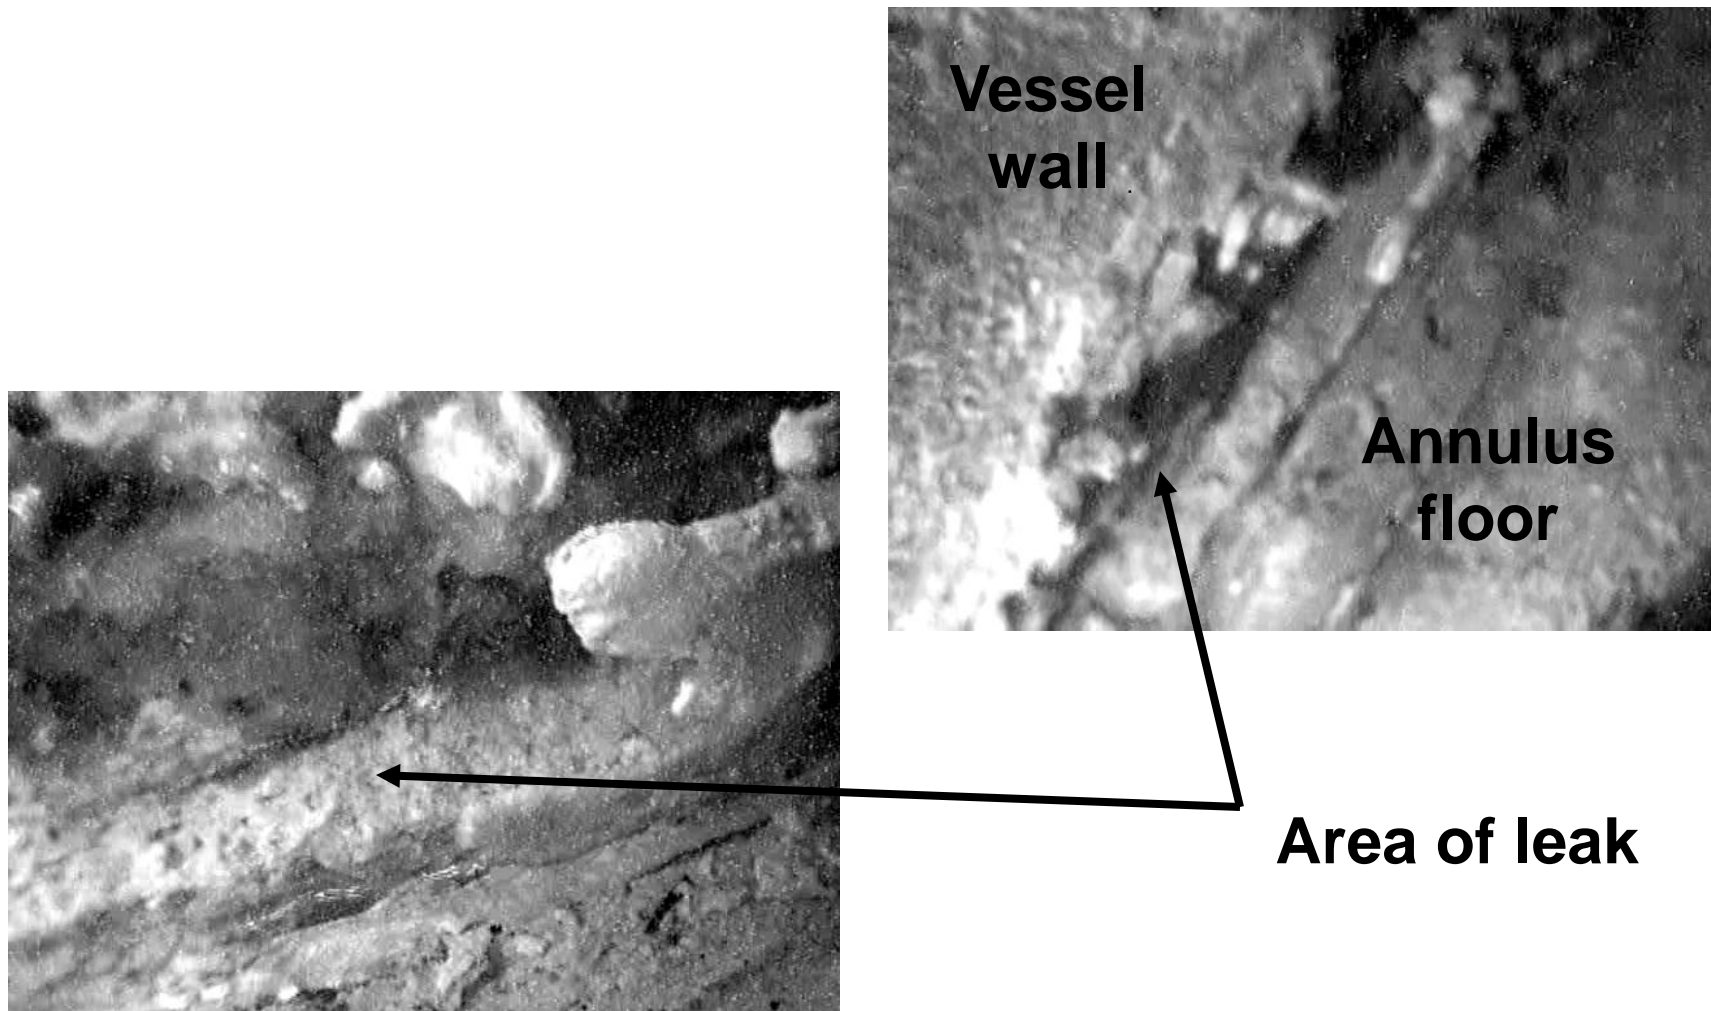
# A Closer Look at the Leak Site

- Minor heavy water leak from the vessel into the surrounding annulus detected (~5 kg/h)
  - Visual inspection determined that the leak site was in the vessel wall at the bottom of the annulus
  - Determined that the heavy water leak was due to corrosion of the reactor vessel wall from the outside
  - Additional areas of corrosion around the base of the vessel also required remediation
  - Decision made to remain shutdown for an extended period to repair the vessel

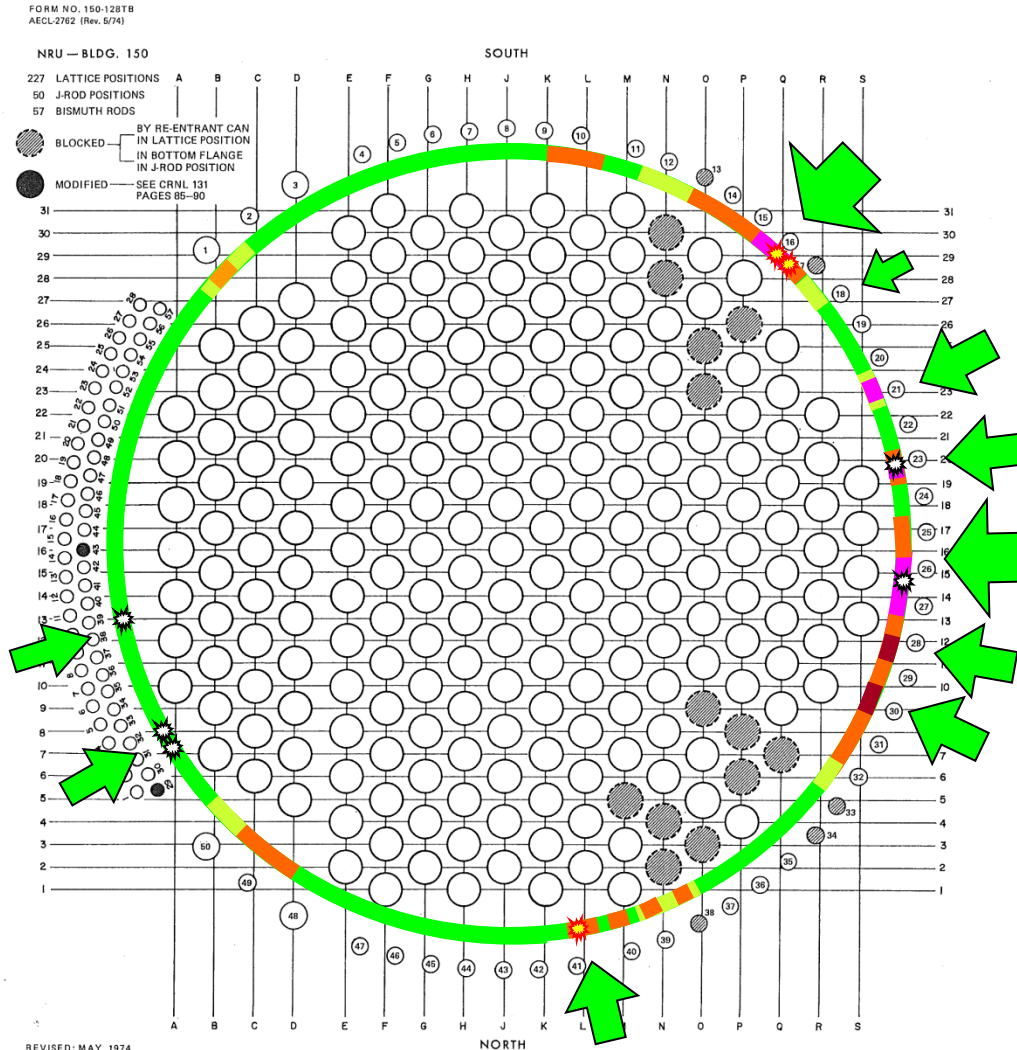
# Locations to Repair

1. BR-45
2. BR-29/30
3. JR-30
4. JR-28
5. JR-21
6. JR-41
7. JR-18
8. JR-23
9. JR-25/27
10. JR-13/17

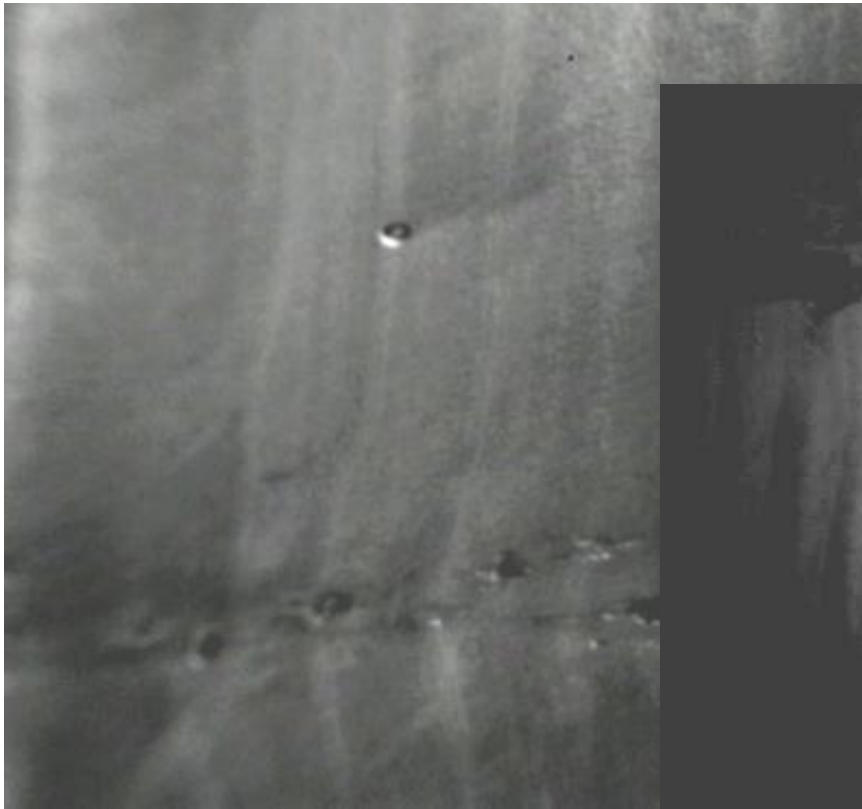
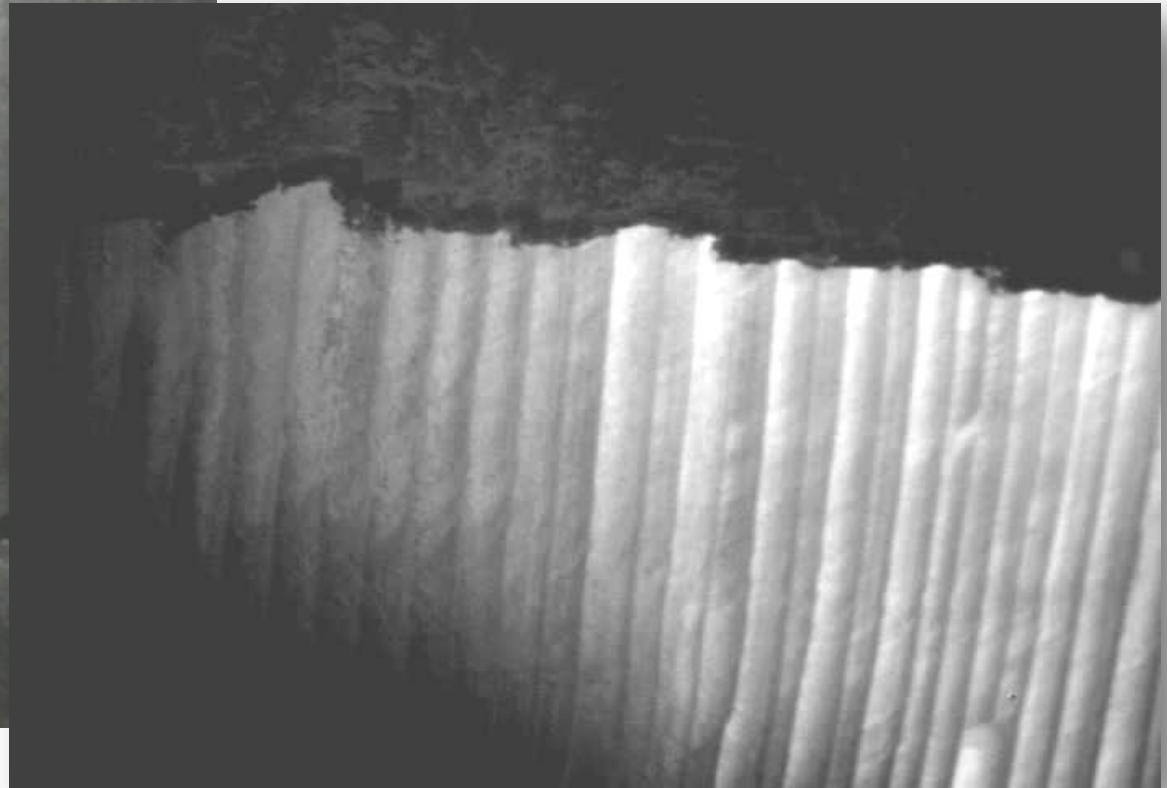
# JR-41 Leak Site After Cleaning

**In-Vessel Cleaning completed for all repairs sites and material sampling locations**

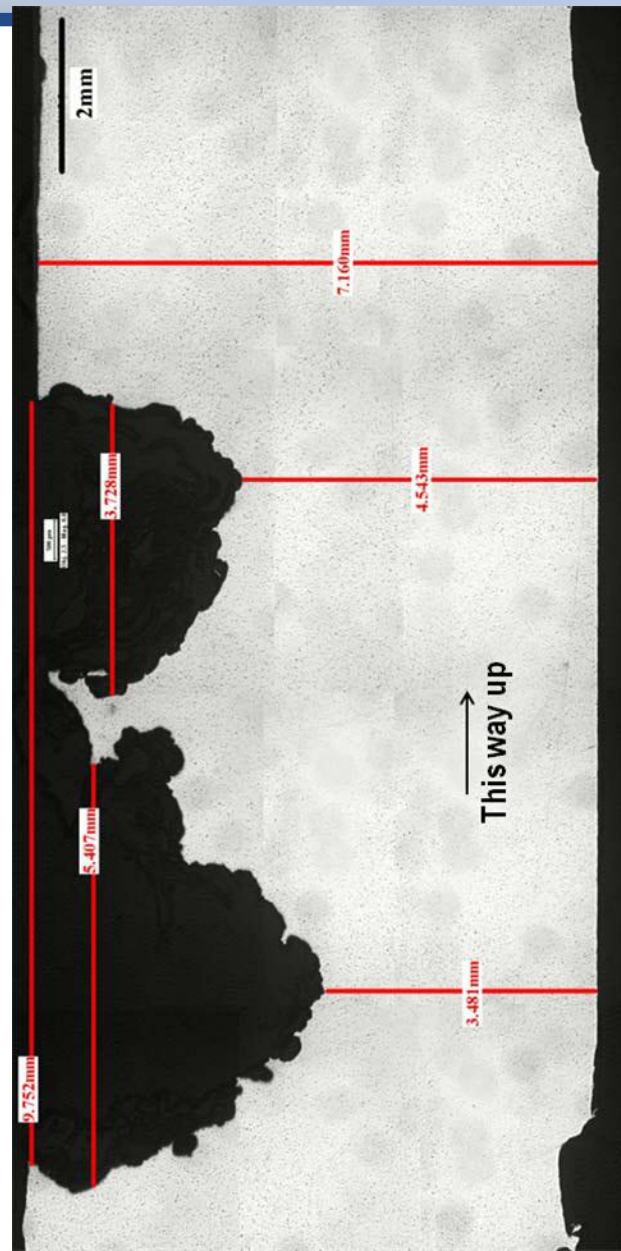
- J-rod Side

- J-rod annulus designed to be filled with carbon dioxide gas and kept dry
- However:
  - Aging of CO<sub>2</sub> system reduced gas flow
  - Light water ingress from reflector leaks into J-rod annulus
  - Air ingress from openings in J-rod annulus
  - High radiation environment
- Created the conditions for radiolytic production of nitric acid
- General wastage corrosion in wetted regions, and localized corrosion at air/water interface

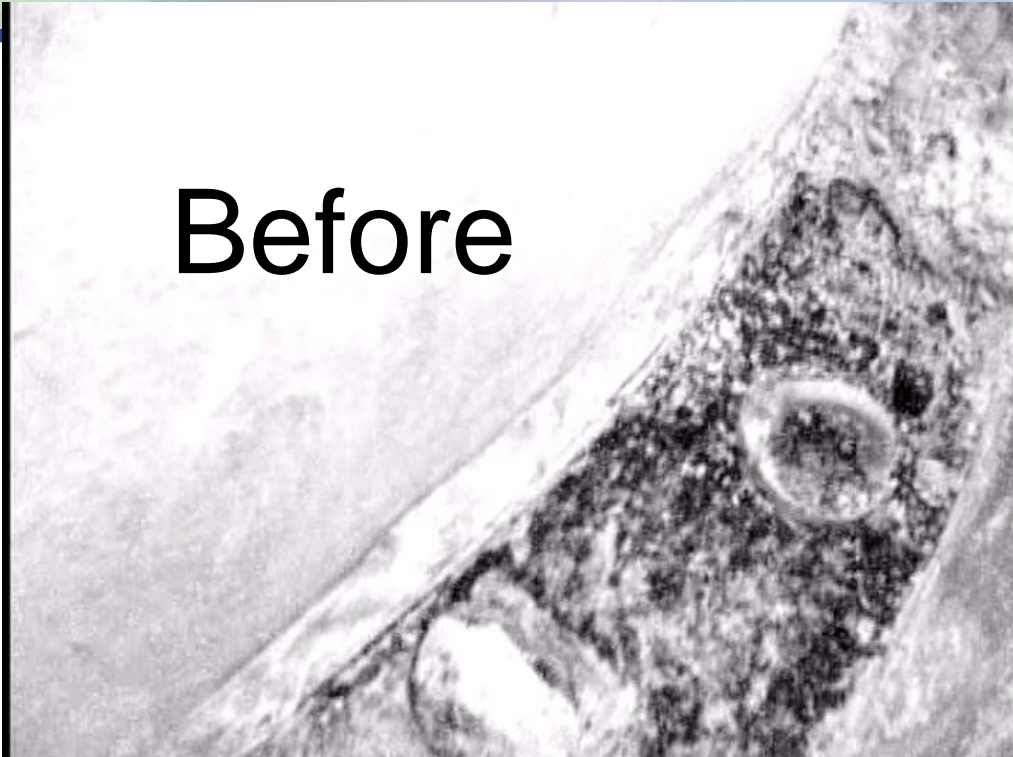
Before

Articulating J-Rod  
Annulus Vacuum Tool  
Near JR-3 position

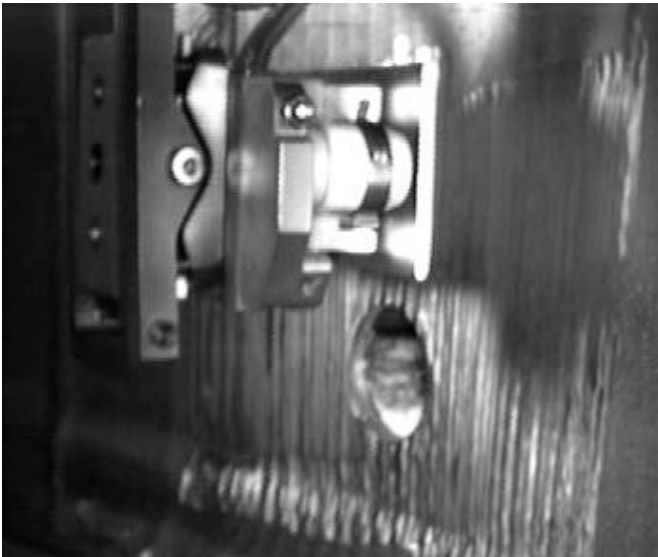
# Repair at JR-41 – The Leak Site

Backing  
strip  
placement

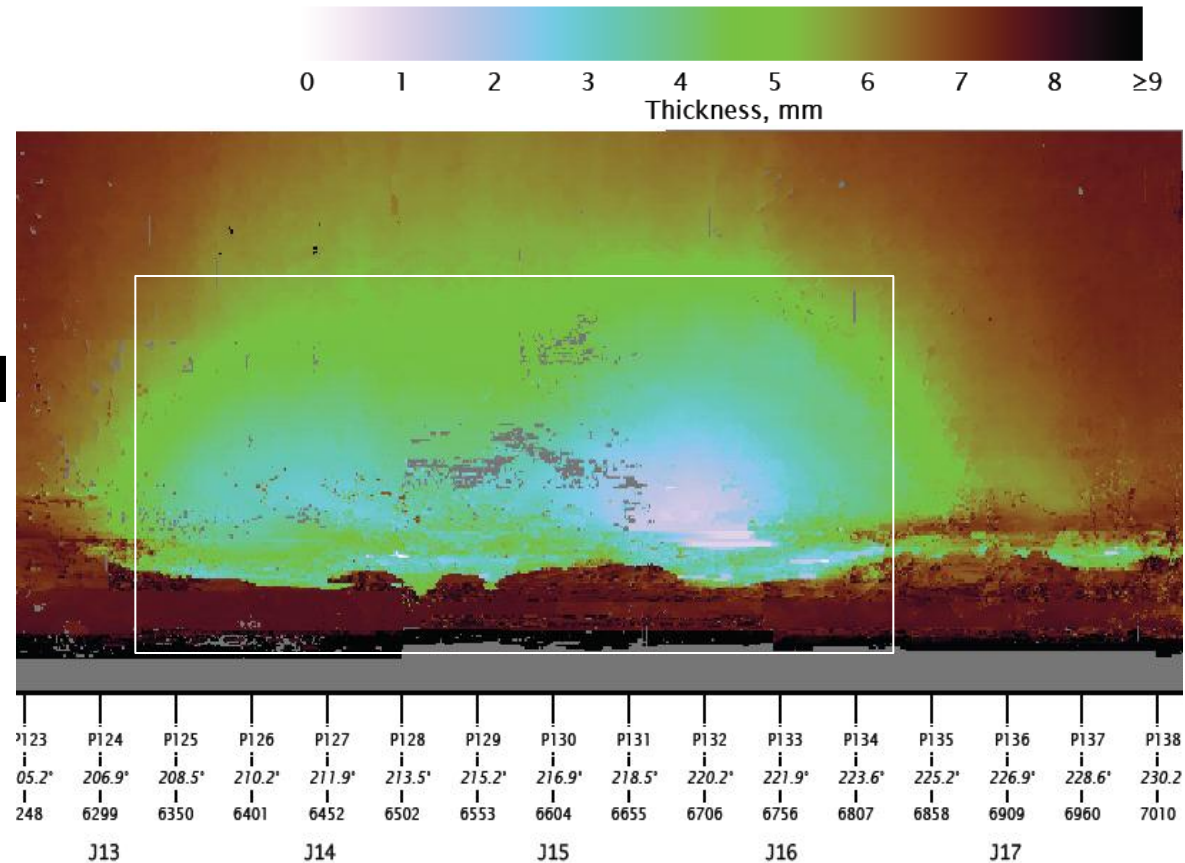
# Final Repair – JR-13/17

- Two through wall penetrations
- Thinning to less than 1mm
- Located below and between two re-entrant cans
- Large area: W x H  
59 cm x 26 cm  
10.4" x 23"

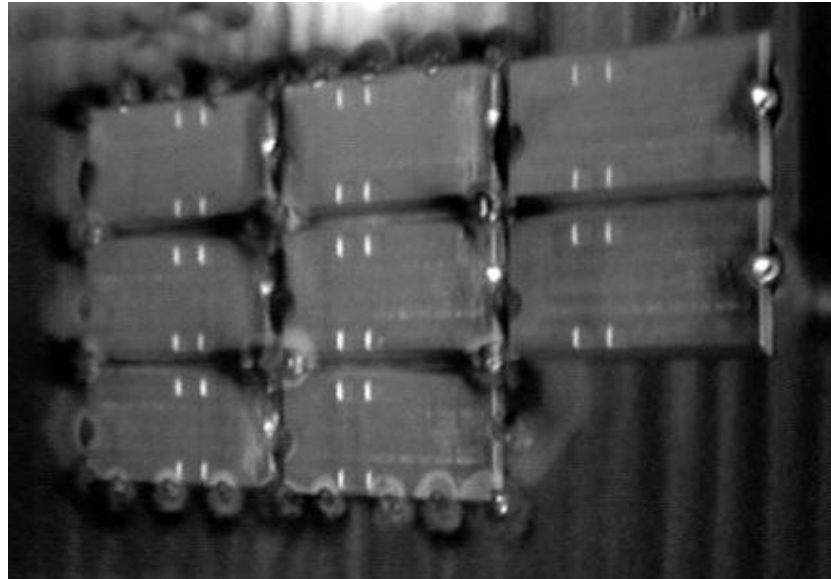
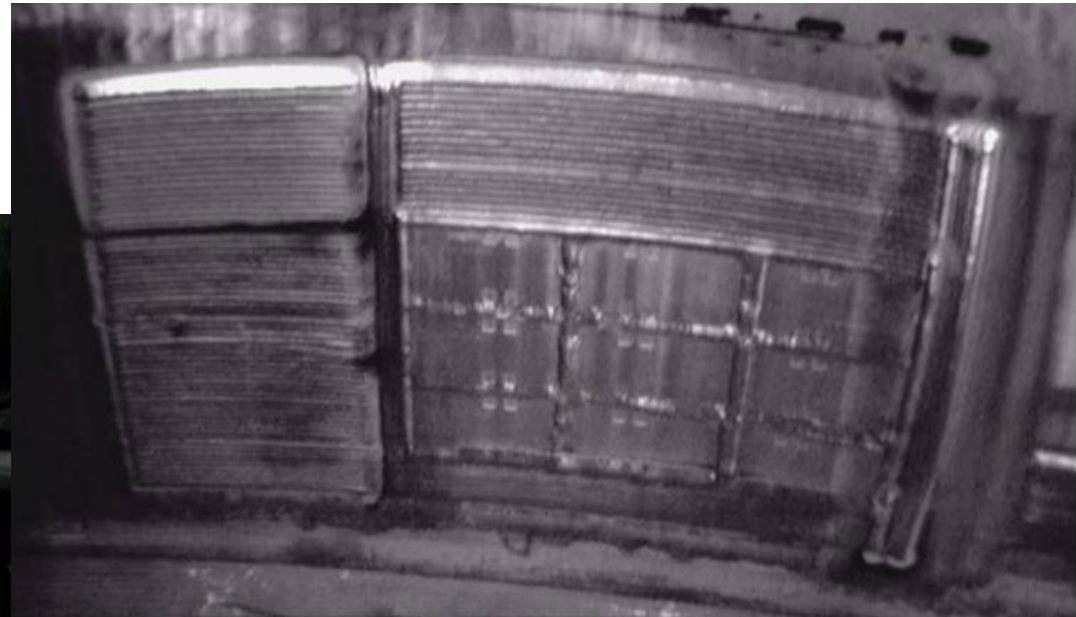
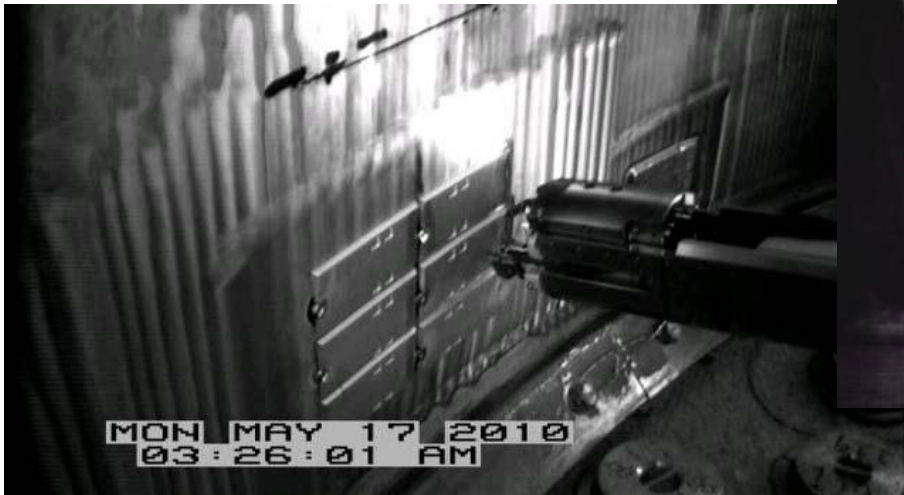
# Repair at JR-13/17

**Multiple challenges encountered:**

- Plate attachment
- Design change
- Crack repair and re-inspection
