International Conference on Research Reactors: Safe Management and Effective Utilization

Corrosion Induced Leakage in the Radial Beam Port of the 3 MW TRIGA Mark-II Research Reactor of Bangladesh

M. Ali Zulquarnain

Atomic Energy Research Establishment
Bangladesh Atomic Energy Commission
Email: zmaliee@gmail.com

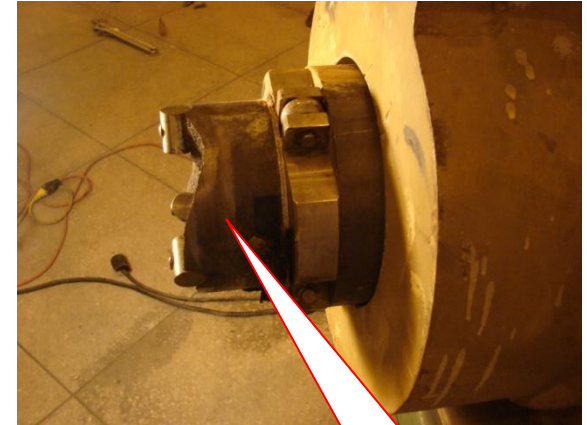
**Removal of
the 1st part**

Broken parts of the radial beam port

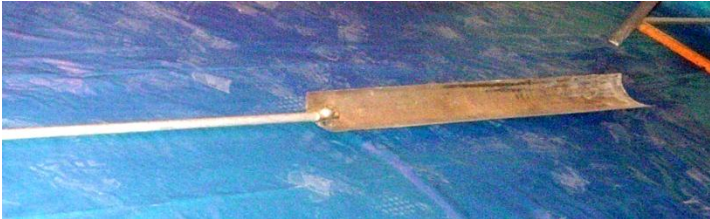
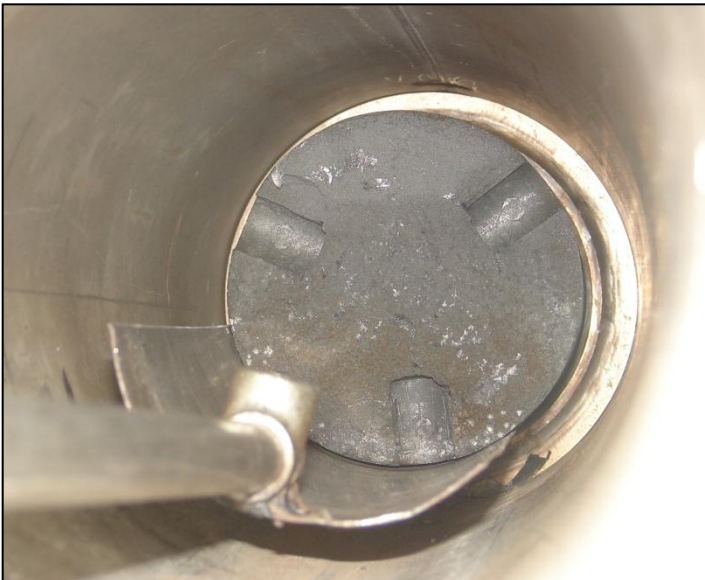
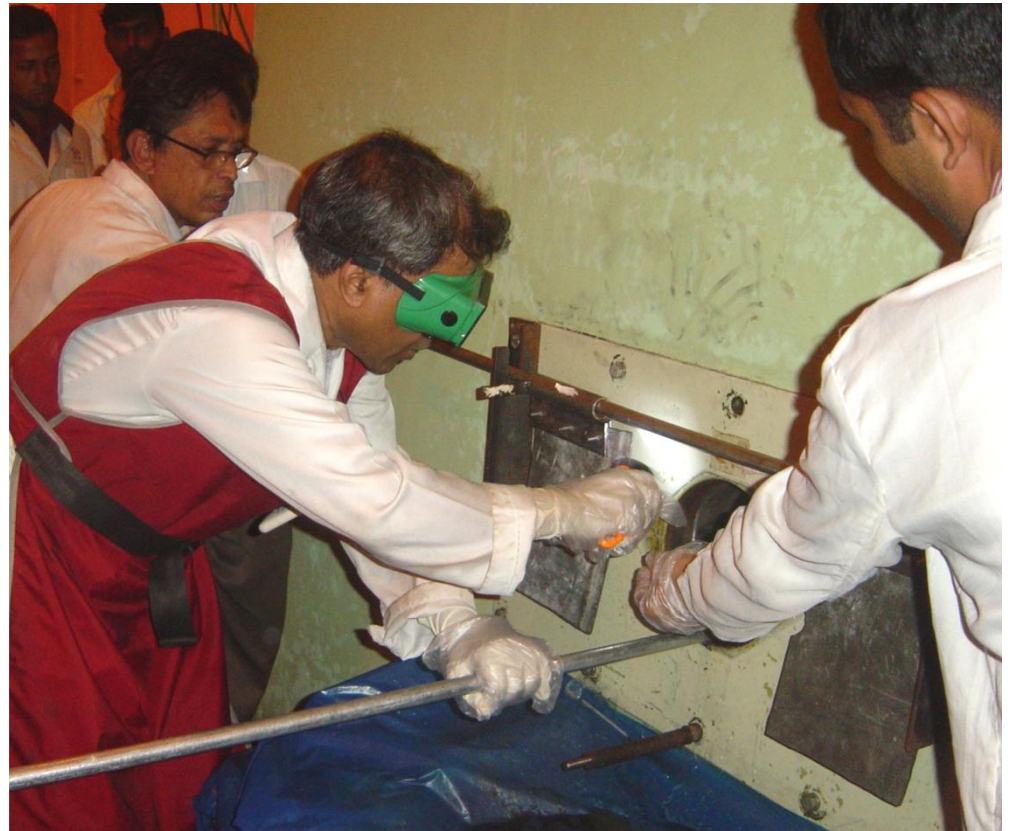
Removal of the 2nd part

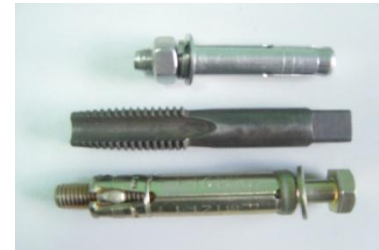
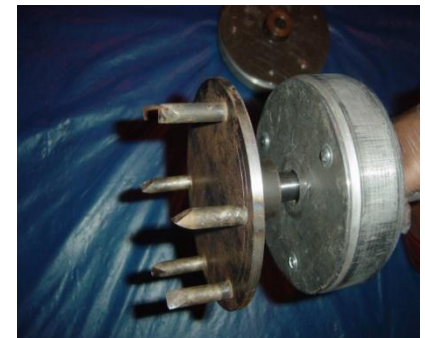
- Removal of the 33.02cm long **3rd part** was quite difficult as it got stuck with the aluminum part of beam port tube very tightly.
- The **plug** was pulled by a mechanical tension application device after installing a rowel bolt on the plug, **but it could not be moved.**

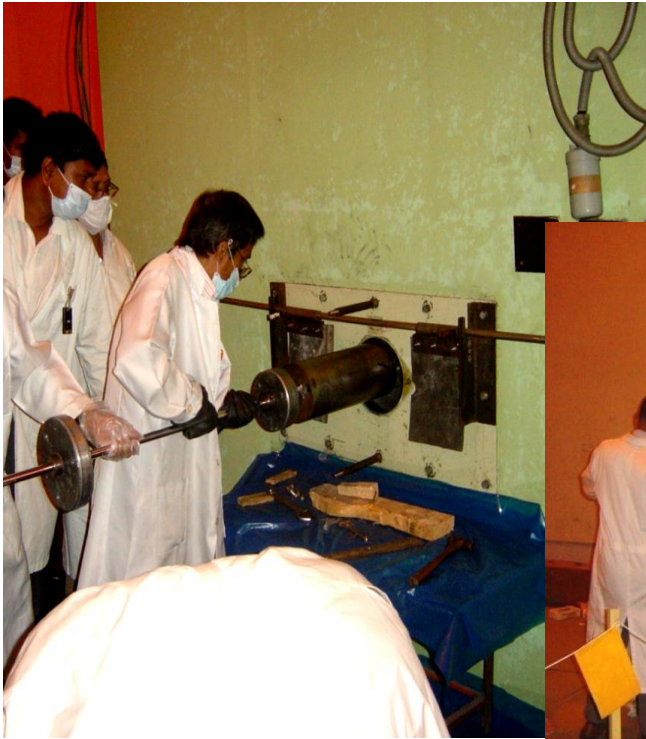
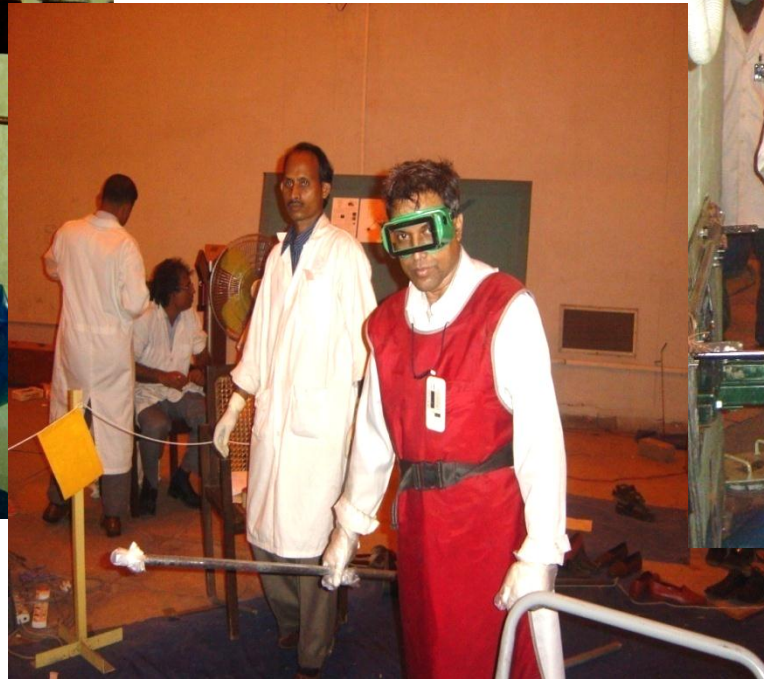
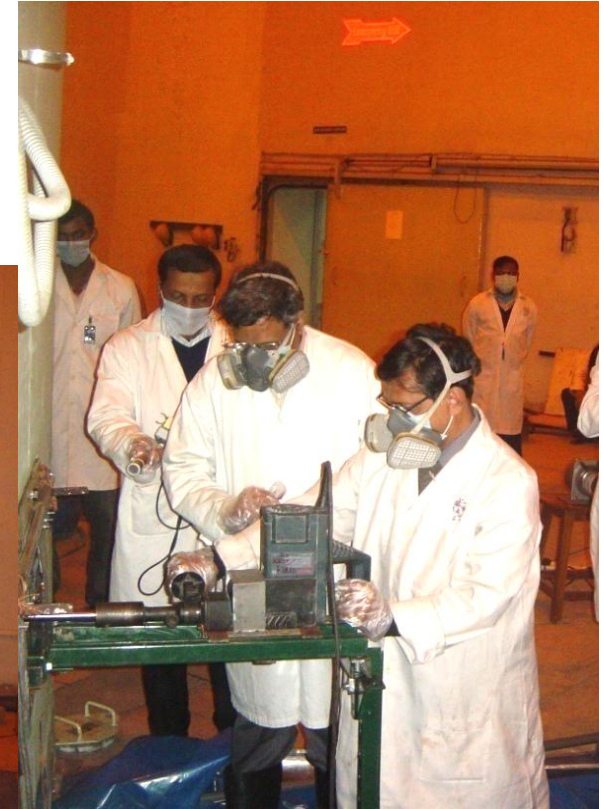
- While performing the removal operation, **extreme care** was taken such that the corroded aluminum **BP pipe did not get damaged** and also that the amount of **graphite dust** generated could be **kept at minimum**.

Activities for removal of the 3rd part of the beam port plug

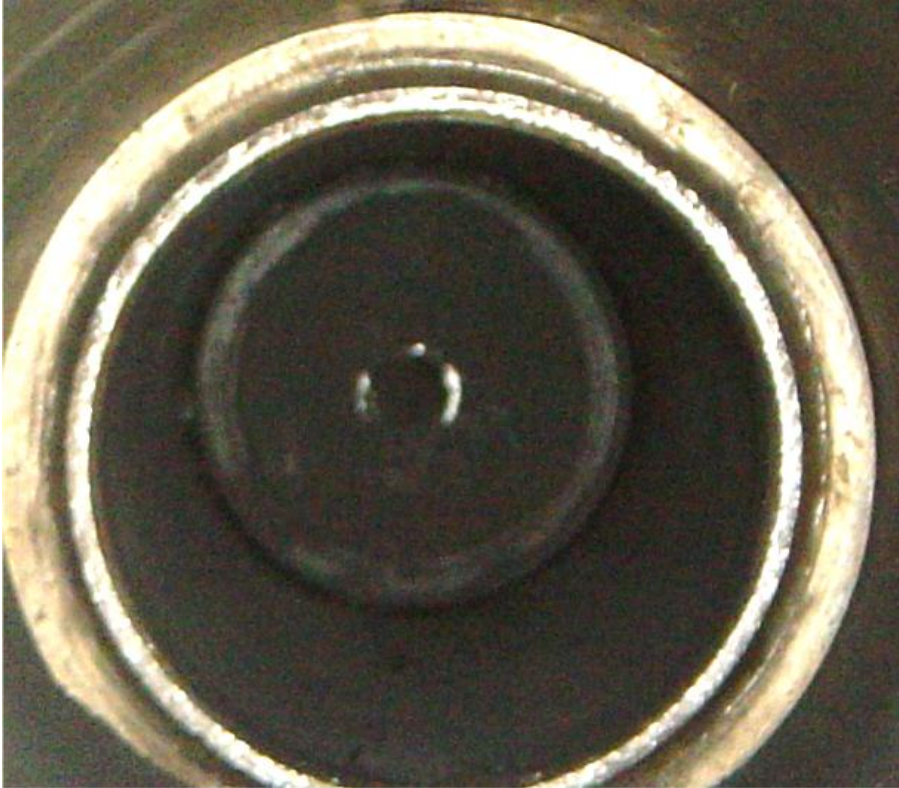
(a) Before removal of the plug

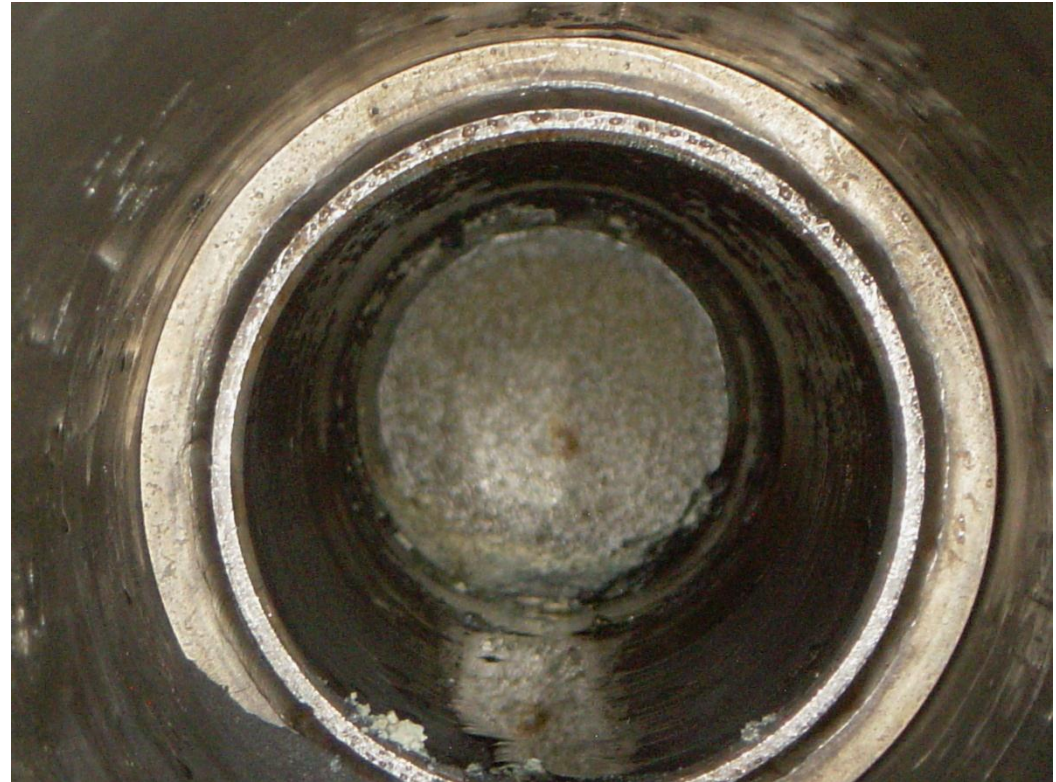
(b) After removal of the plug

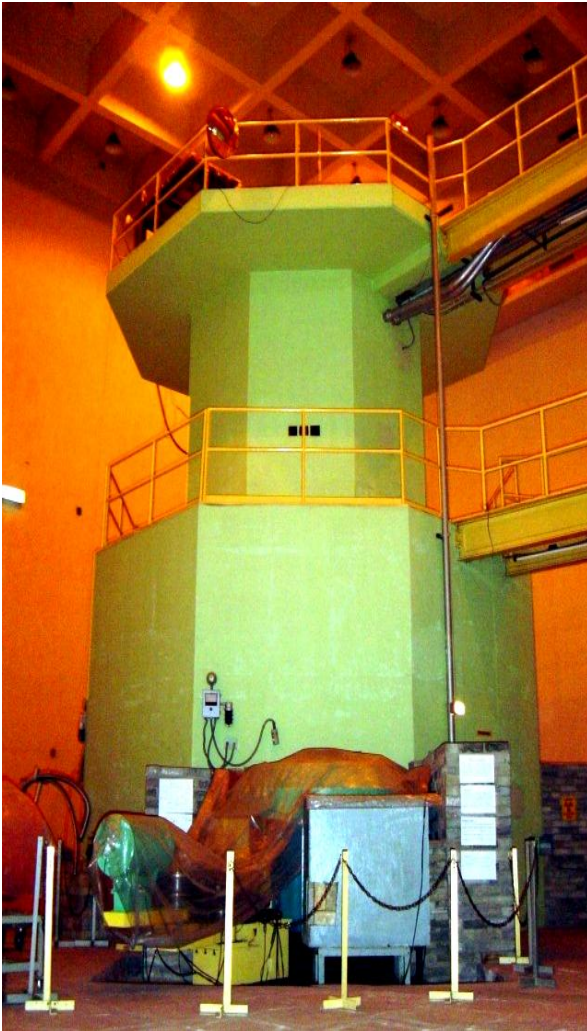
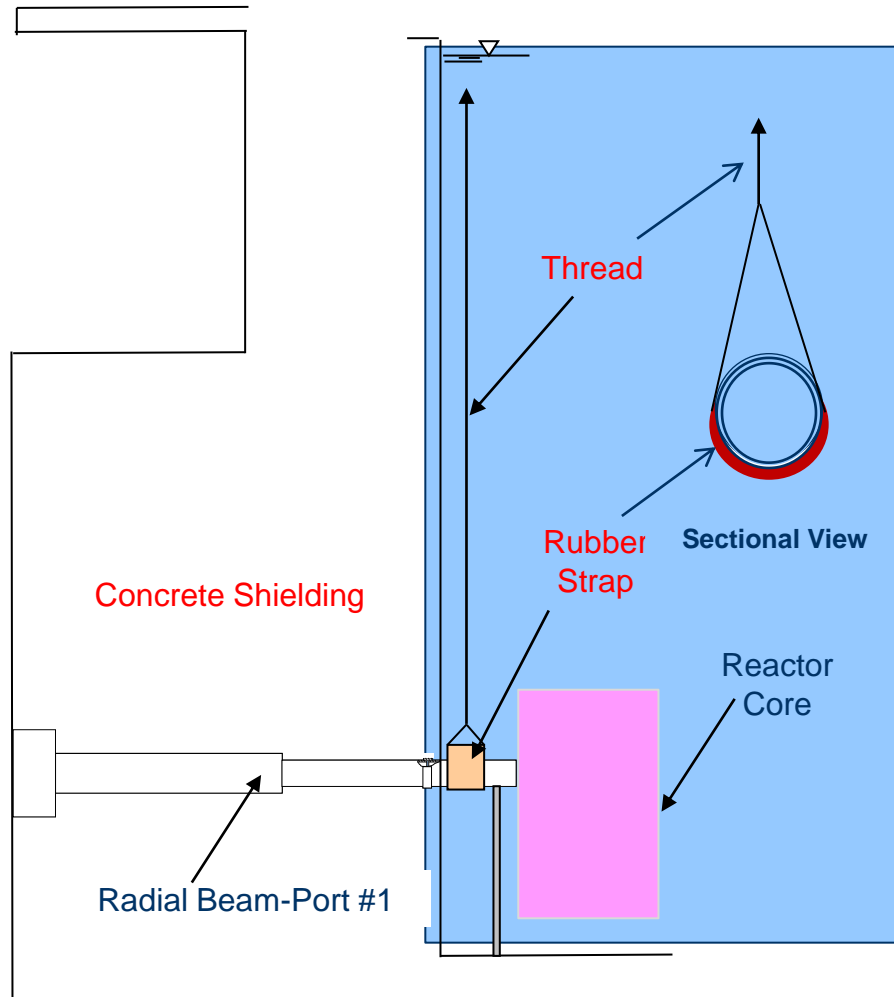
- A couple of days after the stuck out graphite plug had been removed, reactor pool water was found to be leaking through the beam port.
- Leakage of water was stopped temporarily by wrapping a **rubber strap** around the leaking part of the RBP-1.

View Showing Installation of the Rubber Strap

Installation
of Rubber
Strap

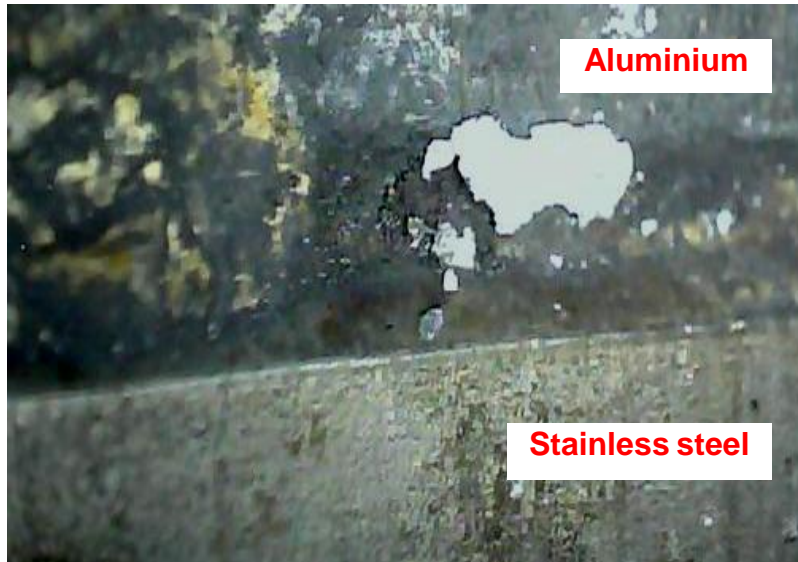
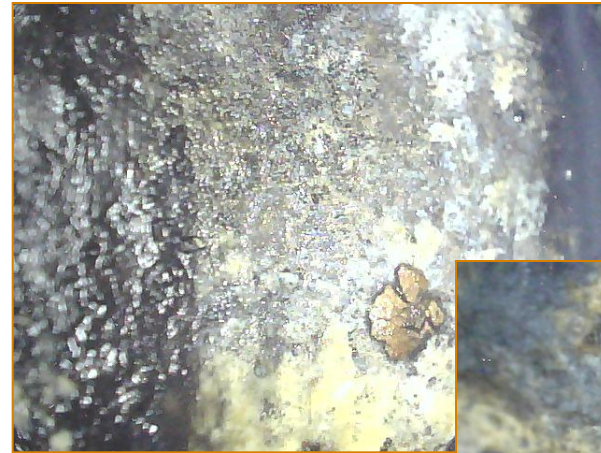
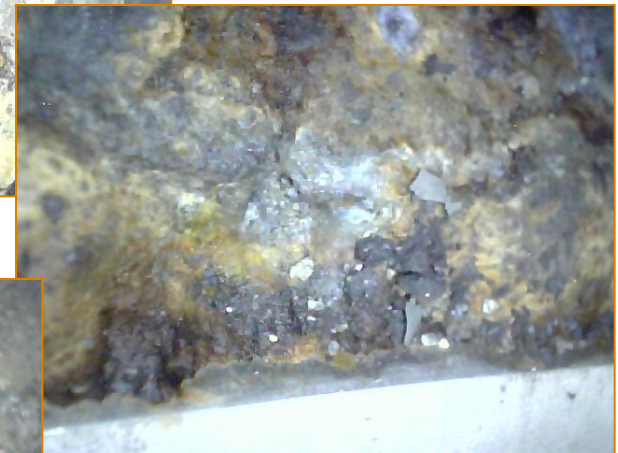
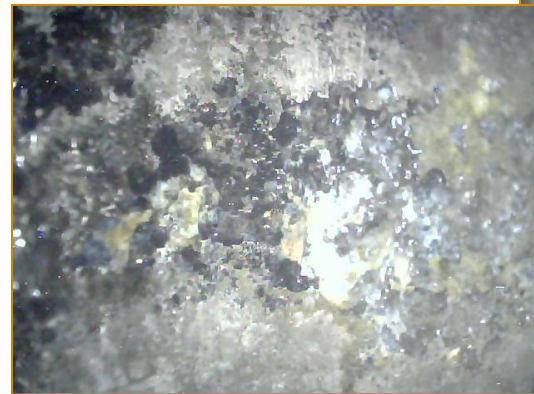
Corrosion at the Al-SS junction

Corrosion Marks Captured by a Digital Camera (web-cam)

- The pictures clearly show **corrosion damage** in the form of **metal removal** and **pits** on the inner bottom surface of the aluminium pipe.
- Brown stains are observed on the surface of the SS pipe, but there does not exist any **pit** or **mark of metal removal**.

- The analysis revealed that the damages in terms of corrosion had been initiated at the **Al-SS interface** where a **SS sleeve/ socket** had been used to cover the circumferential gap between the SS and Al pipes.

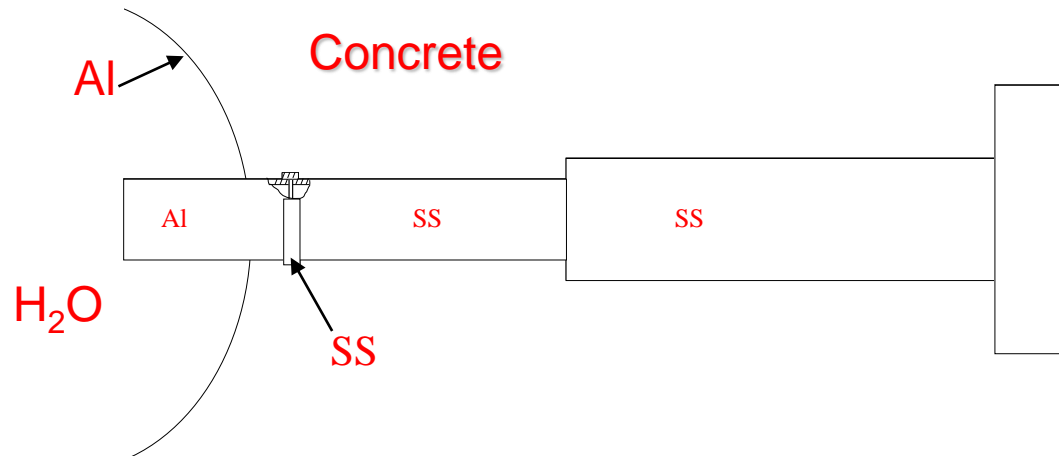
- **The interface with the sleeve/socket around it was not wrapped with sealant during pouring of concrete.**
- **As a result moisture from the surrounding concrete found its way to the gap between the Graphite plug and Aluminium pipe.**

- Later these moistures initiated the corrosion process onto the Aluminium pipe.
- The continual presence of moisture transformed the protective Aluminium Oxide layer into **Aluminium Hydroxide**, which is **porous** and cannot prevent air and moisture to seep through it and attack the fresh Aluminium underneath.

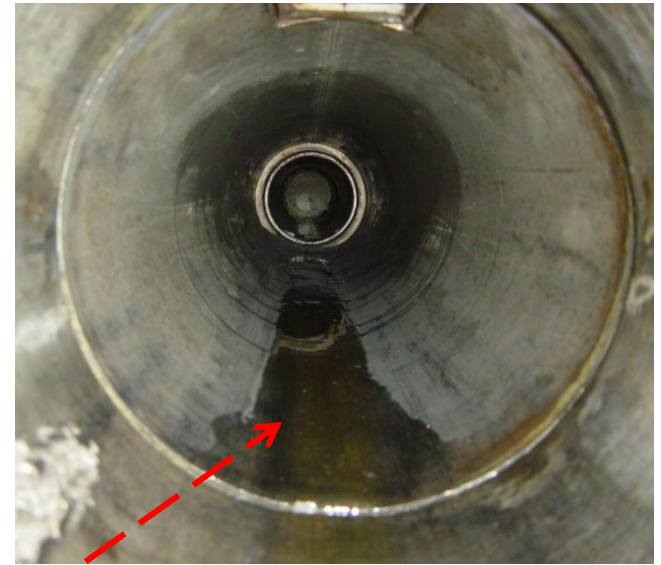
- The cracks and/or pits resulted as the corrosion went through the **inter-granularity** of the Aluminium pipe and **allowed water from the reactor tank to** sip through and drain out of the beam port.

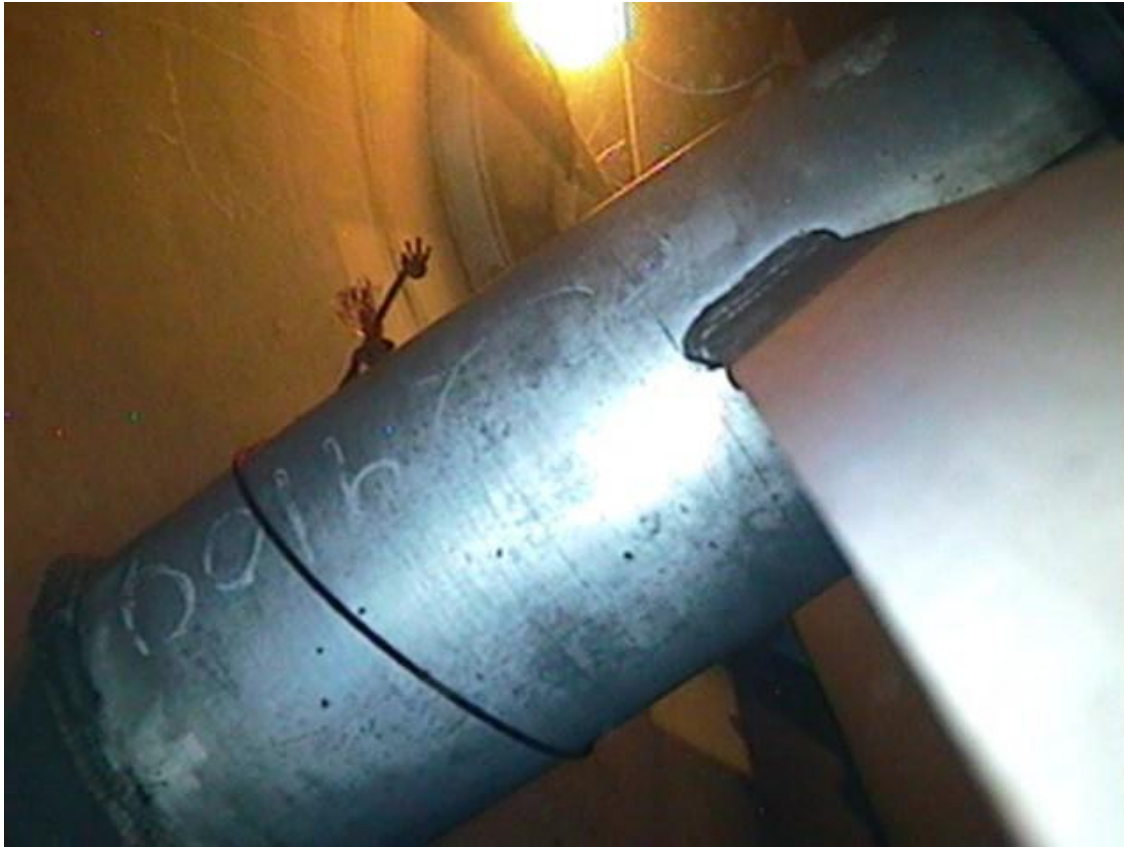
Bottom Part of the RBP-1 as Viewed by the Underwater Camera Supplied by the IAEA

- ❑ Inspection results showed that the leaks were located at distances **between 15.24cm to 35.56cm** from the dead end of the RBP-1.
- ❑ As such it was decided to install an Al-clam with Si-rubber lining around the leaking area of the beam port tube.
