2012–2014

NUCLEAR POWER PLANT
OPERATING EXPERIENCE
FROM THE IAEA/NEA
INTERNATIONAL REPORTING SYSTEM
FOR OPERATING EXPERIENCE
2012–2014

INTERNATIONAL ATOMIC ENERGY AGENCY
VIENNA, 2018

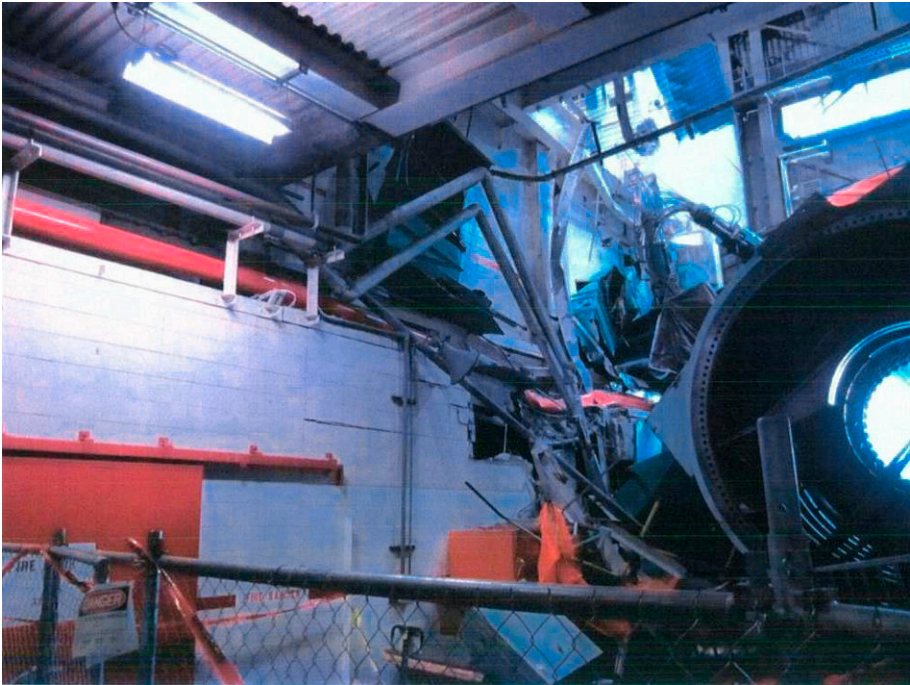
The safety significant event took place at a two unit site. Unit 1 was shut down, cooled down and about one week into a refuelling outage. Unit 2 was operating at 100% power with no technical specification limitations in effect. One of Unit 1's outage activities involved the replacement of the main generator stator. The plant operator hired a contractor to lead this activity, and the main contractor subcontracted another company to carry out the project's heavy lift operation. The temporary heavy lift assembly being used for the main generator stator replacement collapsed while lifting the stator. The main generator stator weighed approximately 500 t (500 10³ kg). One contract worker was killed and several others were injured as a result of the collapse. The impact of the stator drop was felt throughout both plants. Substantial damage was sustained by electrical switch gear and mechanical equipment located on the level below the turbine deck. The complications caused by the stator drop and related equipment damage included the following:

In the event described at the beginning of this section, while a stator was lifted for replacement, the temporary crane that was being used collapsed, and the stator fell. The dropped stator created a lot of debris before coming to rest on the hauler in the train bay (Fig. 2). Licensee staff had not checked the adequacy of the temporary crane before starting the job and instead relied on the contractor's statement that this equipment had been used previously to lift a load of the same weight. A design problem with the temporary crane was therefore missed. The investigation of the event revealed several industrial safety violations by the licensee and the contractors, as well as deficiencies in contractor supervision by the licensee.

FIG. 2. Dropped stator (partially shown on the right).

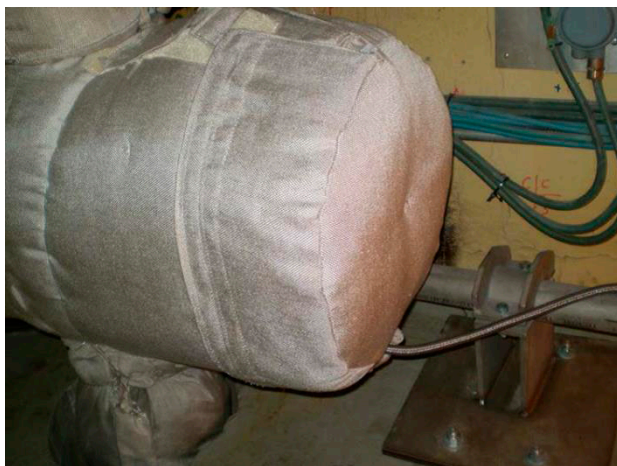
FIG. 3. Improper insulation installation.

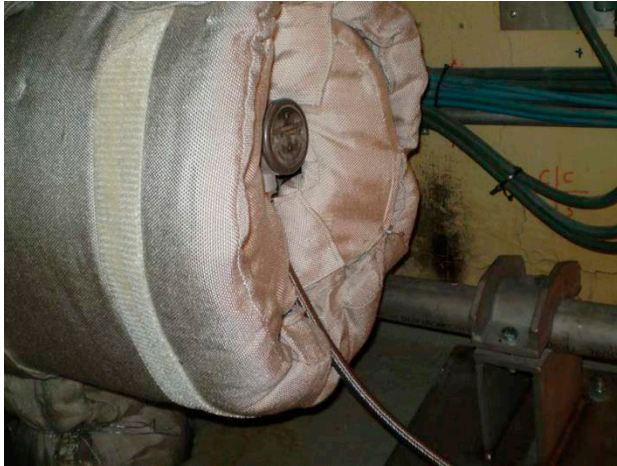
FIG. 4. Proper insulation installation.

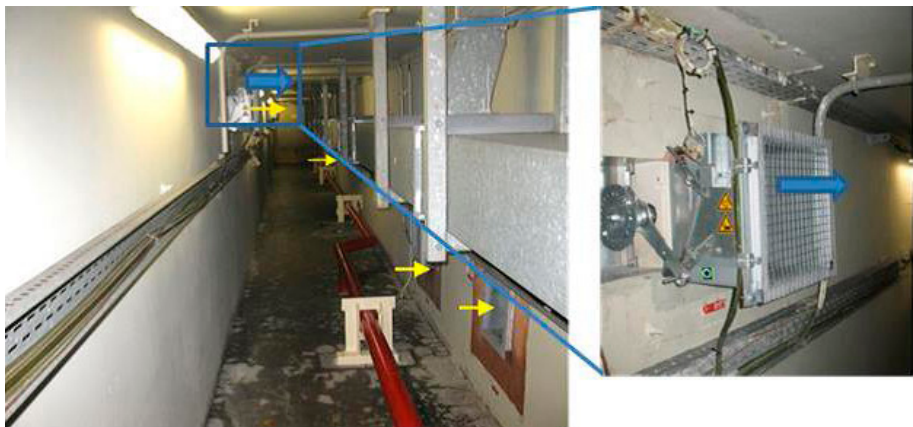
In another event, a failure in the sewage system control circuits led to an internal flood in the room housing the fuel oil tank pumps and caused prolonged unavailability (i.e. more than one day) of one of the diesel generators. Another internal flood was caused by the rupture of a rubber bellow in a diesel generator cooling pipe. An error in the design pressure of the bellow technical specification was the cause of the bellow failure. The flood could have spread to different rooms because the plant flood safety analysis had not included the case of a double guillotine break in low energy piping, according to applicable standards (only a limited leak rate). As a result, the room's sump volume and draining capacity were insufficient (see Fig. 5).

FIG. 5. Examples of internal flooding.

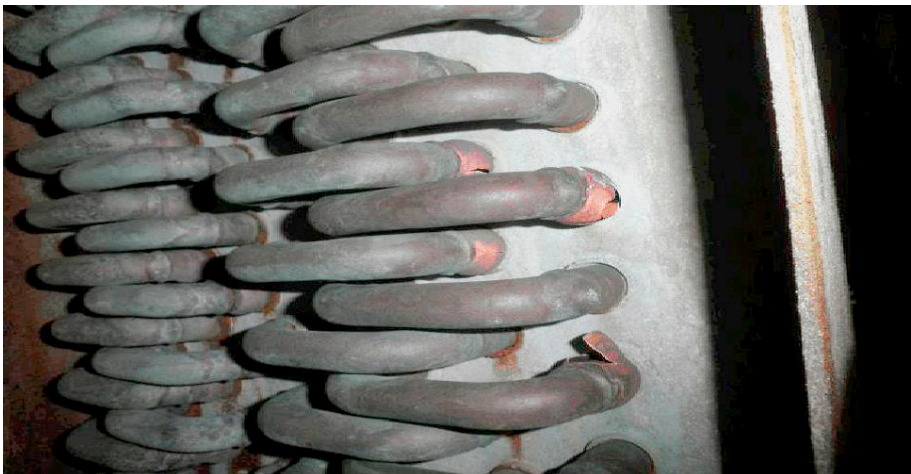
A leak from the heat exchanger tubes (Fig. 7) in a hot water system required to maintain building temperatures could have led to loss of the reactor coolant system's boron make-up function if not dealt with quickly.

FIG. 7. Heat exchanger tubes, showing origin of leak.

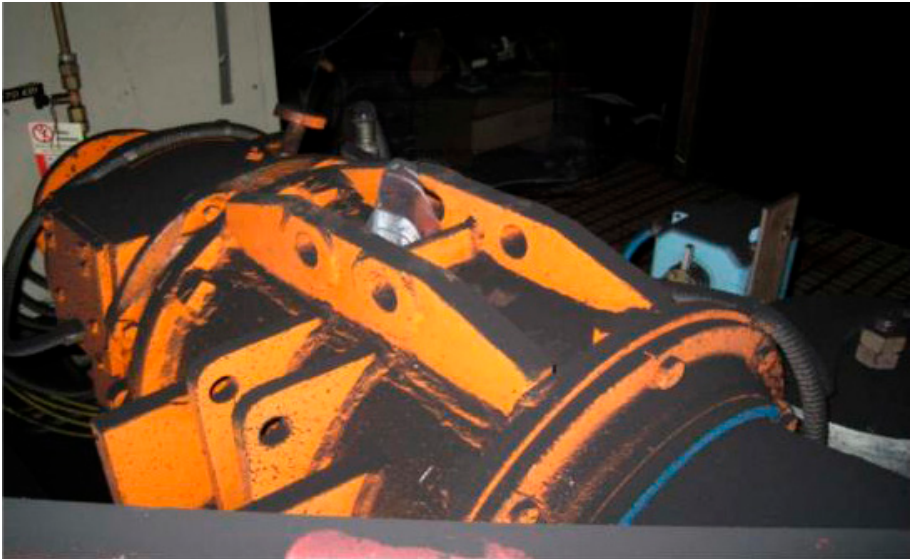
At another facility, a major fire was caused by the inappropriate implementation of a containment air test procedure. According to the procedure, during the test there should be no transient fire loads present and no equipment electrically connected in containment. A violation of the procedure (one vacuum cleaner was energized) led to a fire in one of the electrical motors. The investigation of the event showed that the operation and supervisory management and the operational staff had not fully understood the challenge for the organization because the containment air test had been rescheduled. Organizational weaknesses, including unclear responsibilities, deficient communication and a lack of strategic planning, contributed to the event. Although the event did not result in any consequences for the public or environment, did not lead to fuel damage and did not affect safety systems, it did lead to a large fire that continued for 30 minutes and had the potential for fire or smoke propagation to safety related compartments. In addition, as a result of the fire, the whole containment was covered with black soot particles (Fig. 8) that

FIG. 8. Pump covered with soot after a fire during a containment air test.

resulted in an extended production loss during the cleanup and restoration of the containment and all the components located inside it.

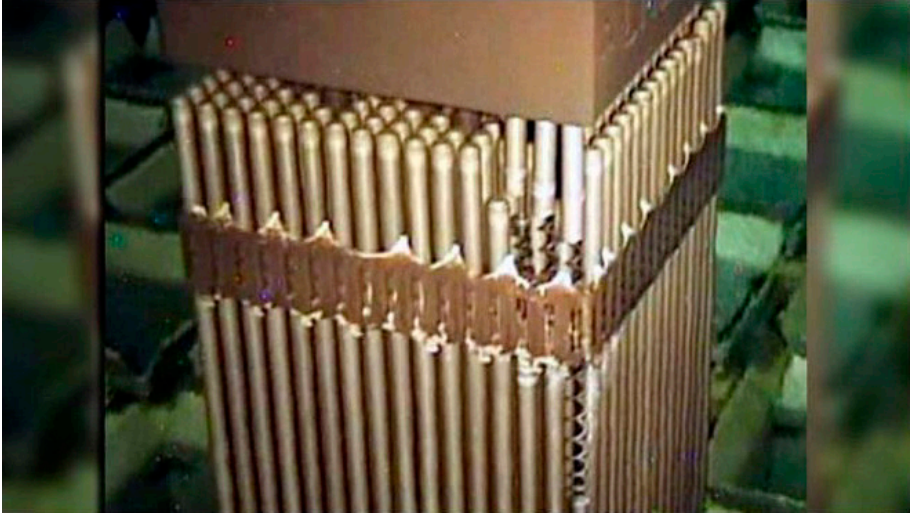
A review of events reported during the 2012–2014 period identified recent occurrences of a previously well known fuel failure mechanism that was first identified in 1971. This phenomenon is called baffle jetting, and this fuel failure mechanism can occur in pressurized water reactors that use core bypass flow to cool the baffle area during operation. In reactors with a downward flow scheme, a portion of the coolant from the reactor inlet flows through a hole in the upper portion of the core barrel into the space between the outside of the baffle plates and the core barrel (this flow is part of what is known as bypass flow). Reactor coolant that is not bypass flow goes down through the annulus and then changes direction to go up through the core support and lower plate and then through the core. The different flow paths and the associated pressure drops between the two can create a differential pressure between these fluids. If enough of an area or gap exists between adjacent baffle plates, and the pressure difference between the core flow and bypass flow is high enough, a high pressure water jet can form between gaps in the baffle plates. This phenomenon is called baffle jetting, and the water jet that is created can impinge on nearby fuel assemblies and result in cladding perforation and a potential for the loss of fuel pellets and other fuel rod components into the reactor coolant, spent fuel pool and other associated systems (see Fig. 9).

FIG. 9. Fuel damage / baffle jetting.
