INTERNATIONAL
ATOMIC ENERGY
AGENCY

THE RADIOLOGICAL ACCIDENT
IN SAMUT PRAKARN

INTERNATIONAL ATOMIC ENERGY AGENCY
VIENNA, 2002

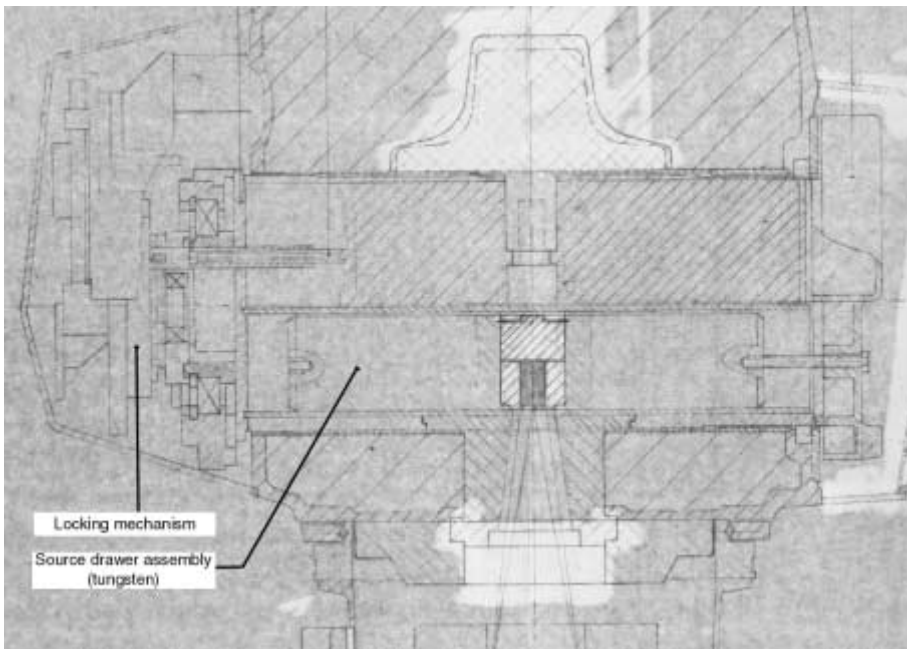
The source holder (and shield) is of lead surrounded by stainless steel. It is cylindrical, 42 cm long by 20 cm diameter. The lead is 5 cm thick, with a weight of 97 kg, within a stainless steel casing that weighed an additional 30 kg. Figure 1 shows the teletherapy unit head and its source assembly.

FIG. 1. The Siemens Gammatron-3 teletherapy head (cutaway side view). The lighter area in the centre is the source. Note the two cylindrically shaped objects around the source.

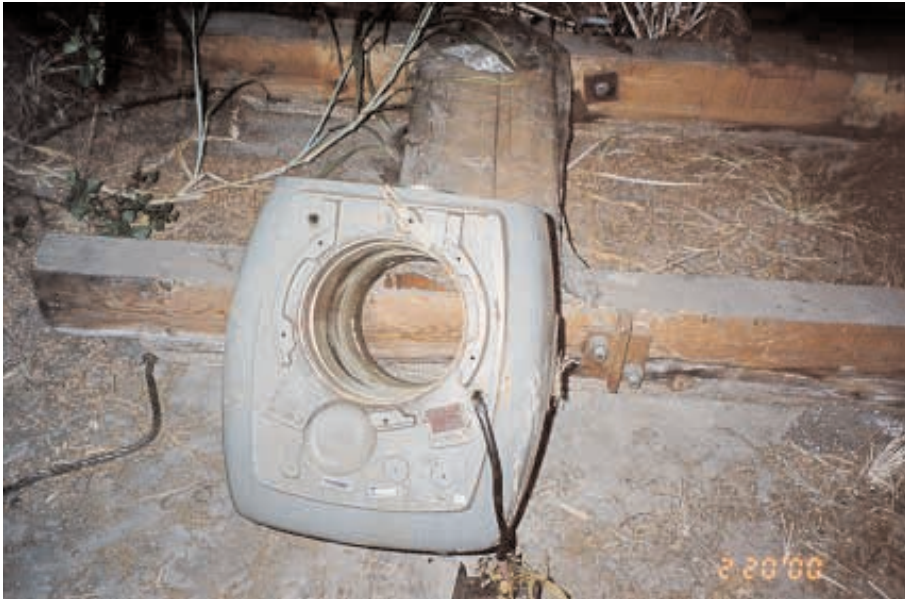
On 1 February 2000, P1, together with P2, P3 (a 19 year old male) and P4 (a 23 year old male and younger brother of P1's wife), reportedly tried to dismantle part⁶ of the cylindrical metal piece of the teletherapy head, which was covered by stainless steel. This action took place at P1's residence. P2 and P4 worked for about an hour trying to separate the steel and the lead using a hammer and chisel. Most of this work was done by P2. They were able only to crack the weld seam, whereupon they noticed an oily liquid seep out. They could, however, see the lead inside the stainless steel box.

FIG. 3. The teletherapy head with the missing source drawer assembly.

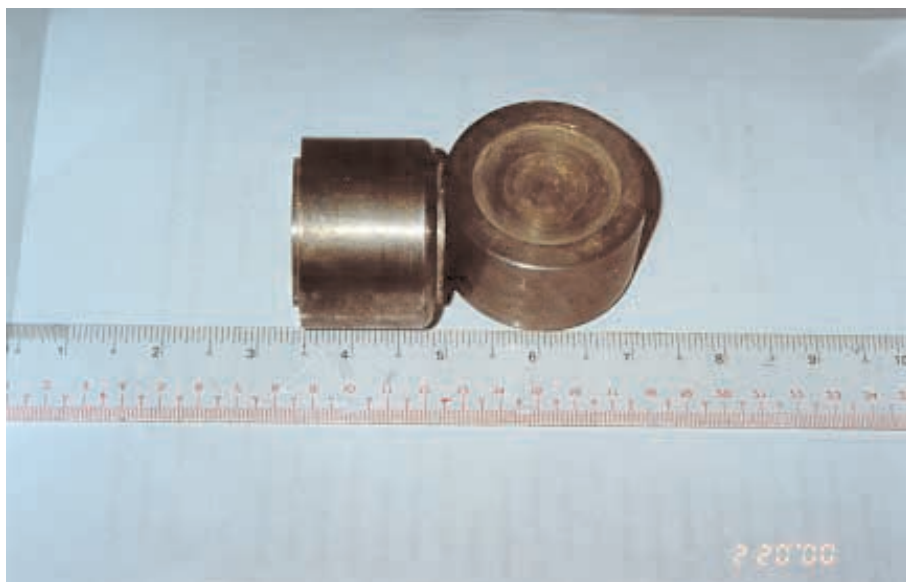
P1 then told them to stop and decided to take the metal to a junkyard for sale there. P1 and P3 brought the lead cylinder and other metal pieces to a junkyard located at Soi Wat Mahawong, Samut Prakarn Province. On the trip from P1's home, which took about 30 minutes, P3 was sitting in the cart with his (right) leg draped over the cylindrical metal piece (Figs 3 and 4).

FIG. 4. Cylindrical pieces from the source assembly (the item at left is hollow; it previously surrounded the ^{60}Co source).

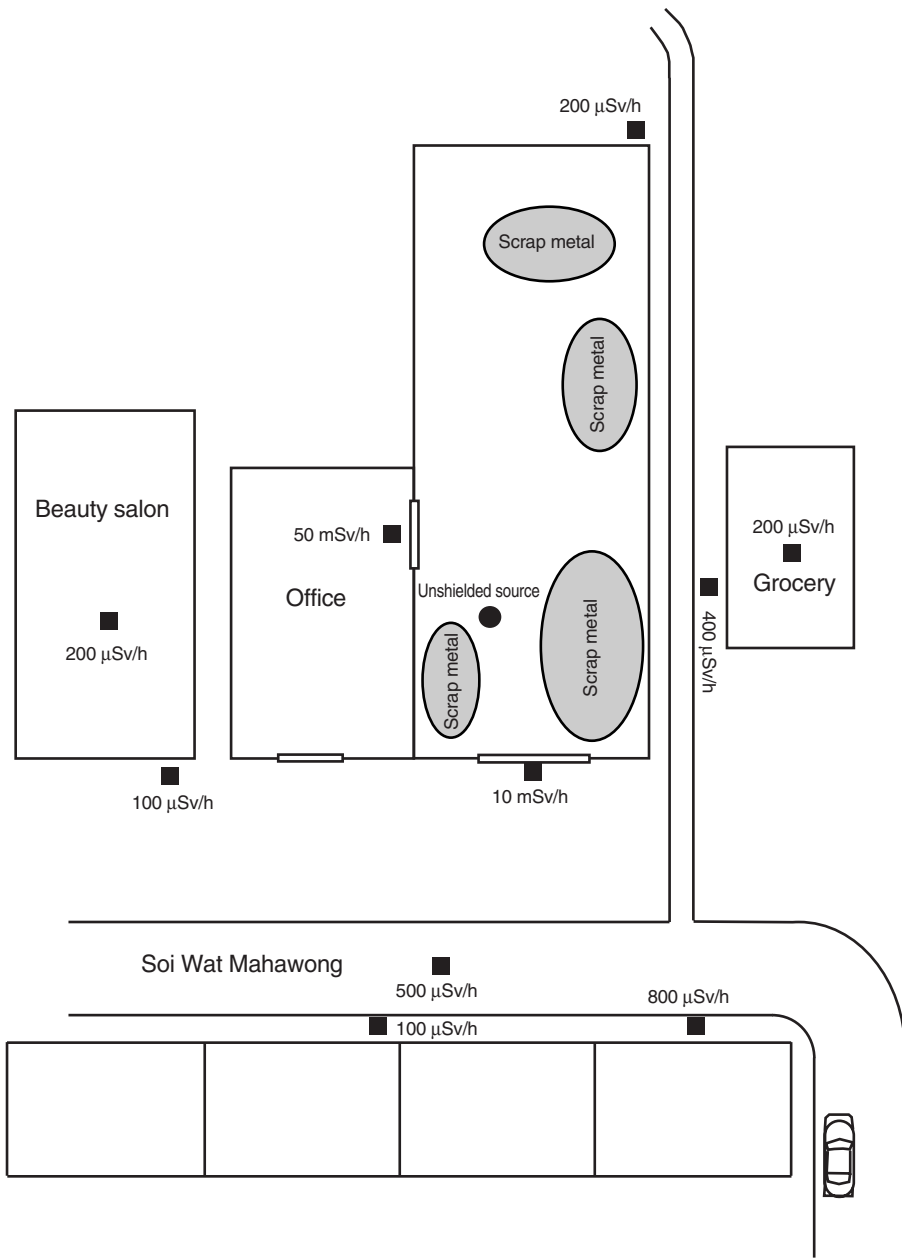
Since these two pieces of metal were not the radiation source, the officers went to check the junkyard. During their journey towards the junkyard the officers had their radiation detectors switched on. Around 19:00 on 18 February 2000, while driving through one of the streets of Samut Prakarn district in the direction of the junkyard, they noted a significant increase in radiation levels (about 20 times normal). They continued moving through two small back streets for about another 150 m or so until they reached the junkyard. There, a radiation level of about 1 mSv/h was measured at the side entrance of the yard, confirming the presence of an intense gamma source. At this point they recognized that this was a serious radiological accident and called for assistance (Figs 5–7).

FIG. 5. Radiation levels encountered at the junkyard.

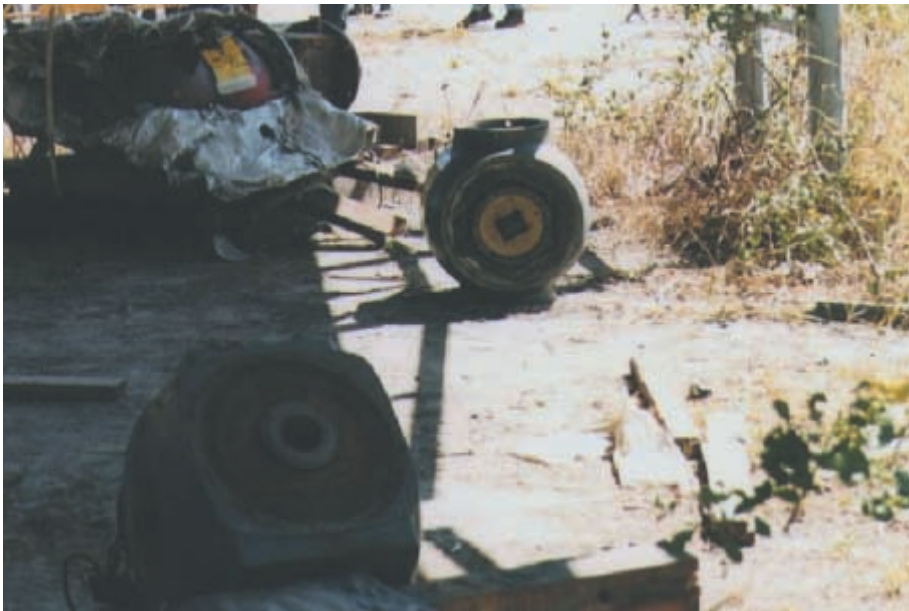
FIG. 13. The three teletherapy heads at the car parking lot. The unit in the foreground was the device from which the source drawer assembly (containing the source) was removed.

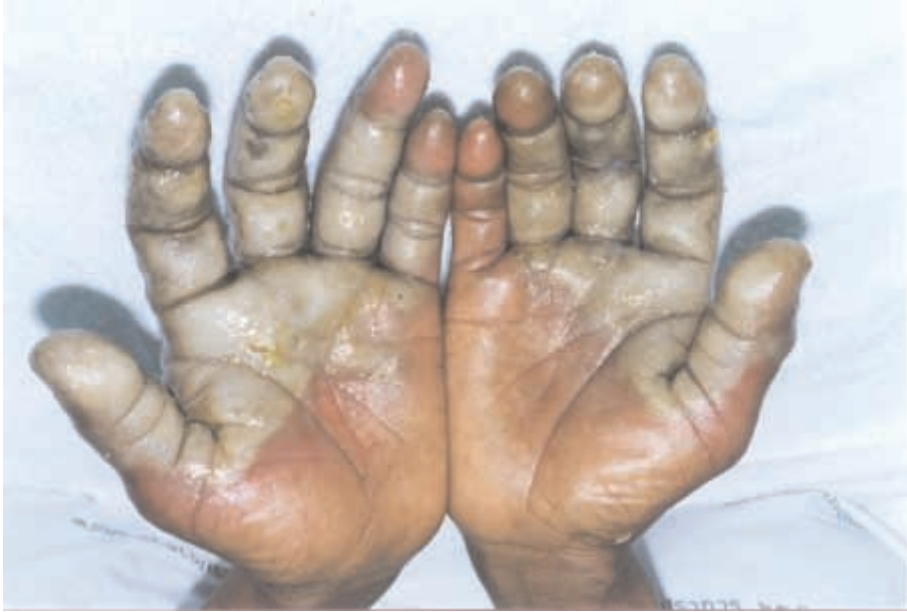
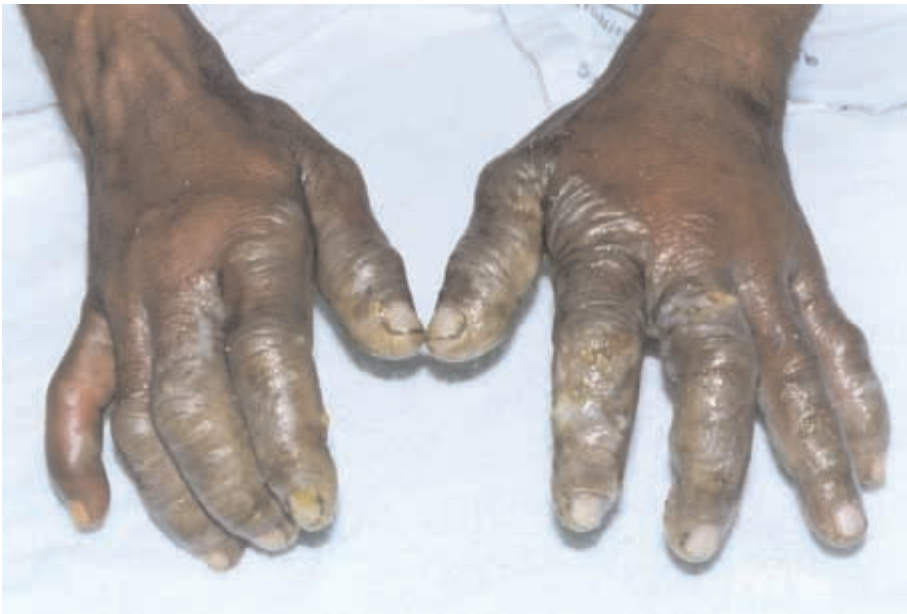
P1 was admitted to Samut Prakarn Hospital with burns on his hands on 16 February 2000. Figure 14 shows hard blisters on his swollen hands with macerated and infected skin, on 23 February 2000, day 23 after exposure.

FIG. 14. Hard blisters on the swollen hands and fingers of P1 on day 23, 23 February 2000. Note the sharp demarcation lines on both the palmar and dorsal sides.

His general clinical symptoms and complete blood count were normal. His burned hands were treated with antibiotic intravenously (Cloxacillin, 4 g/d), Trental (400 mg) and dressings. He occasionally had a low grade fever. His white blood cell count and platelet count progressively decreased, then administration of granulocyte colony stimulating factor (G-CSF) was started (500 µg/d, which was 10 µg/kg per day) on 29 February 2000. On 2 March 2000, he was transferred to Rajavithi Hospital with fever, skin peeling from both hands, and low white blood cell count and platelet count.

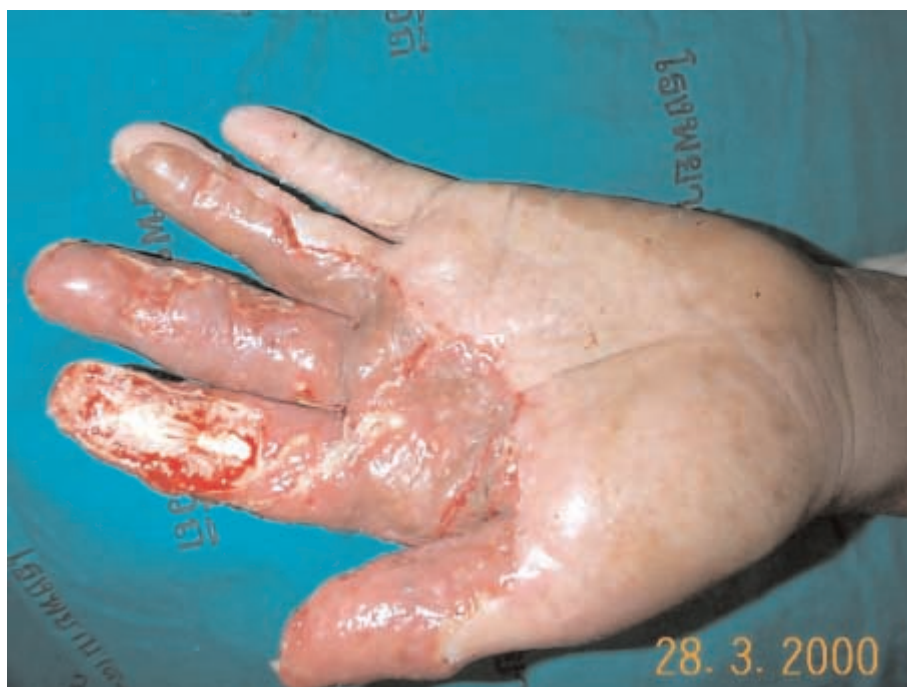
He was readmitted to Rajavithi Hospital on 27 March 2000 owing to continued pain in the area of the graft. The graft on the second and third fingers of his left hand had failed, and surgeons noted that the second finger was deeply necrotic. Figure 16 shows his left hand after debridement on 28 March 2000 with the exposed flexor tendon in the middle phalanx of the second finger.

FIG. 16. Condition of the left hand of P1 eight weeks after exposure. Note the exposed flexor tendon in the middle phalanx of the second finger and adjacent soft tissue necrosis.

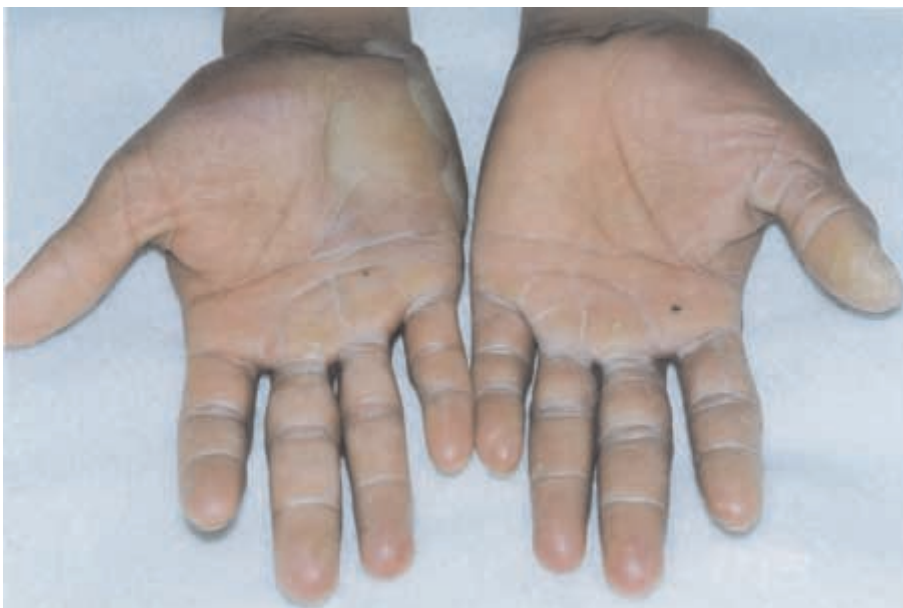
surfaces of both hands and a huge hard blister on the right hypothenar (Fig. 17), epilation and low fever.

FIG. 17. Appearance of the hands of P2 three weeks after exposure. Note the dry desquamation of swollen fingers and both palms, with a large hard blister on the right hypothenar.

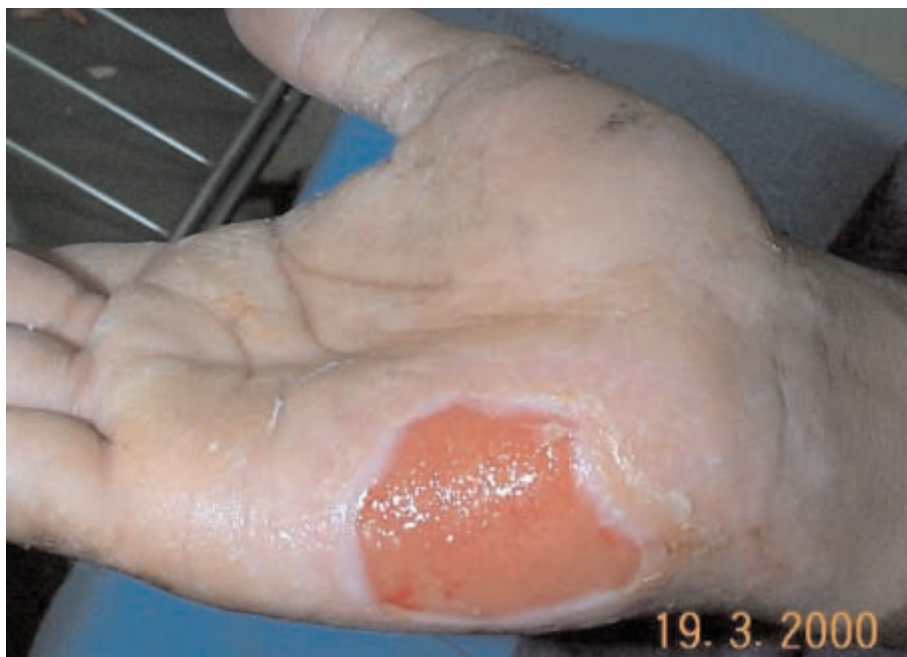
Both G-CSF and GM-CSF were discontinued when his white blood cell count increased. By 9 March 2000, most blisters had healed spontaneously, except for the largest one which appeared to be a chronic wound (Fig. 18).

FIG. 18. Wet desquamation (rupture of huge blister) on the right hypothenar of P2 seven weeks after exposure.

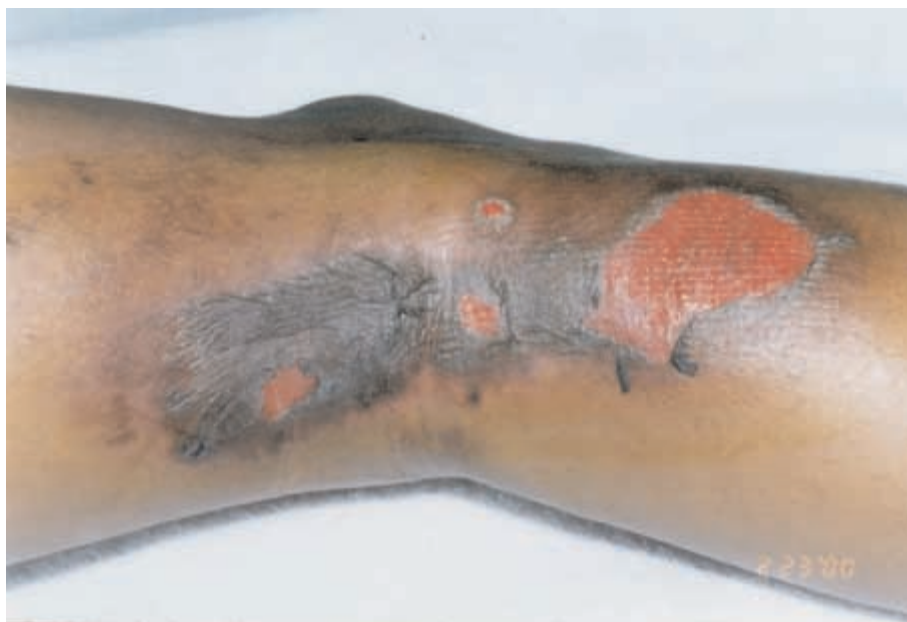
P3 was admitted to Samut Prakarn Hospital on 20 February because of a low platelet count from a study initiated the previous day. He also demonstrated burns at the distal phalanges of the second and third fingers of his right hand and a 30 cm long burn near his right knee. On 23 February 2000, an extended necrosis of the epidermis was observed on the lateral side of his right thigh just above the knee, while below knee level a 5 cm × 8 cm area demonstrated wet desquamation (Fig. 19).

FIG. 19. Extended necrosis and wet desquamation on the lateral side of the right leg of P3 23 days after exposure.

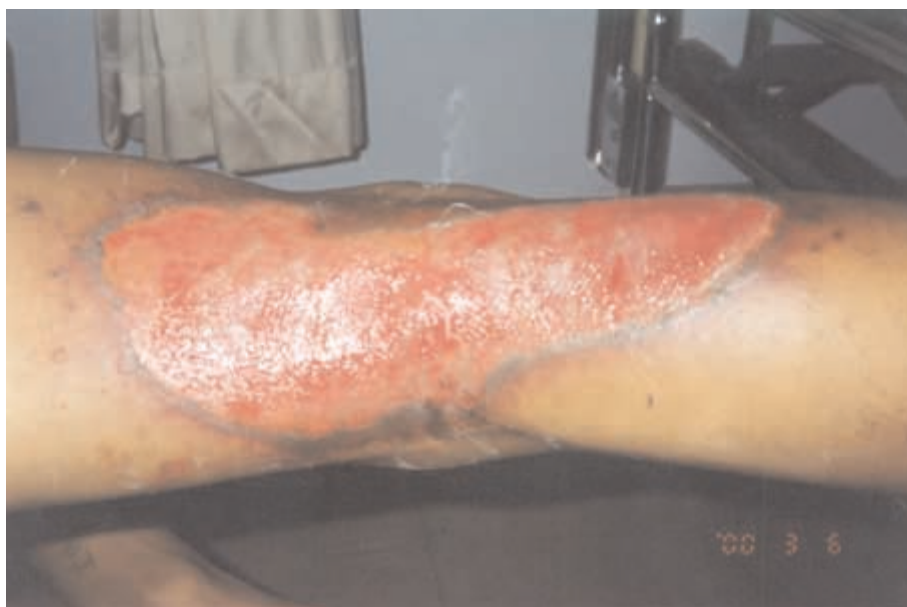
On 3 March 2000, P3 was admitted to Rajavithi Hospital. Second degree burns were seen on the index and middle fingers of his right hand, as well as a 30 cm long wet desquamation in the popliteal area of his right knee (Fig. 20).

FIG. 20. Wet desquamation 30 cm long in the popliteal area of the right knee of P3 five weeks after severe local exposure.

P3 was treated with a combination of G-CSF (250 µg/d) and GM-CSF (300 µg/d). These were discontinued when his white blood cell and platelet counts increased.

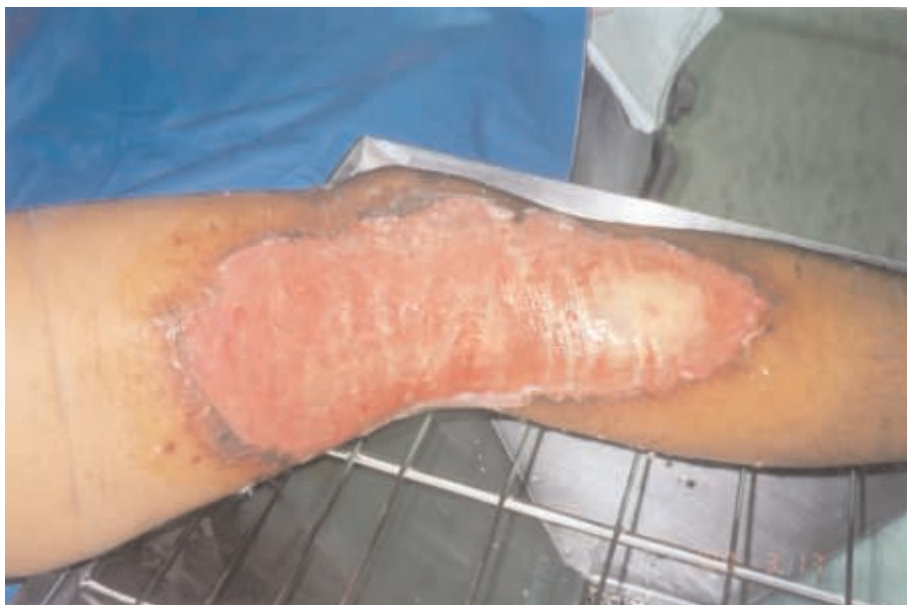
FIG. 21. Appearance of the popliteal area for P3 seven weeks after severe local radiation exposure.

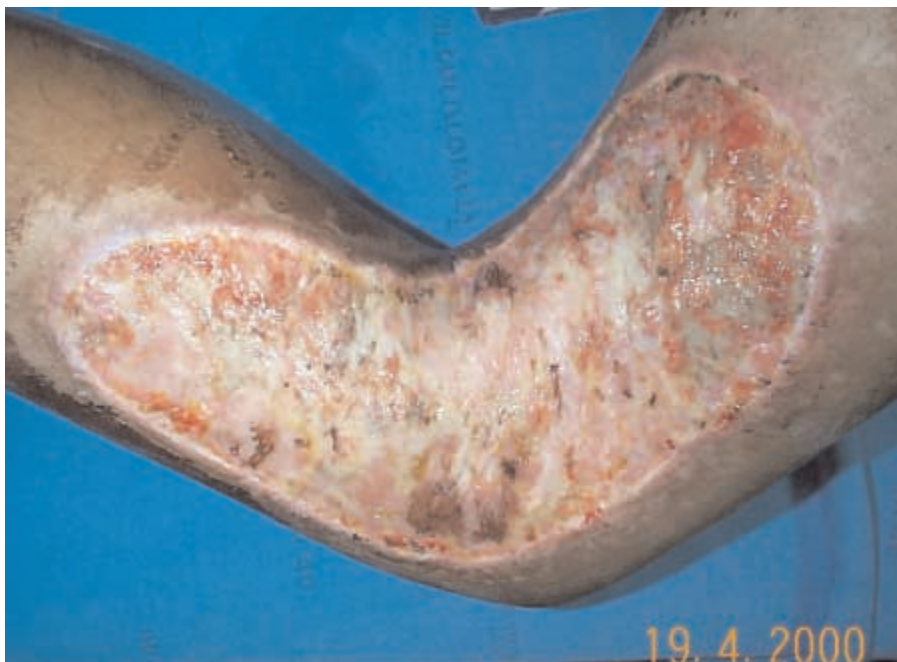
FIG. 22. Massive infection and beginning of necrosis of the extended wound on the right leg of P3 on 19 April 2000, 11 weeks after exposure.

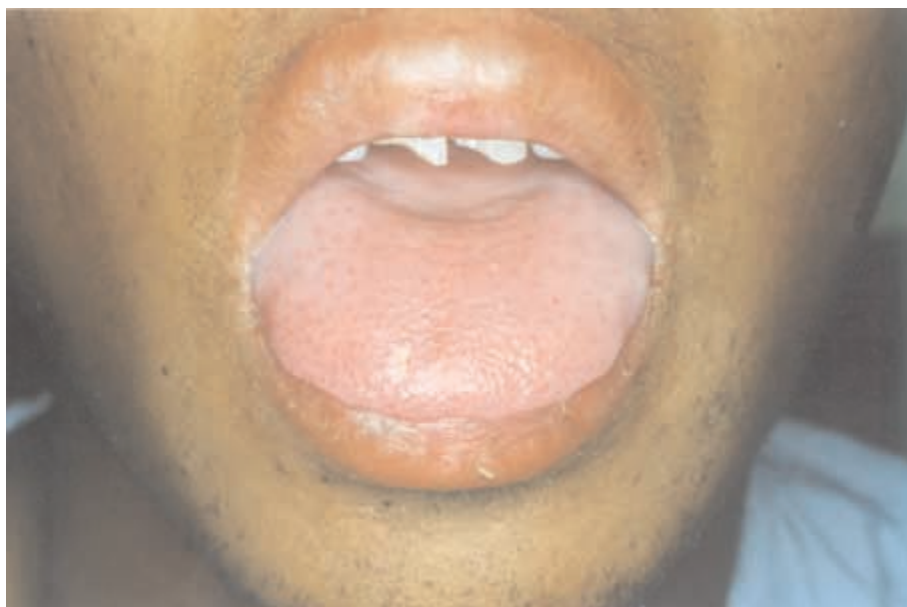
FIG. 24. Swollen lips and tongue of P5 on 22 February 2000, three weeks after severe whole body exposure.

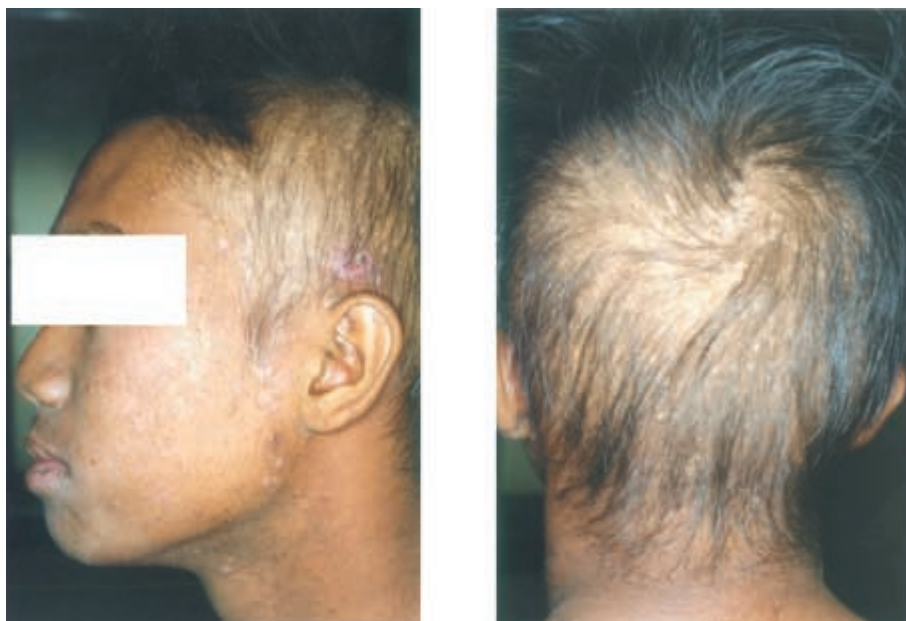
FIG. 25. Severe alopecia and ulceration above the left ear of P6 on 22 February 2000.

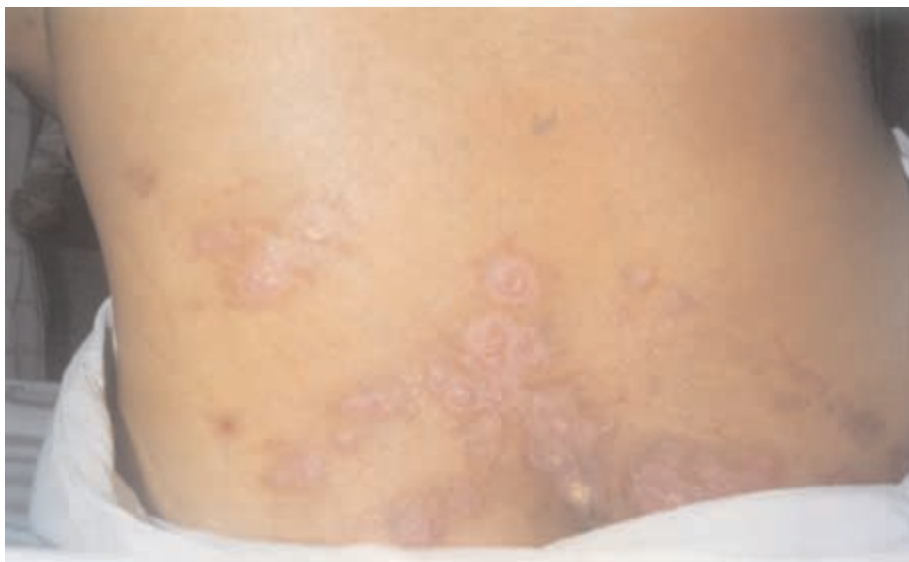
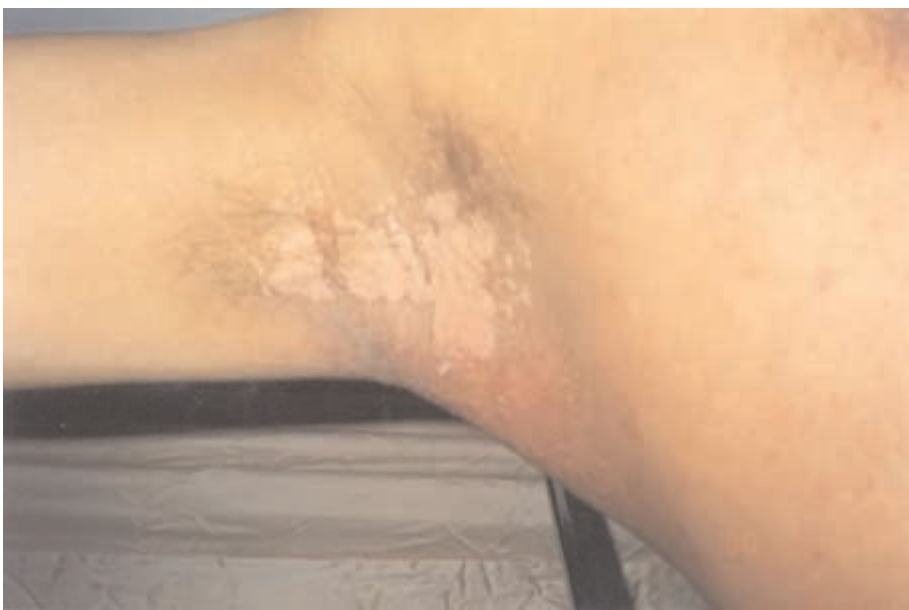
FIG. 26. Viral infection (Herpes zoster) in the lower back (top) and fungal infection in the subaxillary region (bottom) of P8 on day 25 after exposure.
