Material Degradation and Related Managerial Issues at Nuclear Power Plants

Proceedings of a Technical Meeting
Vienna, 15–18 February 2005

**MATERIAL DEGRADATION AND
RELATED MANAGERIAL ISSUES AT
NUCLEAR POWER PLANTS**

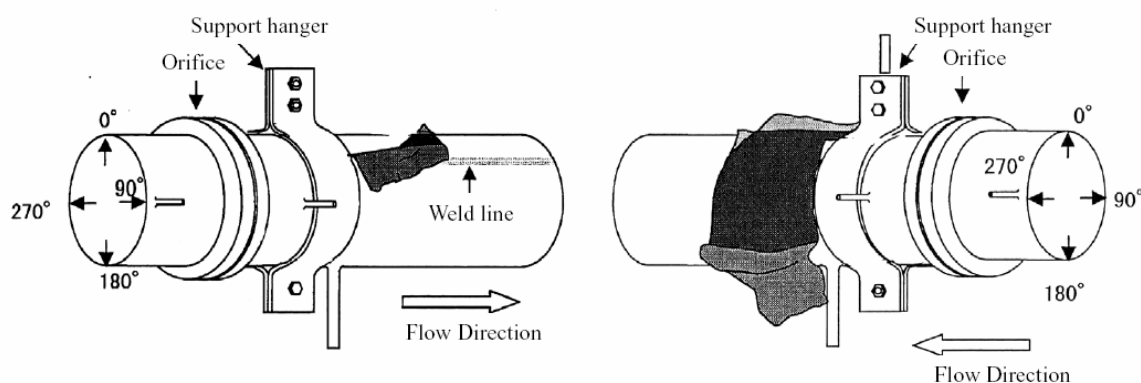
A secondary side carbon steel pipe ruptured (see figures 2 and 3). Thinning had developed at the downstream of an orifice due to the combination of erosion caused by the mechanical action of the internal water flow and corrosion caused by chemical reaction. The pipe had gradually lost its thickness, which led to a loss of strength and eventually to a rupture from internal pressure (about 1 MPa). The investigation has revealed that the dimple pattern typical in this kind of phenomenon was found on the inner surface of the pipe.

Fig. 2. and 3. Rupture of pipe downstream to orifice.

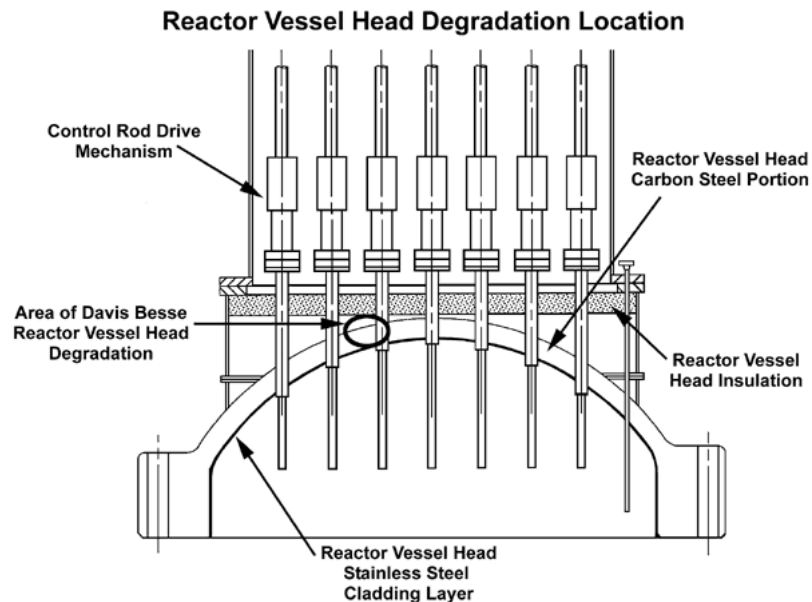
Fig. 4. PWR vessel head penetration cracking of Alloy 600 allowed leakage of the borated coolant to occur. This corroded the RPV head externally down to the stainless steel cladding.

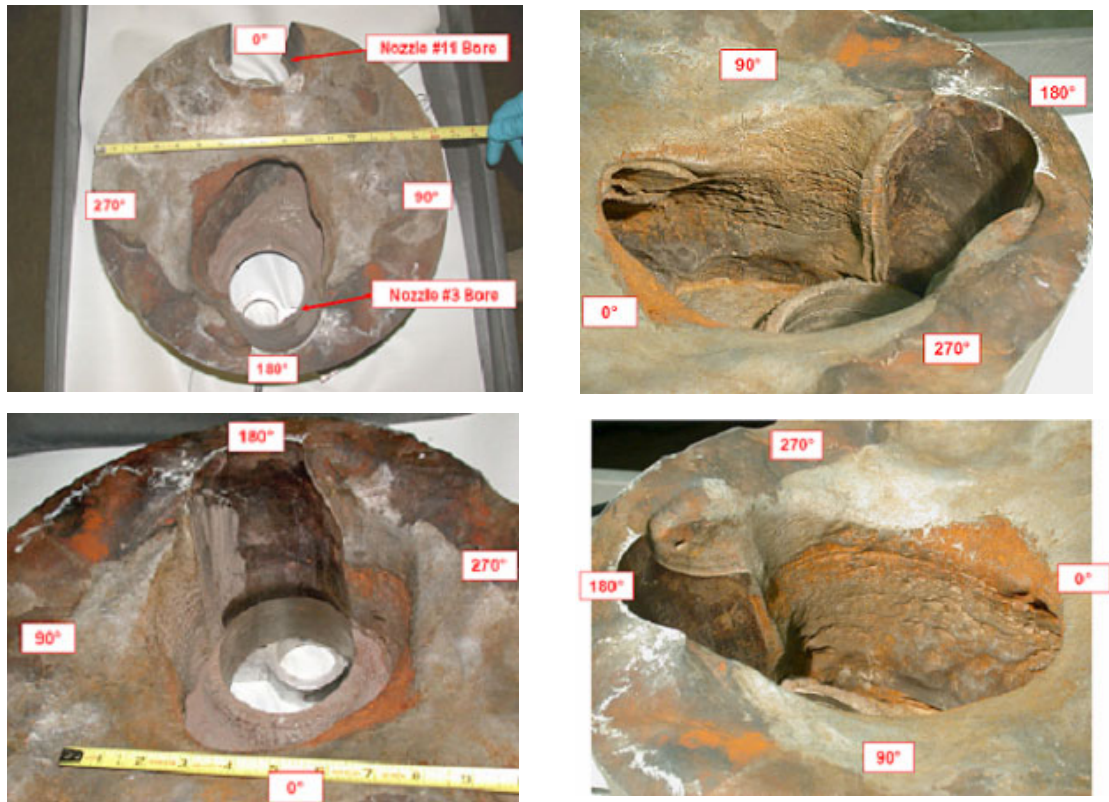
a design pressure of 2500 psig (175.75 kg/square cm). Davis-Besse had accumulated 15.8 effective full power years (EFPY) of operation when the plant shut down for its thirteenth refuelling outage on February 16, 2002. During that refuelling outage, while performing RPV vessel closure head inspections required by the United States Nuclear Regulatory Commission, workers discovered a large cavity in the 6 inch (15.24 cm) thick low-alloy carbon steel RPV head material. The cavity was about 6.6 inches (16.76 cm) long and 4 to 5 inches (10.16 to 12.70 cm) at the widest point extending down to the 0.25-inch (0.635 cm) thick Type 308 stainless steel cladding. See Fig. 4 and 5.

Fig. 5. Davis-Besse Reactor Pressure Vessel Head Degradation.

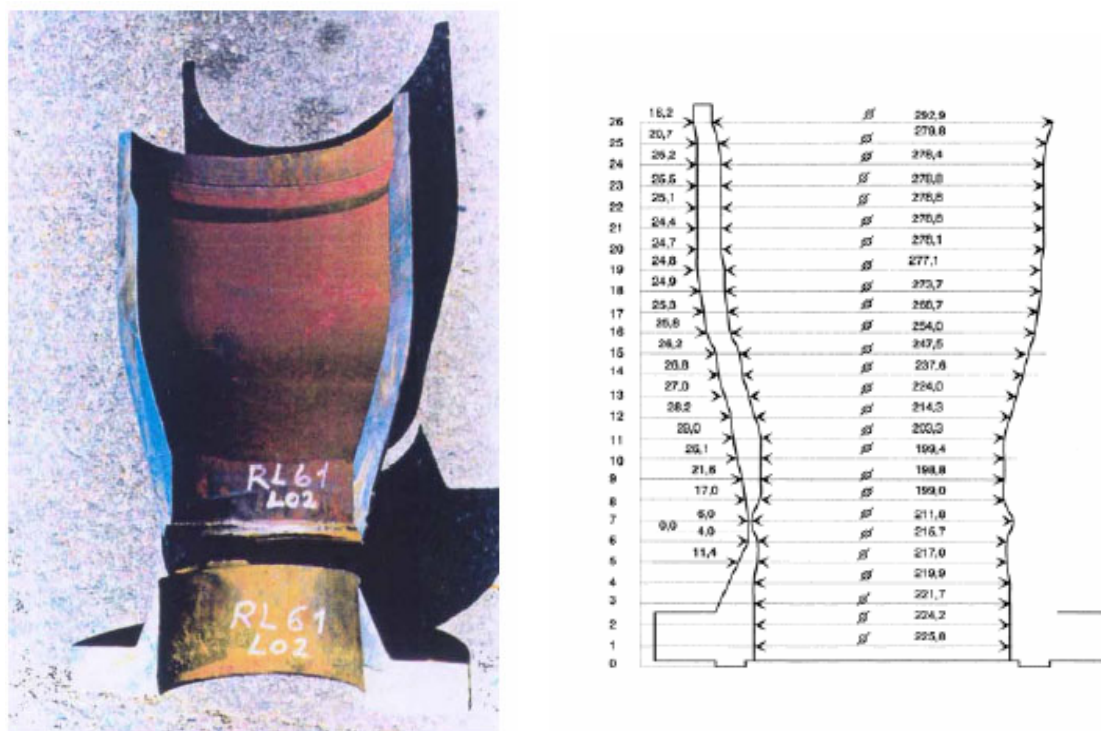
After the guillotine pipe break, the extent of the control programme was further increased. Computer programmes for weak point analysis and the inspection data management were implemented, as well as a review of the extent of the annual inspection programme by the group of experts of the company. However, in spite of the large efforts put into improving the inspection programme, a second guillotine pipe break of the feed water system occurred in 1993 at Unit 2. See Fig. 6.

Fig. 6. Wall thinning of parallel FW-discharge lines (RL61).

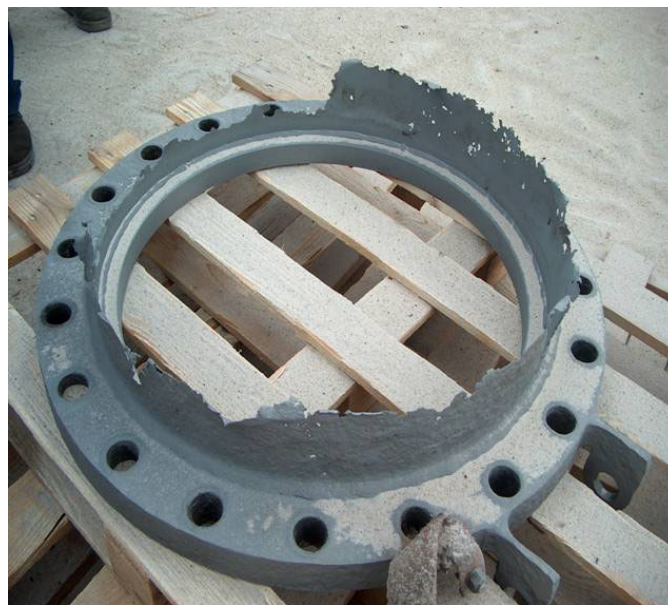
On August 25, 2004 at 5:25 a.m. with Vandellós II operating at full rated power, a circumferential break occurred on the neck of manhole EF-18-I when starting essential service water pump EFP01C. This took out of service one of the two trains of essential service water system (EF) of the plant. See Fig. 7.

Fig. 7. Broken manhole neck of essential service water system.

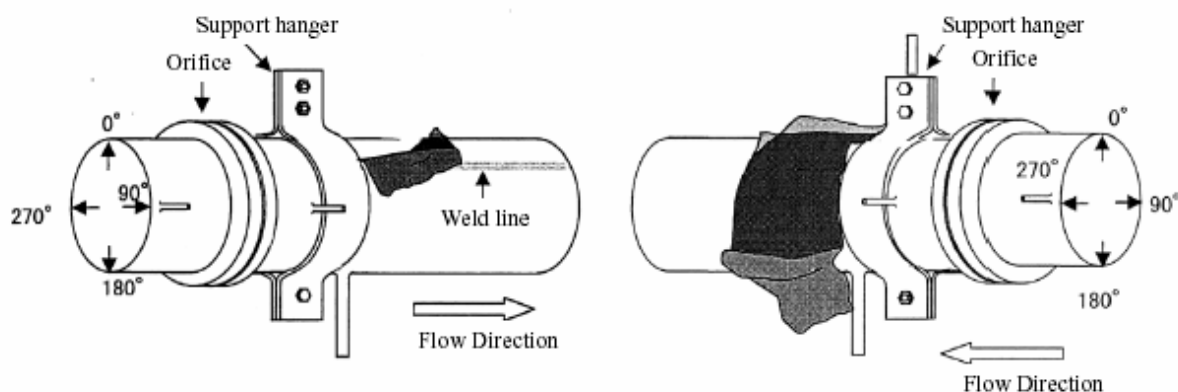
Fig. 2. Configuration of rupture.

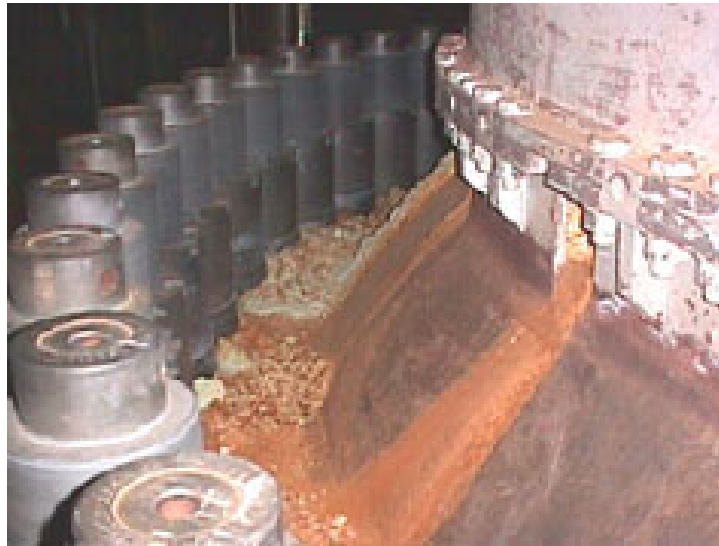
Fig. 1. Condition of Reactor Vessel Head in Refuel Outage 12 (2000).

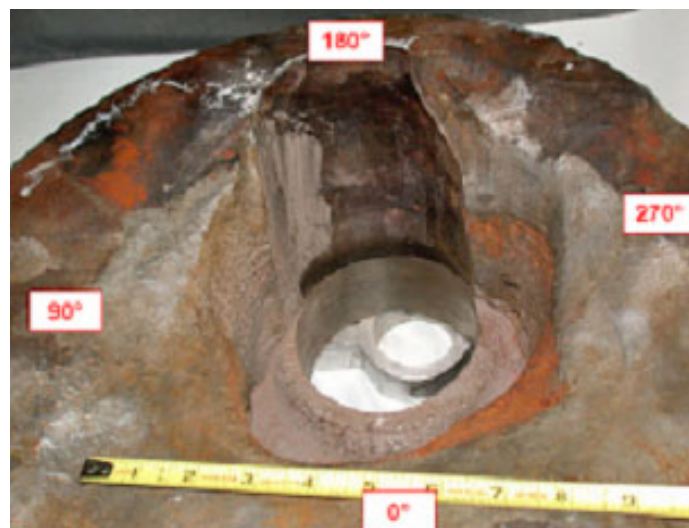
Fig. 2. Cavity with CRDM nozzle removed.

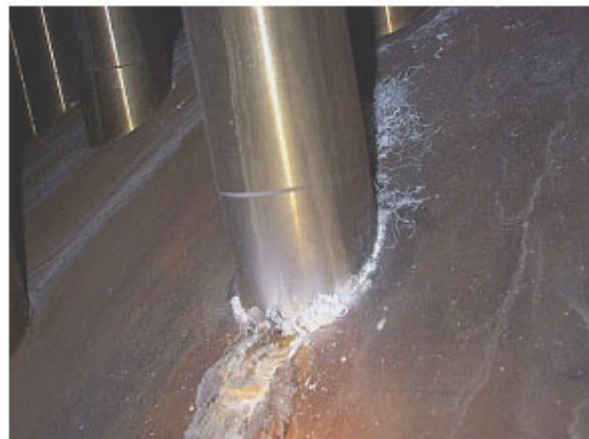
Fig. 4. Typical Appearance of Through Wall Nozzle Crack.

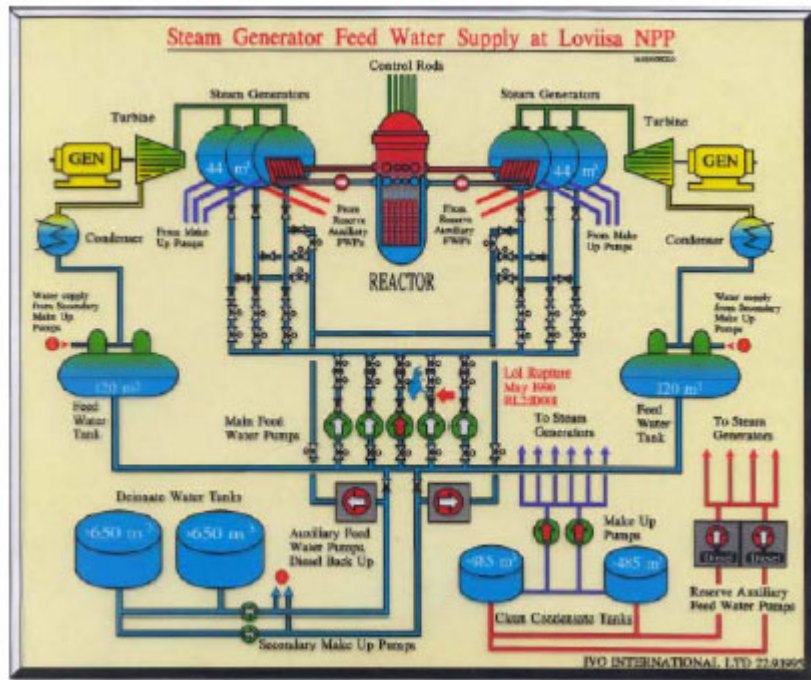
During operation at full power 28 May at 10.27 a.m., an electric failure caused stopping one of the four feed water pumps and switching on the reserve pump. This resulted in a pressure shock in the FW-line, which led to a break in one of the five MFWS pipe branches (diameter 325 mm, figure 1).

Fig. 1. Loviisa 1, feed water supply and location of guillotine break.

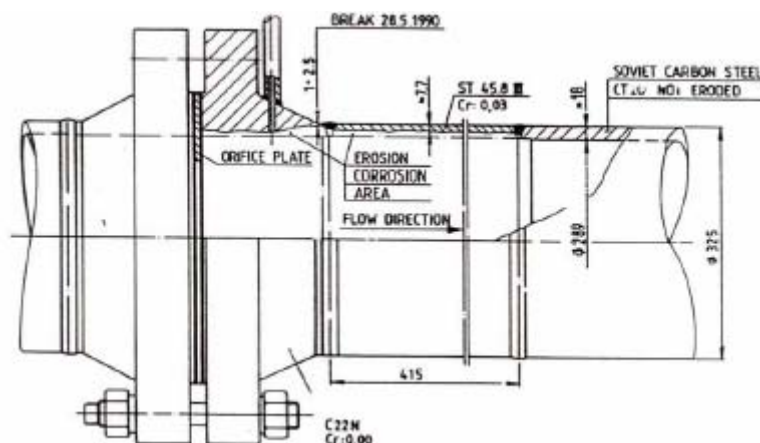
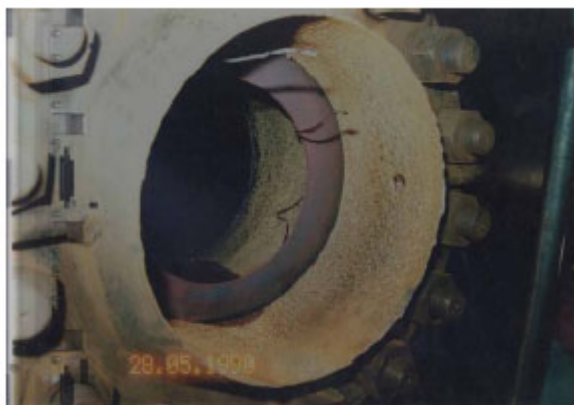
The exact location of the break was adjacent to the flow control orifice, Figure 2. The root cause for the failure was that erosion corrosion after the flow control orifice was incorrectly assumed to be lower than in other fittings (tees, 90 degree elbows, etc.). Other fittings in this particular FW-discharge line were inspected during the previous outages prior to the pipe break.

Fig. 2. Exact location of the break.

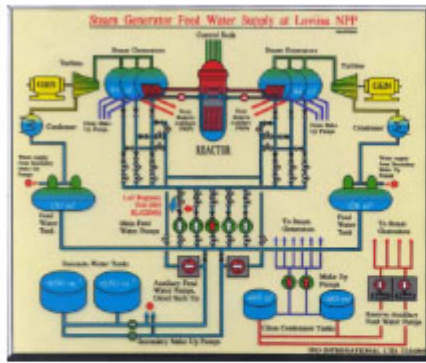
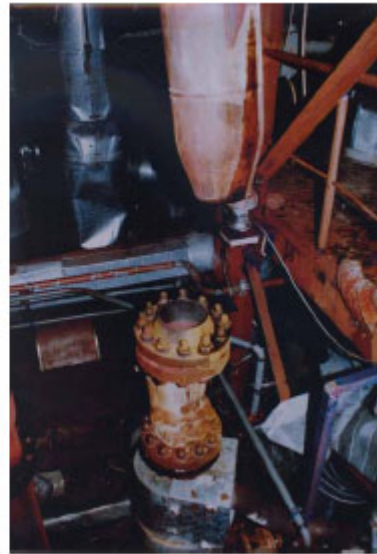
On 25 February 1993 at 2.30 p.m., during operation at full power, the start up procedures of one of the feed water pumps were going on. This resulted to a guillotine break in one of the five MFWS pipe branches (figure 3). The reactor and turbines were tripped manually. The auxiliary feed water system and other major systems operated normally during the incident. The leak was isolated in 9 minutes, and the unit was shut down according to the normal routines. There were no injuries of the personnel [4].

Fig. 3. Location of the broken FW-discharge line Fig. 4. Exact location of the break.

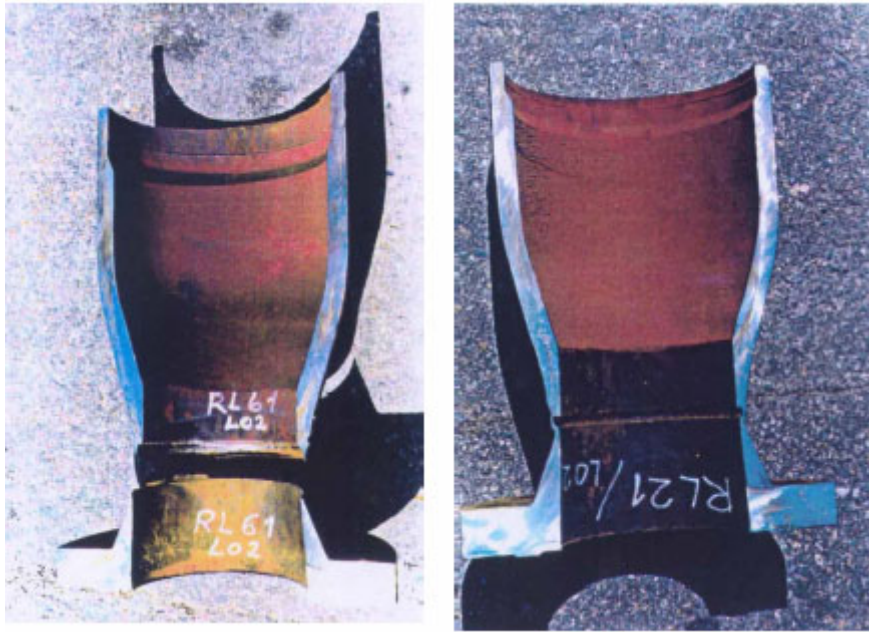
Similar wall thinning was also detected in one of the parallel discharge lines, but it was more concentrated on the weld between the flange and the following expansion than in the flange, Figures 5 and 6. No significant wall thinning of similar flanges in the other three parallel lines was detected [6].

Fig. 5. Wall thinning of parallel FW-discharge lines (RL61/RL21).

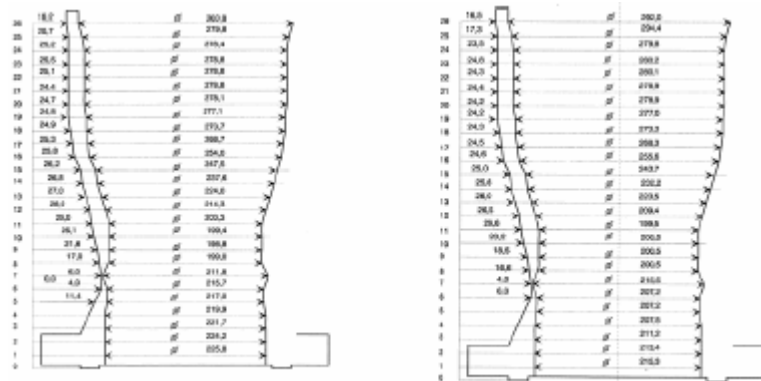
Fig. 6. Wall thickness measurement of flange connection and expansion cone of parallel FW-lines (RL61/RL21).

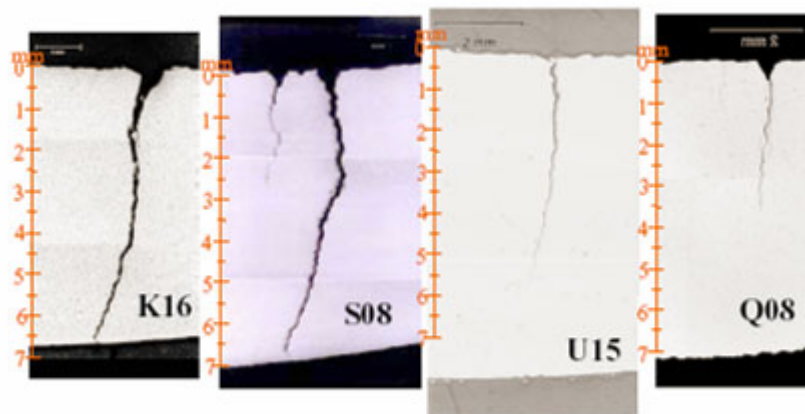
Fig. 2. Typical examples of CANDU feeder cracking.

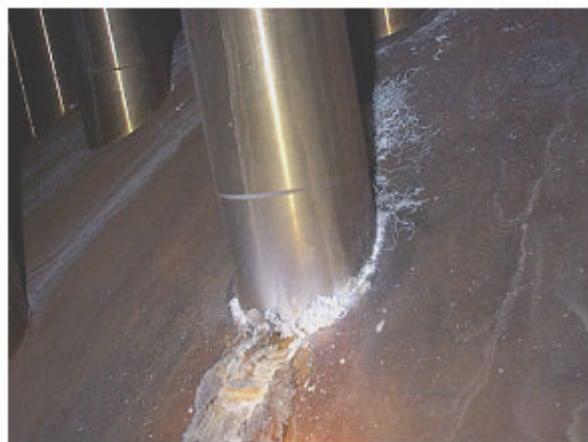
Fig. 2. Typical Appearance of Leakage Due to Nozzle Crack through Wall Cracking.

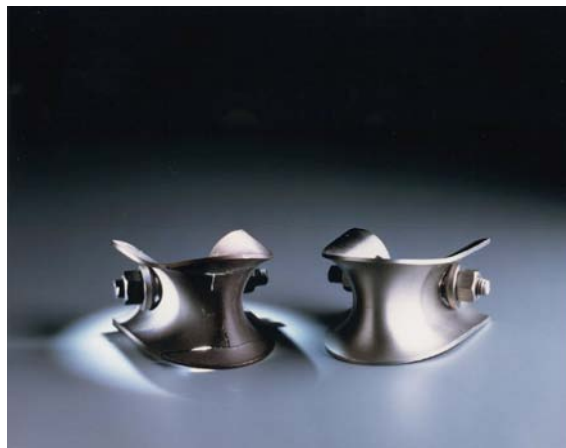
Fig. 2. Reverse U-bends made of Alloy 600 before (right) and after test (left) in PWR primary conditions.

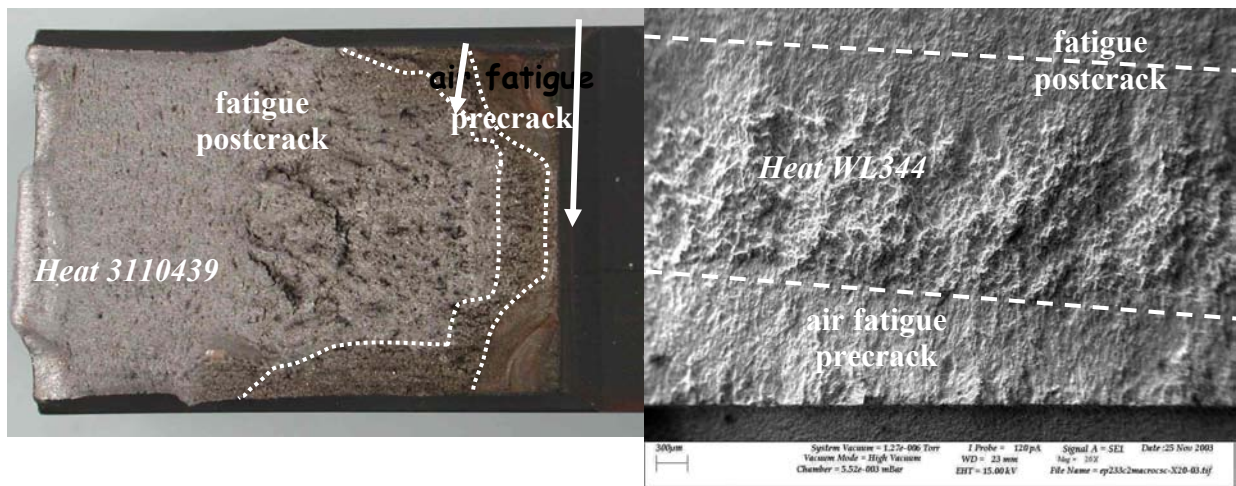
Fig. 8. Fracture surface observed on Alloy 600 for two different heats (PWR primary chemistry, 325°C, cyclic loading).
