Unusual occurrences during LMFR operation

*Proceedings of a Technical Committee meeting
held in Vienna, 9–13 November 1998*

IAEA-TECDOC-1180

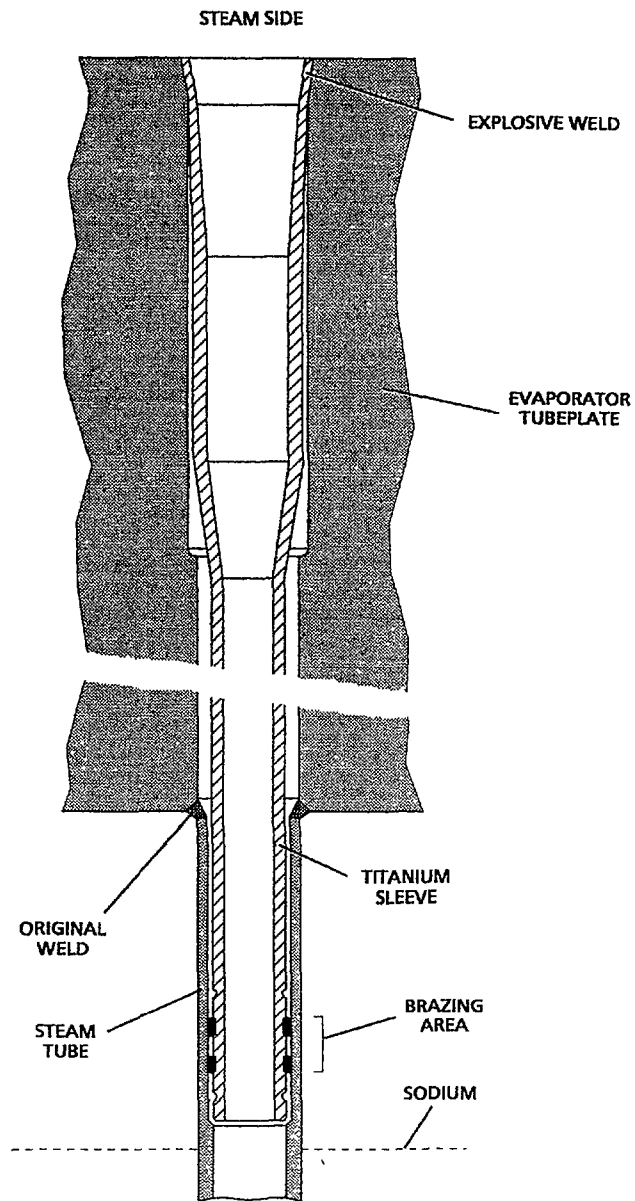
Figure 1.4. A PFR Evaporator Weld Repair Sleeve

The type of direct tube-to-tubeplate weld adopted initially at PFR, which could not be heat treated after manufacture, should be avoided in future fast reactors. Austenitic steels are unsuitable for LMFR steam generators because of the high risk of caustic stress corrosion damage following even small leaks.

The tube-to-tubeplate weld leaks in the PFR evaporators necessitated the development of a repair method by fitting sleeves to bypass defective welds: 3000 sleeves were installed in each end of the 500 tubes of each of the three evaporators. The success of the method was demonstrated by the fact that no further leaks have occurred.

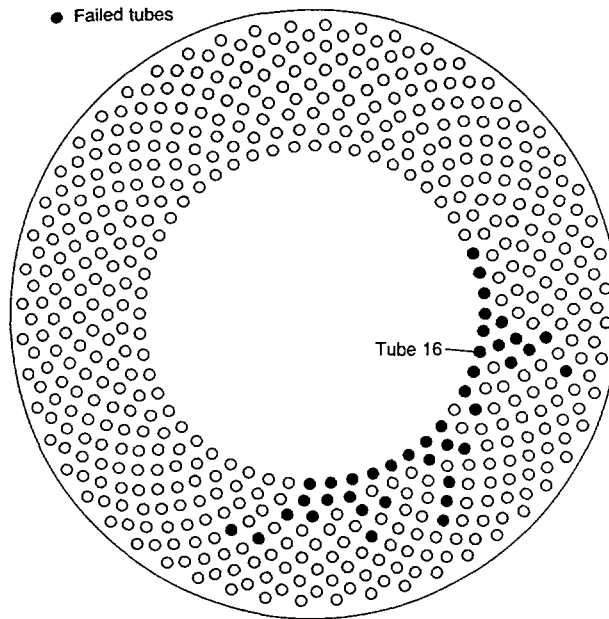
Figure 2.2 The Failed Tubes in PFR Superheater 2

1. A total of 40 tubes failed, 39 due to overheating in a period of 8 seconds following the plant trip. The remaining tube, which initiated the event, failed due to fretting damage caused by tube vibration.
2. The primary small leak grew after passing steam for some tens of seconds. Finally it grew rapidly to give a leak rate of 0.5 to 1.0 kg/s for a period of a few seconds.
3. This induced a plant trip by rupturing a steam-side bursting disc. Isolating valve closed, causing the steam flow to stop, but the steam pressure fell relatively slowly over a period of about 10 seconds.
4. Other tubes already weakened by fretting failed quickly, within a second or so, causing an increase in the heat generated by the sodium-water reaction.

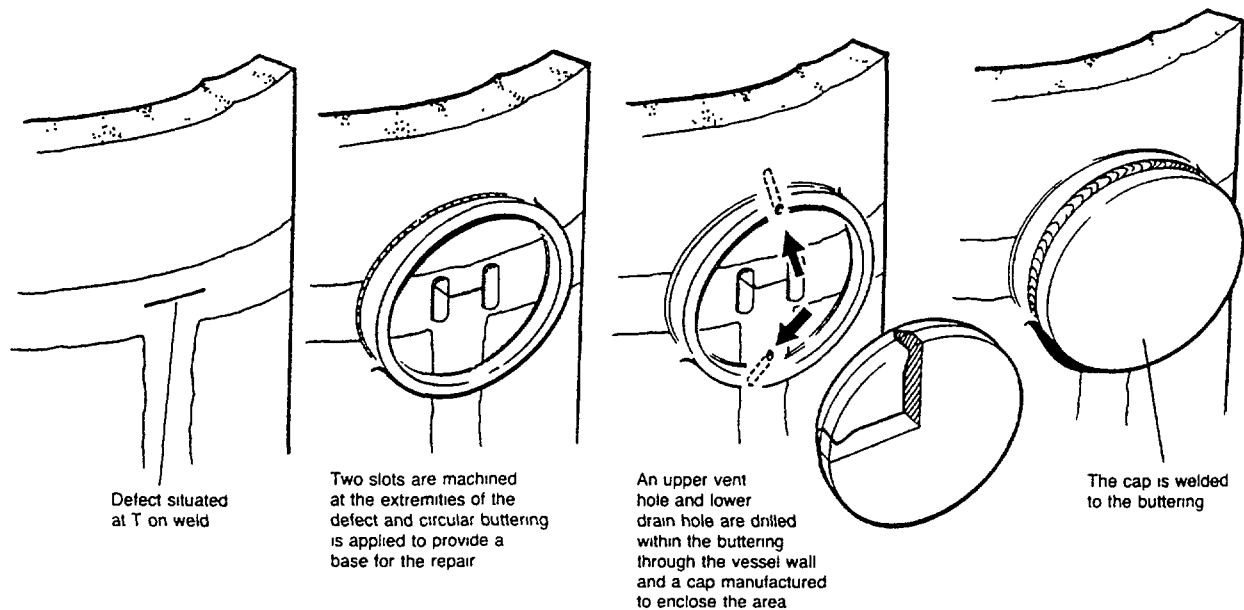
Figure 3.2. The Repair Technique for Cracks in the PFR Steam Generator Vessels

The evidence indicated that cracking in PFR steam generator vessels was initiated by a delayed reheat mechanism driven by residual stresses in the non-stress-relieved welds. Weld rectification during manufacture gave rise to conditions which favoured cracking. It is

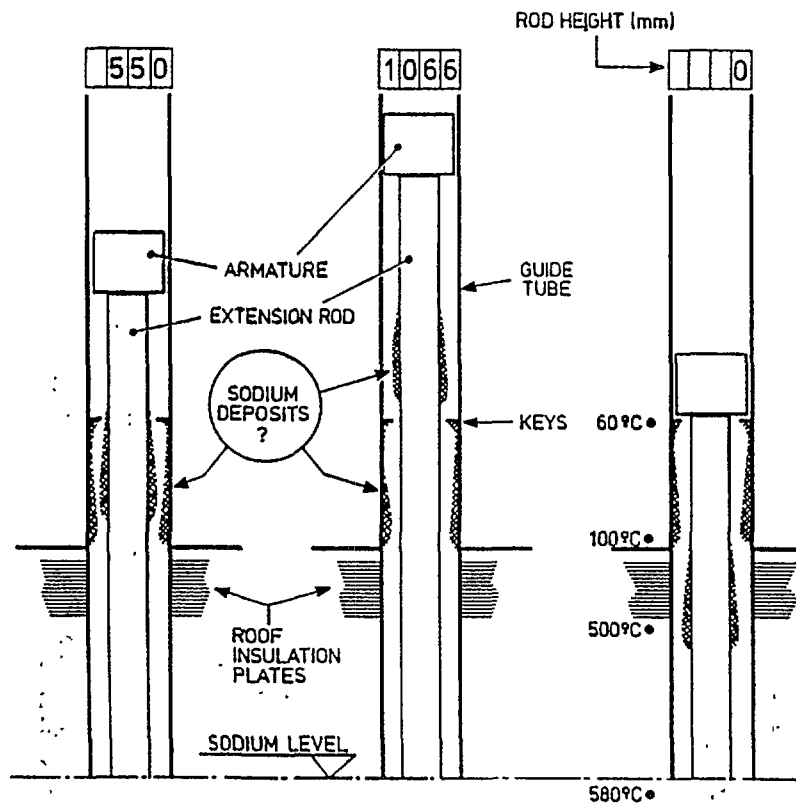
Figure 6.4. Location of Sodium Aerosol Deposits on a PFR Absorber Rod Mechanism

The friction is believed to have been caused by the buildup of sodium aerosol deposits on the inside of the liner tube and on the extension rod of the absorber in the cool region of the rotating shield, as shown in Figure 6.4. Lowering the rod moved the deposit on the guide tubes into the warmer region below the roof insulation where it melted off, reducing the friction.

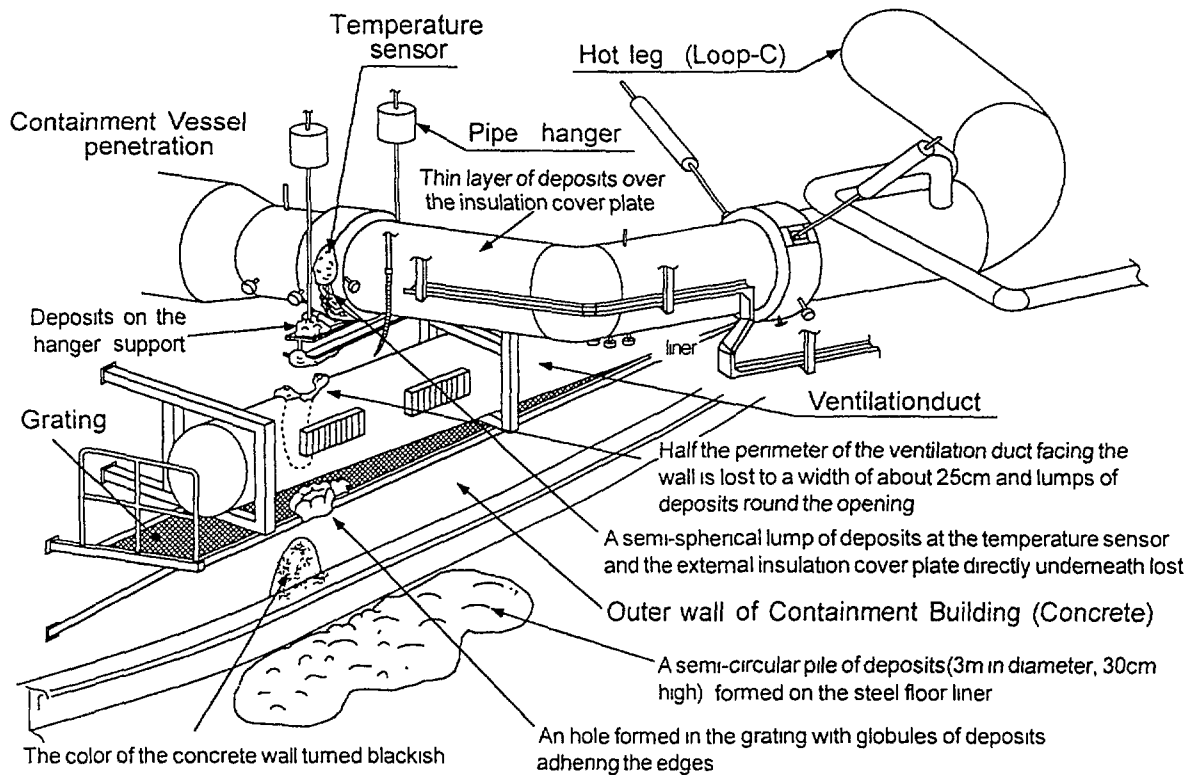
Fig. 2. Sketch of the affected area.

An inspection of the affected piping room on 9th December confirmed the presence of solidified materials associated with the sodium leak around and near the thermocouple well of the outlet of the secondary side of IHX. The state of the piping room after the sodium leak is shown in Fig.2. Approximately 1m³ of a sodium oxide on the 6 mm thick steel floor liner formed a semicircular mound, nearly 3 m in diameter and 30 cm high. Sodium aerosol was lightly diffused over and accumulated on the floor and walls of the room. The ventilation duct directly under the

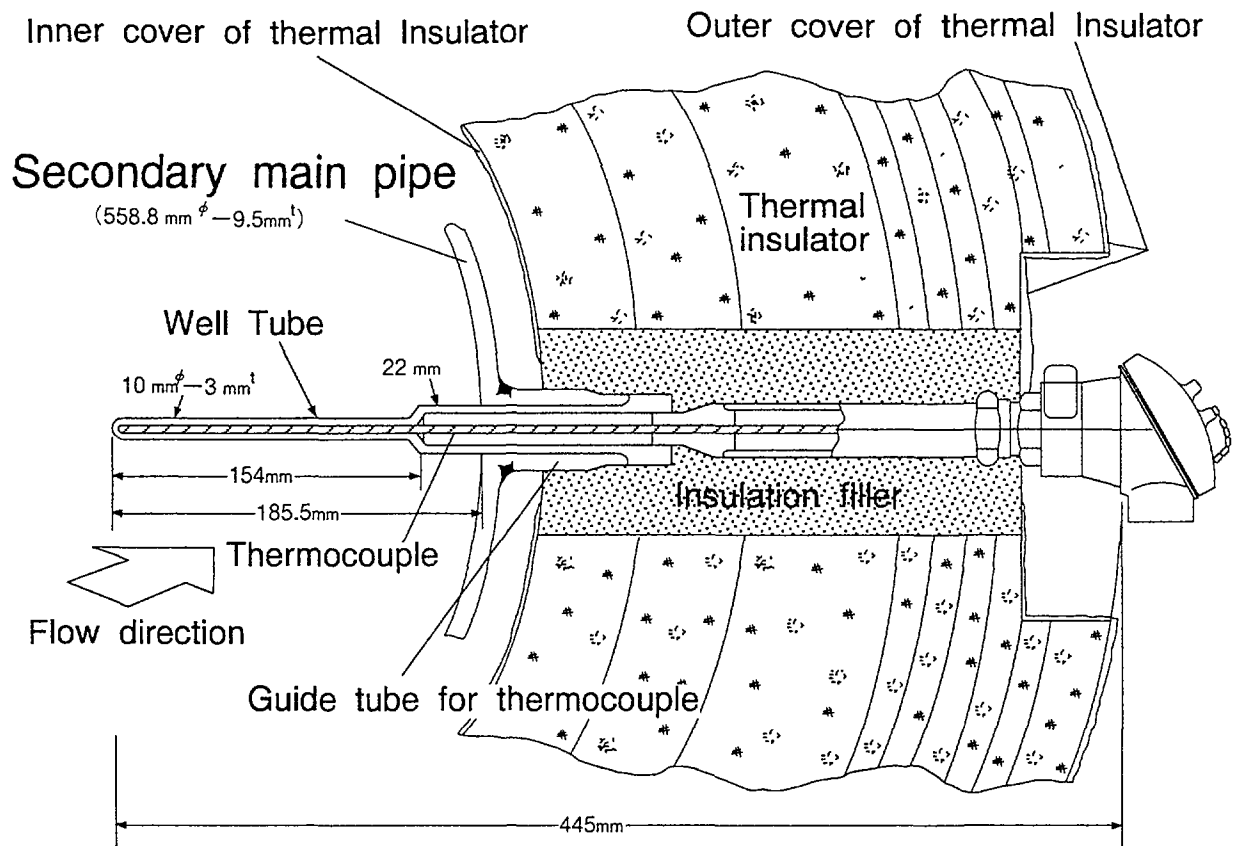
Fig. 3. The thermocouple well of the secondary circuit.

The thermocouple wires are enclosed by a sheath which is itself housed within the well tube. The tip of well tube is inserted horizontally into the center of the pipe. This tip (some 15 cm in length) is thinner in diameter than the base of the sensor. (Fig.3)

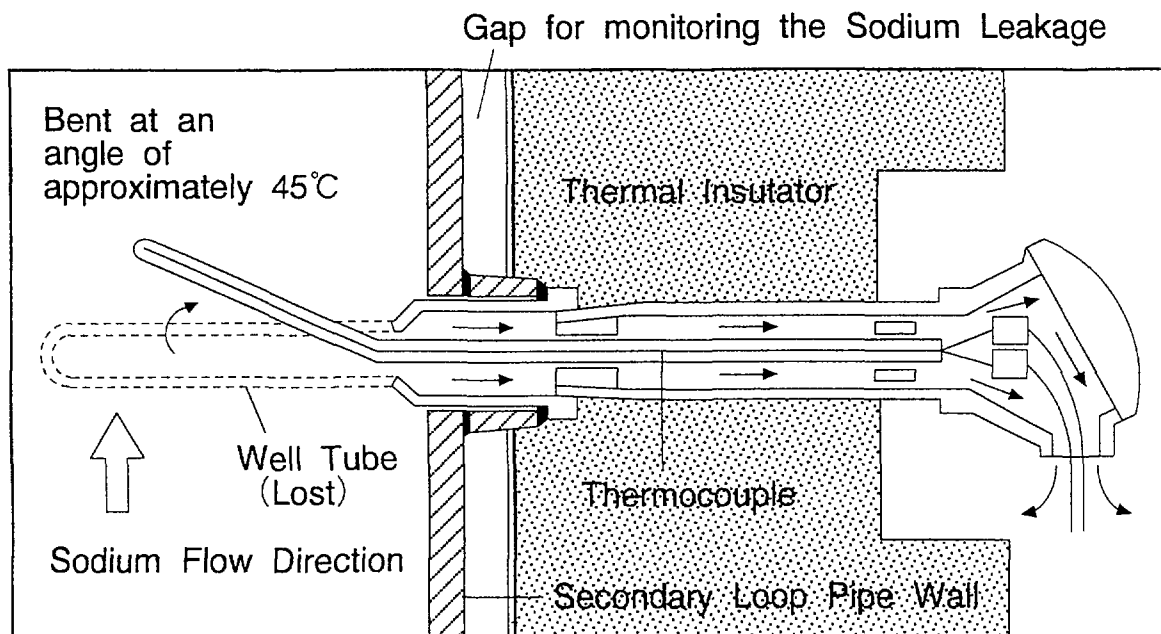
Fig. 4. The sodium leak flow path.

Detailed microscopic and metallographical examinations of the well tube and the fracture surface, examination of welded parts of the well, detailed examination of the sheathed thermocouple were carried out at JAERI and the National Research Institute of Metals (NRIM). The detailed measurement of the damaged part (fracture surface) was undertaken with microscopes and laser microscopes. As a result of these inspections, it was found that the fracture surface showed the typical features of high cycle fatigue with crack initiation, very slow propagation, and final ductile rupture, as shown in Fig.5. In parallel, flow-induced vibration analysis and mockup tests were conducted to identify the direct cause of the failure. These investigations confirmed that the breakage of the thermocouple well was caused by high cycle fatigue of the well tube tip due to flow-induced vibration. This vibration was not caused by well-known Von Karman vortex shedding, but a symmetric vortex shedding (Fig.6). According to fatigue crack analysis on the basis of the flow rate history, it was estimated that the cracks initiated at the early stage of the 100% flow operation, propagated in the subsequent operation, finally leading to the well tube failure in the last 40% flow operation. It was confirmed that the estimated breakage process agreed with the investigation results of the fractured surface and the full scale in-water experiment .
