Root Cause Analysis of Swelling Problem in *Kartini* Reactor

Syarip¹⁾, Sri Nitiswati¹⁾, Y. Sardjono¹⁾, Tegas Sutondo¹⁾, T.W Tjiptono¹⁾, Paul Stathers²⁾, R. Blevins²⁾, Kevin Thorogood²⁾

¹⁾ National Nuclear Energy Agency (BATAN), Yogyakarta, Indonesia.

²⁾ ANSTO, Structural Integrity Group, New Illawarra Road, PMB 1 Menai, NSW, Australia

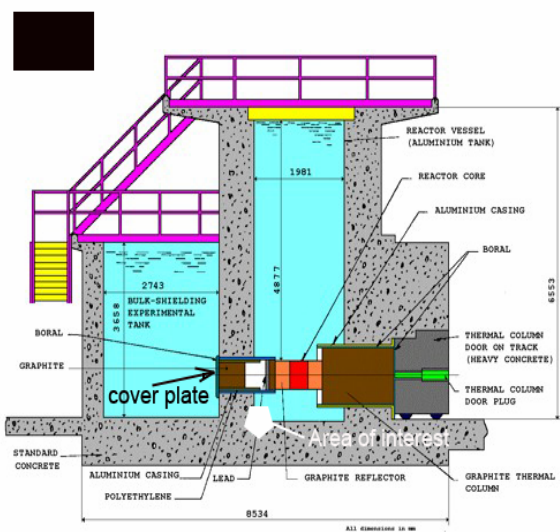
Fig 1. Vertical Section of Kartini Reactor with the area of interest indicated.

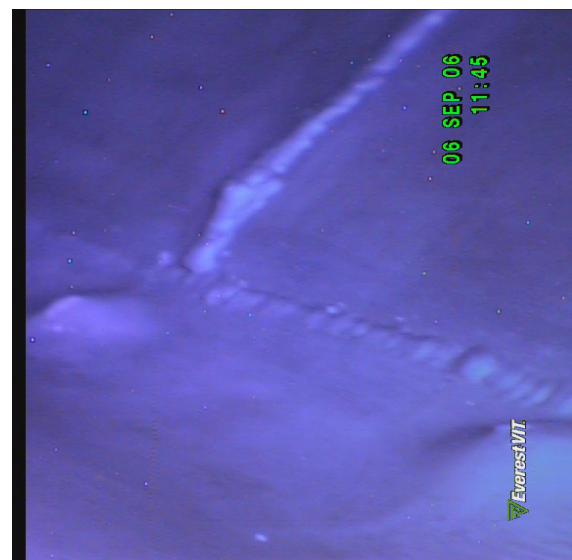
Fig. 2. Swellings S1 & S2 September 06 images.

The periodic inspection revealed that the swelling had increased in size over this period. Visual inspections by the video equipment and replication indicate that the swelling parts observed in 2001 had grown in size. In 2004 the dimension of S1 and S2 were observed to have 7.72 mm and 7 mm of height, and 1365 mm² and 1083 mm² of area, respectively. While in 2005, the heights of S1 and S2 were seen to increase to 7.78 mm and 7.56 mm, and the areas to be 1389 mm² and 1839 mm² respectively [4]. Recent examination (Sep. 2006 and September 2007) showed that the size of the swelling has remained relatively constant since 2005, and the peak of the bulges appears to contain tears (cracks). Fig. 3. below shows an ultrasonic thickness probe measuring the metal thickness at the swelling and Fig. 4. shows replication of the swelling using replication putty.

- The swellings have increased slowly in size over several years.
- The aluminium thickness is still substantial, ultrasonic measurements of the aluminium thickness using equipment provided by funding under IAEA TC INS 9002 shows that the aluminium thickness is predominantly at original values and still greater than 4mm in the area of the bulges. This indicates that the aluminium pool liner has not corroded significantly.

- It is apparent that some element of the reactor block structure is expanding and forcing the pool liner into the reactor pool. Two possibilities have been put forward. The first is corrosion of the steel reinforcement bars that were located close to the inside surface of the concrete pool backing, the second is the possible incorporation of clay nodules into the concrete mix. Both possibilities can result in volume expansion and fracture of the overlying concrete that can result in the pool liner protruding into the

- The first course of action is to dry the concrete block to attempt to remove the conditions that are causing the defects. The bulk storage facility would then be lined to prevent future water penetration of the concrete. If continued monitoring of the swelling indicates that some repair action should be taken the reactor pool will need to be emptied of fuel and control systems and the BSF would be required for storage.
- The second course of action is to maintain the program of periodic inspection to monitor the rate of progression and take action to repair to the areas involved.

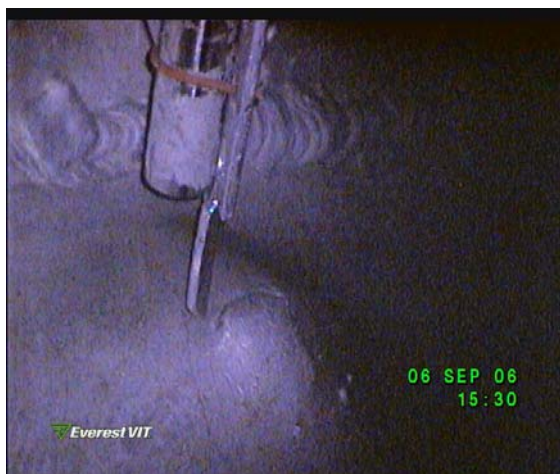
Fig. 3. Ultrasonic thickness measurement of tank wall.

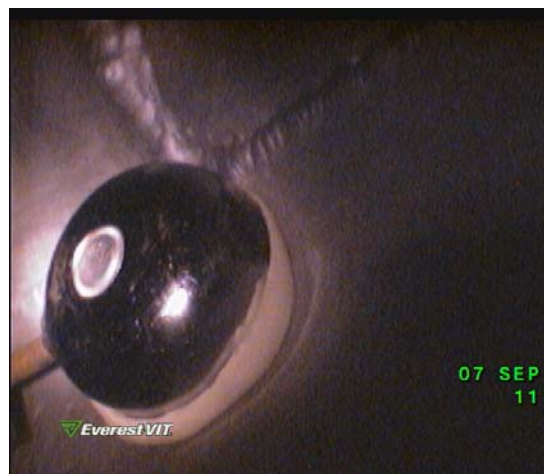
Fig. 4. Replication of bulge to allow accurate measurement of size.

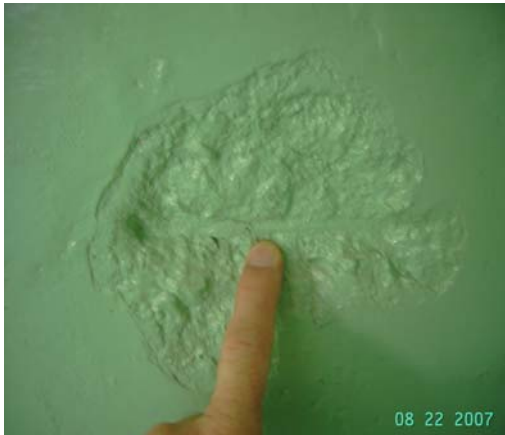
pool. The evidence for both the clay nodule and corroded reinforcement mechanisms can be observed on the external surface of the reactor block, particularly in areas around the base of the BSF. Figures 5 and 6 shown photos of the fractured external surface of the reactor block. The brown material in the centre of the fractured area has been analysed at ANSTO using SEM analysis and indicates a composition typical of clay. Examination of sand in the Yogyakarta region, used to make concrete, shows that clay nodules can be observed in the sand mix.

Fig. 5. Showing reinforcement (painted over) that had corroded and fractured concrete

The construction and supervision aspects of the reactor block have contributed to the issue by allowing reinforcement steel to be placed too close to the concrete surface and this has allowed contact with water and corrosion to occur. The volume expansion of the corrosion product has fractured the concrete and distorted the pool liner. Another aspect that could have contributed to the cause is the use of water containing impurities such as salt that increase conductivity and assist corrosion processes. Analysis shows that clay nodules have been incorporated into the concrete and these have fractured the external concrete surface and the same processes are likely to be occurring in the concrete behind the aluminium pool liner.

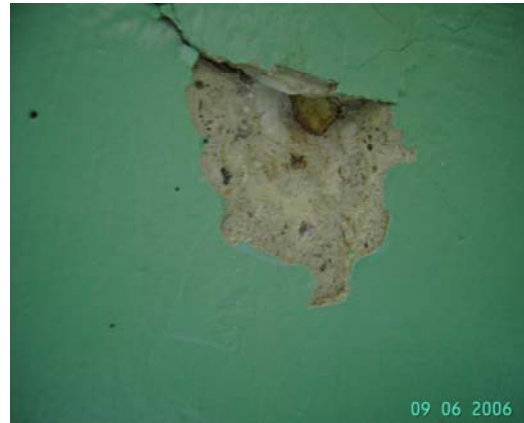
Fig. 6. Showing a clay nodule that had expanded and fractured the concrete

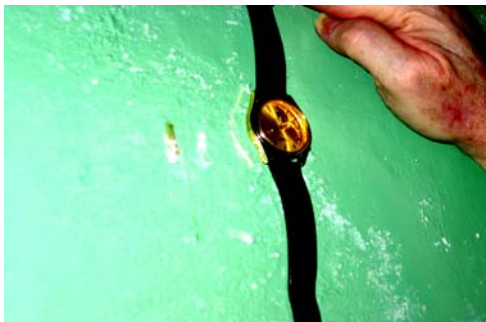
- The external surface of the bulk shielding facility (BSF) shows evidence of water leakage. The white deposits on the side of BSF shown in Figure 7, which were originally thought to be $\text{Ca}(\text{CO}_3)$, were analysed as Sodium carbonate. This indicated that water has been slowly seeping though the concrete wall and carrying with it dissolved material from the concrete which has reacted with CO_2 from the air to form the carbonate. The presence of Sodium poses the possibility that the water used to make the concrete contained salt, which suggests to the possibility of chlorides in the concrete that could lead to corrosion issues.

Fig. 7. Showing white deposits formed by water

seepage through the BSF wall

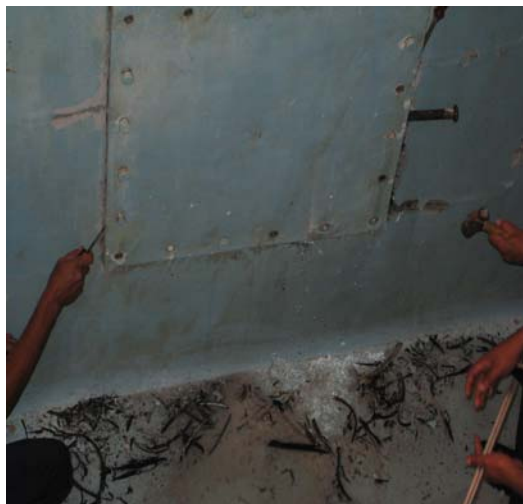
- The seal on the cover plate in the BSF has deteriorated after >25 years of service and allowed water to enter the thermal column. In August 2007 the sealing plate over the thermal column was removed and approximately 200 litres of water was drained from the thermalising column, see Fig. 8. below. The first 200 mm thick layer of graphite was removed to allow inspection of the aluminium behind the Boral layer separating the graphite and thermal column liner. Examination of the condition of the inside of the thermal column indicates that uniform corrosion has occurred on the inside of the thermal column. It can reasonably be assumed that the condition of the areas examined are typical of general corrosion within the column. From the examinations conducted on the accessible internal and external surfaces there are no concerns regarding the integrity of this component.

Fig. 8. Showing water leaking from the thermal column

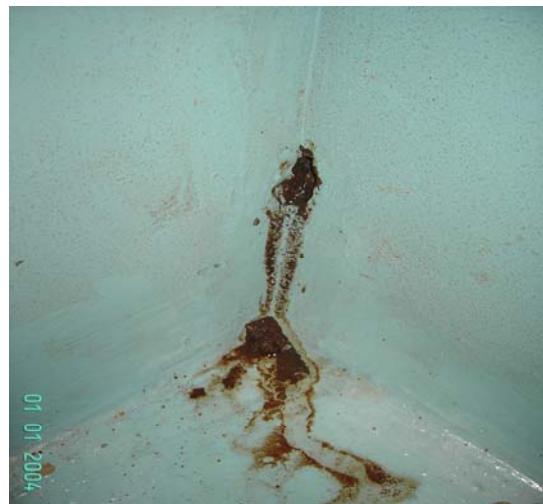
- The surface of the reactor block wall in the BSF contained cracks that could have allowed water penetration. Water could be observed to be seeping from the bottom corner of the BSF and probing allowed brown mud to flow from the area behind the painted surface, see Figure 9 below.

Fig. 9. Showing water and 'mud' seeping from the reactor block wall.
