The Radiological Accident in Soreq

**THE RADIOLOGICAL ACCIDENT IN
SOREQ**

INTERNATIONAL ATOMIC ENERGY AGENCY
VIENNA, 1993

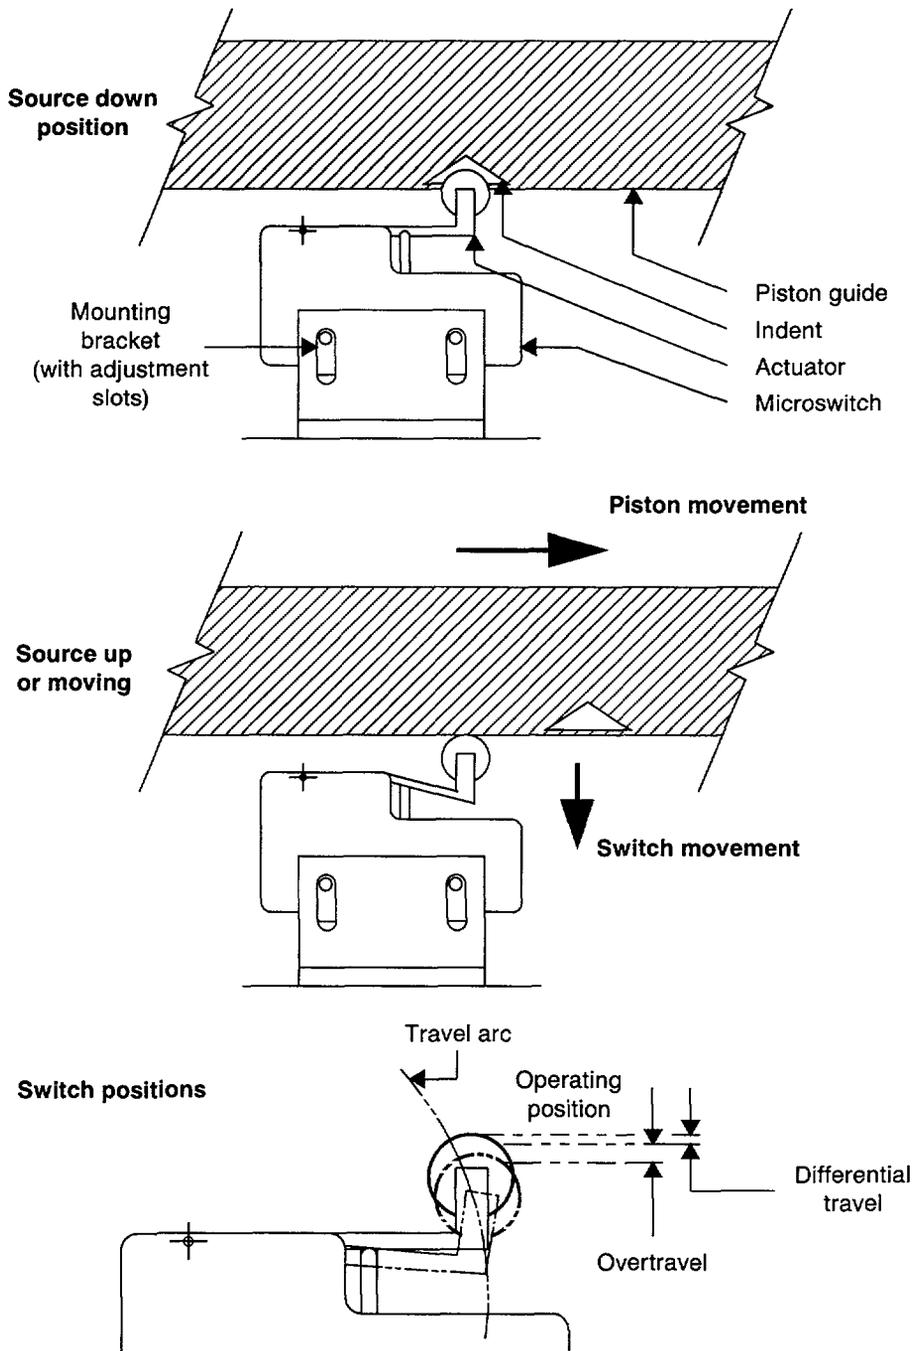
FIG. 6. Diagram showing the working of the LS-109 limit microswitch mounted on the hoist cylinder to indicate when the source is down. (By courtesy of Nordion International Inc.)

Figure 6 illustrates the operation of the limit microswitch. When the source rack is in the down position a roller on the actuator of the limit microswitch drops into an indent on one of the guides for the piston of the hoist cylinder. This is clearly visible through a window opening on the cylinder barrel. As the hoist piston moves to raise the source, the roller is pushed out of the indent and rides on the surface of the piston guide, causing the switch to actuate (i.e. one set of switch contacts opens and another set of contacts closes).

- (1) the transport jam that prevented the descent of the source rack into the pool;
- (2) the false indication by the limit microswitch LS-109 that the source rack was down;
- (3) the grave misjudgement by the operator who assumed that the source down signal was correct and disregarded the radiation alarm;
- (4) the unauthorized action by the operator who failed to consult his superior and defeated the safety interlock mechanism in order to enter the irradiation room;
- (5) the malfunctioning of the portable dose rate meter;
- (6) the failure of the operator to check the portable dose rate meter before entering the irradiation room, notwithstanding the fact (of which he was aware) that the radiation alarm was on.

- (1) A less than adequate design of the limit switch LS-109 (or its assembly).
- (2) A reliability problem with the room monitor test procedure.
- (3) Inadequate tamper proofing of the door interlock mechanism against simple bypassing devices.
- (4) The omission on the part of the plant management to install the protective shroud.

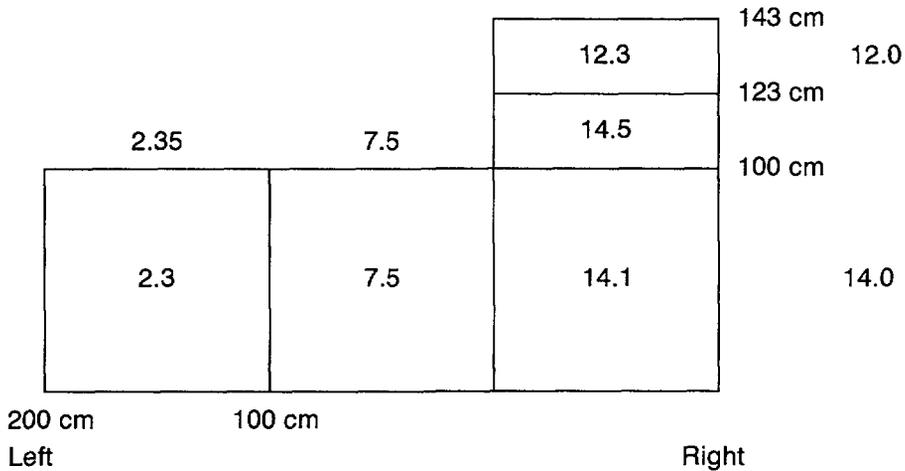
FIG. 12. Evaluation of dose rates where the operator stood in the plane of the source rack: for 10–20 seconds in front of the source, then to the left, then further to the left, with a total duration of exposure of 1–2 min. Dose rates are in Gy/min.

The operator left the irradiation room to fetch a cart, then re-entered the room with one and began to remove the damaged cartons from the conveyor (Fig. 12 shows an evaluation of dose rates in the positions in which he worked). After working for about a minute or so, he began to feel a burning in his eyes and a pounding

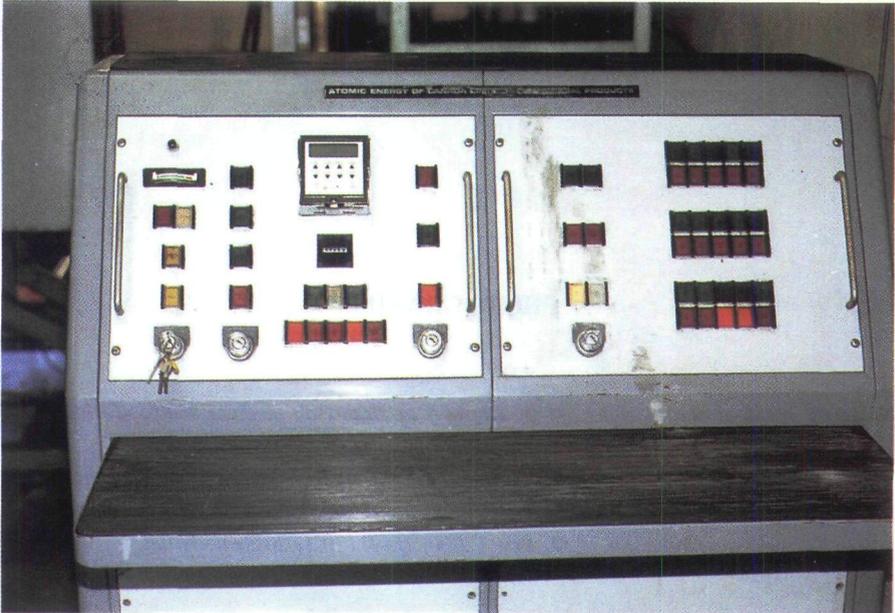
The operator was faced with two conflicting signals, one indicating that the source was safe and one that it was not. He chose to believe that the source down signal was correct and that the radiation alarm was false. Subsequently he said that his reasoning was that the movement of the source rack and the source down signal had never failed but that there had been a false gamma alarm from the radiation monitor about three years previously. Had the operator been in less of a hurry he could have called for assistance from a technician with more knowledge of maintenance procedures who could have gone to the roof to check the position of the indent on the guide of the source hoist piston. This would have indicated that the rack was not down.

1. The control console.

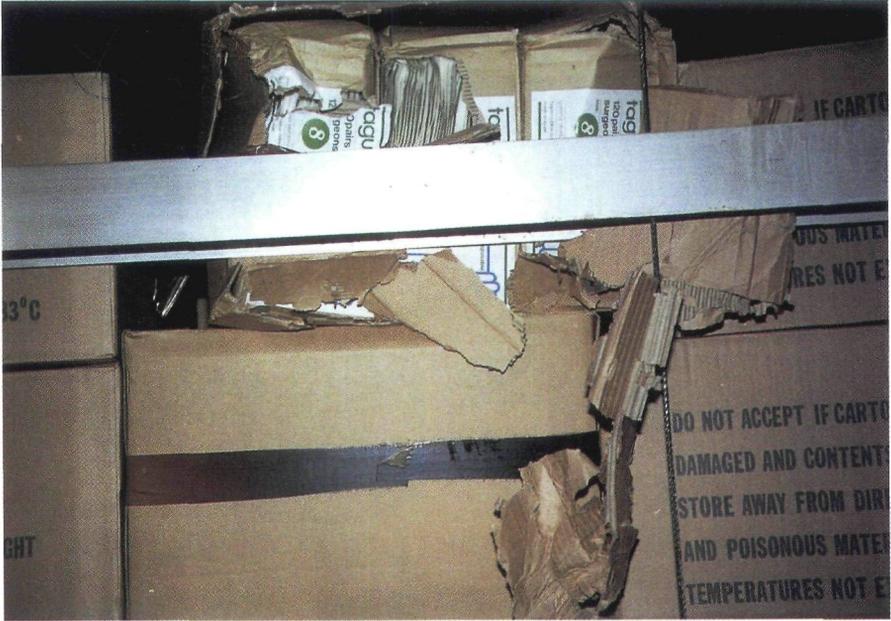
Shortly after 17:00 on 21 June 1990 a jam occurred in the transport mechanism of the irradiator. The cartons undergoing irradiation were reported to have been in good condition, and the exact cause of the jam is unknown. The pressure caused cartons on the outer lower conveyor to bulge and burst (see Photograph 2). This also disrupted cartons on the adjacent inner lower conveyor, causing one carton to protrude towards the source rack. The overdose timer detected the jam and the control system automatically caused the source rack to begin to descend. However, before it had descended one metre it was blocked by a carton on the inner lower conveyor (see Photograph 3) which was protruding under the upper edge of the source rack. (The carton on the inner lower conveyor that hindered the descent of the source rack was torn later in the action of releasing the rack. Photograph 3 also shows the steel guide bar into which the upper edge of the source rack fits and the source hoist cable.)

3. The carton on the inner lower conveyor that obstructed the source rack. Also shown are the steel guide bar and the source hoist cable.

- (1) A protective shroud should be fitted at the source rack irradiation position, as recommended by the supplier.

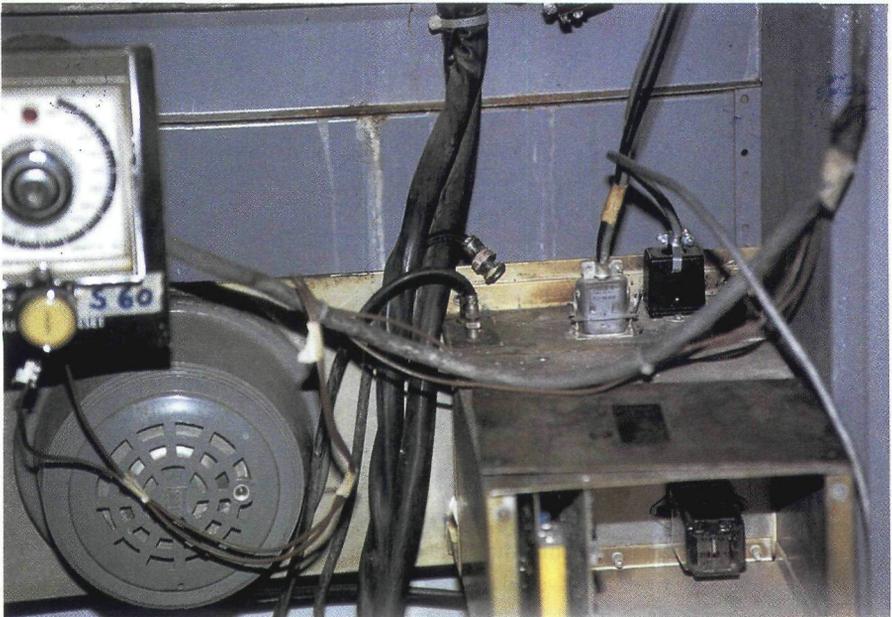
On the basis of his reasoning he decided to enter the irradiation room. There were, however, several safety features designed to prevent this. First of all, in order to silence the horn and possibly, according to his logic, to terminate a false signal from the radiation monitor, he went behind the console, opened the unlocked doors and disconnected the cable from the radiation monitor to the alarm and control circuitry (see Photograph 4). The alarm stopped.

The intention of the design of the safety systems was that disconnecting the monitor cable would have prevented the door from being opened, because the monitor test could not be made and hence power would not be supplied to the door lock solenoid. However, as described in Section 2.5.2, there was an established trick to simulate the monitor test. The operator removed the key from the machine switch and inserted it into the power switch, which he cycled on and off several times while

4. The inside of the control console showing the disconnected cable from the installed radiation monitor.
