## Decommissioning preparations for the accident-damaged Pile 1 reactor at Windscale, UK

Presented at the International Experts' Meeting on  
Decommissioning after a Nuclear Accident, IAEA, Vienna, 28  
January – 1 February 2013

MT Cross, Principal Consultant  
January 2013

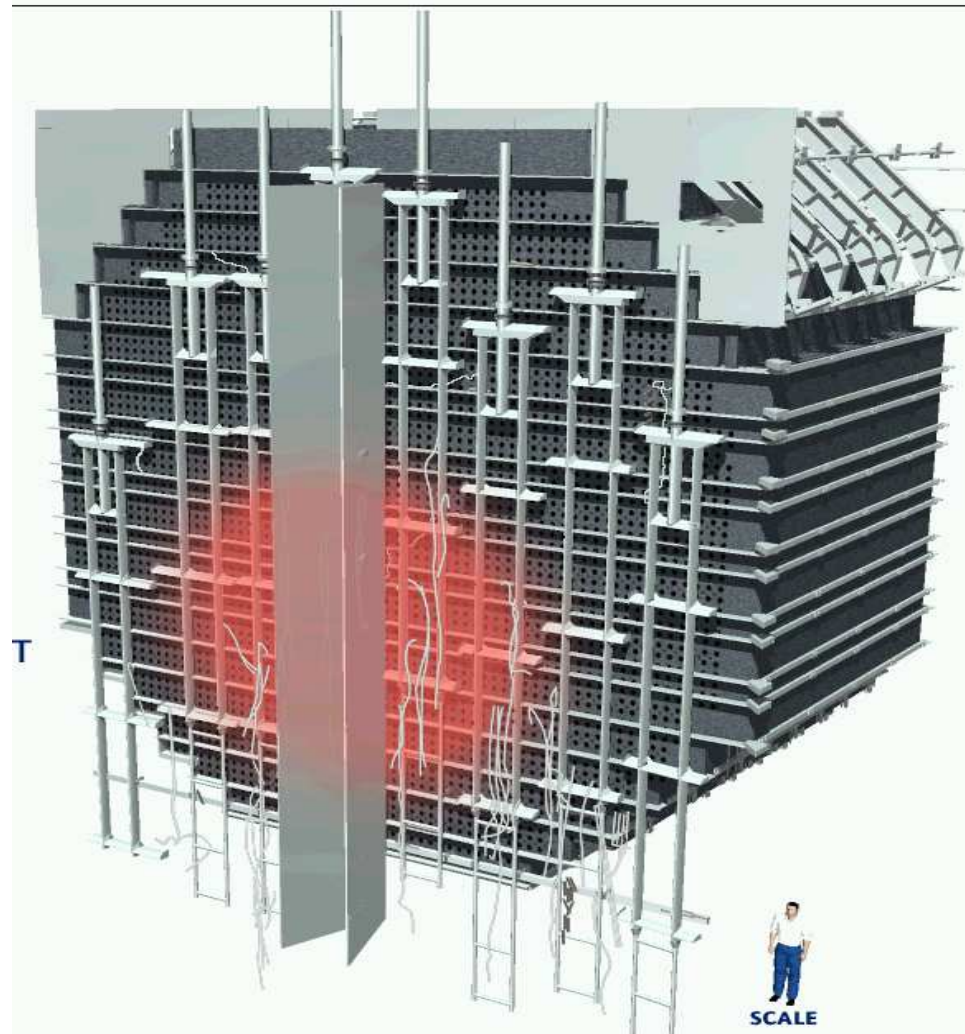
# Fire-Affected Zone (FAZ) in Pile 1

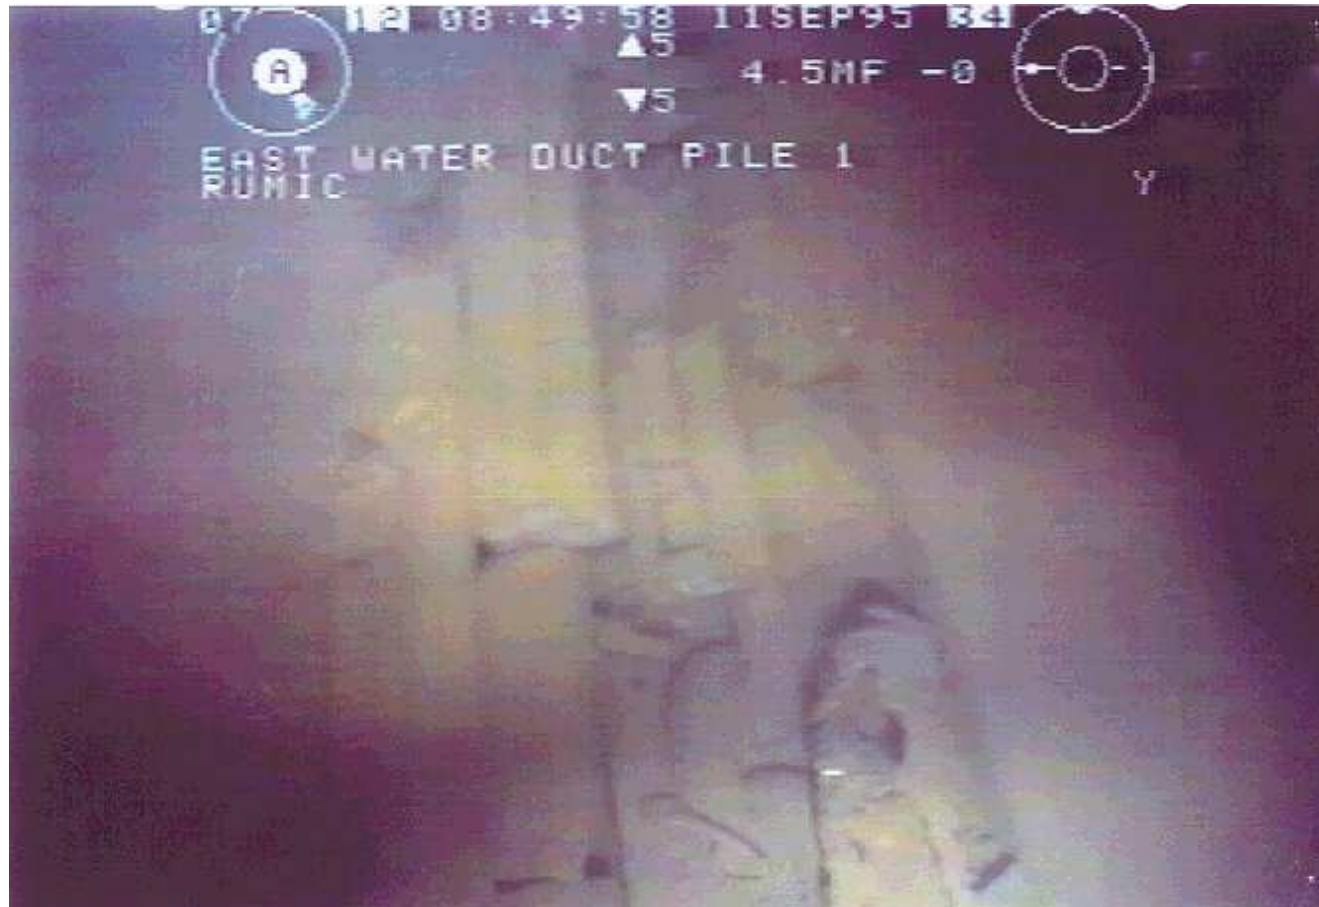
# Water Duct Clearance - Before

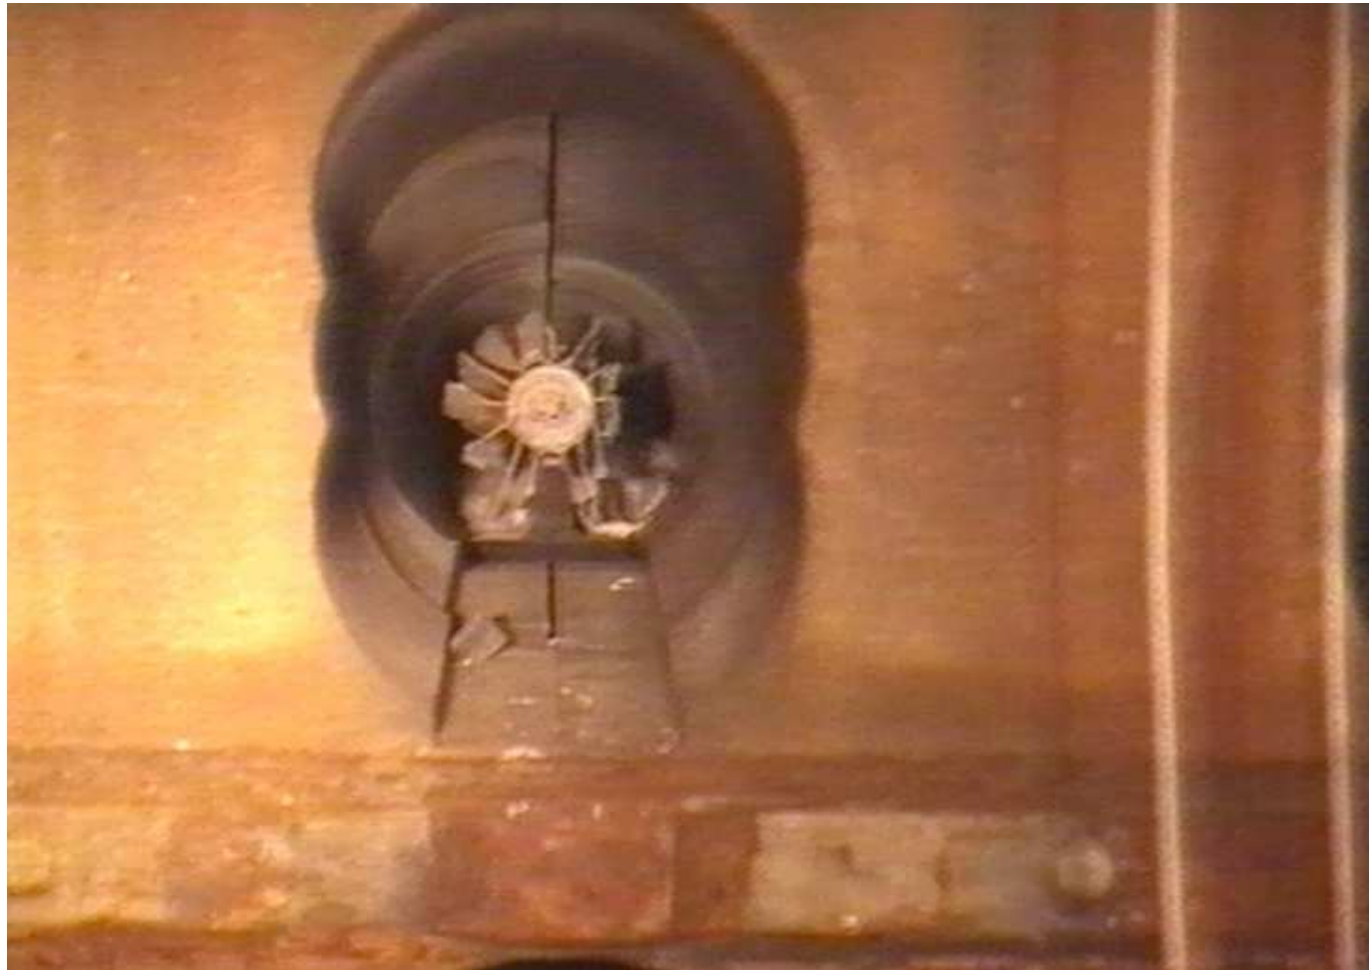
# Slightly Damaged Fuel

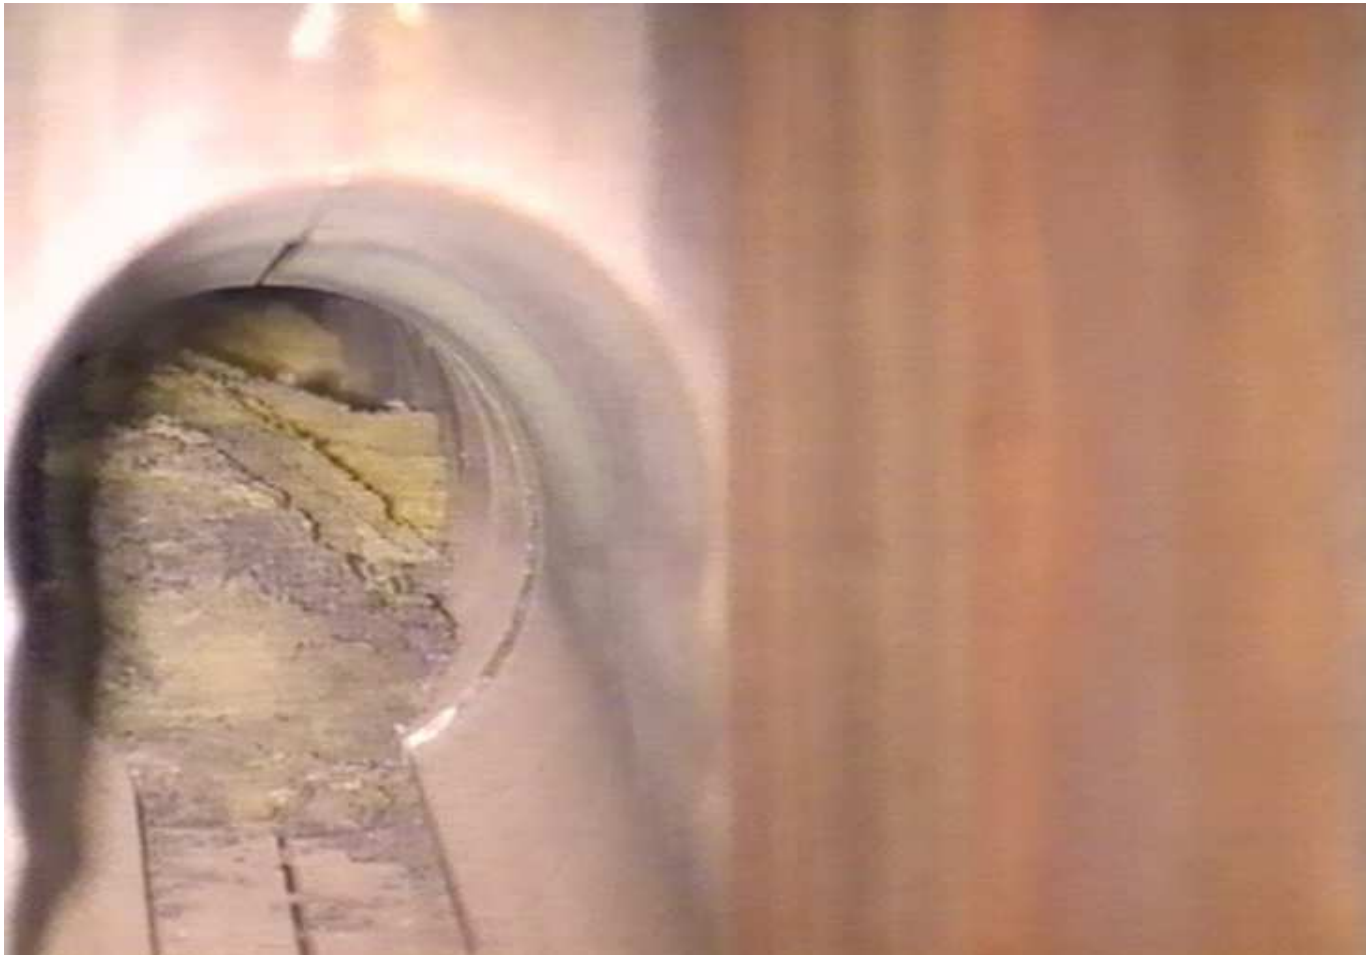
# Destroyed Fuel - 23.54

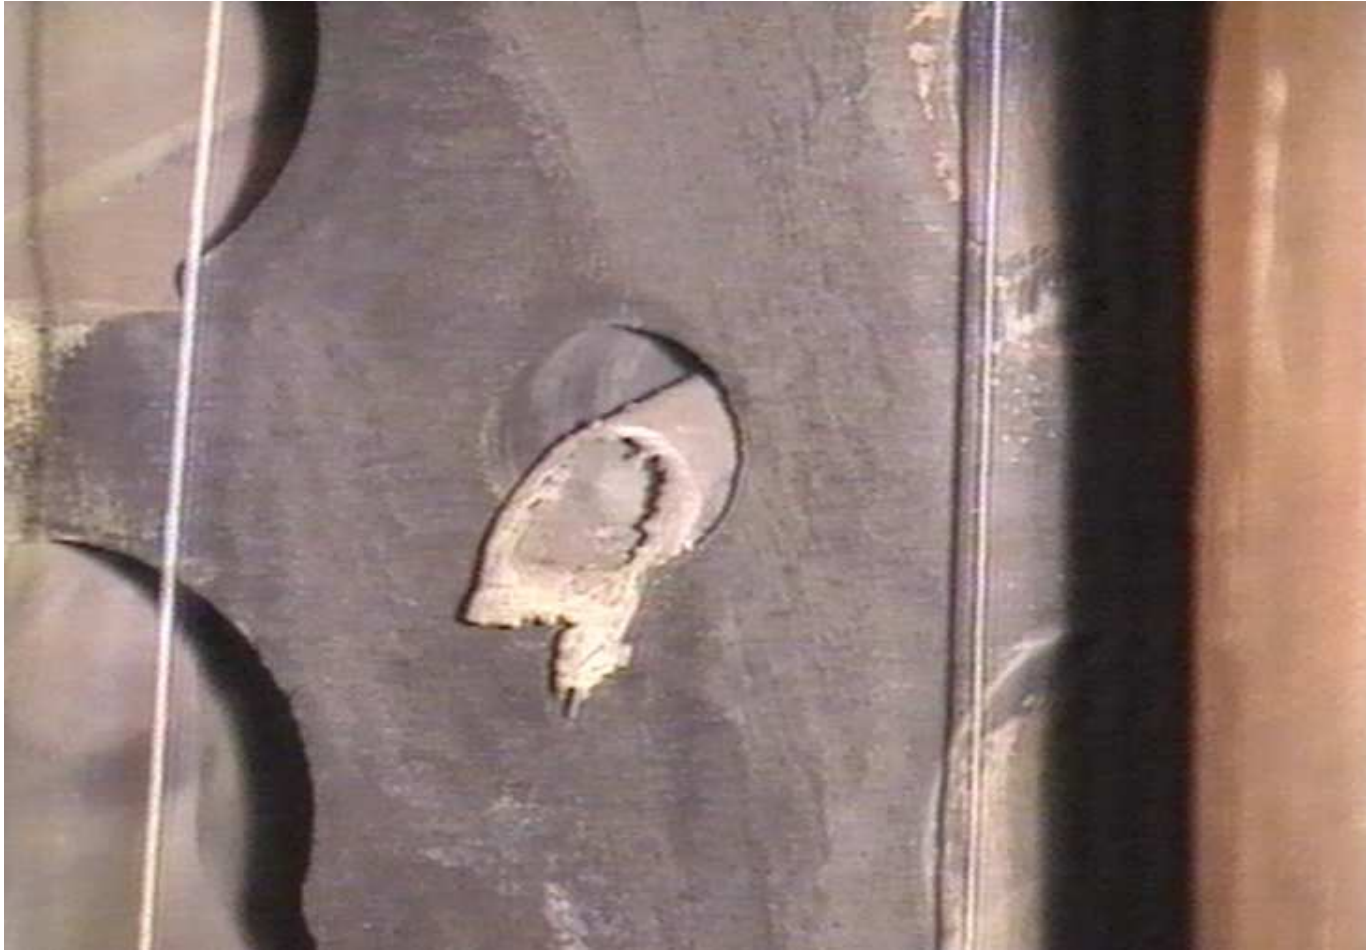
# Damaged Isotope Cartridge

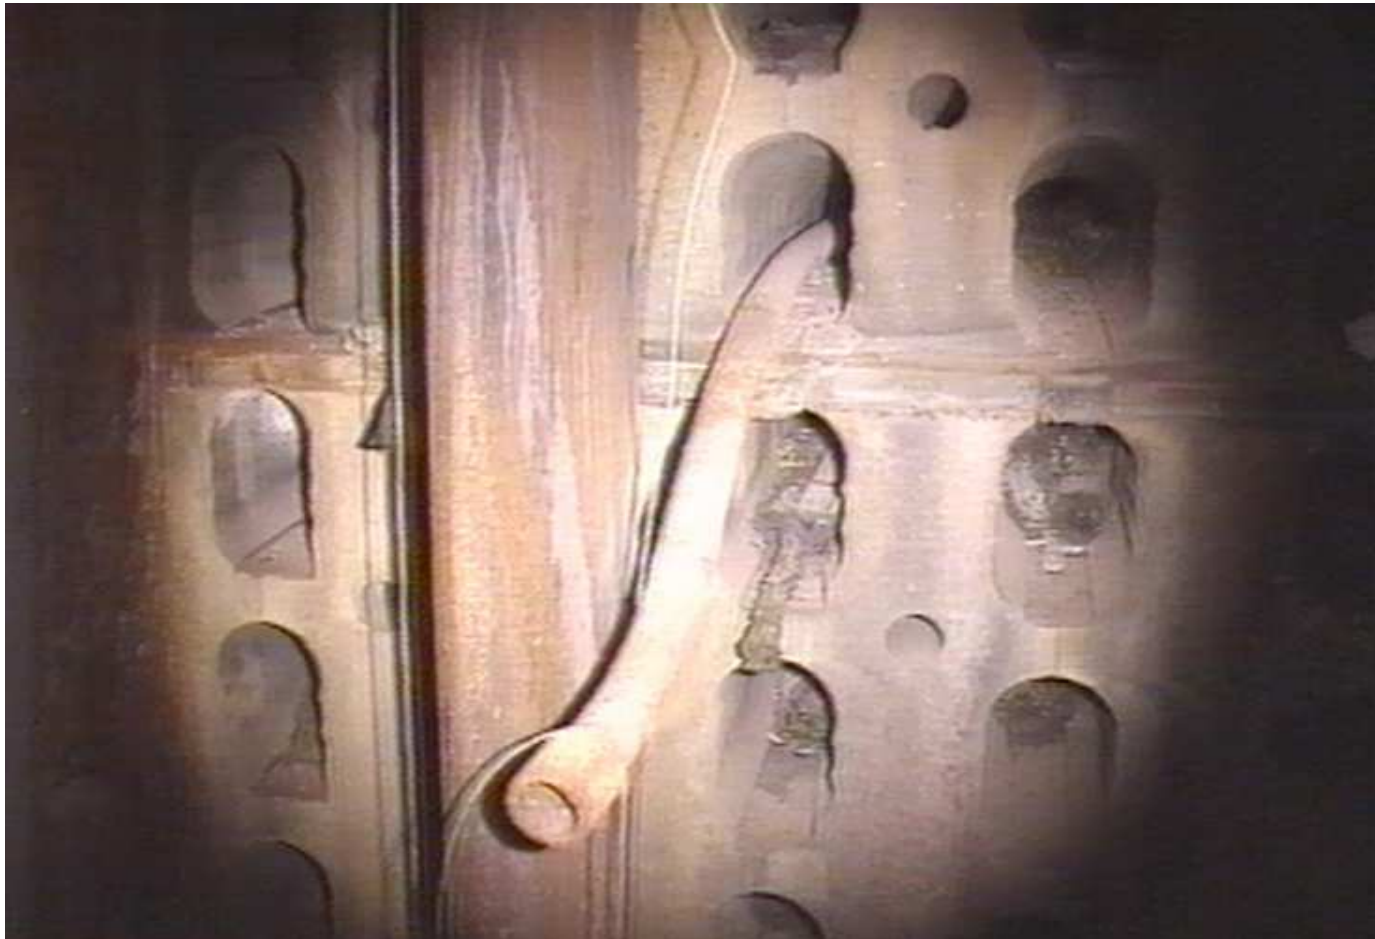
# Metal Pipe - channel 21.55

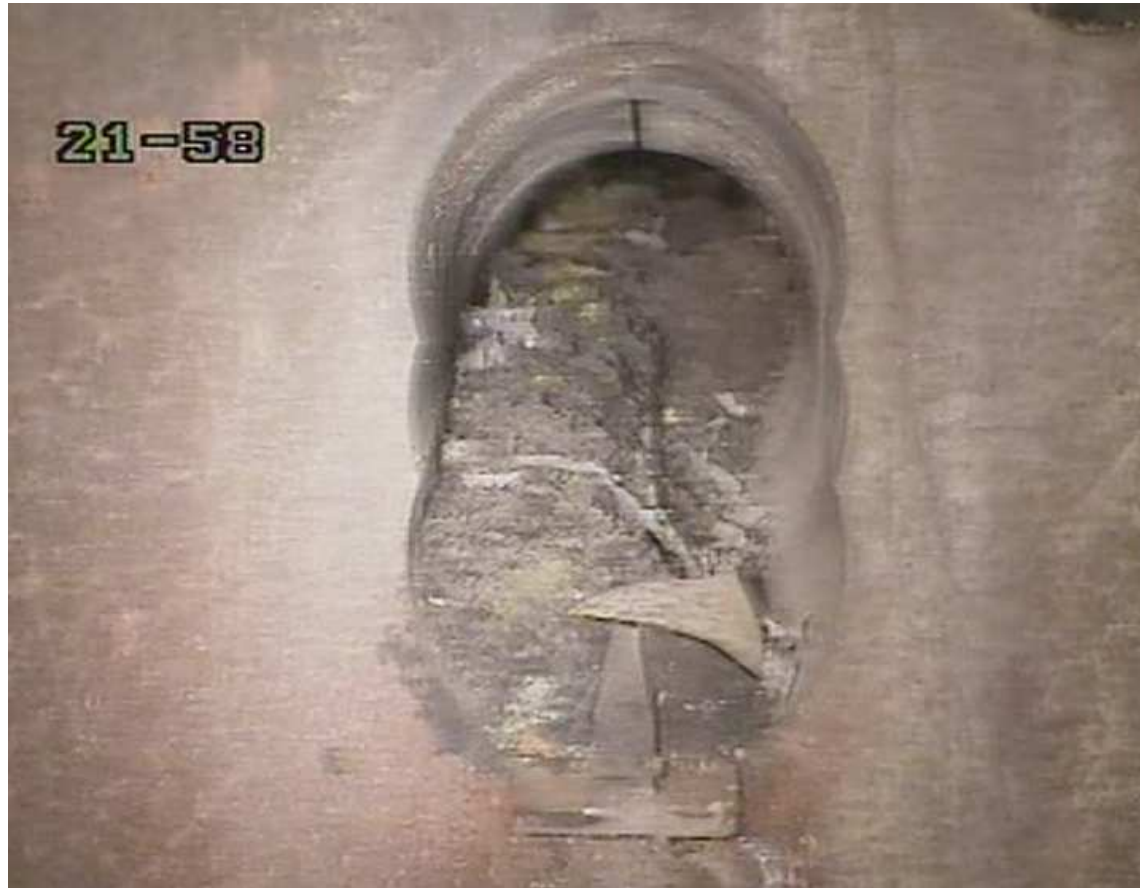
# Fuel element condition - gross corrosion, Channel 21, 58, hydride ruled out

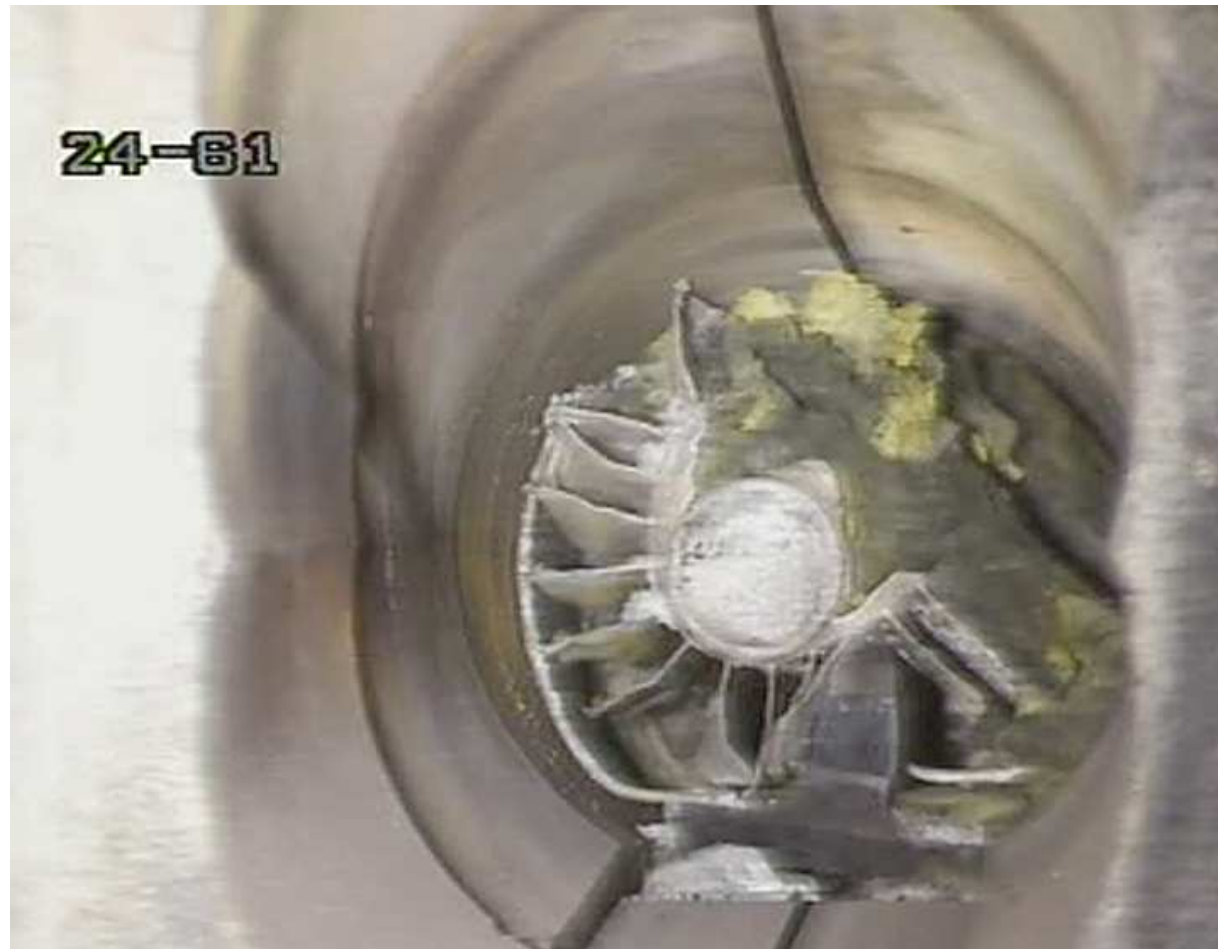
# Fuel element condition - severe fuel damage, Channel 24, 61, unlikely hydride survived

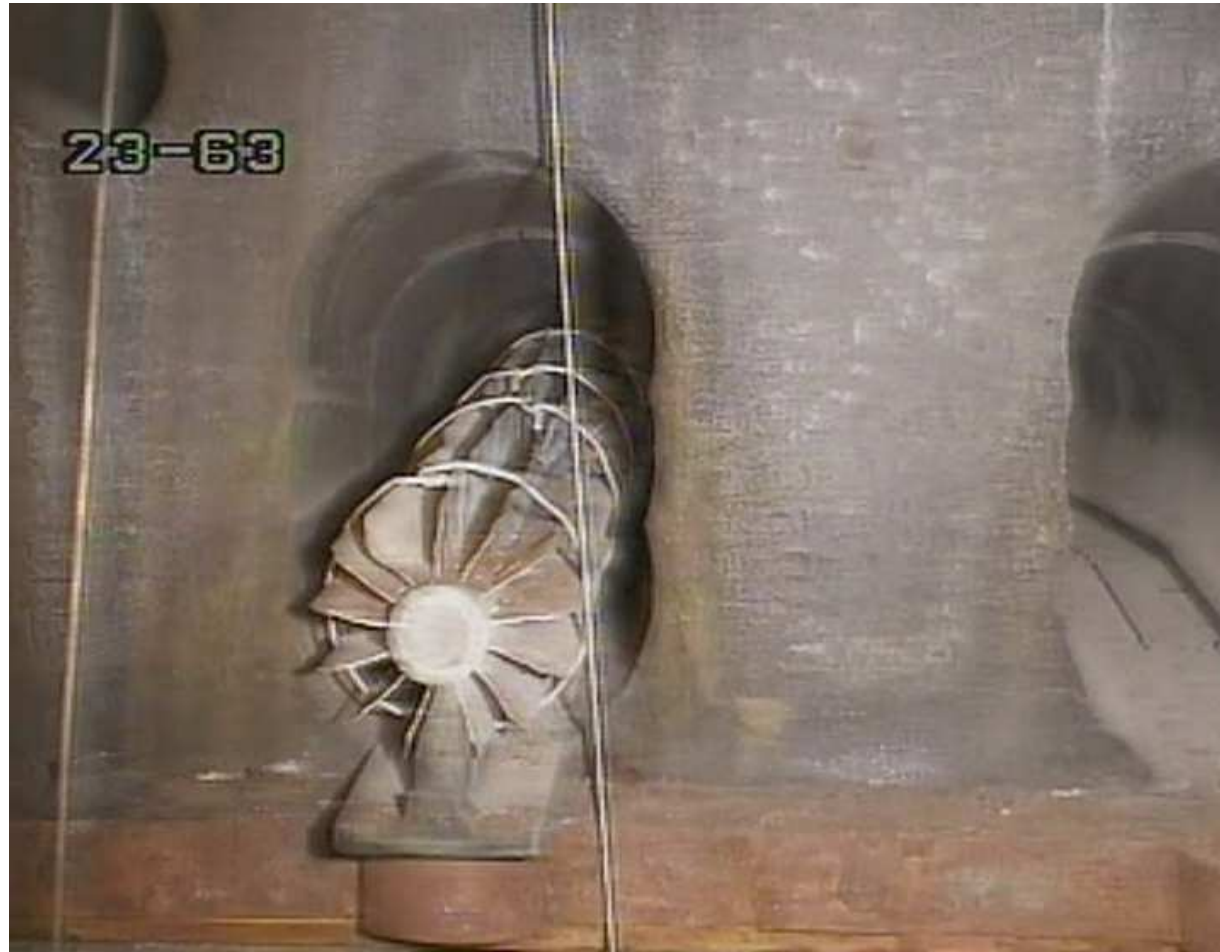
# Fuel element condition - minor fuel damage, Channel 23, 63, hydride possibility?
