East Japan Earthquake on March 11, 2011 and Emergency Response at Fukushima Daini Nuclear Power Plant

March, 2014

Naohiro Masuda

Former Site Superintendent at Fukushima Daini NPP

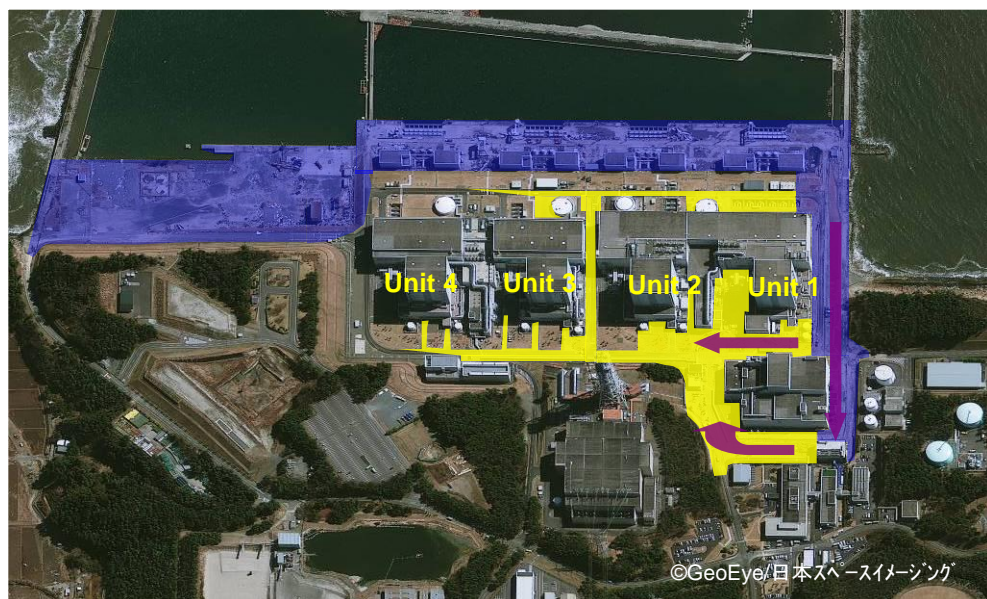
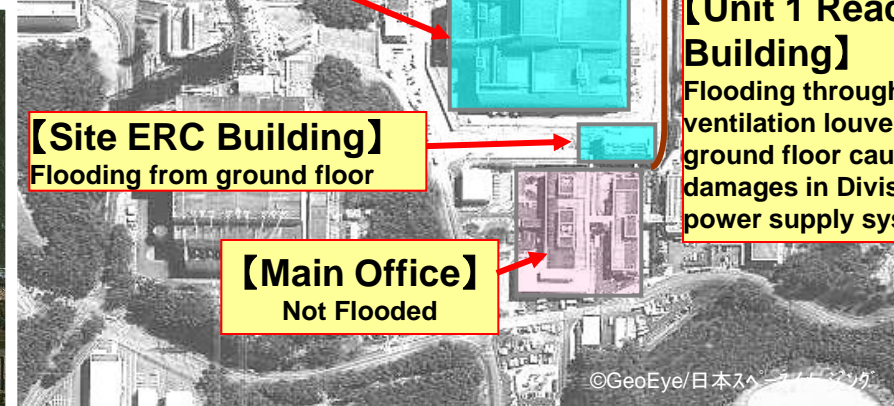
Flooding Caused by the Tsunami(1)

Equipment hatches were damaged by the tsunami causing flooding on the ground floor and below.

Pump function and power panel on the first floor in the south side of Unit 3 Heat Exchanger Building were available since the area was not inundated.

Flooding through the trench from Heat Exchanger Bldg to the basement

【Rad-Waste Building】
Flooding from ground floor

Flooding through the ventilation louvers on the ground floor caused damages in Division-A power supply system

【Site ERC Building】
Flooding from ground floor

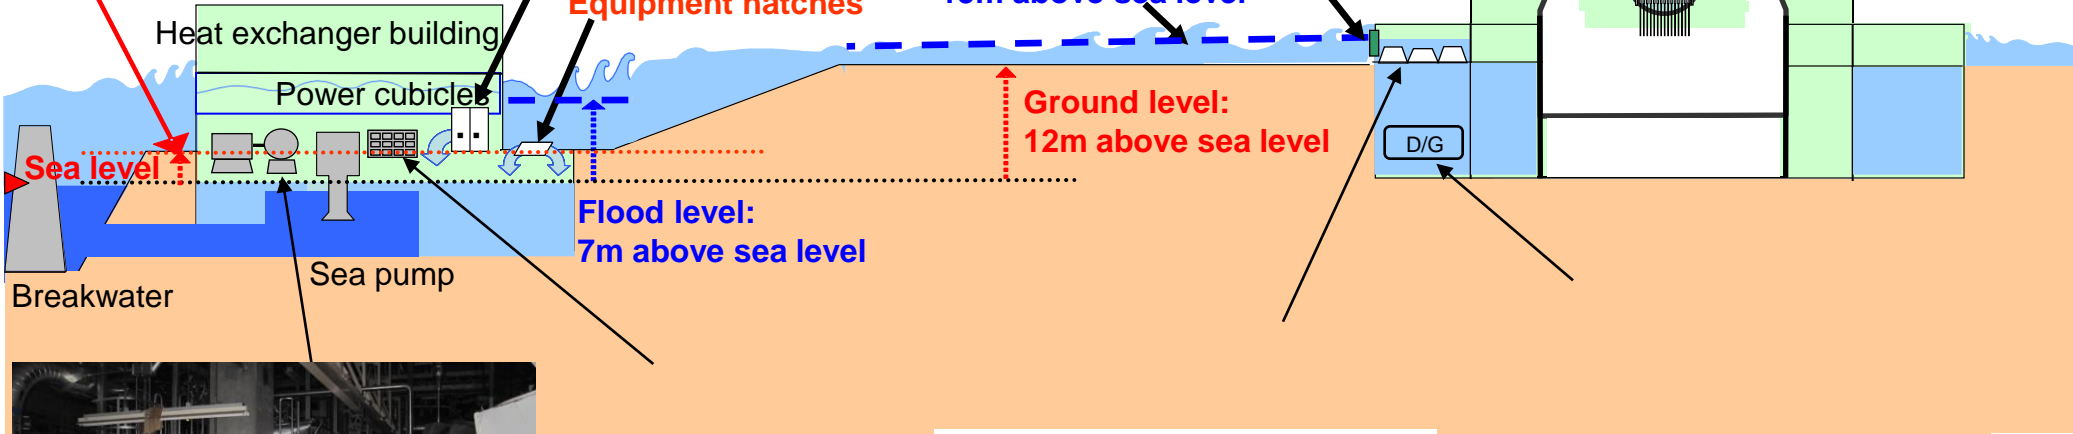
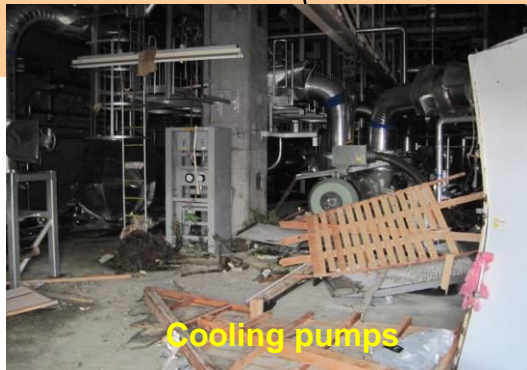
※Unit 1
Flooding to Reactor building through ventilation louver

Power cubicles

Unit 1 EDG air blower

Unit 1 EDG

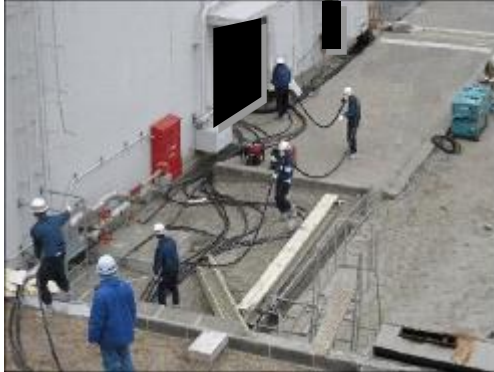
Electricity was supplied from mobile power vehicle

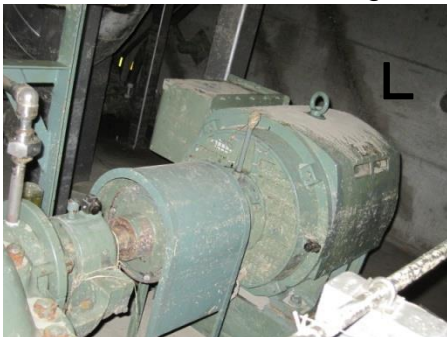
Water damage on motors induced by tsunami
TOKYO ELECTRIC POWER COMPANY

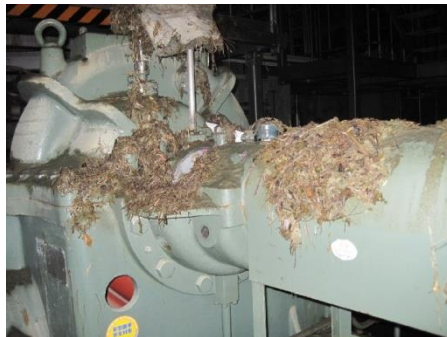
Water damage on pumps induced by tsunami

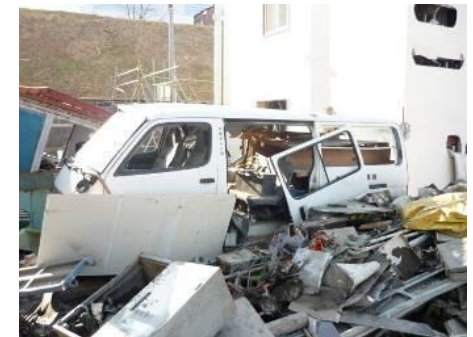
Debris near the seaside road

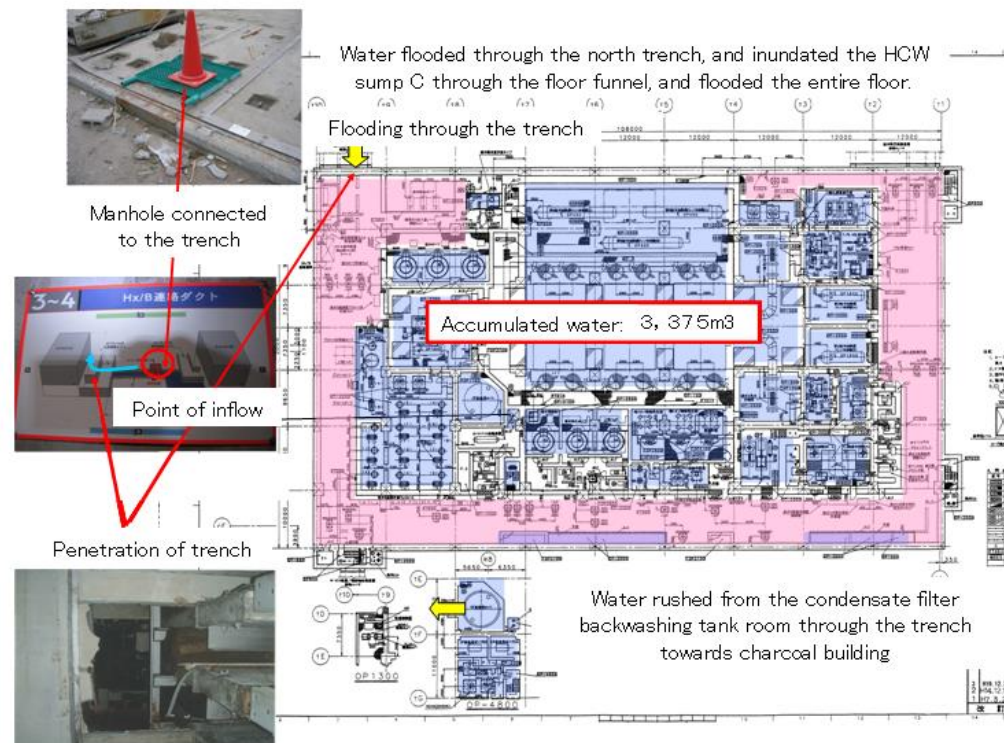
3号 T/B B2F

Example of flooding map
