# Major Influential Phenomena on the Accident Progressions of Fukushima Daiichi NPP

Masanori Naitoh The Institute of Applied Energy mnaito@iae.or.jp

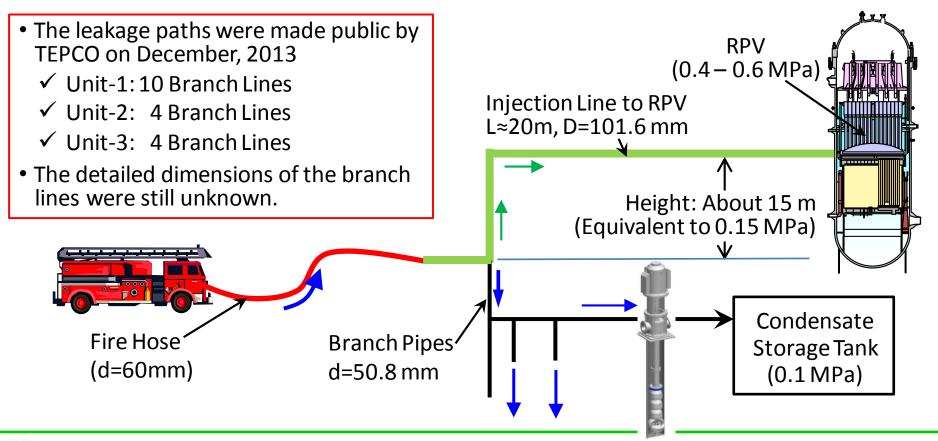
[Leakage of Alternative Water Injected by the Fire Pump]

- The discharged mass flow rate from the fire pump was enough to remove decay heat, but a mass flow rate into the core was much less because of leakage from the branch pipes.
- A leak flow rate was calculated based on estimation of a pipe length, numbers of elbows, friction losses, and the pump Q-H curve. (Uncertainty still remains.)

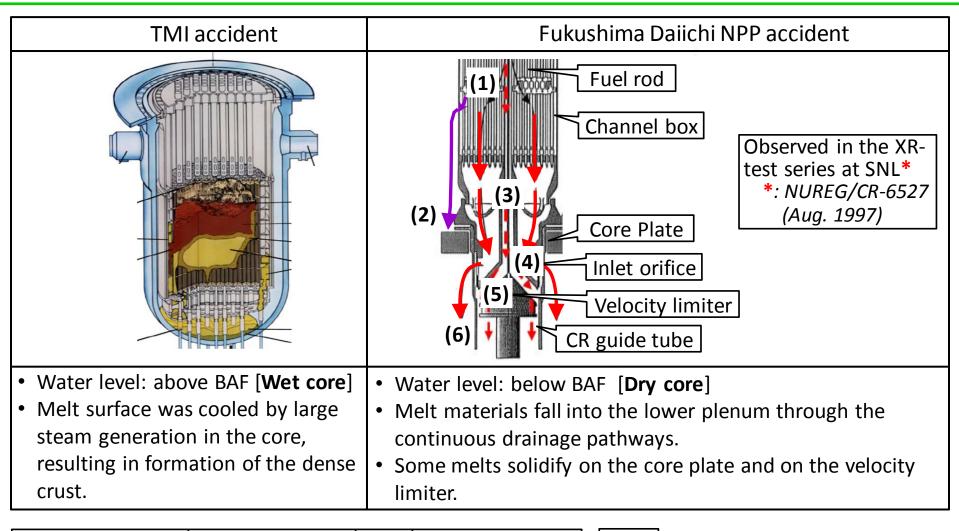
## Distinctive Phenomena of Fukushima Daiichi NPP Accident (4)-Debris Relocation Path

XR-2 Test Analysis	Above Core Plate			Below Core Plate	
with SAMPSON	(1)+(2)	(3)	(4)	(5)	(6)
Test	9%	11%	11%	37%	37%
Analysis	7%	15%	15%	28%	43%

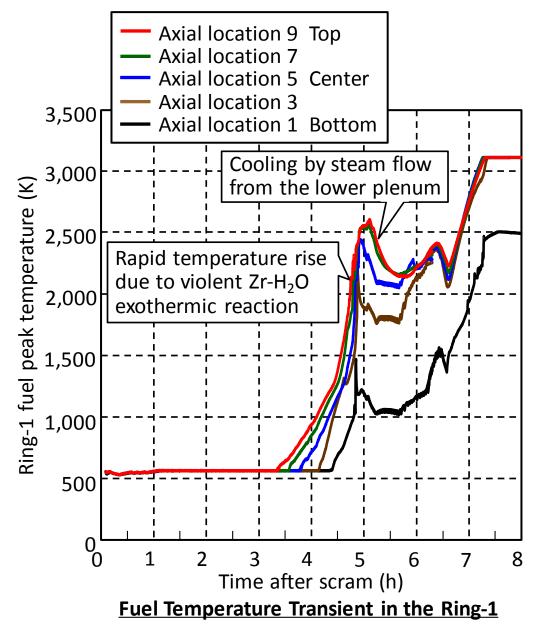
- Molten materials had already fell down on the pedestal at the start time of the alternative water injection, 15 hours after scram.
- Constituent of molten materials in the pedestal at 15 hours after scram

• About 30% of fuel (UO<sub>2</sub>) has remained in the peripheral region of the core

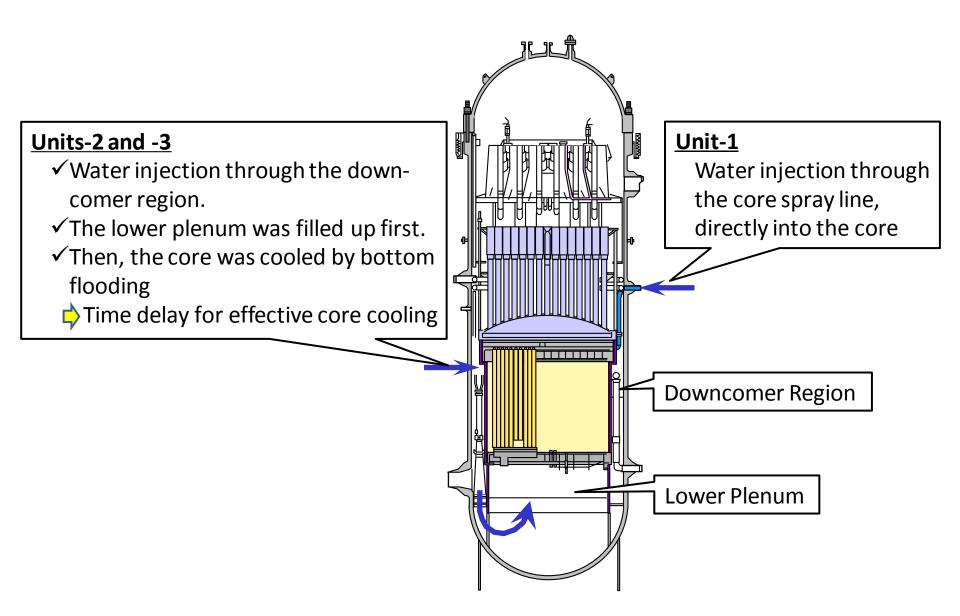
## SAMPSON Result for UNIT-2 – Core Melt and Relocation

- After the core was completely reflooded at about 105 h by the sea water injection, the fuel temperature decreased to almost the saturation temperature of water.
- Since the RPV bottom was not damaged, all the melt materials accumulated in the lower plenum of the RPV.
- Constituent of molten materials in the lower plenum at 105 hours after scram

- There still are uncertainties which affect very much the melt behaviors.
  - Node division in core region [Finer node division, especially in *r*-direction, is required.]
  - Mass flow rate of sea water injected into the core
     Possible RPV bottom damage (IRM/SRM melt) if the mass flow rate would be slightly less than the current estimation.
  - Time delay for effective core cooling (water injection into the downcomer region resulting in bottom reflooding)
  - RCIC part load performance under two-phase flow condition

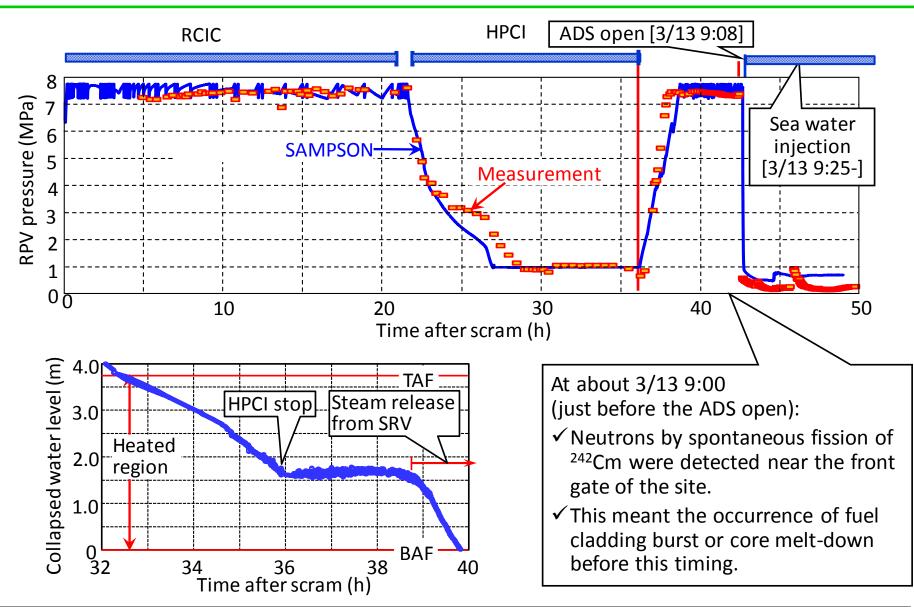
**SAMPSON Result for UNIT-3 – Pressure Transient**

• The water mass flow rate by HPCI under low pressure condition is very sensitive to the melt behavior.

- 39.8 h after scram: Water level to BAF
- 41.7 h after scram: Initiation of fuel cladding burst [FP release]
- 41.8 h after scram: Initiation of melt of UO<sub>2</sub> eutectics

- 42.2 h after scram: Detection of neutrons
- 42.6 h after scram: Initiation of sea water injection
- 44.3 h after scram: RPV bottom break [IRM/SRM housing melt]

- Since the sea water was injected through the downcomer, effective core cooling was delayed.
- After the RPV bottom break, the injected water leaked through the breaks.

- Finally, all the core materials had melted down onto the pedestal.
  - It is still unknown whether HPCI was stopped by operator's manual switch off or it stopped naturally when the pressure decreased to the lower design limit earlier than the operator's switch off.
