**MINISTRY OF HEALTH AND SOCIAL SERVICES**

**TITLE: INSPECTION OF CONVENTIONAL DIAGNOSTIC X-RAY FACILITIES**

**TITLE:** Inspection of conventional diagnostic x-ray facilities in Namibia

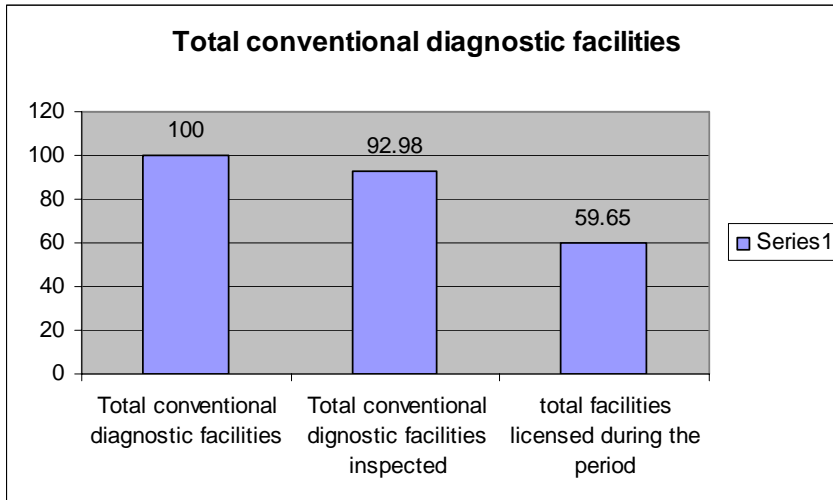
Figure 3.1: Total conventional diagnostic facilities

For the purpose of compliance and enforcement 53 out of 57 diagnostic x-ray facilities were inspected. Figure 3.1 (below) indicates the total number of facilities inspected and authorized.

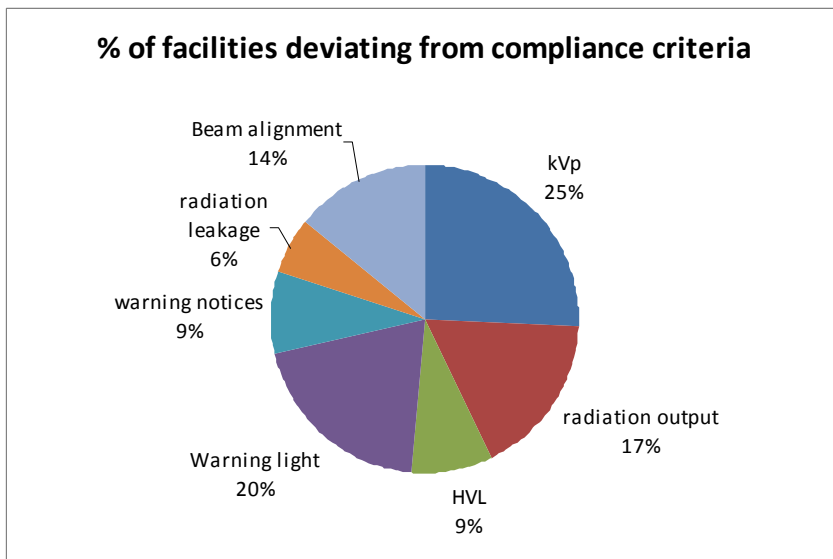
Figure 3.2: Percentage of facilities deviating from compliance criteria

Figure 3.2 below shows that 26% of the facilities failed the kVp test, while radiation warning lights followed with 20%. In most cases the radiation leakage and half value layer were within the recommend limits.

As a result of the inspection performed recommendations were issued to the management of the facility in order to implement corrective measures and only 6 facilities that were inspected and not authorized carried out the corrective actions recommended. The division is thus recommended to improve its enforcement mechanism.
