THE RADIOLOGICAL ACCIDENT IN GOIÂNIA

THE RADIOLOGICAL ACCIDENT IN GOIÂNIA IAEA, VIENNA, 1988 STI/PUB/815 ISBN 92-0-129088-8

FOREWORD

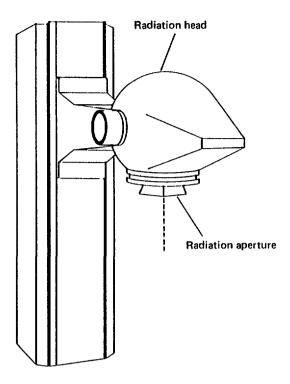
FIG. 4. Schematic view of a teletherapy machine similar to the one from which the source assembly was removed in Goiânia. The radiation head is adjustable vertically and can be rotated about two horizontal axes.

of Italy. Figure 4 shows an artist's impression of a similar teletherapy unit. In order to understand what happened subsequently, it is necessary to distinguish the major components of the teletherapy unit.

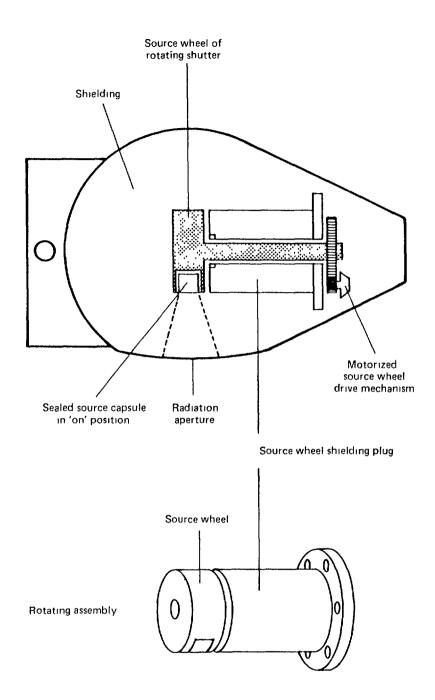
The sealed radioactive source capsule was set in a source wheel, made of lead and stainless steel, to form the rotating shutter mechanism (see Fig. 5). To produce a radiation beam, the shutter was rotated electrically to align the source capsule with the radiation aperture. After an exposure or in the event of a power failure, a spring loaded device returned the shutter with the radioactive source to the 'off' or 'safe' position. Between the rotating shutter and its electric drive mechanism there was a cylindrical shielding plug. These elements can be collectively referred to as the rotating assembly. The unit was designed so that the rotating assembly could be removed with special tools from the shielding of the radiation head.

FIG 5 Cross-sectional diagram of the radiation head of a teletherapy machine similar to the one from which the source assembly was removed in Goiânia, showing the rotating assembly for the source capsule

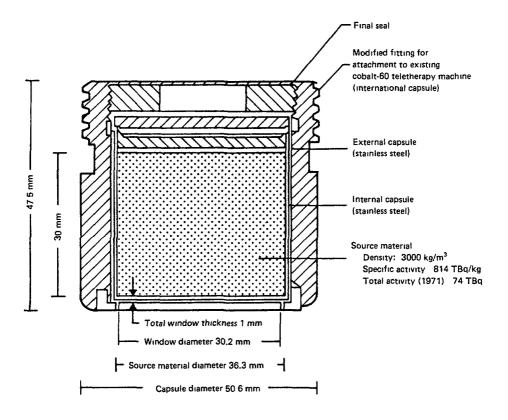
FIG. 6. Cross-sectional diagram of an international standard capsule. Such a capsule of radioactive caesium chloride was broken open in the accident in Goiânia. The source was compacted to a coherent mass and sealed within two stainless steel capsules

The serial number of the sealed radioactive source is not known, but from other information the source is thought to have been produced at the Oak Ridge National Laboratory (ORNL) facility in the United States of America in about 1970. The radioactive source was caesium-137 in the form of highly soluble caesium chloride salt. This had been compacted to form a coherent mass which was doubly sealed within two stainless steel capsules, as shown in Fig. 6. These in turn were sealed within what is known as an *international standard capsule* having standardized dimensions common to most radiotherapy units. Figure 6 shows a cross-sectional view of a source sealed in an international standard capsule.

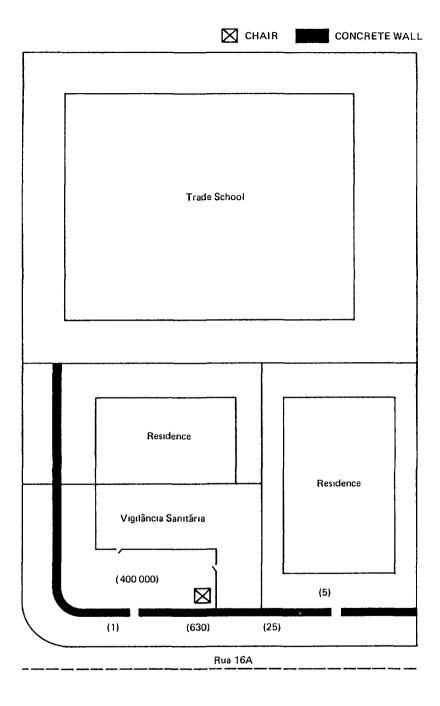
FIG 10. The dose rate (in $\mu Sv h^{-1}$) around the Vigilância Sanitária on Rua 16A (16A Street) (the public health department in Goiânia)

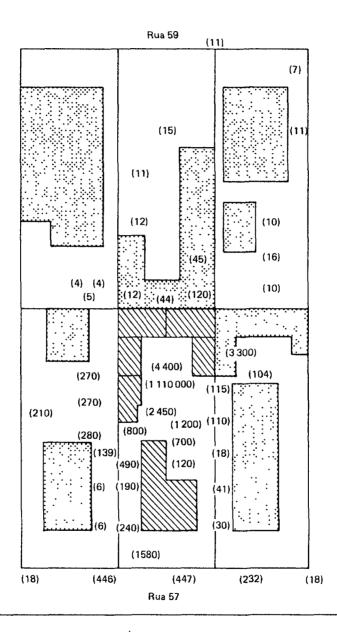
FIG 20 Dose rates (in $\mu Sv \cdot h^{-1}$) around the house of R A in Rua 57 (57th Street).

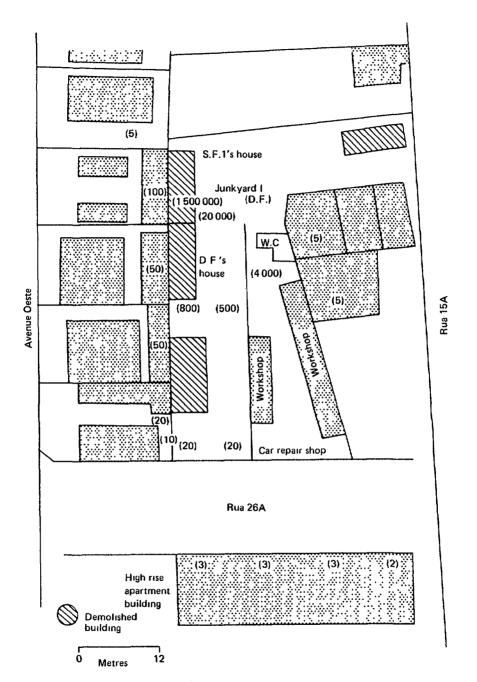
FIG. 21. Dose rates (in $\mu Sv \cdot h^{-1}$) around the house of D.F. in Rua 15A (15A Street).

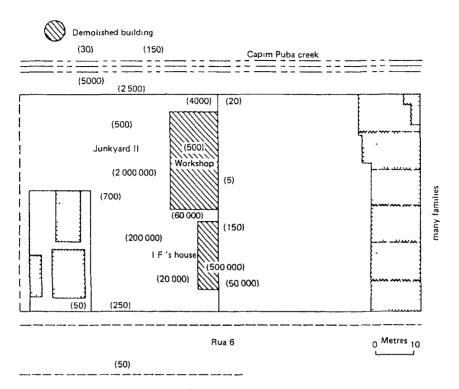
FIG 22 Dose rates (in $\mu Sv \cdot h^{-1}$) around the house of IF in Rua 6 (6th Street)

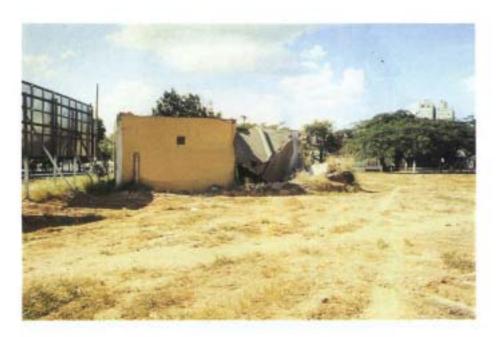
1. The derelict radiotherapy clinic in Goiânia from which the caesium source was taken.

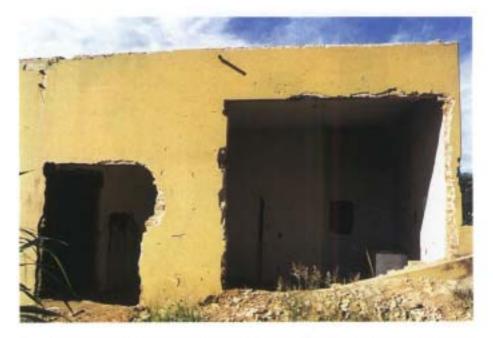
2. The derelict radiotherapy clinic in Goiānia from which the caesium source was taken.

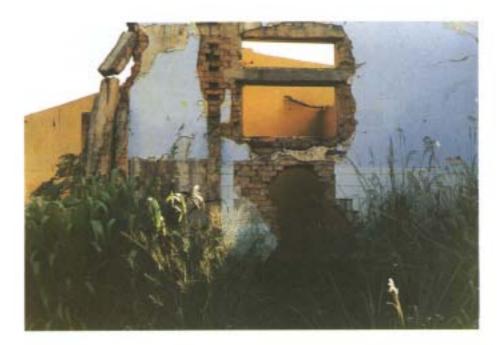
3. The derelict radiotherapy clinic in Goiânia from which the caesium source was taken.

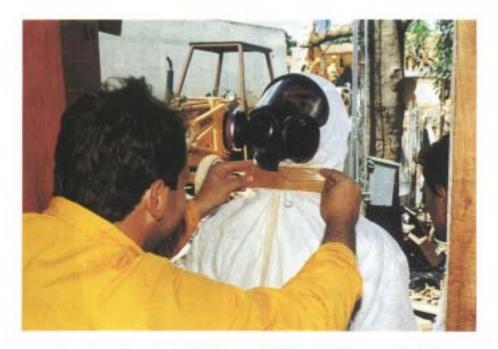
7. Preparing to demolish the house of E.F.2 and S.F.1. near Junkyard I.

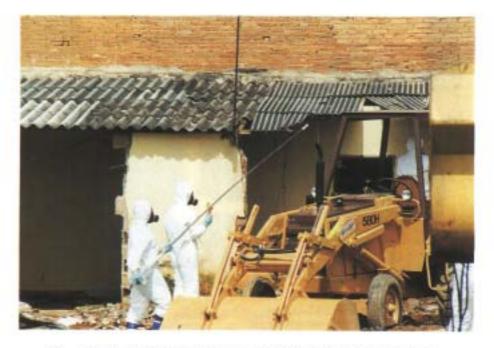
8. Monitoring the roof of the house of E.F.2 and S.F.1 during demolition.

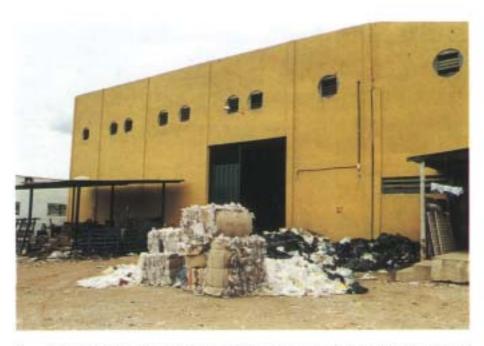
9. Contaminated bundles of paper that had been collected by the junkyards for recycling.

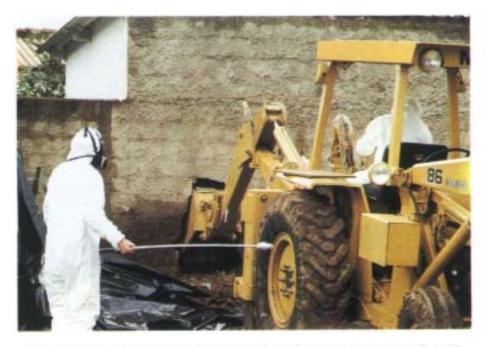
10. A hole is made to remove a radiation hot spot giving a dose rate of 0.5 Sv-h⁻¹.

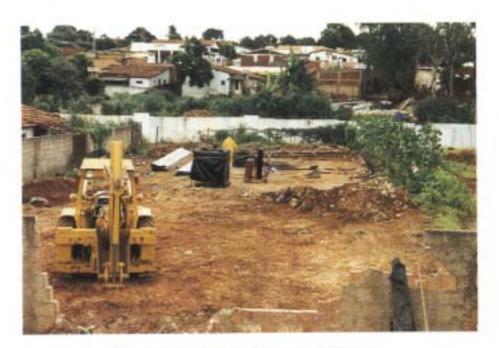
11. Clearing the site at Junkyard II on 6th Street.

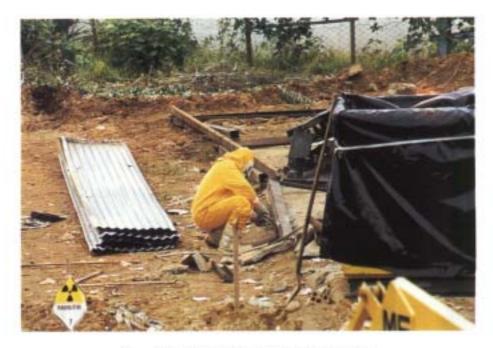
12. Junkyard II: cutting up contaminated girders.

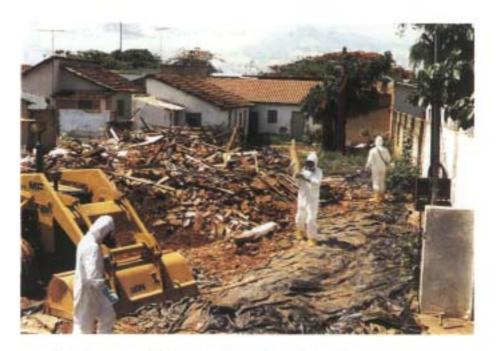
13. Contaminated rubble from the demolition of R.A.'s house on 57th Street.

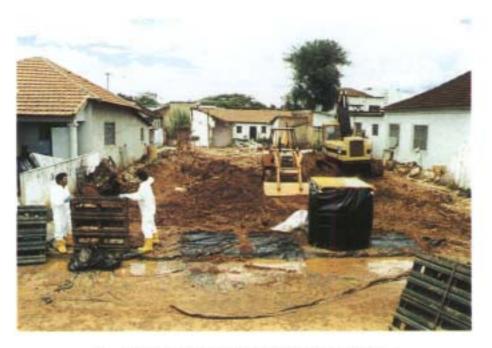
14. The same site after removal of the contaminated rubble.

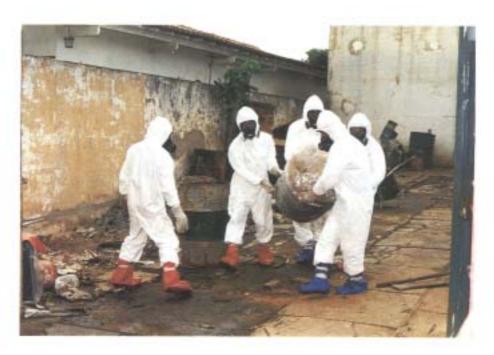
15. Removing contaminated items from Junkyard III.

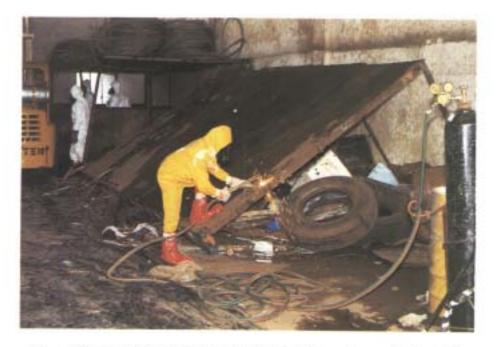
16. Cutting up contaminated items for removal from the warehouse of Junkyard III.

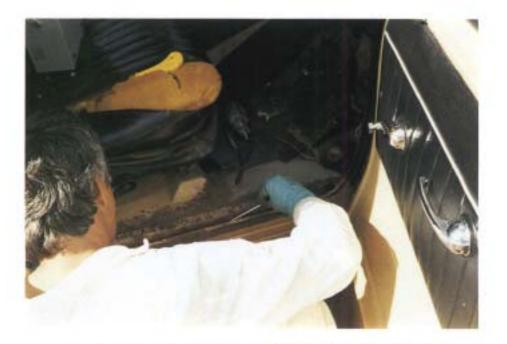
17. Decontaminating a vehicle. About 50 contaminated vehicles were found.

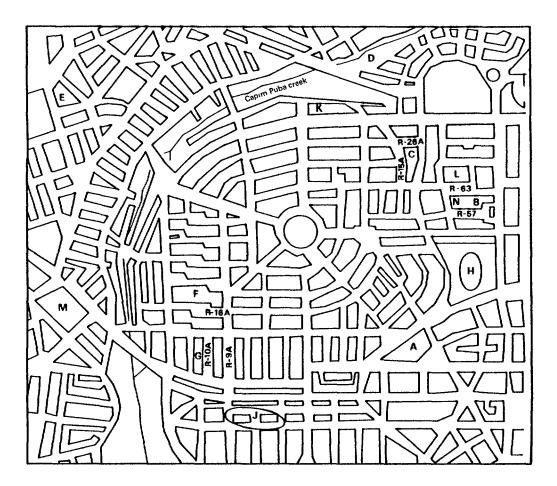
- A: IGR clinic
- B: Source first exposed
- C. Junkyard I
- D. Junkyard II
- E Junkyard III
- F. Vigilância Sanitária
- G Physicist W F 's house
- H: Olympic stadium
- J. General Hospital
- K, L: Other contamination points
- M: Initial CNEN command post
- N: Present CNEN office

FIG. 7. Plan of Goiânia showing the principal sites of contamination.

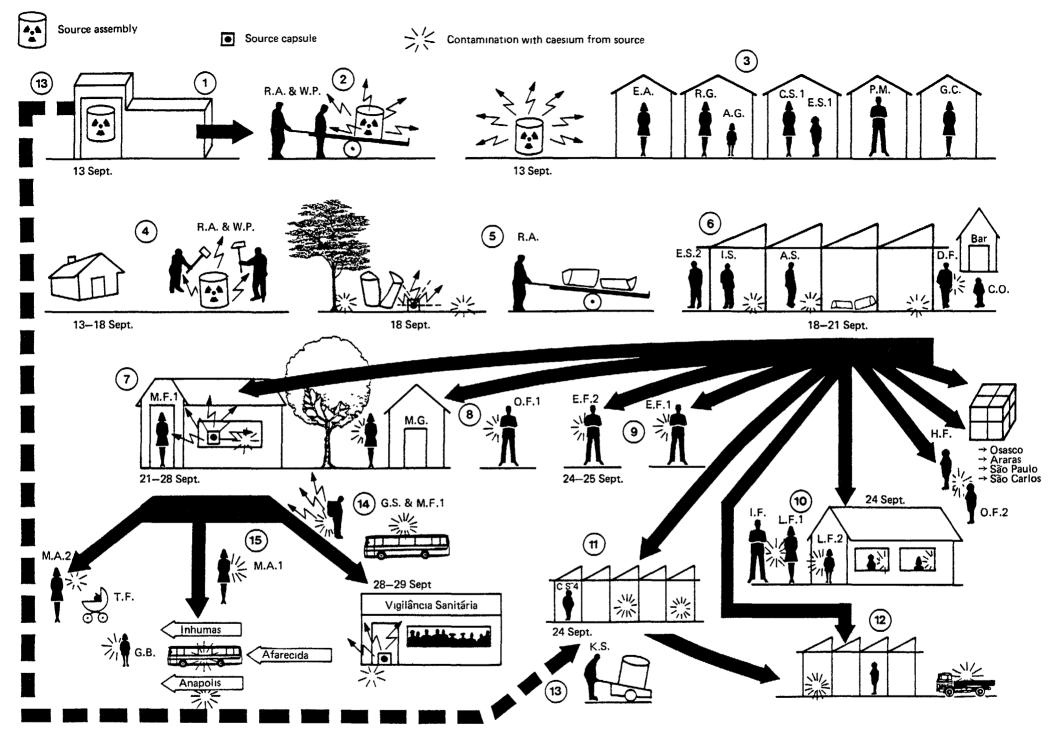
FIG. 8. Schematic diagram of the dispersal of caesum-137 in the accident in Goiânia. The diagram is based on a drawing made shortly after the discovery of the accident in attempting to reconstruct what had happened. It is reproduced in the format in which it was originally drawn even though it differs in minor details from what is now considered to be the best description of events (see the text of the report). Key: (1) the derelict clinic of the IGR; (2) removal of the rotating source assembly from an abandoned teletherapy machine by R.A. and W.P.; (3) source assembly placed in R.A.'s yard near houses rented out by R.A.'s mother E.A.; (4) R.A. and W.P. break up source wheel and puncture source capsule; (5) R.A. sells pieces of the source assembly to Junkyard I; (6) Junkyard I. the caesium

chloride is fragmented and dispersed by I.S. and A.S. via public places; (7) D.F.'s house: contamination is further dispersed; (8) visitors and neighbours, e.g. O.F.1, are contaminated; (9) E.F.1 and E.F 2 contaminated; (10) I F.'s house; other arrows indicate dispersion via visitors and contaminated scrap paper sent to other towns; (11) contamination is spread to Junkyard II; (12) contamination is spread to Junkyard III, (13) K.S returns to the IGR clinic to remove the rest of the teletherapy machine to Junkyard II; (14) M.F.1 and G.S. take the source remnants by city bus to the Vigilância Sanitária; (15) contamination transferred to other towns by M.A.1. (By courtesy of CNEN, Brazil.)
