Reflectivity Reduction of Retro-Reflector Installed in LHD due to Plasma Surface Interaction

Abstract: Optical reflectivity of the retro-reflector installed in LHD as the first mirror was reduced seriously by plasma wall interaction. In order to understand the mechanism of the reflectivity reduction, optical and material properties of the mirror surfaces have been examined extensively. It was found that the deposited impurity layers caused the serious reduction of the reflectivity. Formation of iron oxide, bulges structure and He bubbles are the major factors for the reflectivity reduction in the wide wave length range.

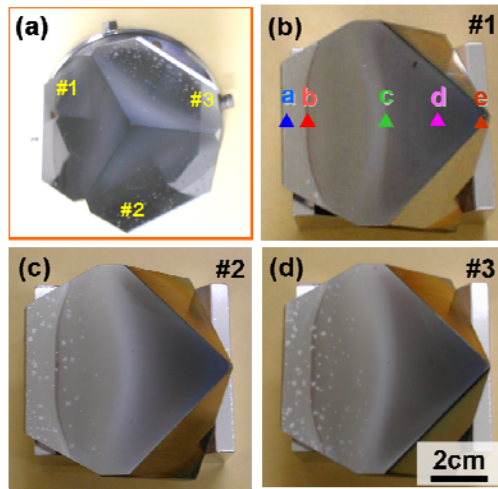
Photographs of the retro-reflector and its three flat mirrors are shown in Fig.2. As can be seen, strong blacking, namely reduction of optical reflectivity, occurred especially at the cubic corner where three mirrors contacted each other (corner at right-hand side in the photographs). Inspections were carried out mainly for the #1 mirror.

Fig.2 Photographs of a retro-reflector looking from the laser incident direction (a), and its three flat reflectors (b)-(d). Reflectivity and corresponding surface morphologies are mainly examined at the points *a*, *b*, *c*, *d* and *e* of the #1 flat mirror.

In case of He plasma discharges in LHD, typical energy contributing to material damage at the wall surface and its flux of the neutral He atoms were estimated to be about 1keV and $1 \times 10^{19} \text{He/m}^2\text{s}$, respectively [10]. These data indicate that the sputtering rate of stainless steel placed on the protection wall is about $1 \times 10^{-2} \text{nm/s}$. In case of H plasma discharges, neutral hydrogen with the similar energy and flux causes damage in materials placed on the wall surface [11]. Average sputtering rate under He-GDC is estimated to be $1 \times 10^{-4} \text{nm/s}$. This value, however, depends on the distance from the electrode of the glow discharge. These estimations support the observed strong erosion around the aperture (point **a** in Fig. 2(a))

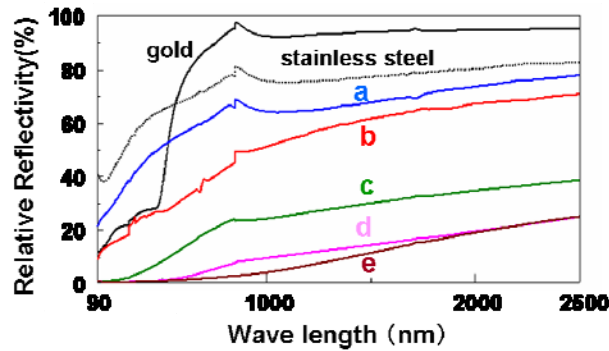
Figs. 3 and 4 show optical reflectivity measured at the five points **a**, **b**, **c**, **d** and **e** from the aperture edge to the cubic corner of the reflector as denoted on the photo in Fig. 2 (b). Discrete data at 900nm in Fig.3 was caused by changing the detectors at this wave length. Reflectivity of a stainless steel mirror and a gold mirror are also plotted in the figure for comparison. The area near the aperture edge had lost the original gold color but shows a typical gloss of metals. As can be seen in Fig. 3, reflectivity spectrum at the point **a** is quite similar to that of stainless steel. Point **b** corresponds to the narrow arc region having brown color. In contrast, the reflectivity at the points **c**, **d** and **e** decrease drastically by approaching to the cubic corner where the laser beam reflected. The reflectivity for short wave length below visible region is almost 0%. It is worth to note that the reduction of reflectivity at infrared region is also remarkable; for example, reflectivity reduction for CO₂ laser (wave length=10.6 μ m) at the points **d** and **e** is 50-60%. In case of retro-reflectors the substantial reflectivity is less than 20%, because reflection occurs three times.

Fig.3 Reflectivity at the points *a*, *b*, *c*, *d*, and *e* for the wave length between 90nm and 2500nm. Those for gold and stainless steel are also plotted in the figure.

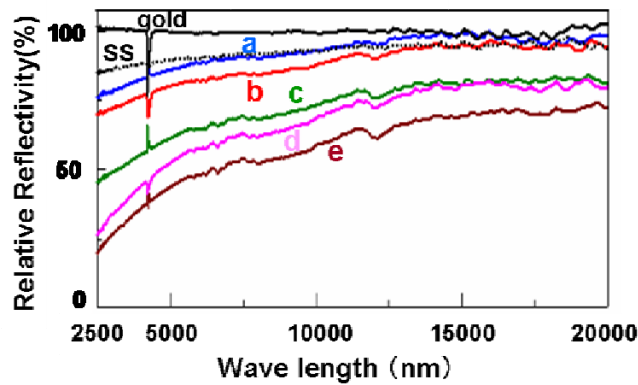
Fig. 4 Reflectivity at the points *a*, *b*, *c*, *d*, and *e* for the wave length between 2500nm and 20000nm. Those for gold and stainless steel are also plotted.

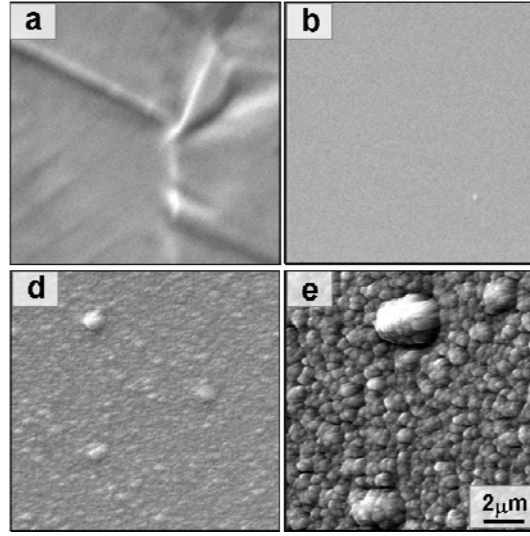
In order to understand the reasons for the reflectivity degradation described in 3.1, observation of surface morphology and surface analysis were performed with SEM/EDS for the points from **a** to **e**. In Figs. 5 and 6 SEM micrographs and corresponding EDS spectrum for each point are summarized. On the surface of the point **a**, the coated gold layer has completely disappeared and the stainless steel substrate is bared. The surface has typical rough morphology of poly-crystals eroded by ion sputtering. On the other hand, the surface of the point **b** is very smooth and gold is a major component. This indicates that net erosion at the brown belt-like

Fig. 5 SEM micrographs showing surface morphology at points **a**, **b**, **d** and **e**.

Beyond the point **b** metallic gloss diminished gradually and the color of the surface turned to black. As shown in the SEM micrographs in Fig.5 (d) and Fig.5 (e), the surface is covered by fine sub-micron hills of about 200-800nm in diameter. In addition projections larger than 1μm in diameter exist in places. Height of the sub-micron hills and the large projections increases by approaching to the cubic corner.

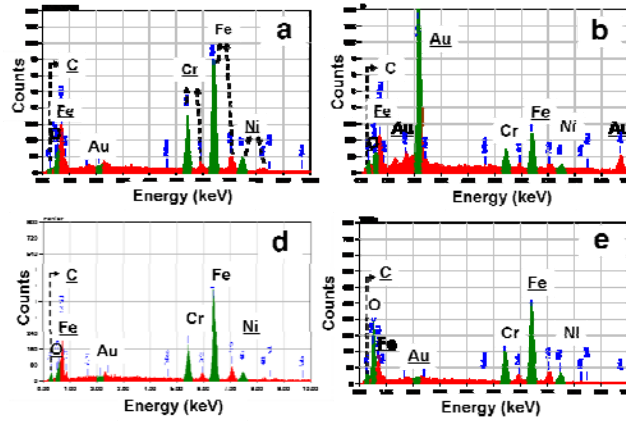
Fig. 6 EDS spectrum showing chemical composition at the points **a**, **b**, **d** and **e**.

EDS analysis shown in Fig.6 indicated that the major elements at the points **d** and **e** are Fe, Cr, Ni and O. Content of O is very large at the point **e**. These results indicate that majority of the deposited impurities came from the plasma. Fig. 8 is a SEM image where the deposition detached at the interface between the gold (point **e**). Thickness of the deposition is about 2μm.

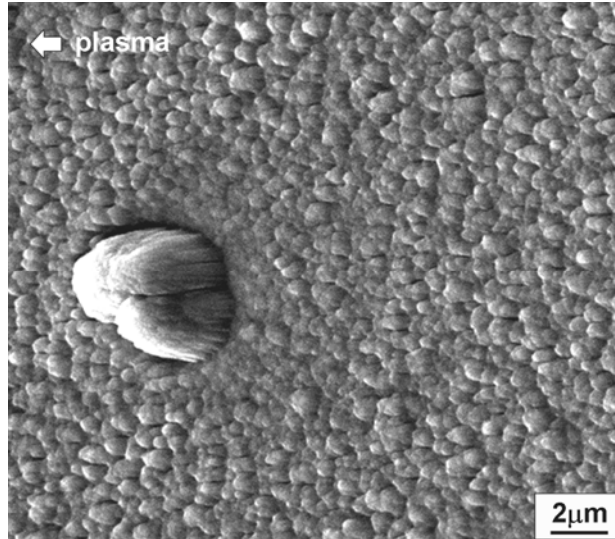
Fig.7 is a magnified SEM micrograph showing details of the surface morphology. It is interesting that the sub-micron hills and the projections incline somewhat toward the left-hand side in the micrograph, namely toward the aperture of the retro-reflector. Development of the sub-micron hills in the left hand area of the large projection is delayed. The height of the sub-micron hills was estimated to be 100-500nm from the stereoscopic observation. Height of the large projection exceeds 2.5μm.

Fig. 7 Formation of sub-micron hills around a large projection, SEM micrographs at the point e.

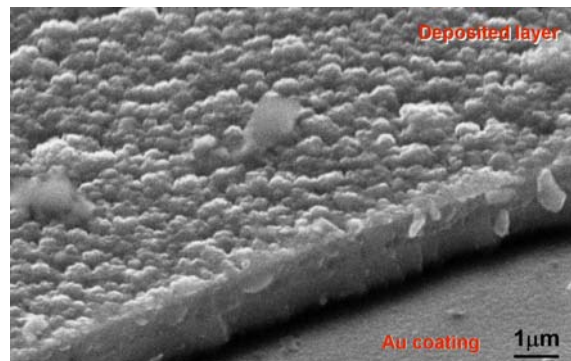
Fig. 8 SEM micrograph showing exfoliation of the deposited layer. Original Au-coated surface appeared after the exfoliation (lower right part).

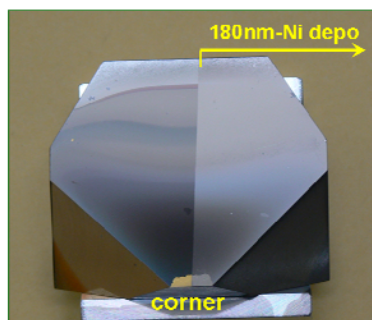
In order to clarify the mechanism of reflectivity degradation, 180nm-thick nickel layer was deposited in vacuum on the surface of the mirror. This thickness is high enough to hide the optical properties of the original surface and change them to those of Ni, but thin enough to keep the surface morphology with sub-micron scale roughening. As can be seen in the photo of the mirror after Ni deposition in Fig.9., influence of the original surface had gone and showed typical color of Ni in the area of the points **a** and **b** where the surface is rather smooth. In contrast, at the heavily blacken area (points **d** and **e**), the Ni deposition hardly changed the color. These results indicate that the major reason of the blacken near the cubic corner is the surface roughening by the formation of sub-micron-scale hills.

Fig. 9 Photograph of the reflector whose right-half was covered by a vacuum deposited Ni thin film of about 180nm thick.

The result of Ni deposition effects shown in Fig. 9 strongly indicates that the serious reduction of the reflectivity at the visible wave length region can be explained by the formation of the dense hills of about 200-300nm-high. It is well known that the relative reflectivity of the uneven surface is given by the following equation [12].

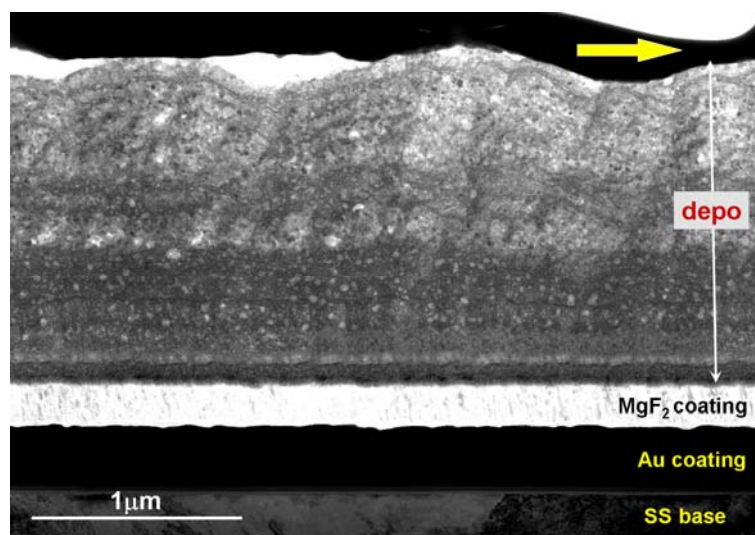
In order to understand the mechanism of the reflectivity reduction, cross-sectional structure and its chemical composition of the deposition were examined microscopically by using TEM and STEM with EDS. The thin cross sectional samples of about 200nm-thick were prepared by means of FIB technique from the area **e** shown in Fig. 2. Fig. 10 is cross-sectional TEM image of the deposition formed on the original mirror surface coated by MgF_2 . It is remarkable that the deposition has clear layer structure. Up to about $0.67\mu\text{m}$ for the original mirror surface the layer was rather flat and has dark contrast. Above $0.67\mu\text{m}$ the layers become wavy suddenly and the wave inclines toward the main plasma direction just as expected from the SEM image shown in Fig. 7. The final thickness of the deposition is about $1.6\mu\text{m}$ in this case. The image of lower flat part is uniformly dark, while that of the upper wavy part is rather light. This result indicates that the average density of the former is high but that of the latter is low. EDS analysis indicates that Fe, Cr, Ni, Au and O are the major elements composing the deposition. Fig. 11 shows two dimensional distributions of deposited elements, O, Fe and Au together with the corresponding STEM image. The distribution of Cr and Ni are similar to that of Fe.

Fig.10 Cross-sectional TEM image of the deposition at the point e.

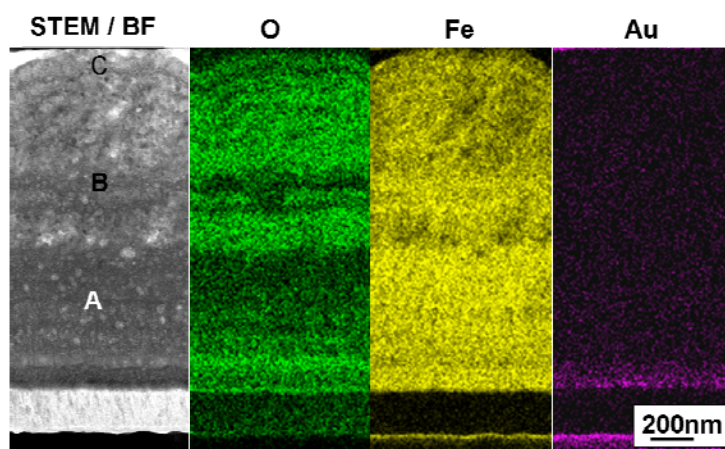
At the beginning of the experimental cycle long He glow discharge cleaning were performed previous to the main discharge experiments. As shown in Fig. 11, EDS data indicate that Au from the mirror itself, probably from the point **a** area shown in Fig. 2 where strong erosion occurred and the plated gold has gone, was deposited together with Fe and O from the protection wall made of stainless steel. Content of Au quickly decreased.

Fig.11 Two-dimensional distribution of O, Fe and Au in the deposition at the point e.

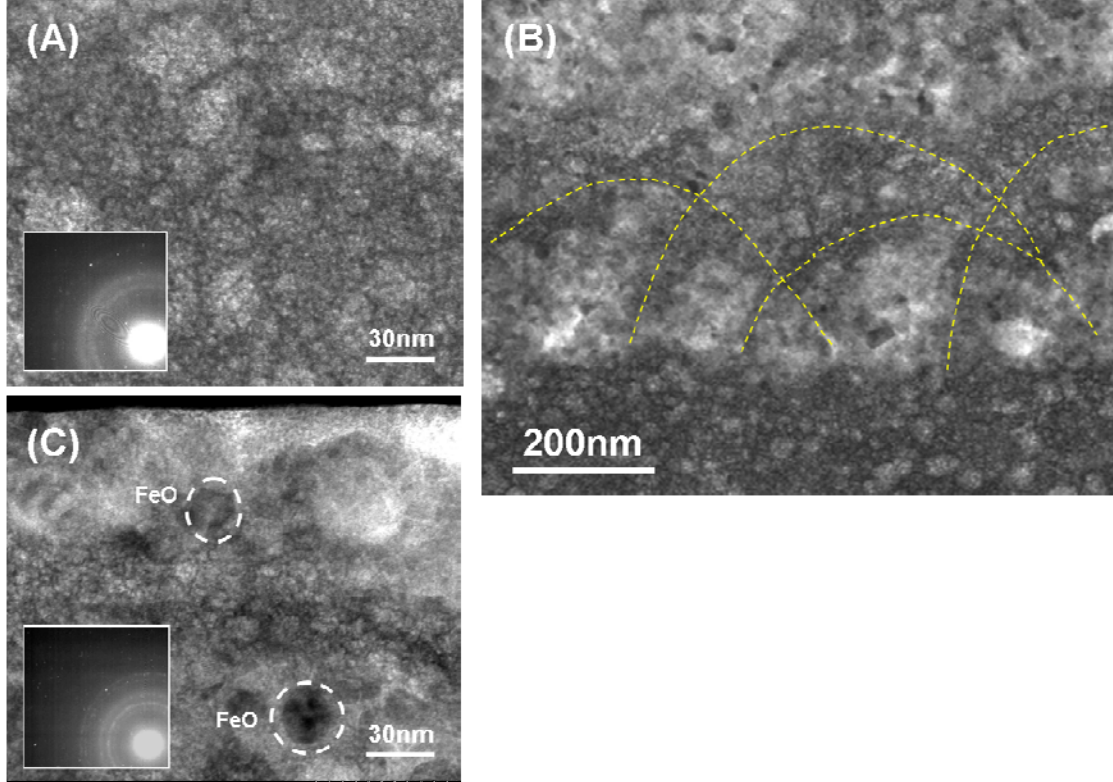
Characters of the deposition changed clearly at the height of about 100nm. Above this level the content of O increased discontinuously and then gradually decreased up to 670nm by reaping fluctuation. A typical microstructure of this area (point A in the figure) is shown in Fig.12 (a). The deposition is composed of very fine crystals. The electron diffraction pattern (EDP) indicates that most of them are FeO crystals. It is remarkable that the nano-scale bubbles having white dot image were formed densely together with large bubbles of about 10-40nm in size. It is likely that high pressure gas of He and H exist in these bubbles.

The looking of the deposition drastically change above 670nm. Fig.12(b) is the magnified micrograph at the interface and EDP from the upper region. Just above the interface the

deposition is hollow (large white region in the micrograph). Content of O is very high and large FeO crystals of about 10-30nm in diameter are formed. The most prominent feature is the deposition is not flat but very complicate. The dotted lines in the figure trace the layer with dark image of about 100nm-thick. It is clear that the layers have half-circle shape of about 500-600nm in diameter extending from the interface. It is also important that below the half-circle dense layer, there is a large hole. Taking into account that the thickness of the sample is about 100nm, these images indicates that they are blisters with shape of half-sphere domes of about 300nm-high. They are densely formed at the interface. The material of the blisters is mainly fine FeO crystals and dense nano-scale bubbles are formed in it. After the formation of the blisters surface of the deposition becomes wavy and wavy with increasing the thickness of the deposition.

A magnified micrograph and EDP near the top surface (point C in Fig. 11) is shown in Fig.12(c). It is clear that layers with lower density (light contrast) and those with higher density (dark contrast) were formed one after another.

Fig 12 Magnified TEM micrographs at A, B and C.

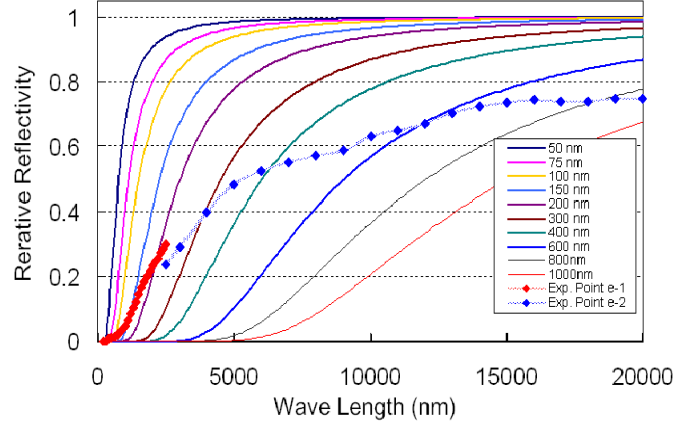
Here, R , R_0 , δ , θ and λ are reflectivity, reflectivity of the flat surface, average roughness, reflection angle and wave length, respectively. In Fig. 15, measured reflectivity at the point e is compared with those estimated from equation (1) for several average roughness as a function of the wave length. The very low reflectivity at ultra-violet and visible wave length can be explained roughly by the surface roughness, but large reduction of the measured reflectivity at the longer wave length region can not be explained by the surface roughness alone.

Fig.15 Wave length dependence of relative reflectivity, R/R_0 , estimated from the equation (1) for various average roughness. Relative reflectivity (experimentally measured reflectivity/reflectivity of stainless steel) for the point e is also plotted for comparison.

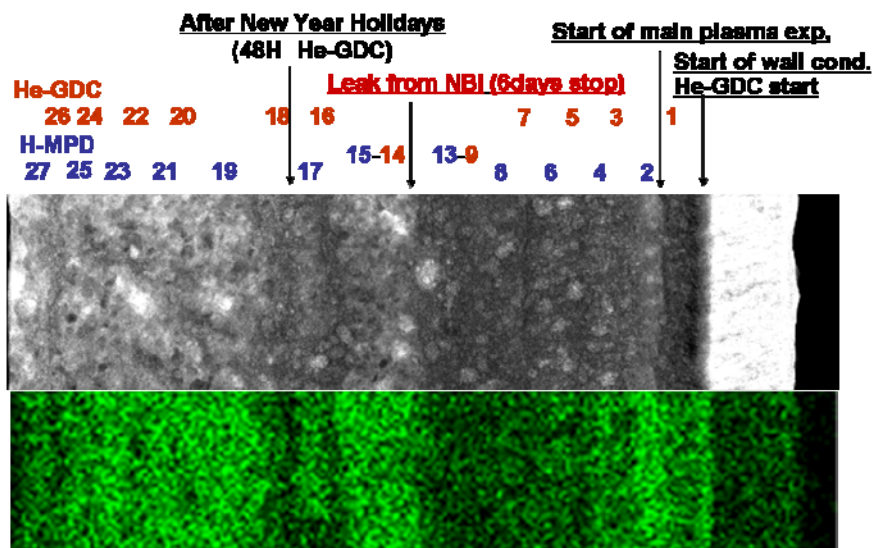
By supposing the identification of the layers, it was tried to assign when each was formed by comparing the discharge history of the experimental cycle. Fig. 16 shows the layer structure of the deposition and the order of main discharge period and He-GDC period. They fit quite well. If the assignment is collect, it is likely that the formation of the blisters, which were the trigger of the wavy surface, occurred after the leakage of cooling water from NBI.

Fig. 16 Comparison of cross sectional microstructure of the deposition and with discharge history
