Root Cause Analysis of Swelling Problem in *Kartini* Reactor

BATAN (Indonesian National Nuclear Energy Agency)

Description of KARTINI reactor

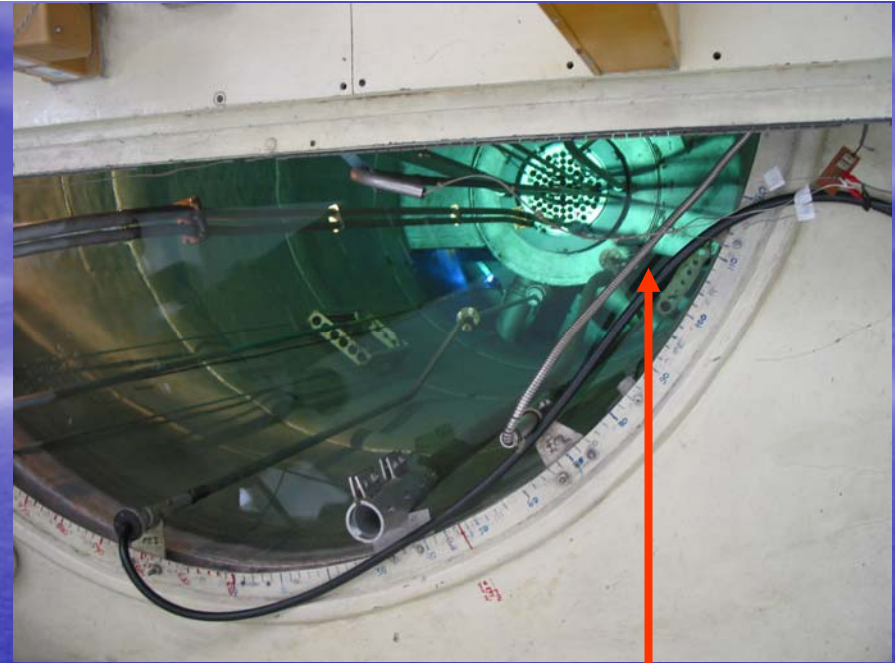
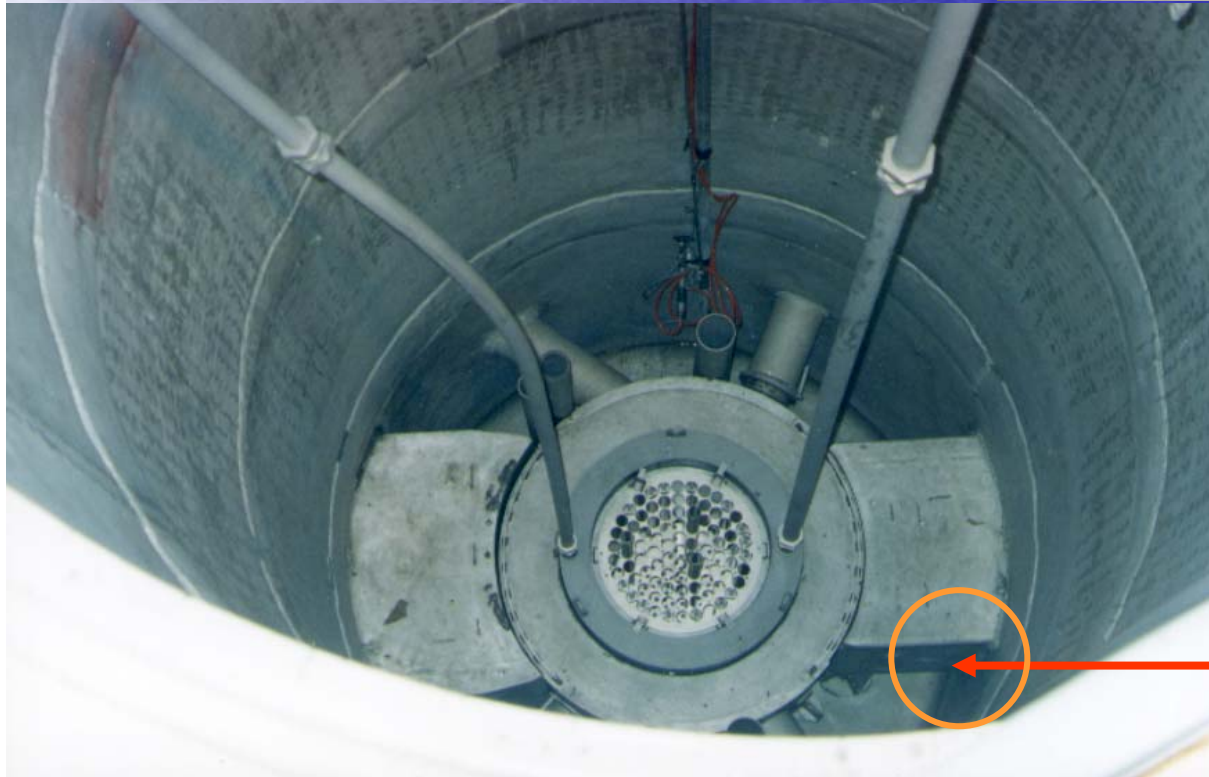
Location of the Bulges

- A small area with apparent thinning
- A small crack (analysed as an original manufacturing defect)
- Two small areas of bulging under the thermalizing column (S1 and S2).

near the curved transition between the wall and the pool liner bottom under the thermal column,

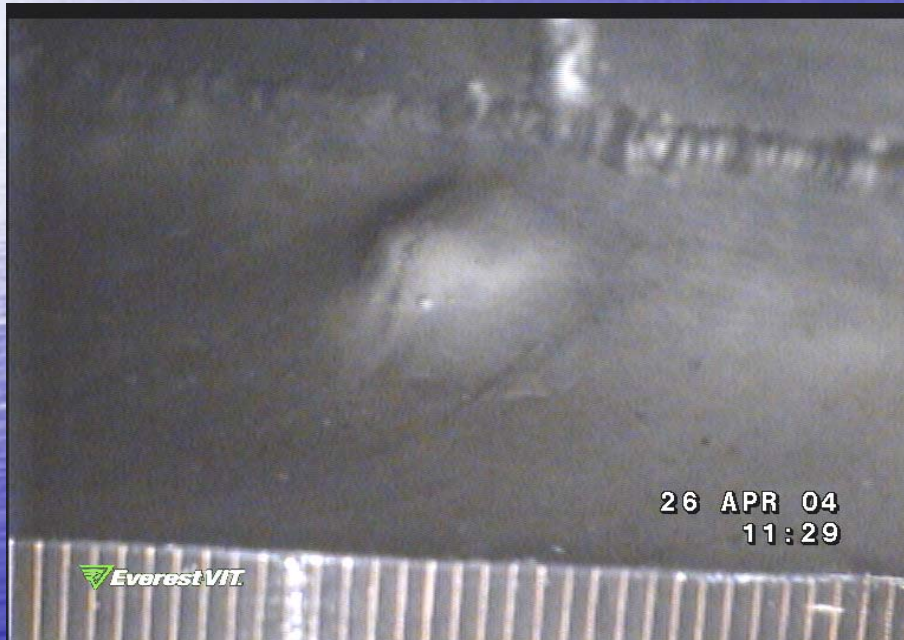
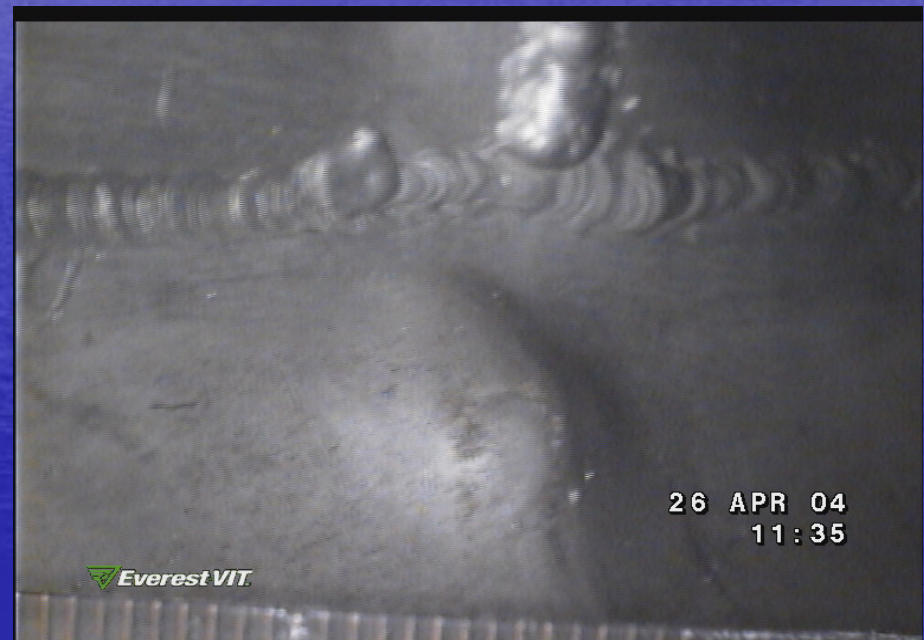
- The bulges re-examined in 2003, 2004 and 2005, the bulges had increased in size over this period.
- The increase of height and area of S1 and S2 were :
 - 7.72 mm and 7 mm (2004), and the areas were 1365 mm² and 1083 mm² respectively.
 - 7.78 mm and 7.56 mm (2005), and the areas were 1389 mm² and 1839 mm² respectively.
- Recent examination (Sept 2006 and Aug 2007) shows that the size of bulges relatively constant.
- The peak of the bulges appears to contain tears (cracks) in the metal.

Images from the video inspection equipment **April 04** (S1 & S2)

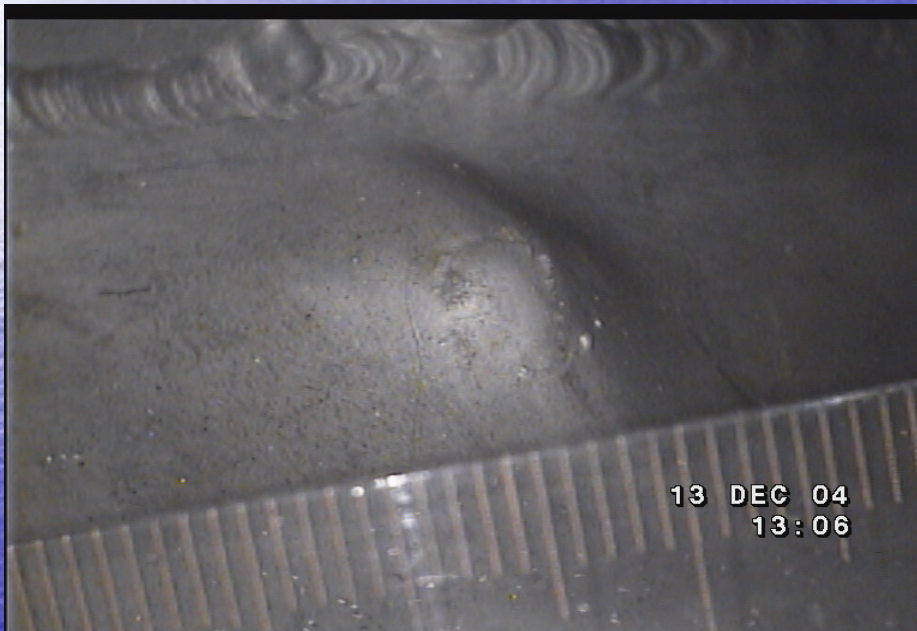
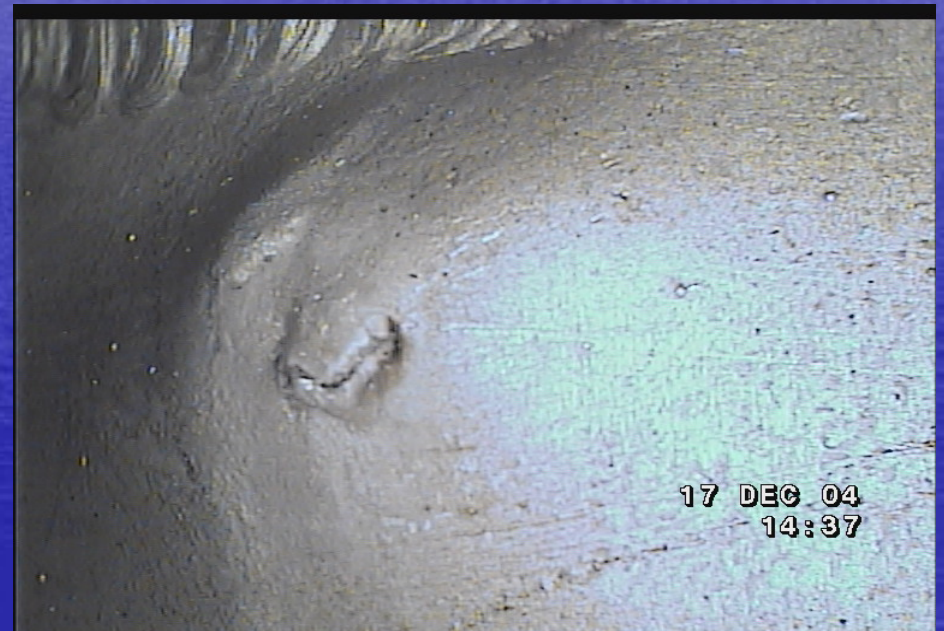
Image with Scale (1mm divisions) Taken **December 2004** – S1 & S2

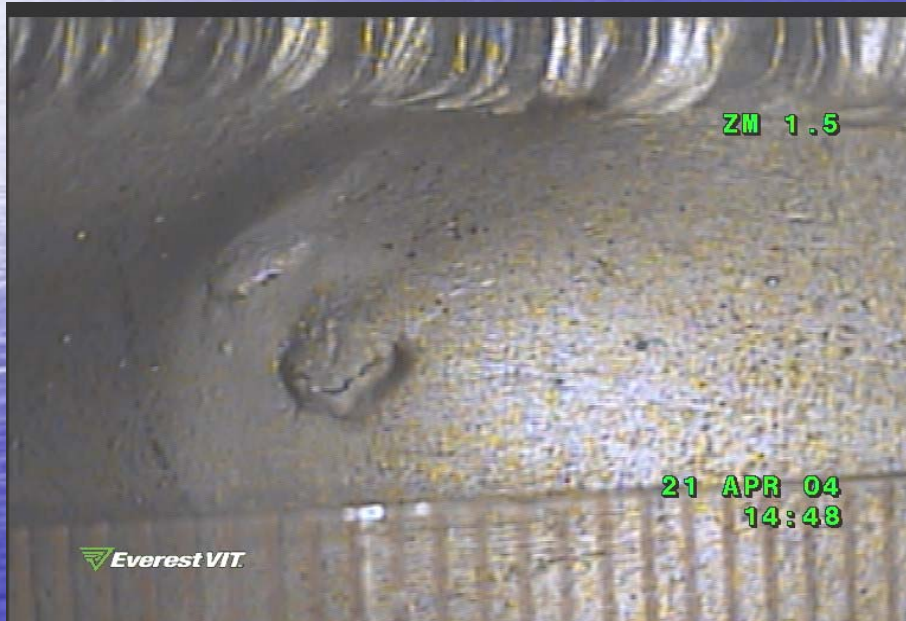
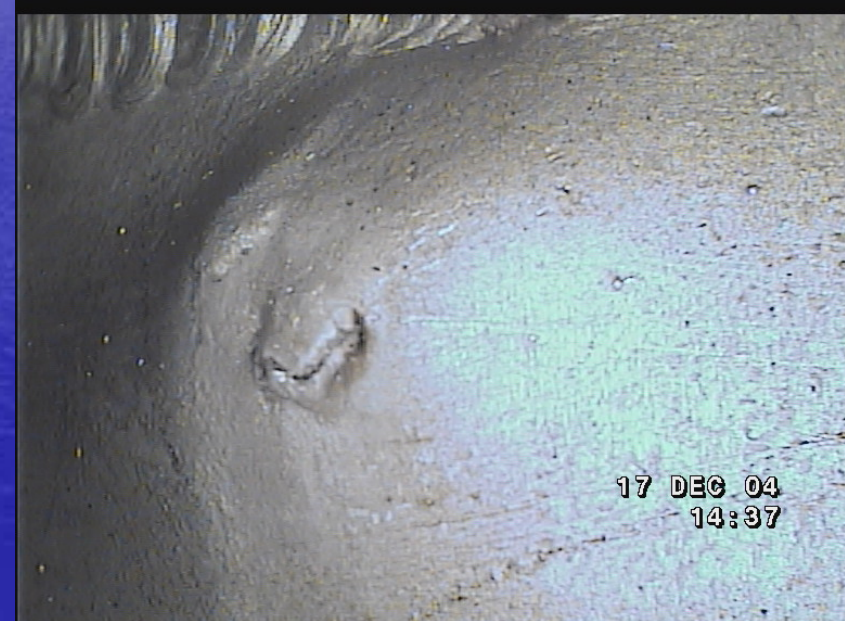
Comparative images of April and December 2004 Inspections – S2

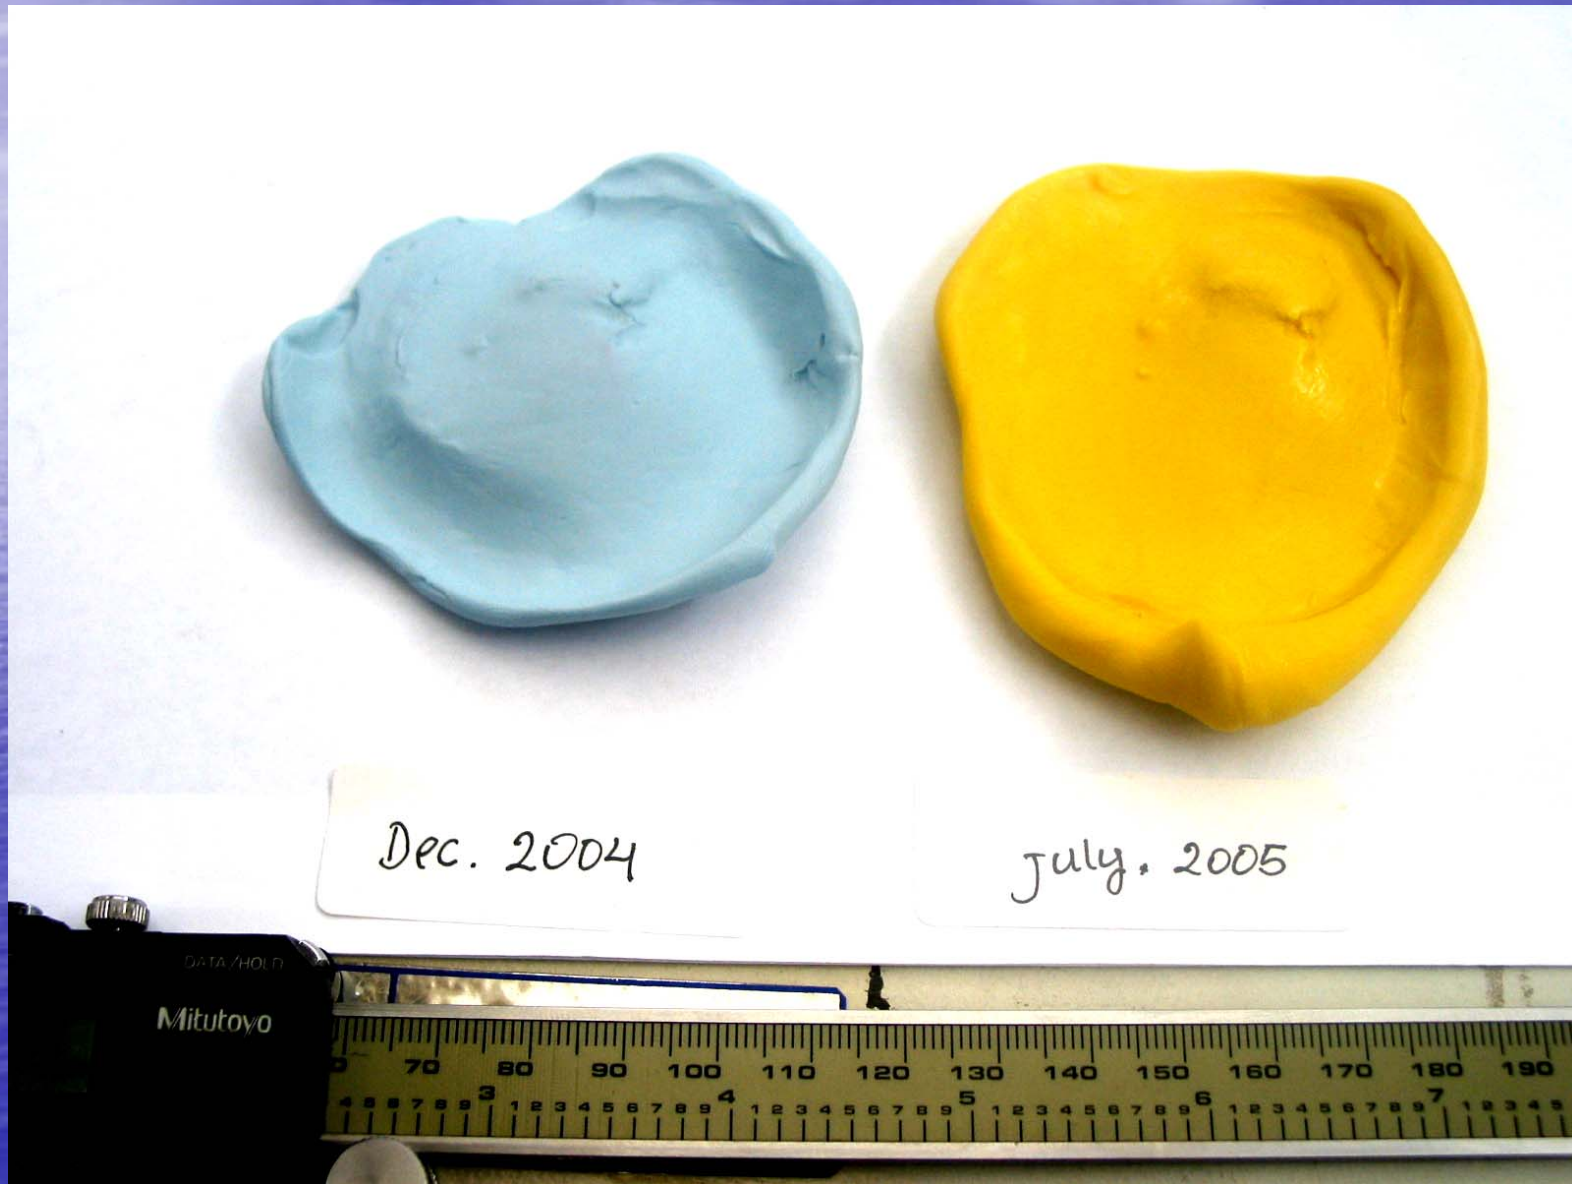
Replicas of bulges

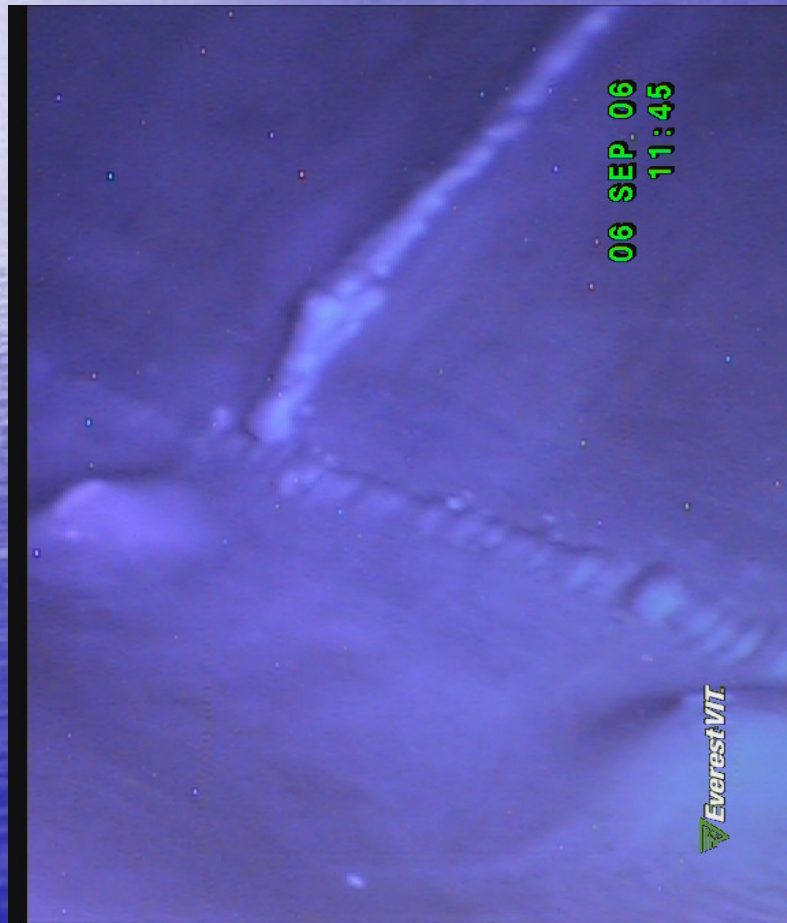
Swellings S1 & S2 September 06 images.

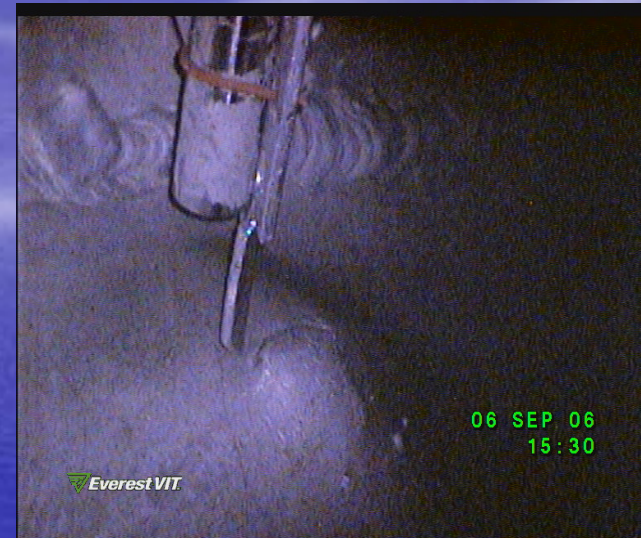
Ultrasonic thickness measurement
of tank wall.

The Al thickness is still substantial, measurements shows that the Al thickness is predominantly at original values and still greater than 4mm in the area of the bulges. This indicates that the aluminium pool liner has not corroded significantly.

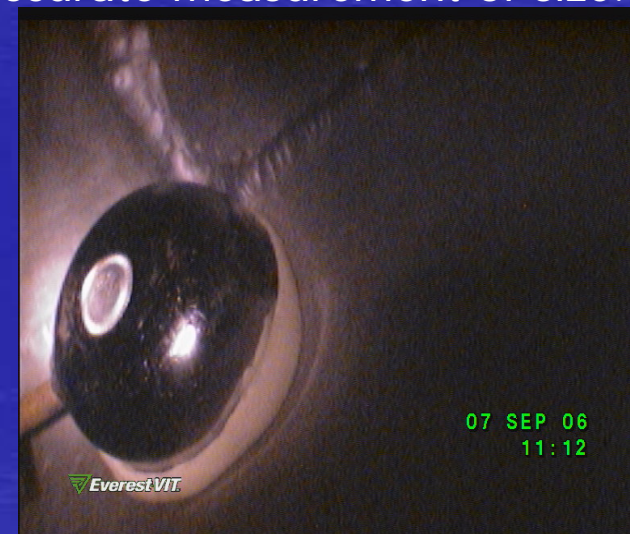
Replication of bulge to allow
accurate measurement of size.

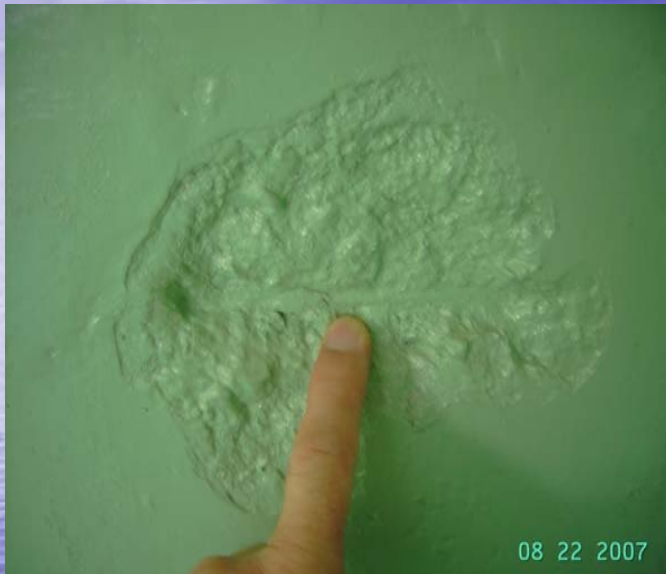
Fig. 5. Showing reinforcement (painted over) that had corroded and fractured concrete

The construction and supervision aspects of the reactor block have contributed to the issue by allowing reinforcement steel to be placed too close to the concrete surface and this has allowed contact with water and corrosion to occur.

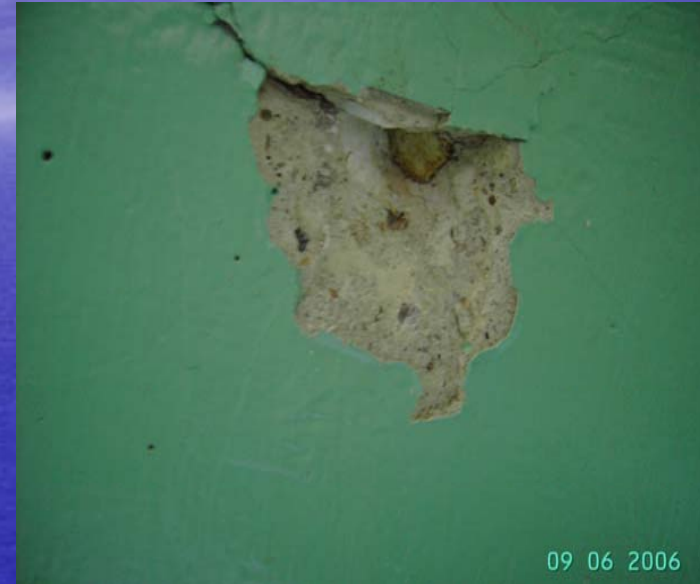
Two possibilities have been put forward : corrosion of the steel reinforcement bars that were located close to the inside surface of the concrete pool backing, and the possible incorporation of clay nodules into the concrete mix. This can result in volume expansion and fracture of the overlaying concrete that can result in the pool liner protruding into the pool.

Fig. 6. Showing a clay nodule that had expanded and fractured the concrete

The quality of the concrete from both a constituent viewpoint and the quality of water used to make the concrete are important. Particular attention should be given to exclude and clay material that can expand and damage the concrete under wet conditions.

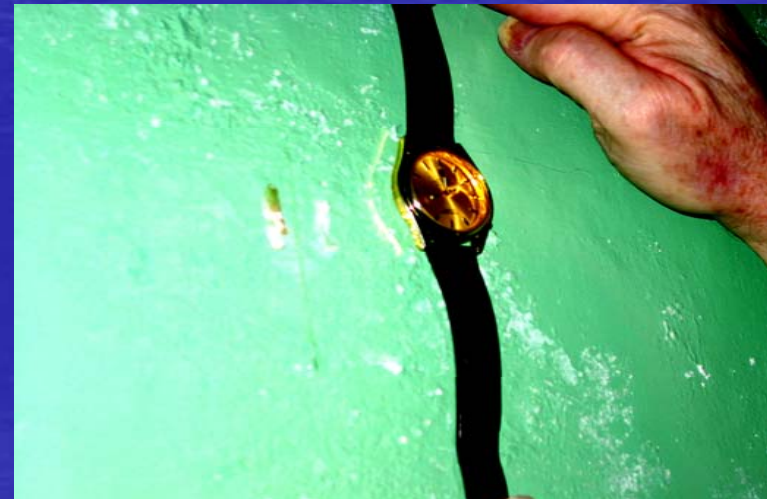
The external surface of the bulk shielding facility (BSF) shows evidence of water leakage. The white deposits on the side of BSF shown in Figure 7, which were originally thought to be $\text{Ca}(\text{CO}_3)$, were analysed as Sodium carbonate.

Fig. 7. Showing white deposits formed by water seepage through the BSF wall

- To dry the concrete block to attempt to remove the conditions that are causing the defects. The BSF would then be lined to prevent future water penetration of the concrete. If continued monitoring of the swelling indicates that some repair action should be taken the reactor pool will need to be emptied of fuel and control systems and the BSF would be required for storage.
- To maintain the program of periodic inspection to monitor the rate of progression and take action to repair to the areas involved.

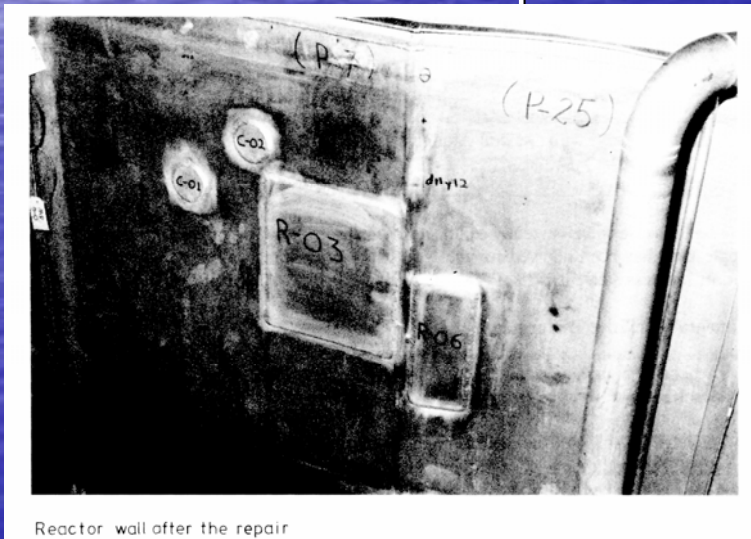
Photo of repairs to Mexican TRIGA III reactor pool liner

Reactor wall after the repair
