# Degradation Monitoring of G.A. Siwabessy Research Reactor's Secondary Cooling Pipe

Roziq Himawan

Indonesian National Nuclear Energy Agency (BATAN)

International Conference on Research Reactor: Safe Management and  
Effective Utilization, 14-18 November 2011, Rabat, Morocco

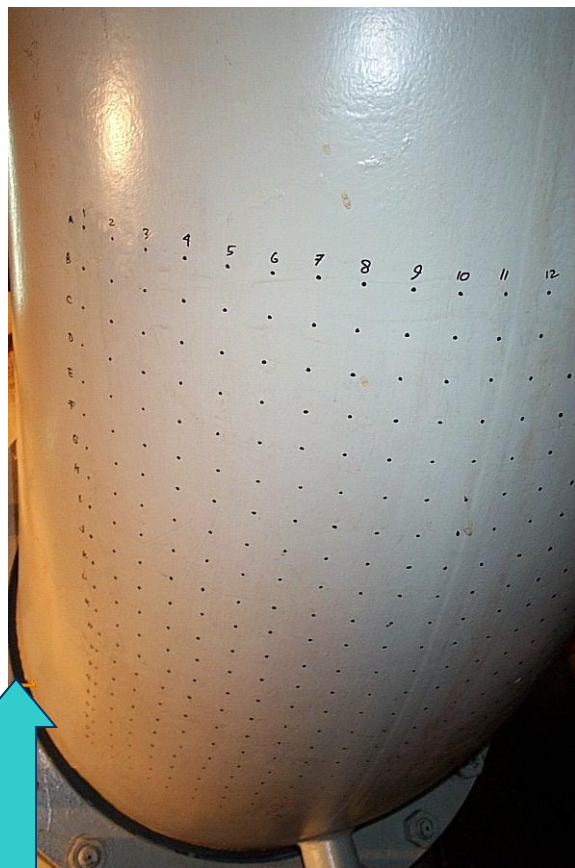
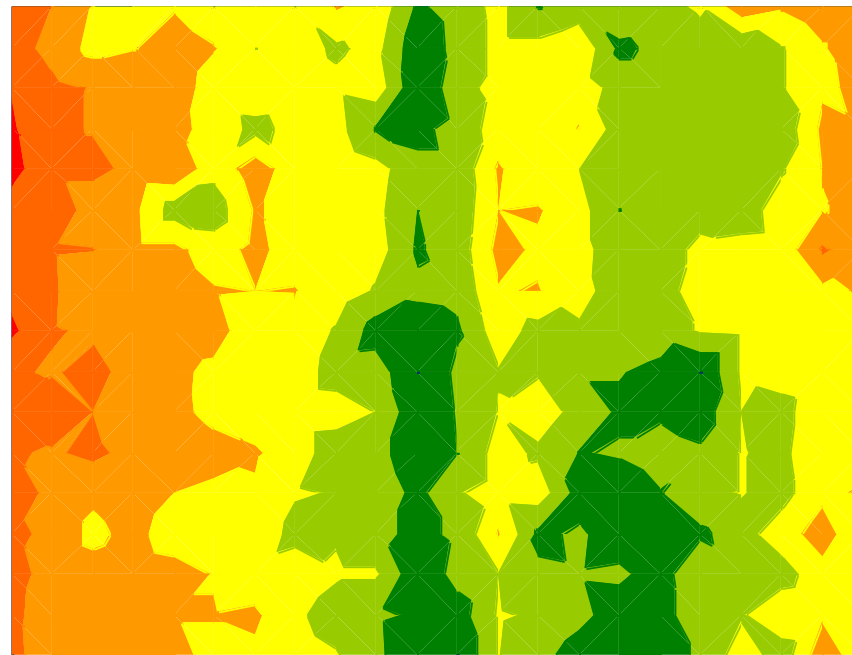
Thickness mapping : Indicated Pitting corrosion

- Degradation of pipe are due to homogenous and pitting corrosion rather than erosion-corrosion (flow accelerated corrosion)
- Improvement of water treatment are needed to suppress corrosion occurred in the internal surface

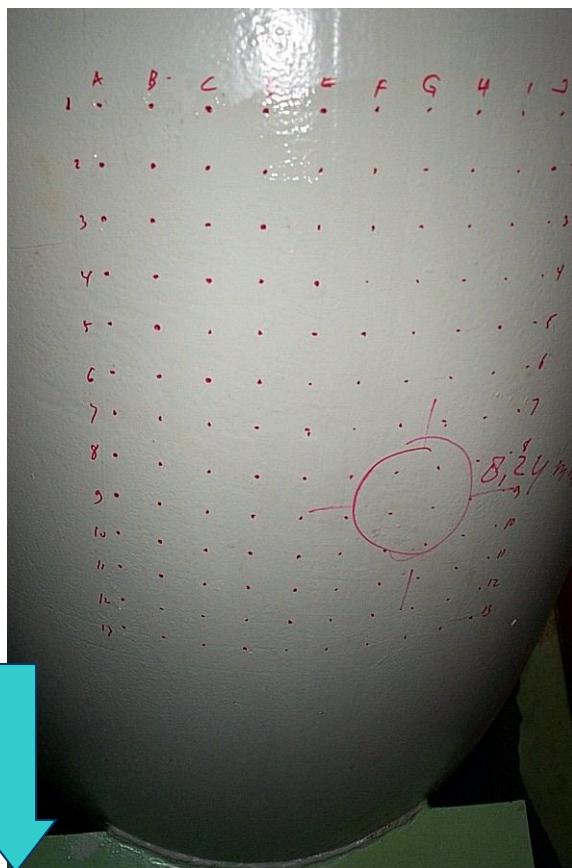
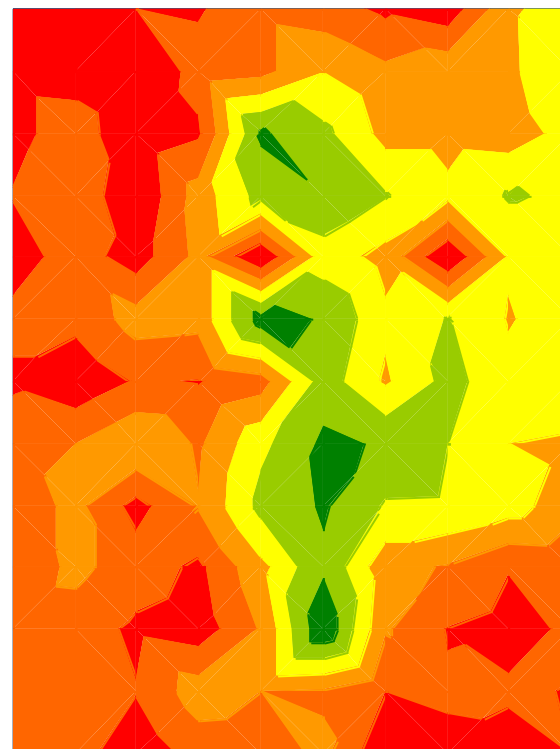
Measurement results which larger than initial thickness are caused by

- Paint layer
- Corrosion (product)
- Sedimentation from cooling water (impurity of raw water, chemical agent)
