IAEA-TECDOC-1112

***Root cause analysis for  
fire events at nuclear power plants***

INTERNATIONAL ATOMIC ENERGY AGENCY

September 1999

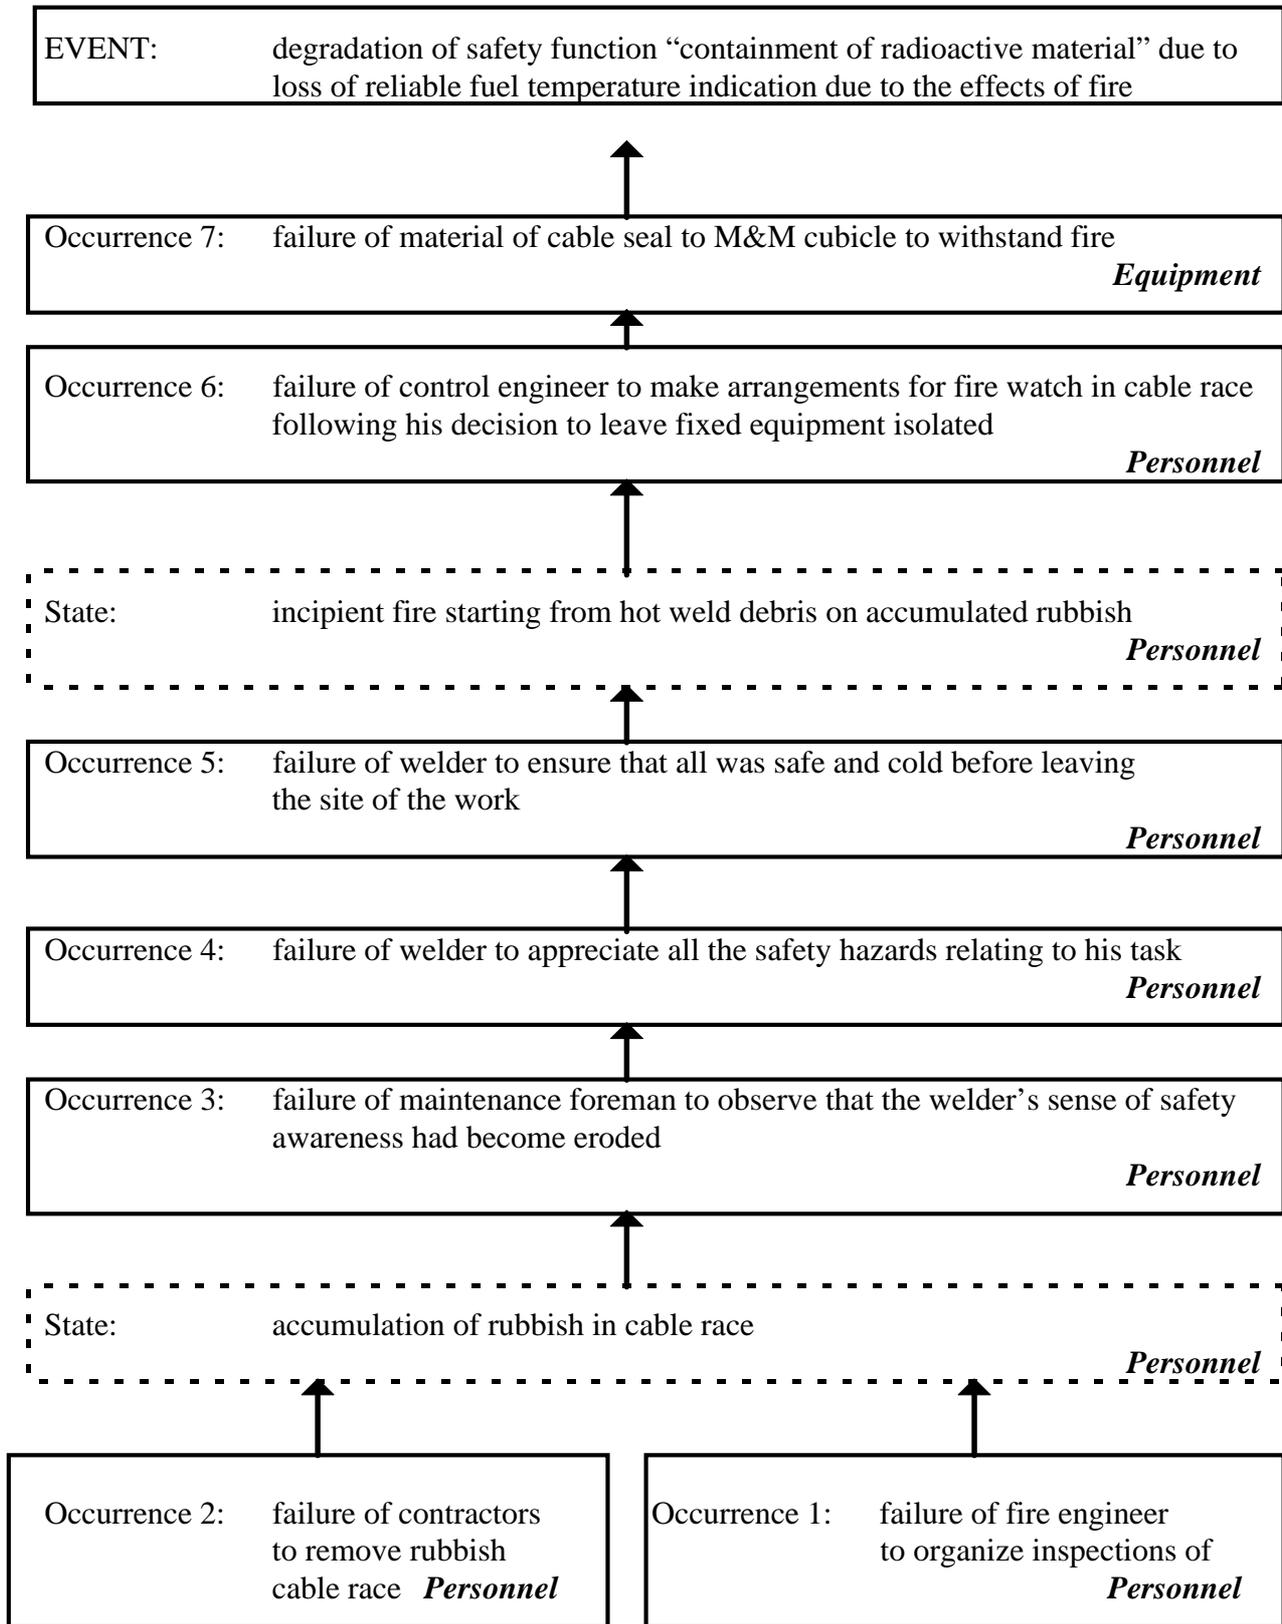
FIG. 1. Example of logic tree of occurrences.

Occurrence 1:	Continuous before event	Failure of relevant operating staff to organize inspections of cable race.
Occurrence 2:	Continuous before event	Failure of contractors to remove rubbish.
Occurrence 3:	04:30	Failure of maintenance foreman to observe that the welder's sense of safety awareness had become eroded.
Occurrence 4:	04:50	Failure of welder to appreciate all the hazards relating to his task.
Occurrence 5:	05:35	Failure of welder to ensure all was safe and cold before leaving the site of the work.
Occurrence 6:	05:40	Failure of control engineer to make arrangements for manual supervision of the cable race following his decision to leave fixed equipment isolated.
Occurrence 7:	07:40	Failure of material of cable seal to M&M cubicle to withstand fire.

**Event:** Potential for degradation of safety function “containment of radioactive material” due to loss of reliable fuel temperature indication due to the effects of fire.

It should be noted that occurrences (1) to (6) are failures of safety culture rather than equipment.

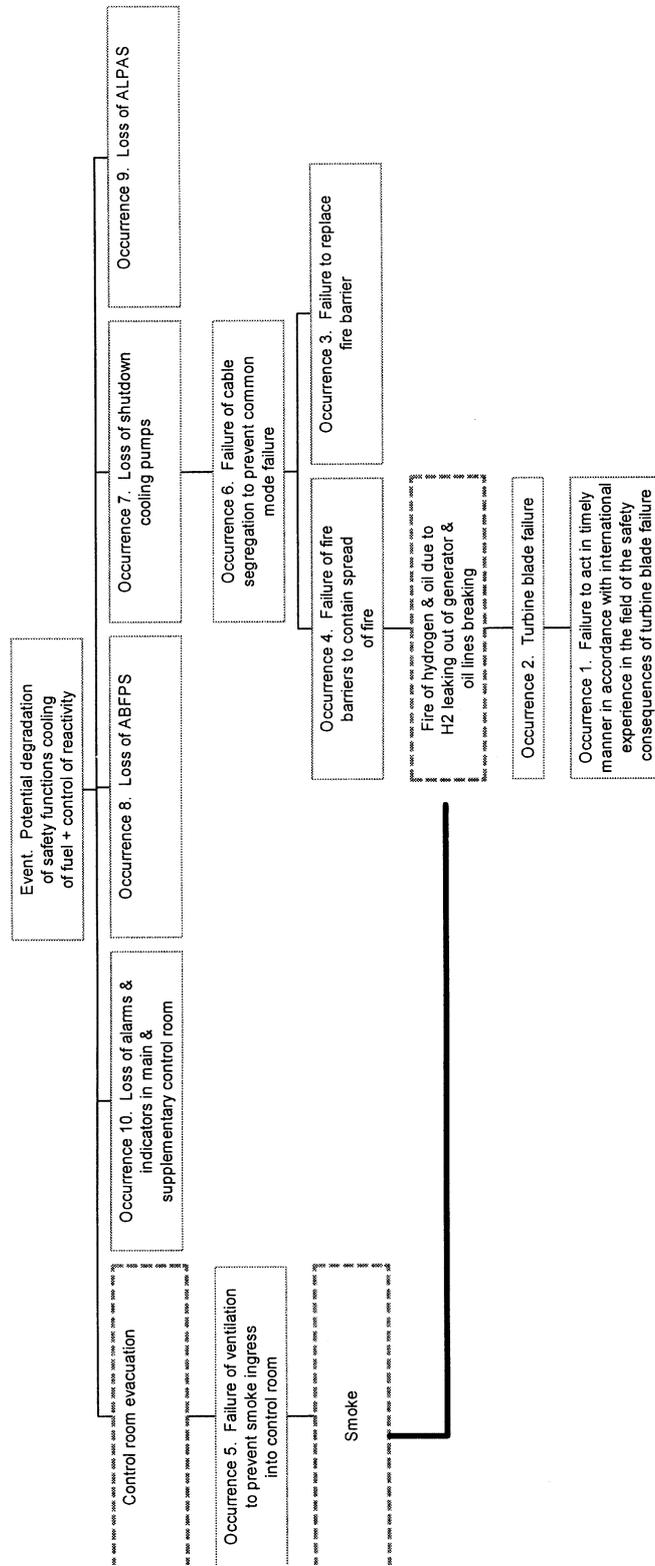
FIG. I.1. Logic tree of occurrences for reference plant 1.

- Occurrence 1: Failure to act in a timely manner in accordance with international experience in the field of the safety consequences of turbine blade failure
- Occurrence 2: Turbine blade failure

Since the event occurred, various rehabilitation works have been carried out in Unit 1. These include:

- assessing of the extent of damage to the civil structure during the incident and restoring it to its original strength;
- replacing the turbine generator;
- cable re-routing;
- replacing the PVC cables by FRLS (fire retardant low smoke) cables; and,
- providing fire barriers and fire stops at the required locations.

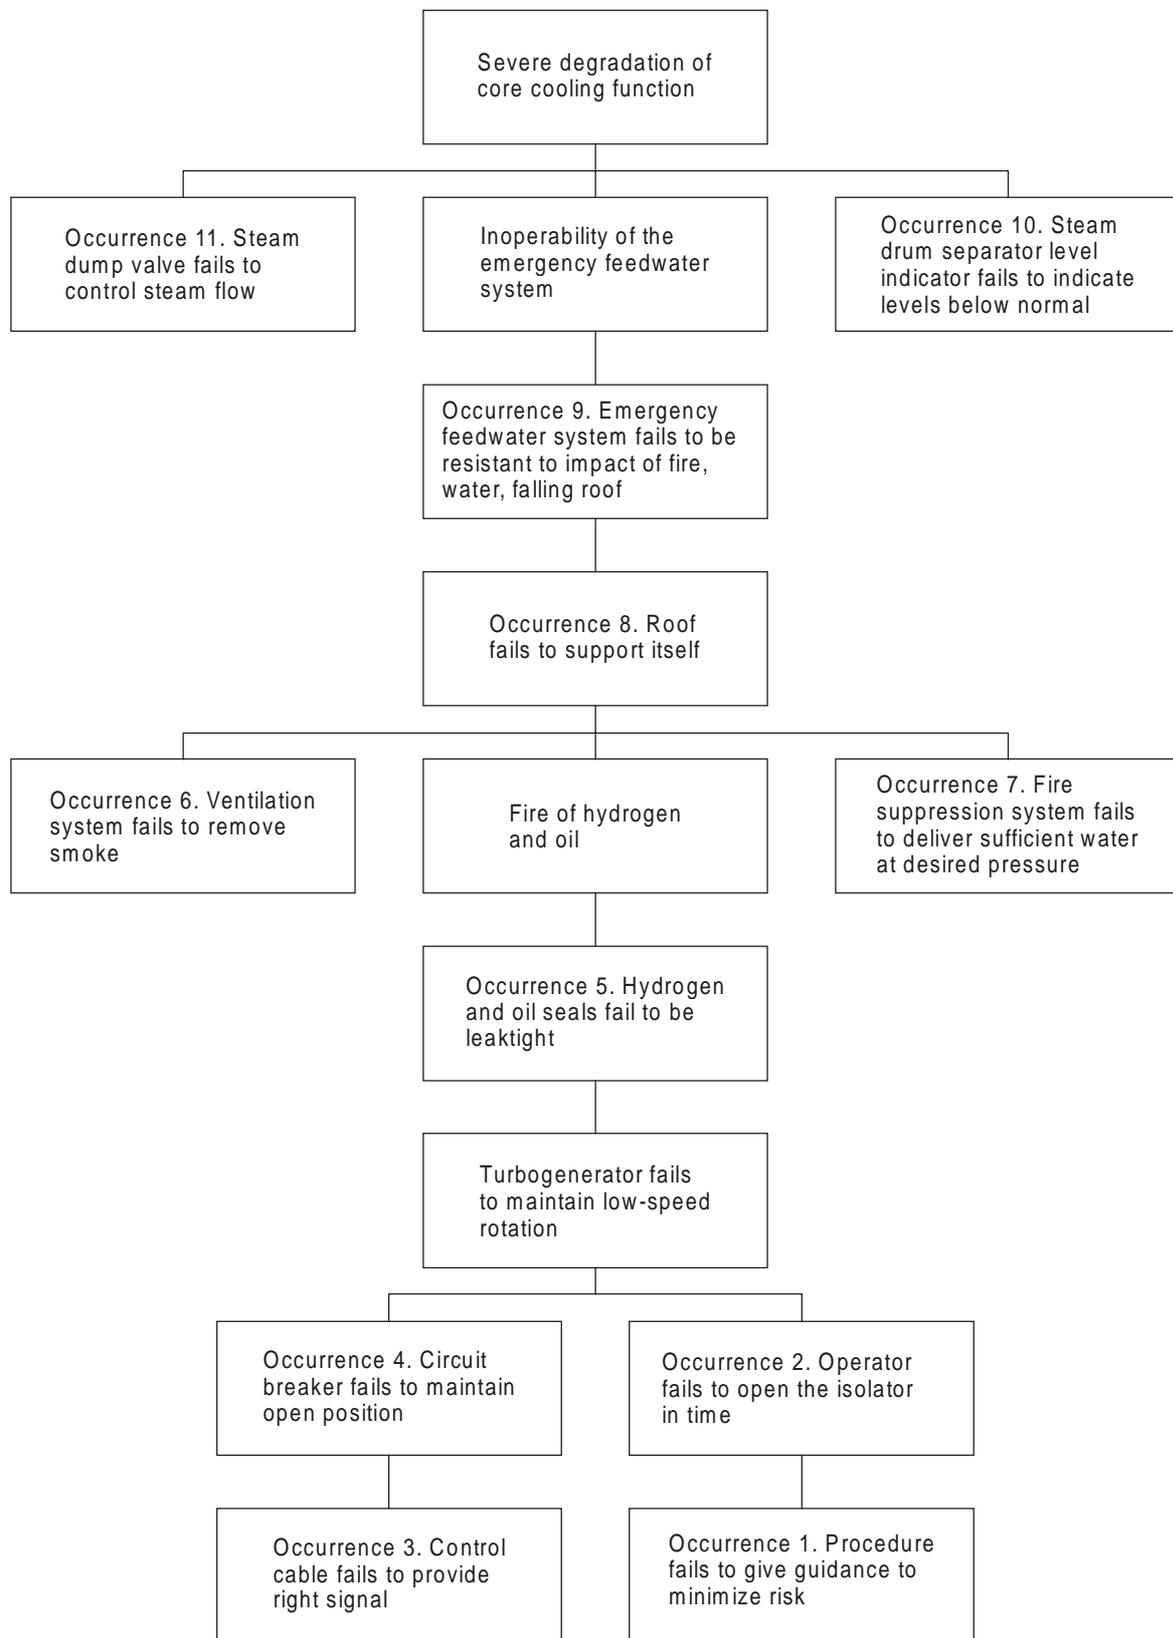
FIG. II.1. Establishment of the logic tree of occurrences.

IAEA		EVENT ROOT CAUSE ANALYSIS FORM EXAMPLE: REFERENCE PLANT 2, OCCURRENCE 1				ASSET					
<b>Event title:</b>		Degradation of core cooling system due to fire in the turbine hall				Safety consequences due to initiating failure					
<b>SAFETY PERFORMANCE: OCCURRENCE: What failed to perform as expected?</b>						Corrective actions by plant					
<b>Occurrence title:</b>		Procedure failed to give guidance to minimize risk									
<b>Nature of the failure</b>			Personnel failure	Occurrence results from a failure during operation	X	Appropriate	Comprehensive	Implemented			
			Equipment failure	Occurrence results from a deficiency discovered by							
		X	Procedure failure	Periodic testing							
<b>SAFETY PROBLEMS: DIRECT CAUSE: Why did it happen?</b>				<b>How to eliminate the problem?</b> (Corrective actions by ASSET method)		Y	N	Ye	N	Ye	No
Latent weakness of the element that failed to perform as expected		No detailed guidance given for disconnection and isolation of T/G from grid to ensure prompt isolation from the grid		I Revise and update procedure – operations manager and electrical engineer.

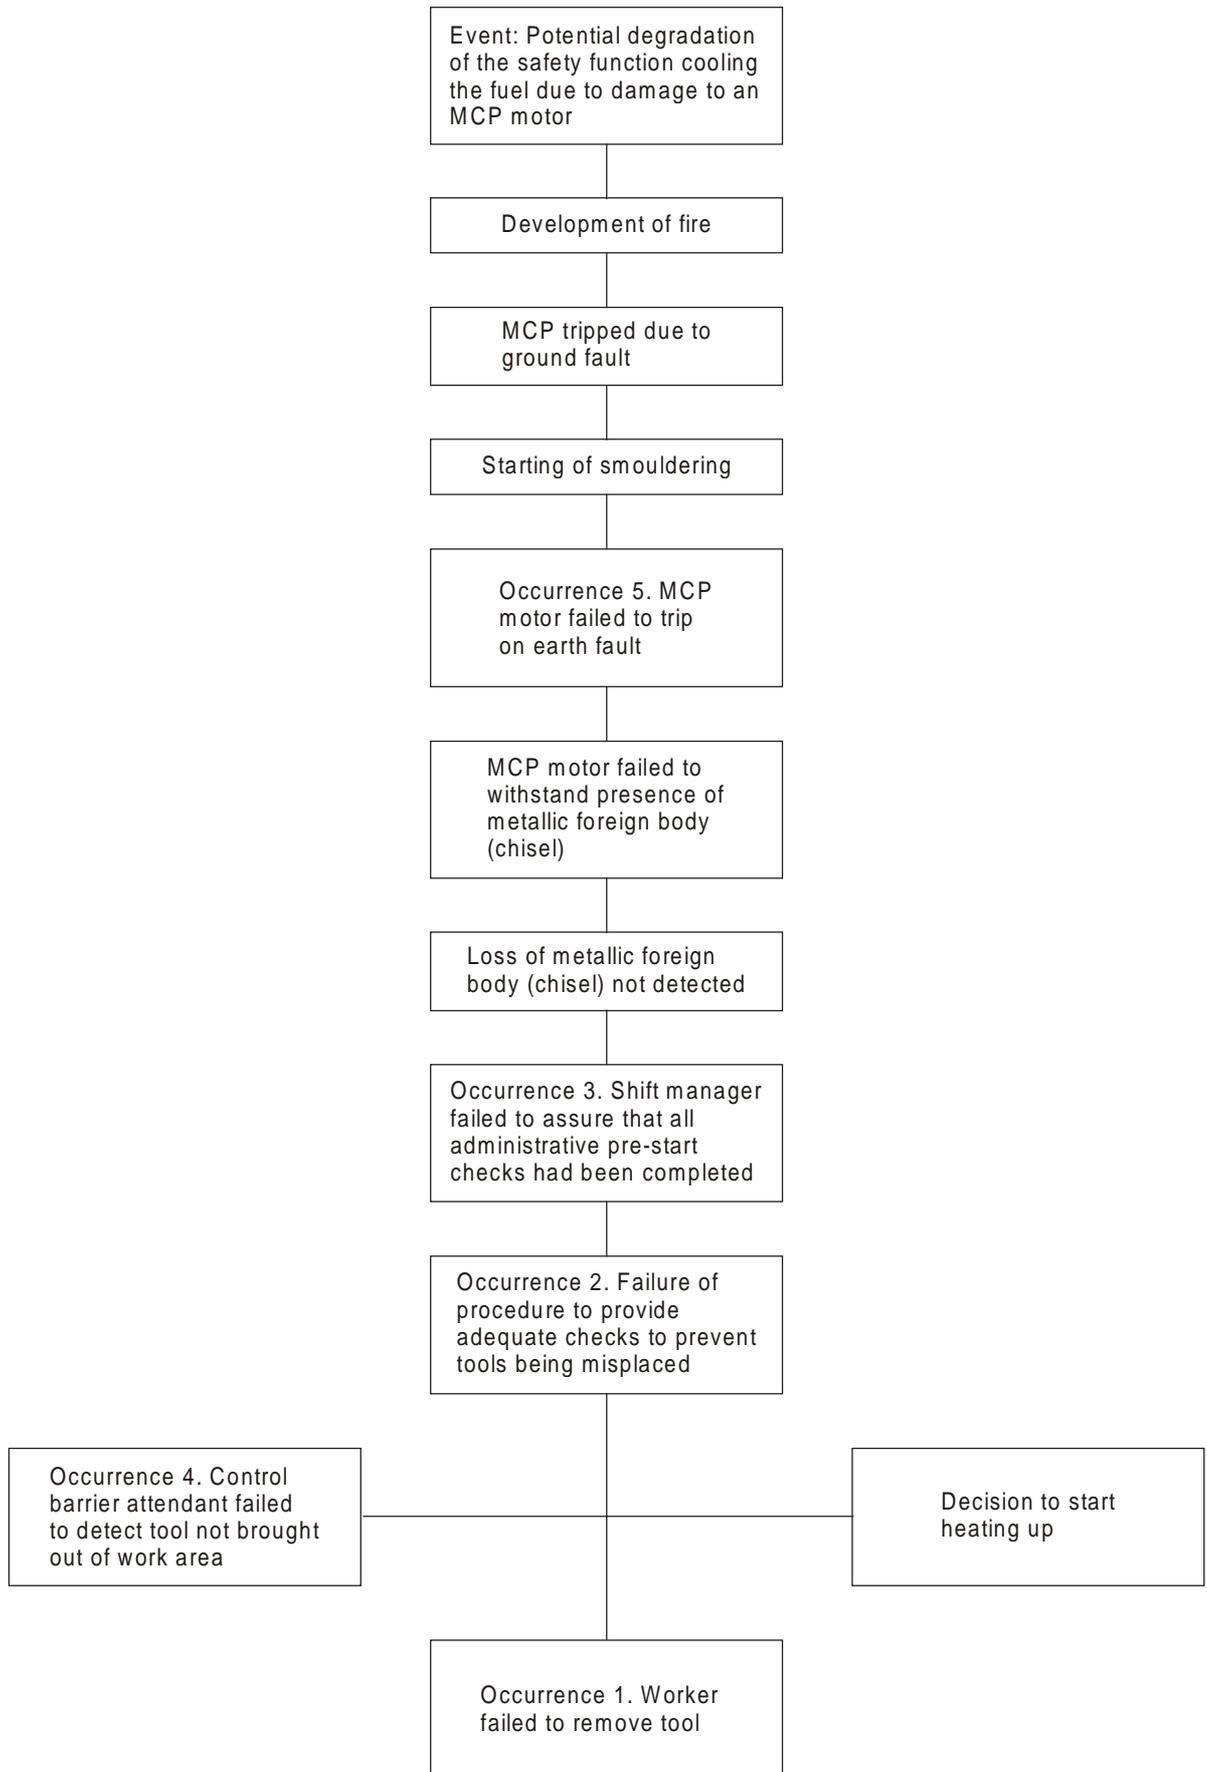
FIG. III.1. Logic tree of occurrences at reference plant 3.

IAEA		EVENT ROOT CAUSE ANALYSIS FORM EXAMPLE: REFERENCE PLANT 3, OCCURRENCE 1				ASSET					
<b>Event title:</b>		Potential degradation of the safety function cooling the fuel due to damage to the motor of a reactor main coolant pump				Safety consequences due to initiating failure					
<b>SAFETY PERFORMANCE: OCCURRENCE: What failed to perform as expected?</b>						Corrective actions by plant					
<b>Occurrence title</b>		Worker failed to remove tool									
<b>Nature of the failure</b>		x	Personnel failure	Occurrence results from a failure during operation	x	Appropriate	Comprehensive	Implemented			
			Equipment failure	Occurrence results from a deficiency discovered by periodic testing							
			Procedure failure								
<b>SAFETY PROBLEMS: DIRECT CAUSE: Why did it happen?</b>				<b>How to eliminate the problem?</b> (Corrective actions by ASSET method)		Y	N	Ye	No	Ye	No
Latent weakness of the element that failed to perform as expected		Degraded safety awareness of contract worker in that he failed to remove all his tools from workplace in controlled area		I Training engineer and contractor supervisor to review acceptance criteria of contractor induction training and the frequency of re-training
