IAEA-TECDOC-611

***Use of plant specific PSA  
to evaluate incidents  
at nuclear power plants***

**USE OF PLANT SPECIFIC PSA  
TO EVALUATE INCIDENTS AT NUCLEAR POWER PLANTS  
IAEA, VIENNA, 1991  
IAEA-TECDOC-611  
ISSN 1011-4289**

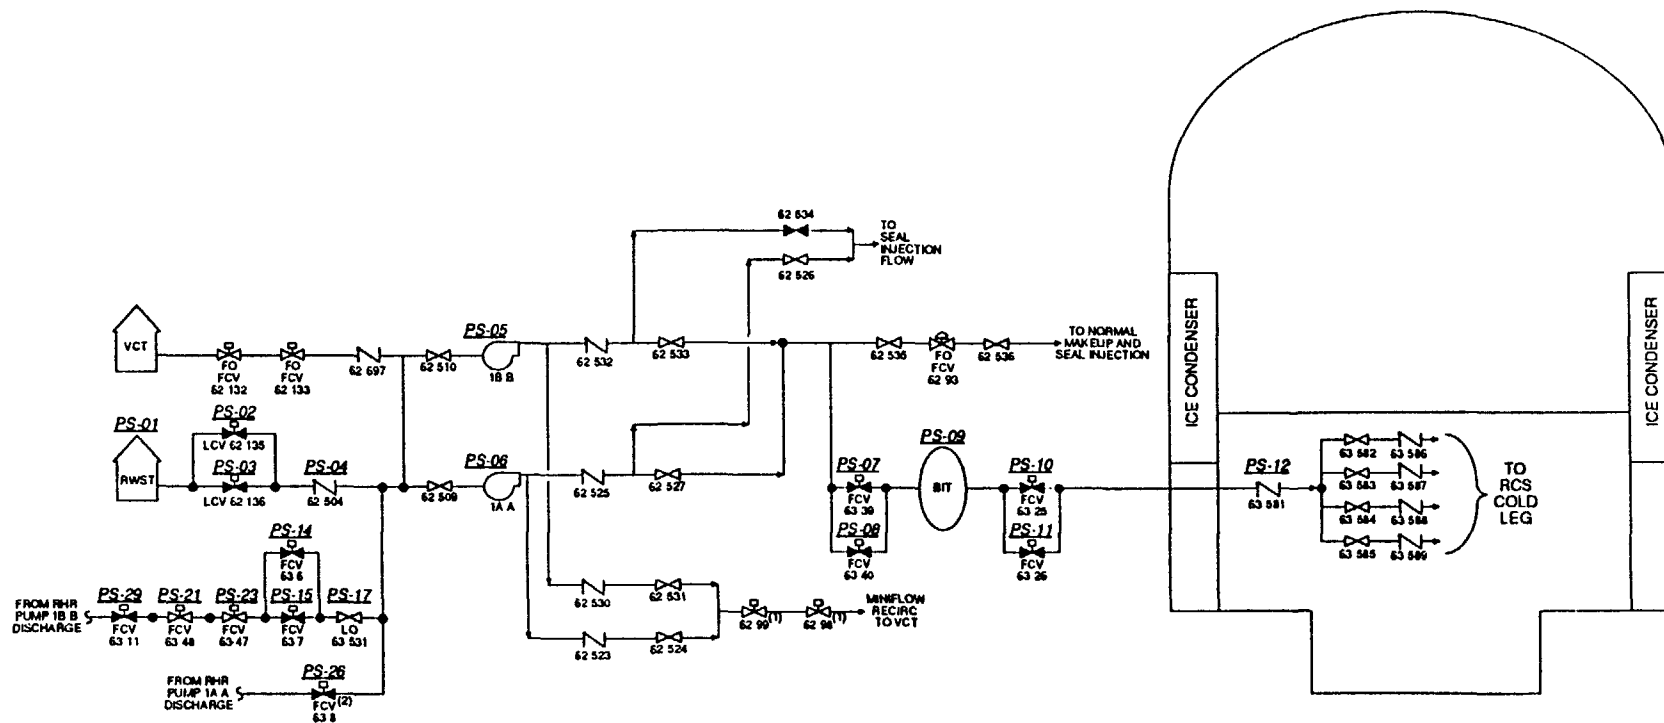
FIG. A1-1. Simplified schematic of charging system.

The charging system consists of two independent trains with high head centrifugal charging pumps. A simplified schematic of the system is shown in Figure A1-1. The charging system, in conjunction with the safety injection system, is used to maintain adequate reactor coolant system inventory for a spectrum of small break loss-of-coolant accidents. If a small break LOCA occurred at full operating pressure and the CCPs were not available, then the operator could depressurize the RCS if necessary, via the pressurizer spray system or by opening the power-operated relief valves, to achieve 1,400 psi RCS pressure where the safety injection (SI) pumps could be utilized for emergency core cooling. The charging system also serves to provide emergency boration for a number of transients including anticipated transients without scram (ATWS) and main steam line break (MSLB).

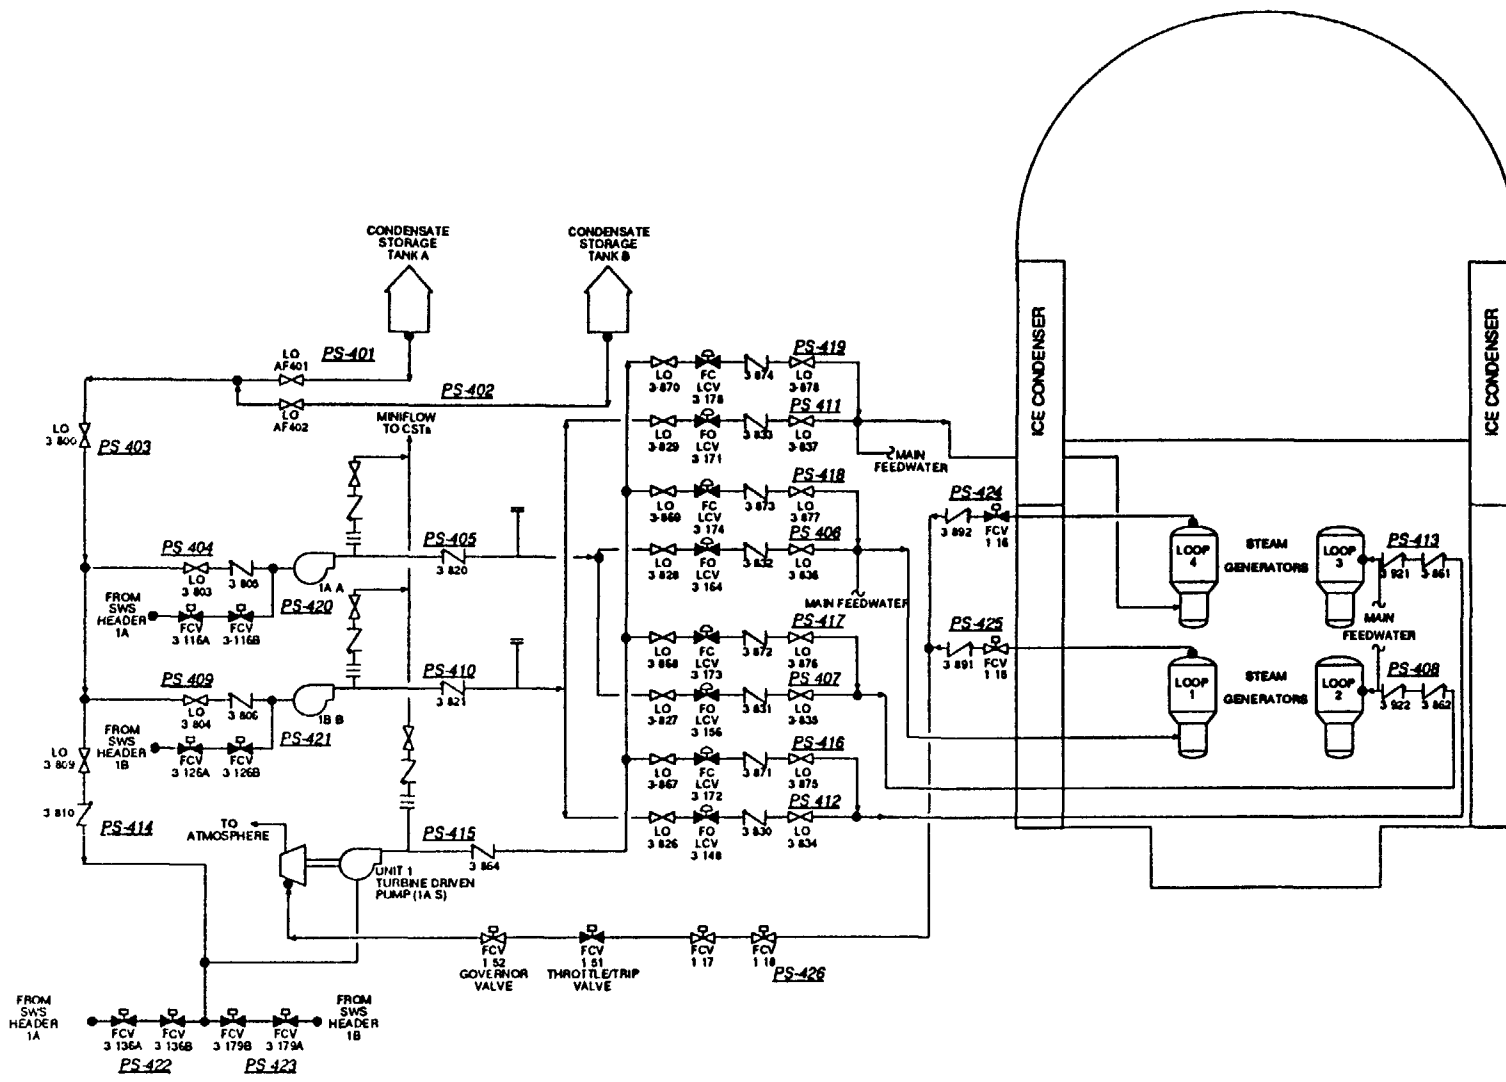
FIG. A2-1. Simplified schematic of the auxiliary feedwater system.

The charging system is described in case study 1. On loss of main feedwater, high pressure injection is only required if a reactor coolant system leak develops (or letdown is not isolated) or AFW is not available. Use of the safety injection system would require depressurization of the reactor to 1400 psig. If AFW was not available operator action would be required to implement feed and bleed for adequate core cooling.

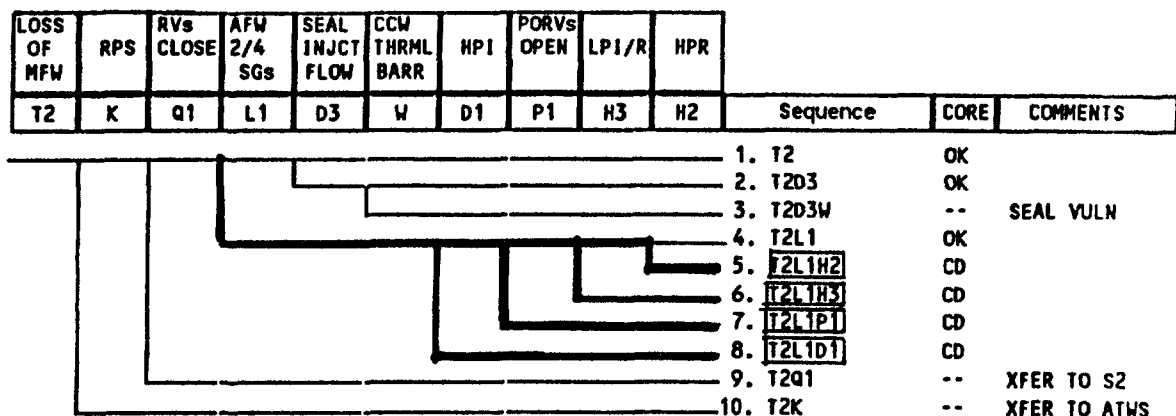
FIG. A2-2. Event tree for T<sub>2</sub> — loss of main feedwater.

This incident has been modeled as a loss-of-feedwater transient with the A train CCP and B train AFW/MDP unavailable due to test and maintenance. The potential accident sequences associated with the incident are found on the T<sub>2</sub> event tree. AFW (L<sub>1</sub>), and high pressure injection (D<sub>1</sub>, D<sub>3</sub>) functions are potentially affected. The sequences which are potentially affected by the incident have been identified in Figure A2-2.

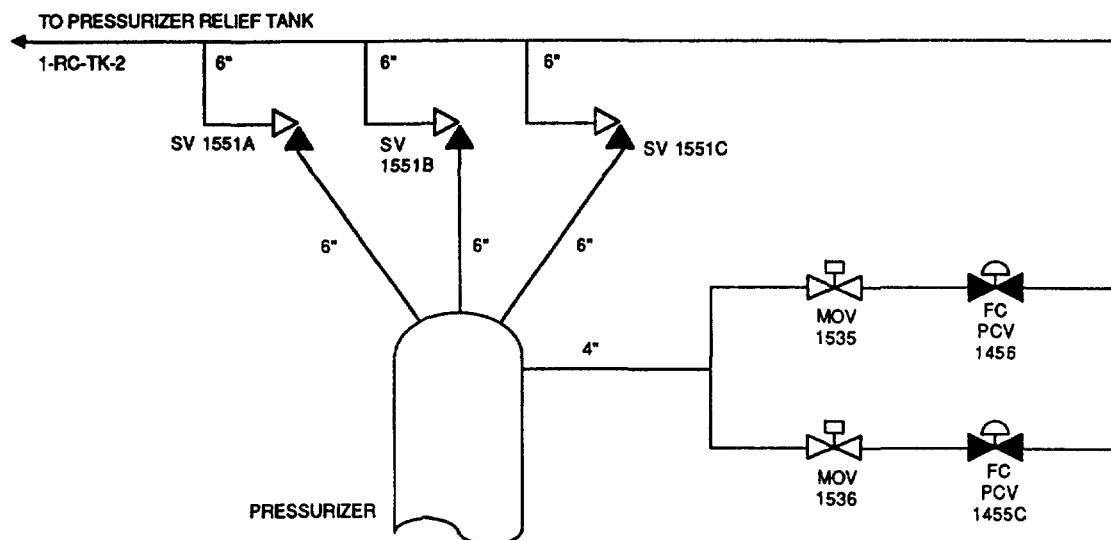
FIG. A3-1. Simplified sketch of PPRS system.

PORVs 1433C and 1456 failed to open on demand
