Review of the Experience with Worldwide Fast Sodium Reactor Operation and Application to Future Reactor Design

*J. Guidez – L. Martin
DCP*

18 sodium-cooled fast reactors (two of which use sodium-potassium coolant) have been operated or are currently in operation throughout the world. These reactors account for a cumulative 385 years of operating experience.

This article summarises the incidents and problems encountered during reactor operation, classifies them on a functional basis, and describes the solutions implemented to such events.

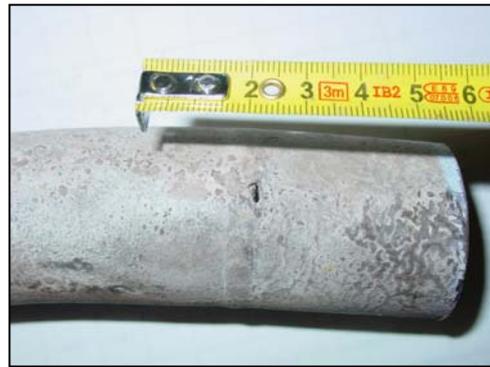
- * Manufacturing problems
Several sodium / water reactions occurred at sodium-filling or shortly afterwards, due to constructional faults, in particular on the Russian reactors.
At the PFR reactor, a crack was found in a sheet metal/plate weld during filling (1976).
- * Fatigue cracks
The combination of a design flaw or inappropriate operating procedures led to thermal shocks and mechanical fatigue. Fatigue cracks can initiate sodium/water reactions. This was the case for the first 4 reactions at Phénix where the spurious arrival of cold water in the reheater during start-up caused fatigue cracking.
- * Corrosion
Corrosion phenomena can lead to a surface-breaking crack and a sodium/water reaction. This was the case for the PFR, where repeated corrosion occurred at the tube/plate junctions.

Phenix – Nitriding defect on the steam tube of steam generator – Sodium/water reaction n°5

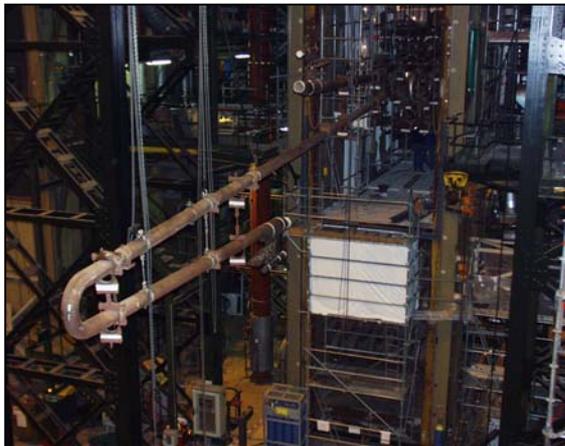
Phenix : disassembling of a SG module for repair

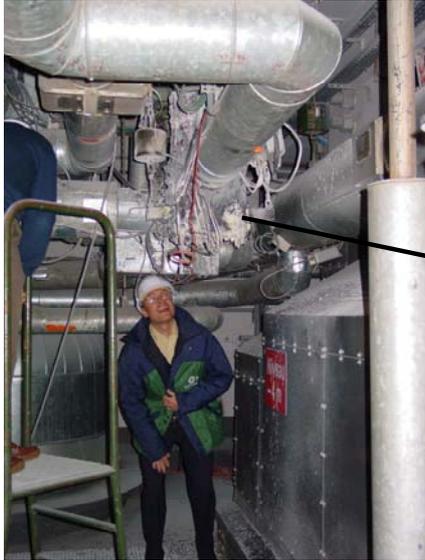
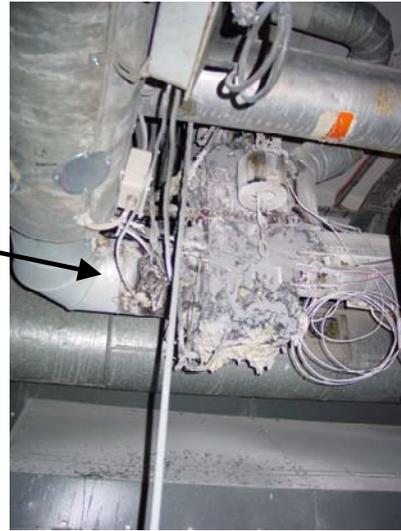
Examination of the circuit after a sodium leak located on a valve bellows

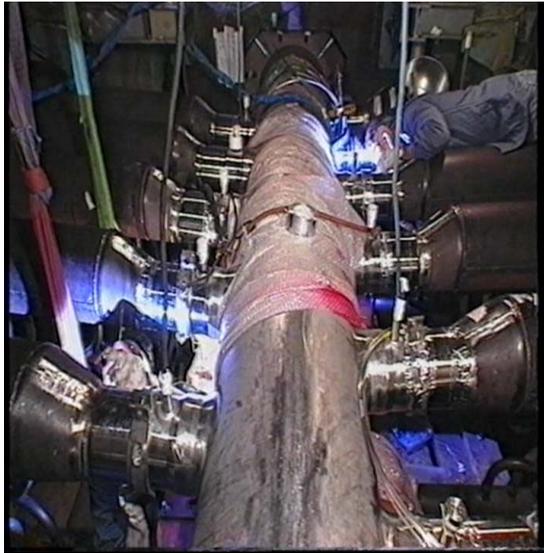
- Use of 321 austenitic steel
Used extensively at Phenix and PFR, this steel showed cracks over time corresponding to residual welding stresses, particularly in the hot areas.
As a result, all the 321 parts at Phenix were gradually replaced. Many successive repairs were made to the PFR steam generators, and all the parts made of 321 on existing reactors are closely monitored.

Phenix : repair of the SG sodium inlet header
