Ageing Management Program of Kartini Reactor for Safe Operation

Abstract

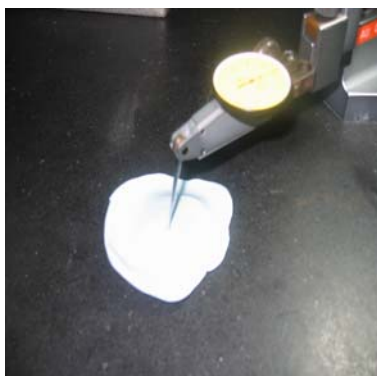
FIG.1.
Measurement of Swelling Height

Data related to the areas of swelling areas and height of the swelling from inspection results made in December 2004, July and December 2005 and September 2006 are tabulated in Table 1 [3,5]. Figure 1 shows the measurement of swelling height as a function of time. Figure 2 shows the graph of S1 and S2 swelling areas (a) and height (b) as a function of time. Data presented in the Table 1 shows that the swelling area and height had grown slowly in size and became relatively stable (grow has ceased). Taking into account the remaining thickness of the aluminium at the swelling location the swelling could not be accounted for by the formation of corrosion products from aluminium due to the low “Pilling-Bedworth ratio” for aluminium [4]. The occurrence of the swelling was analyzed as an ageing consequence. It is obvious that some localized pressure is being exerted on the outside of the aluminium tank liner to create the swelling. Root cause analysis of swelling problem has been discussed more detail in the reference [6].
