Ageing Management of Reactor Internals for TEPCO

I. Impact to the Kashiwazaki-Kariwa NPS from the big earthquake on July 16th

II. Aging management of reactor internals considering seismic load

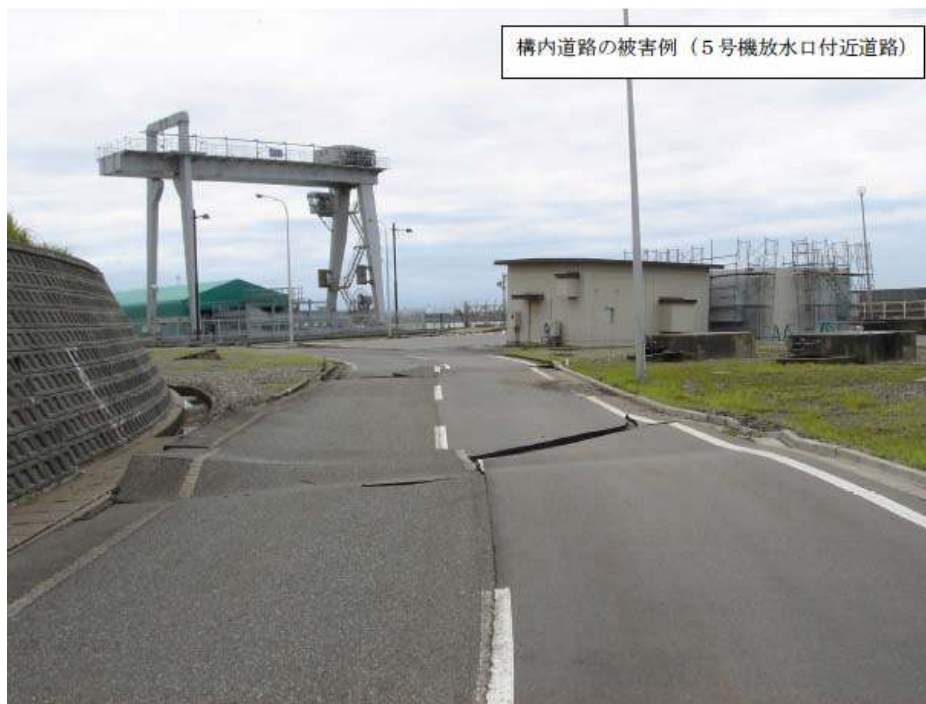
■ Road damage near K-5.

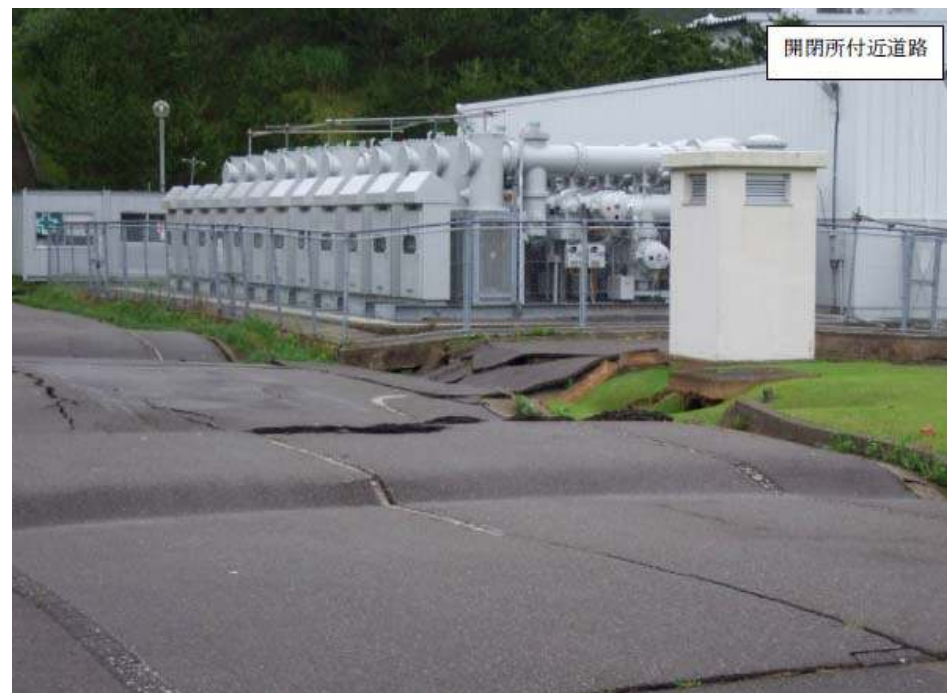
■ Road damage near Switch Yard.

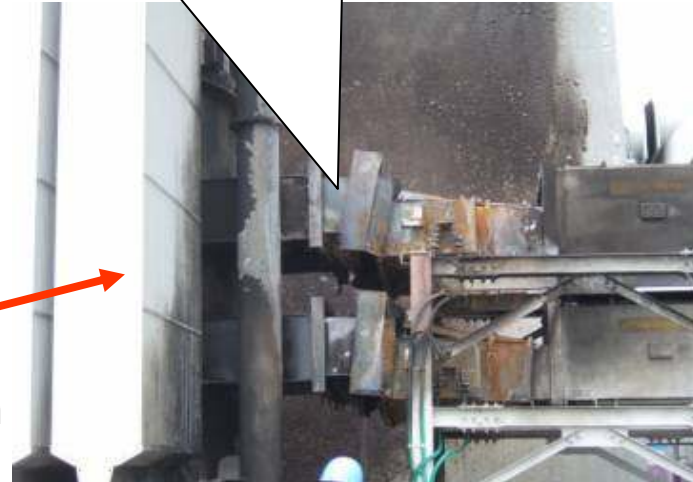
Connecting bus bar of the secondary side shifts vertically.

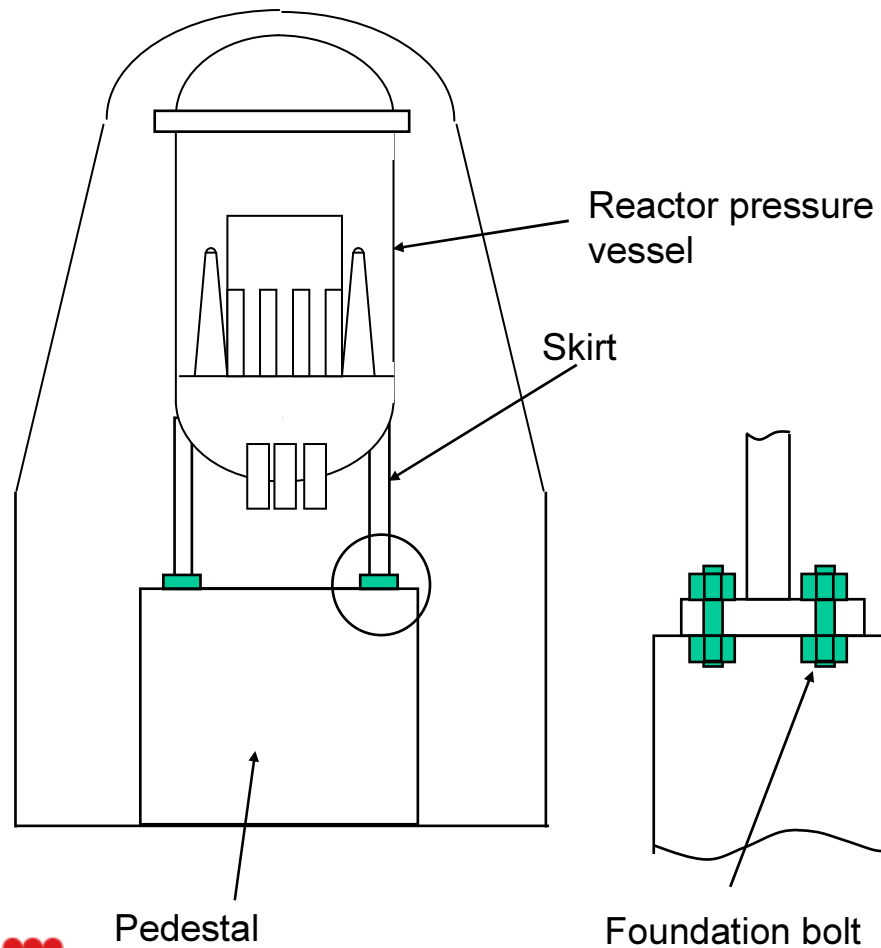
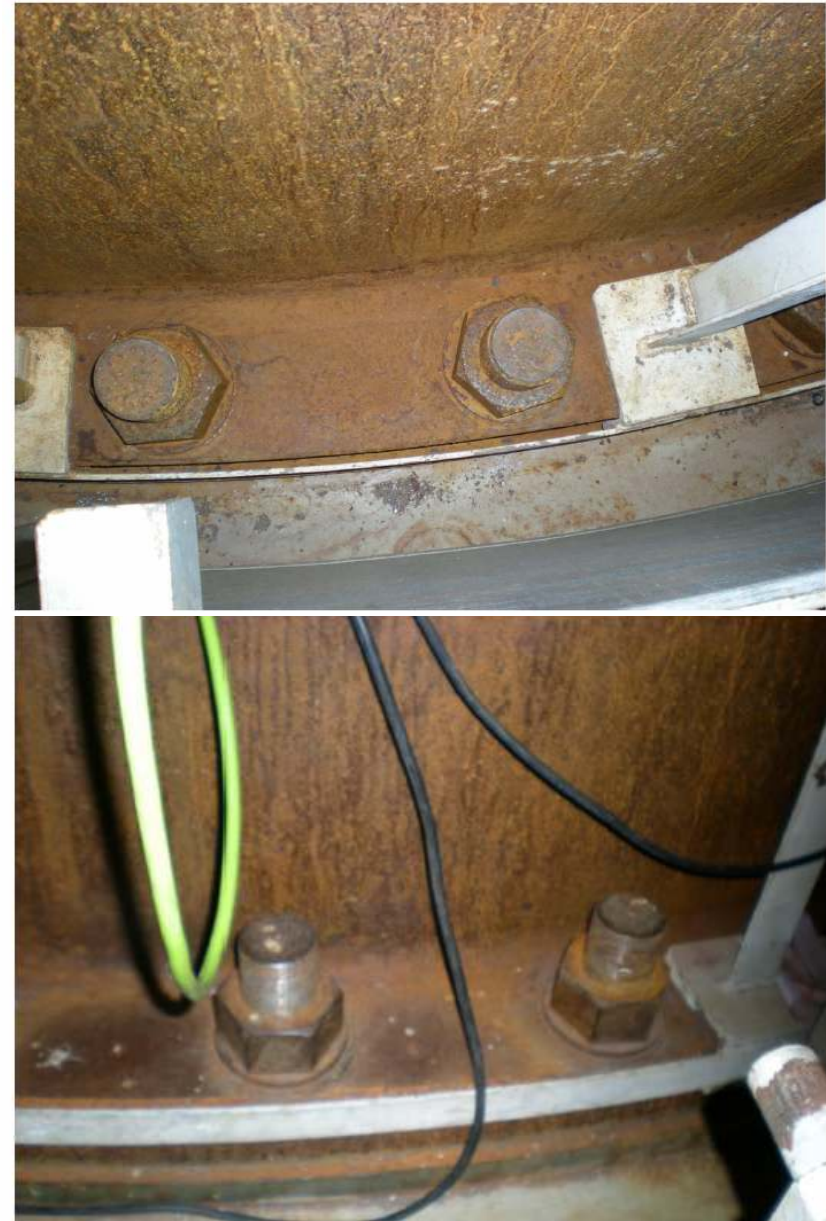
Foundation bolts for the reactor pressure vessel at K-1

- Visual inspection of the foundation bolts for the RPV at K-1

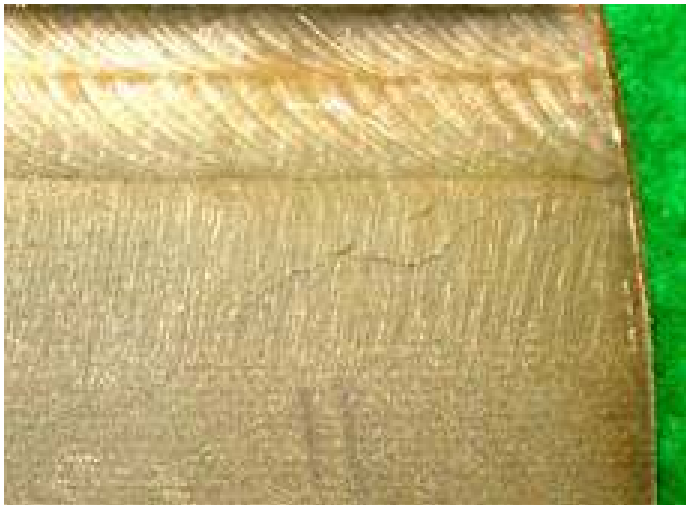
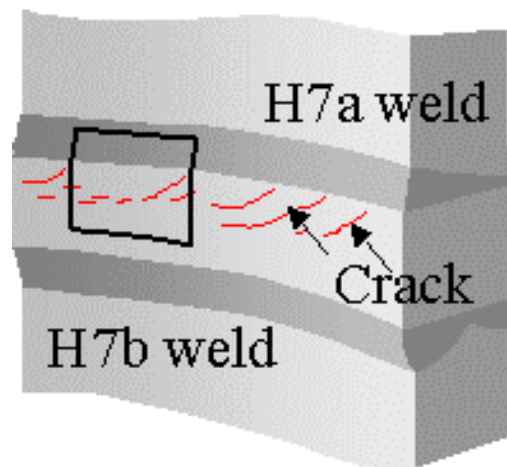
- ✓ TEPCO has experienced SCC and damage to Reactor Internals.
- ✓ Typical examples: Shroud, Core Spray, Sparger T-BOX and ICM Housing

- ✓ Adoption of SUS 316 L
- ✓ Replacement of shrouds (1F-1,2,3 and 5)
- ✓ Peening
