ASSESSMENT OF CRACK-LIKE FLAW IN EX-SERVICE MONEL 400 STEAM GENERATOR TUBE REMOVED FROM PICKERING UNIT 4 STEAM GENERATOR 12

Abstract. This paper documents the considerable efforts to characterize and assess an axial crack-like flaw on the outer surface of Monel 400 steam generator tube R41C52, which was removed from service from Pickering Unit 4 Steam Generator (SG) 12 in 2005. Metallurgical examination showed that this flaw had a maximum depth of 81% through-wall (tw), and was at least 65-mm long. The flaw initiated at a manufacturing defect on the outside surface. Orientation Imaging Microscopy (OIM) showed that no organized plastic strain fields are present at the crack tip. This implies an absence of plastic deformation as a driving force for crack propagation. These observations, along with others such as the blunt nature of the crack tip and intergranular attack (IGA) ahead of the advancing crack tip, suggest the crack growth rate is therefore very slow. The flaw in tube R41C52 did not pass the Condition Monitoring Assessment of the Ontario Power Generation Steam Generator Fitness-for-Service Guidelines (FFSG) when the non-mandatory FFSG axial flaw model was applied. If an a

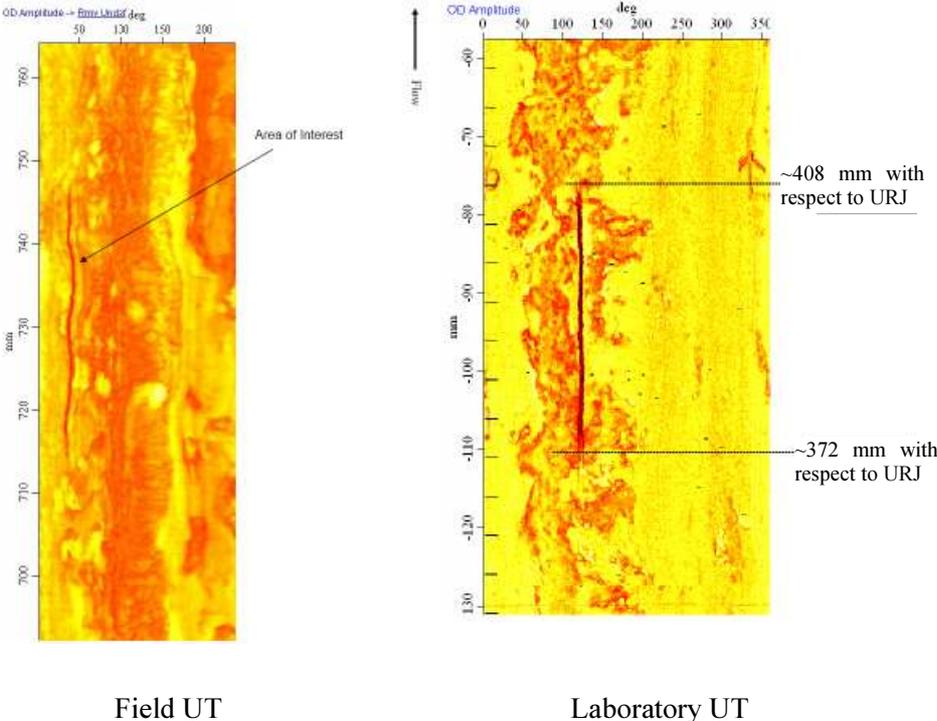
FIG. 1: Ultrasonic inspection results from field and laboratory

FIG. 1 shows the field UT axial indication of tube R41C52. Laboratory UT of the removed tube confirmed the NDE results. The axial length is about 36 mm, extending from 372 mm to 408 mm above the upper roll joint (URJ).

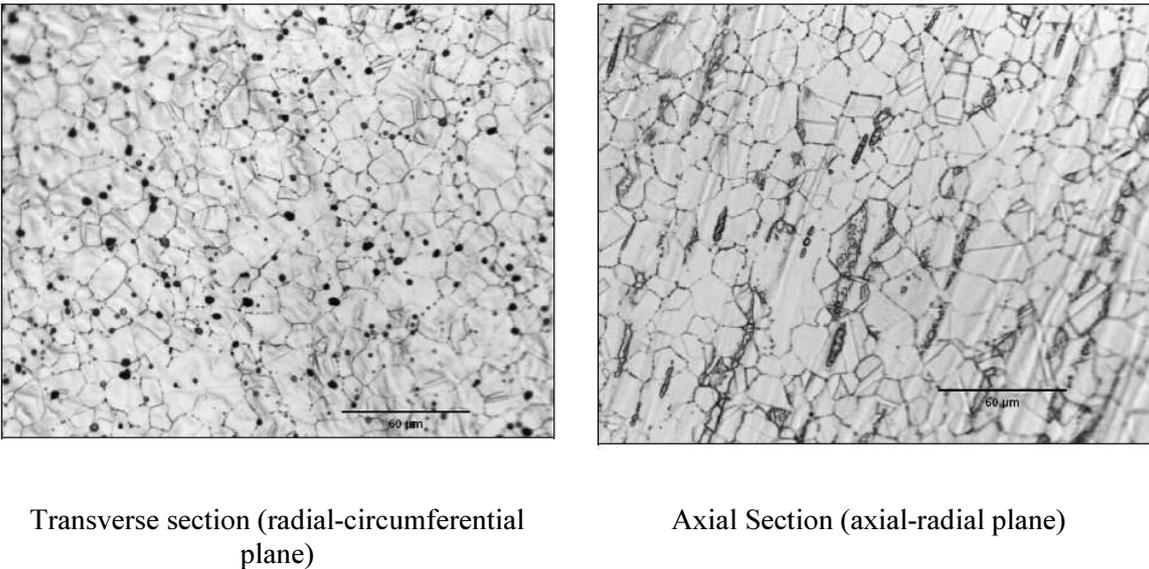
FIG. 2: Representative microstructure of tube R41C52 shown along the transverse and axial directions

FIG. 4 shows the fracture surface between the two cross sections in FIG. 3. Analysis by Energy Dispersive Spectroscopy (EDS) indicates the presence of Al, Cu, Cl, Si, and S on the “woody” propagation part of the fracture surface. This is consistent with secondary side water contaminants. This woody fracture surface is related to the elongated inclusions, as shown in the axial-radial plane of the microstructure presented in FIG. 2.

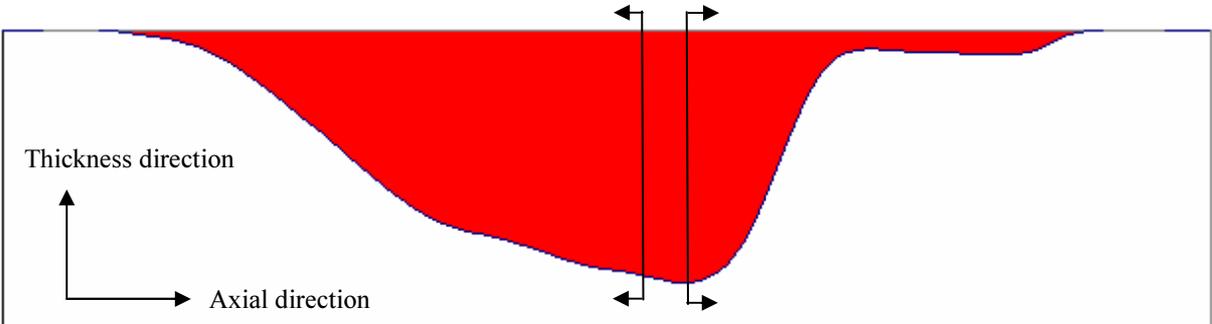
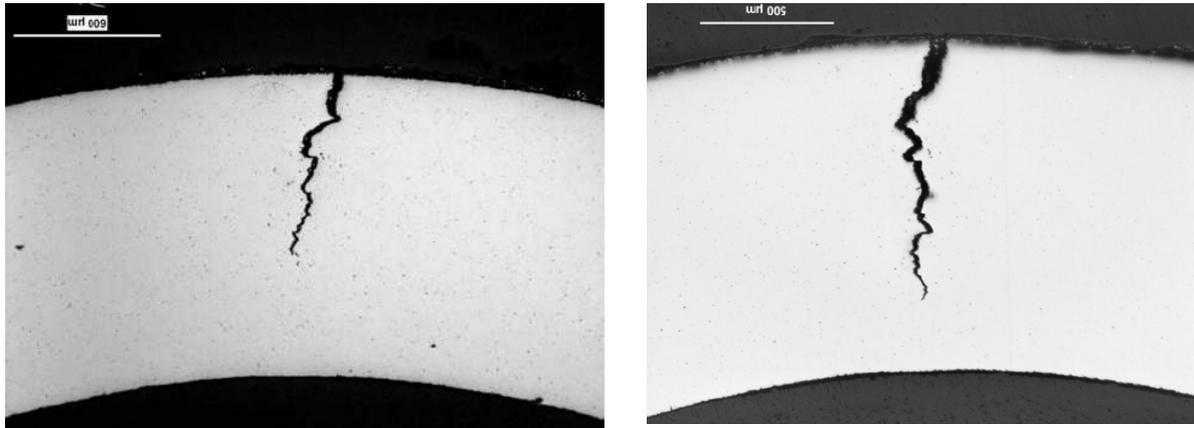
FIG. 3. Crack profile and two cross sections from Tube R41C52

Crack depth of 71%tw

Crack depth of 81%tw

A series of cross-sections are cut to examine the crack morphology, see the schematic illustration in FIG. 3. Metallurgical examination shows that the deepest portion of the flaw is 81%tw deep having initiated at an OD manufacturing defect (lap).

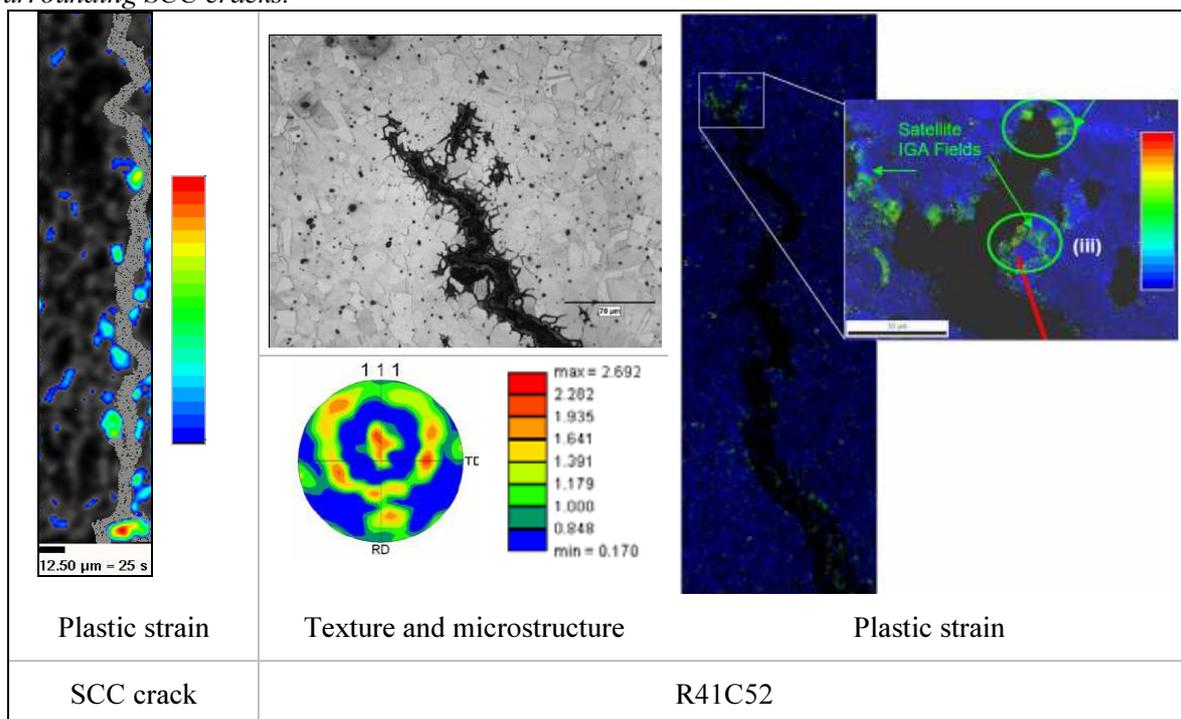
FIG. 5. Micrograph, pole figures and plastic strain distributions from the OIM analysis at the tip of the crack in tube R41C52. Also shown for comparison is the typical plastic strain morphology surrounding SCC cracks.

FIG. 5 indicates the relative magnitude of plastic strain ranging from low (blue) to high (red) found along the cross section of the 71%tw deep portion of the crack. No evidence exists for the presence of localized strain fields (above background levels) along the overall crack length even at locations associated with abrupt changes in crack direction. Rather, very weak but localized strain fields are confined to the “branched” crack tip and along adjacent grain boundaries associated with “satellite” Inter Granular Attack (IGA) fields as indicated in the encircled areas of the strain image. This implies that this defect did not propagate along its length under the influence of intense plastic strain or transients encountered in-service. This point is emphasized by contrast to a typical Stress Corrosion Cracking (SCC) crack produced in the lab where very intense plastic strain fields develop along the propagation length at triple junctions in response to abrupt changes in the crack direction.

Collectively, the results imply that there is a weak stress concentration due to the global loading, e.g. internal pressure differential in this case but it is unlikely that the defect propagated substantially in-service. The blunt crack tip, the skewed crack path and the discrete IGA sites indicate that the crack grows slowly by corrosion, rather than by a stress corrosion cracking mechanism. The weak ($<2.7 \times \text{random}$) $\langle 111 \rangle$ fibre texture is indicative of the tube forming process by drawing. The grain boundary analysis indicates that there are a sufficient number of grain boundaries, with a character that would allow such grain boundary cracking, that it is possible to grow a through wall crack (with a maximum possible propagation depth of $834 \mu\text{m} \pm 438 \mu\text{m}$) in structures like this, see References [8] and [9] for detailed description of this calculation. In other words, the crack could develop into a through-wall flaw for this steam generator tubing material.

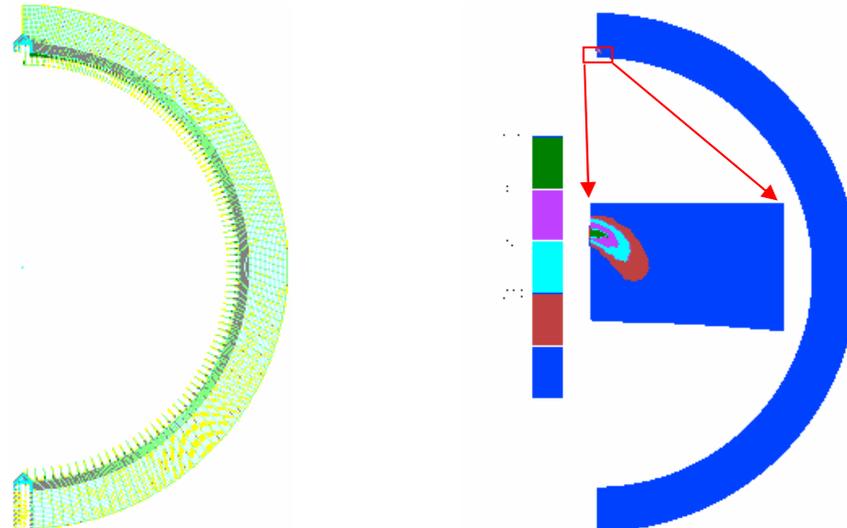
FIG. 6. Finite element model and the predicted plastic strain distribution at the internal pressure of 8.7 MPa

FIG. 6 shows the 2-D plane strain model (infinite crack length), boundary conditions (symmetrical displacement constraints and internal pressure loading), and the calculated distribution of effective plastic strain. The calculated plastic strain at the crack tip for the maximum normal operating pressure differential (8.7 MPa) is limited at the crack tip and the maximum value is 0.005, as shown in the figure. This agrees well with the measured plastic strain distribution from the OIM. It is to be noted that the plastic strain from the OIM analysis is performed at the cross section with 71%tw crack depth. The present plane strain assumption and the 81%tw crack depth in the finite element models indicate that the results from HFEM are very conservative. The actual plastic strain should be less than the 0.0054 calculated by HFEM.

Using the methodology (plastic collapse load) documented in Reference [3], the predicted failure pressure for this flaw is 27.0 MPa, resulting in sufficient margin on load to meet the

“prohibiting leakage” acceptance criteria of the FFSG. Therefore the tube R41C52 passes the Condition Monitoring Assessment of the FFSG if this alternative HFEM simulation is used.
