CORROSION INDUCED LEAKAGE IN THE RADIAL BEAM PORT OF THE 3 MW TRIGA MARK-II RESEARCH REACTOR OF BANGLADESH

Abstract

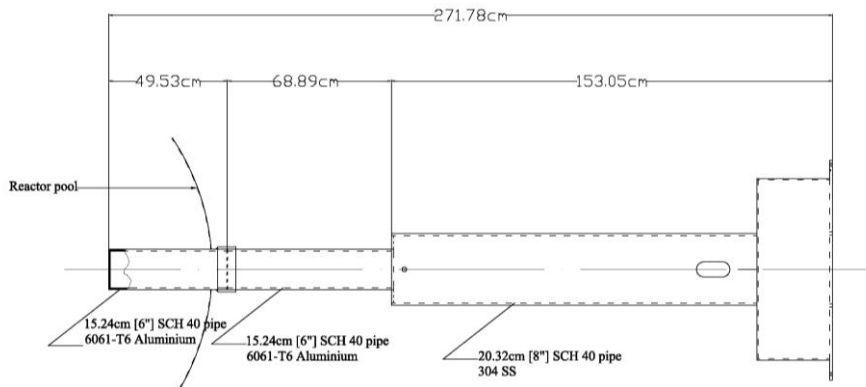
FIG. 2. Details of the radial beam port.

As shown in Figure 2, the aluminium part of the RBP-1, which has a length of 48.26cm, pierces the reactor pool liner and terminates near the outer surface of aluminium liner of the reactor core. The end of the beam port tube is closed with a 6.125 mm thick aluminum disc. The graphite plug occupied about 34.29cm of the aluminium pipe. Therefore about 15.24 cm of the aluminium pipe of the beam port from its dead end remained void. The leaks that developed from corrosion damage mainly took place on the inner bottom surface of the aluminium pipe located at distances from 15.24 cm to 35.56 cm from the dead end of the RBP-1. Corrosion damage also occurred to some extent on the stainless steel pipe and at the aluminium-steel interface. These were confirmed by visually inspecting the inner walls of the beam tube with a digital camera that was inserted inside the beam tube and operated remotely.

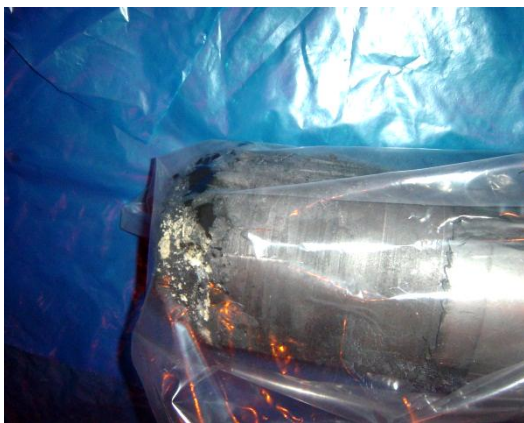
Fig. 6. Last segment of the graphite plug.

Operations for removal of the 33.02 cm long broken part of the graphite plug was undertaken after getting formal approval of the regulatory authority. Before that Reactor Operation & Maintenance Unit (ROMU), the authorization holder of the reactor facility, had to submit to the regulatory authority detailed work plan, emergency response preparedness plan and QA program to be implemented in connection with plug removal work. While performing the removal operation, extreme care was taken such that the corroded aluminum BP pipe did not get damaged and also that the amount of graphite dust produced could be kept at minimum. The stainless steel auger, designed and fabricated mainly by ROMU personnel, was found to be very effective in this regard. A picture of the auger and associated fixtures used are shown in Figure 5. It is to be mentioned that the auger was operated manually so as to be sure that it was not cutting the wall of the aluminium BP tube. It took about 12 working days to complete the cutting operation. The picture of the last segment of the graphite plug is given in Figure 6. In this picture clear corrosion marks are seen on the surface of the graphite plug that was not trimmed off by the auger.

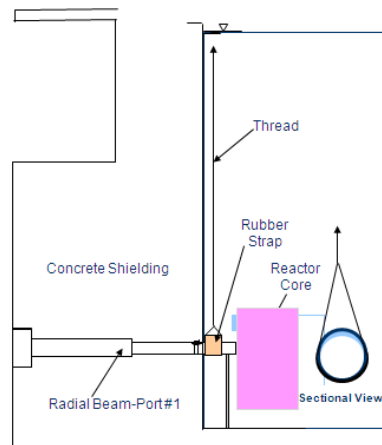
FIG. 7. Installation of the rubber strap

As the leakage of water through the beam port came to the notice of the operators, it was stopped by putting a rubber strap around the leaking part of the RBP-1 (see FIG. 7). Efforts were then made to carry out visual inspection of graphite plug and the inner part of the beam port using a digital camera. At the same time initiatives were taken to develop a device that could be used to prevent leakage of reactor pool water.

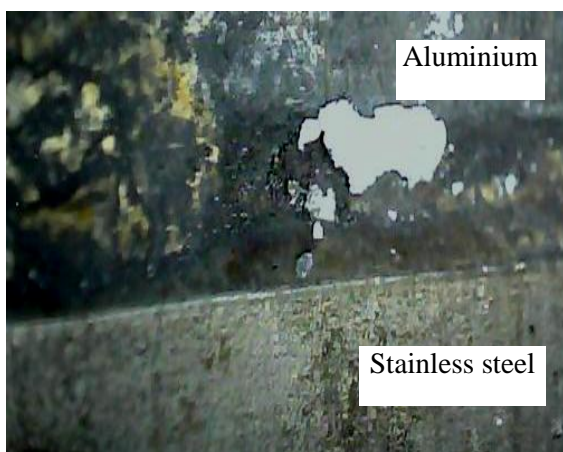
Fig. 8. Corrosion at the Al-SS junction.

moisture from the condensate that had accumulated in the annular space between the plug and the beam port tube. Deposits or scales were found on the outer surface of the lead plug and these deposits consist of species resulting from the corrosion. Photographs obtained from a digital camera inserted into the RBP-1 clearly showed the corrosion damages in the form of metal removal and pits on the inner bottom surface of the aluminium pipe. It also revealed that the damage in the form of pits had initiated at the interface between the stainless steel and aluminium. Brown stain marks were observed on the stainless steel surface but no pits or metal removal was found on the stainless steel surface as shown in Figure 8.

Detailed analysis pointed out that the aluminium (Al) pipe of the RBP-1 suffered extensive damage as a result of corrosion caused due to the presence of air and moisture inside the beam tube. It also attributed that damages in terms of corrosion had been initiated at the Al-SS interface where a SS sleeve had been used to cover the circumferential gap between the SS and Al pipes (see *FIG. 2*). It is to be noted that the interface sleeve was not wrapped with sealant during installation. As a result water vapour from the surrounding concrete found its way to condense into the gap between the graphite plug and aluminium pipe. Later these moistures initiated the corrosion process onto the aluminium pipe. The continual presence of moisture transformed the otherwise protective aluminium oxide layer into aluminium hydroxide, which is porous and cannot prevent seepage of air and moisture through it and attack the fresh aluminium underneath. The cracks and/or pits resulted from corrosion went through the aluminium pipe inter-granularly and allowed water from reactor tank to seep through and drain out of the beam port. The rubber sleeve used underneath the aluminium pipe temporarily sealed the mass flow of water from reactor tank and stopped water seepage through the beam port.
