## DEGRADATION MONITORING OF G.A. SIWABESSY RESEARCH REACTOR'S SECONDARY COOLING PIPE

R. HIMAWAN, SUWOTO, SRIYONO, A. TRIYADI  
National Nuclear Energy Agency (BATAN),  
Center for Reactor Technology and Nuclear Safety,  
Banten,  
INDONESIA

### Abstract

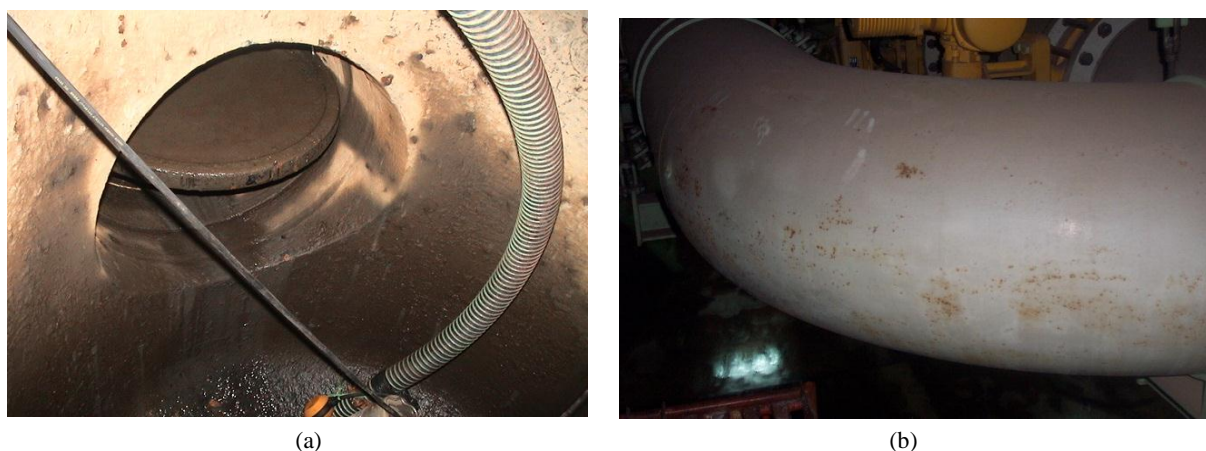
Figure 3 shows the condition of internal and external surface of pipe in secondary cooling system. It is seen that corrosion occurred almost entire of internal surface. This type of corrosion is homogenous corrosion. Besides, a spots of corrosion were also observed. They were considered as pitting corrosion. Concerning to the external surface, there is difference corrosion occurrence between the sections of pipe installed inside the building and the ones installed outside the building. Figure 3(b) shows pipe section installed inside the building. It can be seen that only minor corrosion occurred on the surface. An external surface is protected by paint layer. In case of pipe section installed outside the building, corrosion attack more serious compares those installed inside the building. Differences in environment condition between inside and outside of building, affected corrosion attack on the pipe.

Fig. 3. Corrosion on internal surface (a) and external surface (b).

According to chemical analysis on scales, it is known that scales are formed by the corrosion product of pipe and deposition of inhibitor (chemical agent) added to the cooling water[4]. It indicates that chemical agent added to the cooling water couldn't dissolve homogenously and perfectly into the entire of cooling water. In this time, the method of chemical agent injection was by poured out a large volume of chemical agent into the water basin in cooling tower. That's why the chemical agent couldn't dissolve homogenously. Based on this chemical analysis result, it is recommended to improve injection method of chemical agent into the water. Automatic injection directly to pipe line along the operation of reactor could be considered.

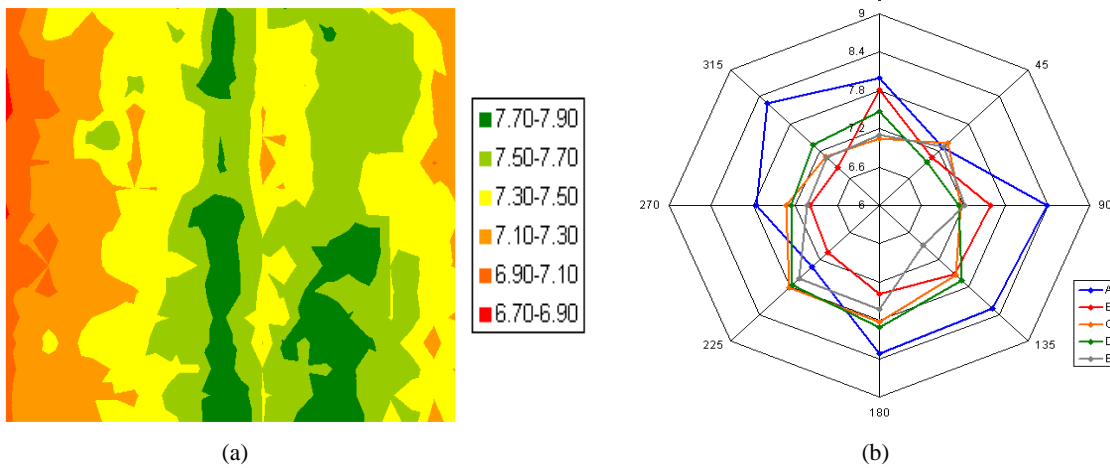
Figure 4.a shows one of thickness measurement results from measurement performed in 2004. This area covers 30 cm height and 40 cm width in pipe surface which has 61 cm diameter (see Figure 2(a) ). As shown in Table 1, this pipe has initial wall thickness of 6.3 mm. This figure shows that wall thickness has a range from 6.70 mm to 7.90 mm. In the middle part, the wall thickness is rather thicker compare to the side part. This condition represents the real condition of wall thickness to be measured.

From Figure 4.a it is known that the measurement results are thicker compare to the initial wall thickness. It indicated as if wall thickness became thicker during the reactor operation. In this measurement, paint layer on the surface was not removed. Thus, it is considered that paint layer result to thicker wall thickness. In the other hand, from visual inspection of internal surface using CCD camera, scales were observed in many places on internal surface. The presence of scales should affect the accuracy of thickness measurement.

Figure 4.b shows measurement results from the same part as shown in Figure 4.a, which performed in 2009. The measurement method is shown in Figure 2. This measurement covered along circumferential direction. This figure shows that wall thickness has a range from 6.70 mm to 8.40 mm. Result in Figure 4.a can't be compared to Figure 4.b directly, due to the difference of measurement points. However, the range of wall thickness indicates a same condition.

Fig. 4. Example of thickness measurement result for elbow: (a) first measurement, (b) second measurement.

According to thickness mapping results (performed in 2004), it is confirmed that wall thickness of pipe relatively has a big range. Besides, it is also known that there are several points with small value of thickness. The minimum thickness reached 3 mm. Due to the minimum value which detected on spot point, it could be considered that the thinning proses in this point is a result of pitting corrosion. Based on these results, some replacements were conducted to the pipe which experienced significant thinning.

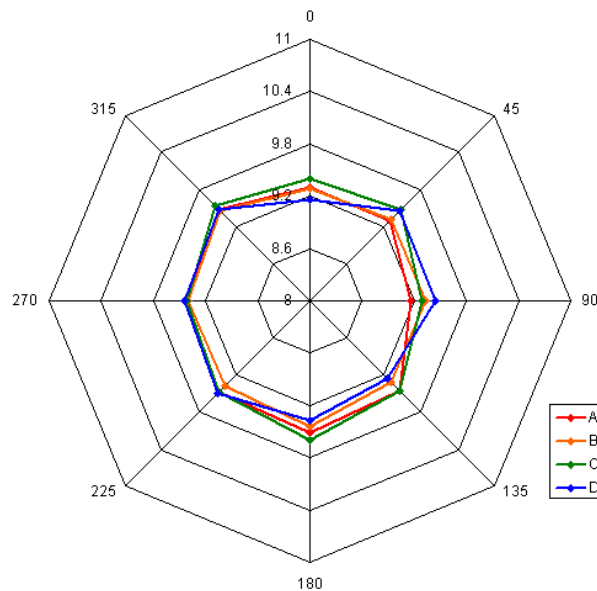
Figure 5 shows one of thickness measurement results fro new installed pipe which the measurement were performed in 2009. As indicated in Table 1, this new pipe has 9 mm wall thickness. This figure shows that according to the measurement result, the wall thickness of pipe varies from 9.2 mm to 9.4 mm. Considering the paint layer, measurement results are close to the initial wall thickness. According to these results, it is confirmed that scale and corrosion product on the internal surface of pipe affect the measurement.

Fig 5. Example of thickness measurement result for new installed pipe.
