# Restoration work for obstacle and upper core structure in reactor vessel of experimental fast reactor Joyo

December . 7<sup>th</sup> , 2009

Japan Atomic Energy Agency (JAEA)

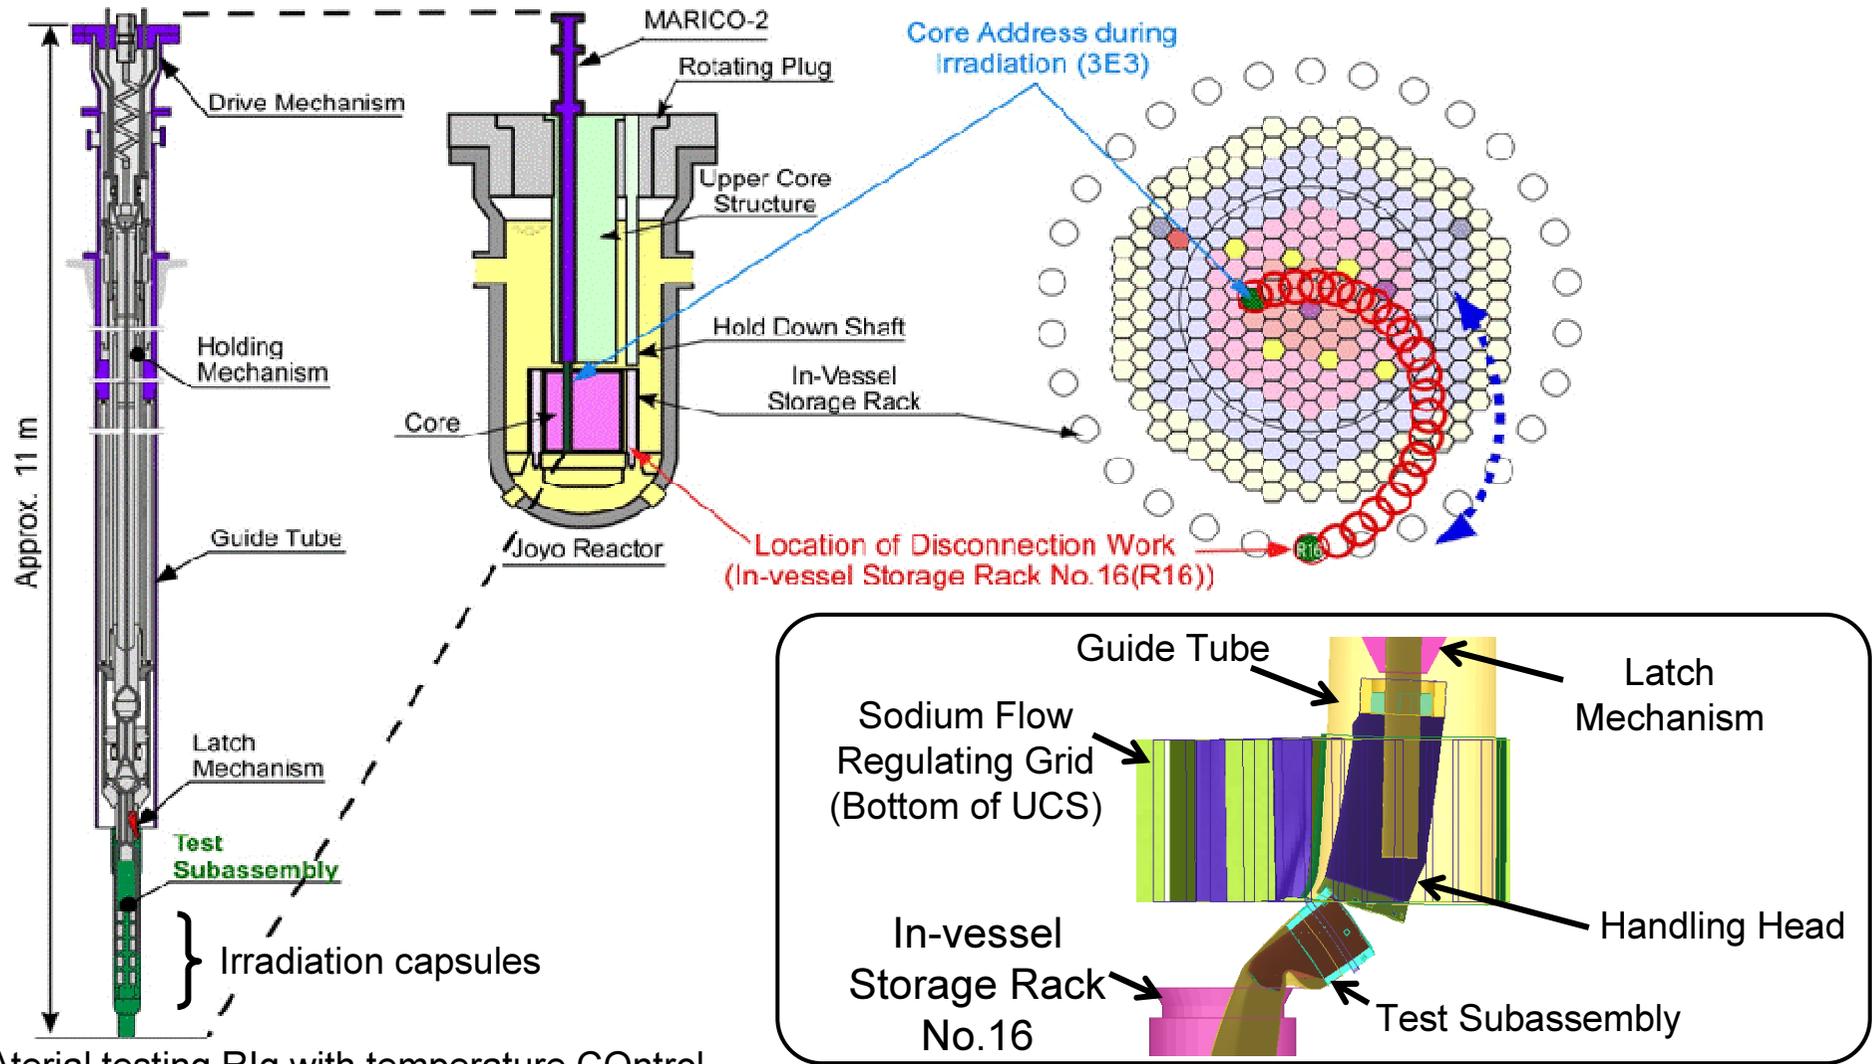
- The test subassembly wasn't disconnected from the holding mechanism.
- Test subassembly was bent on the in-vessel storage rack.

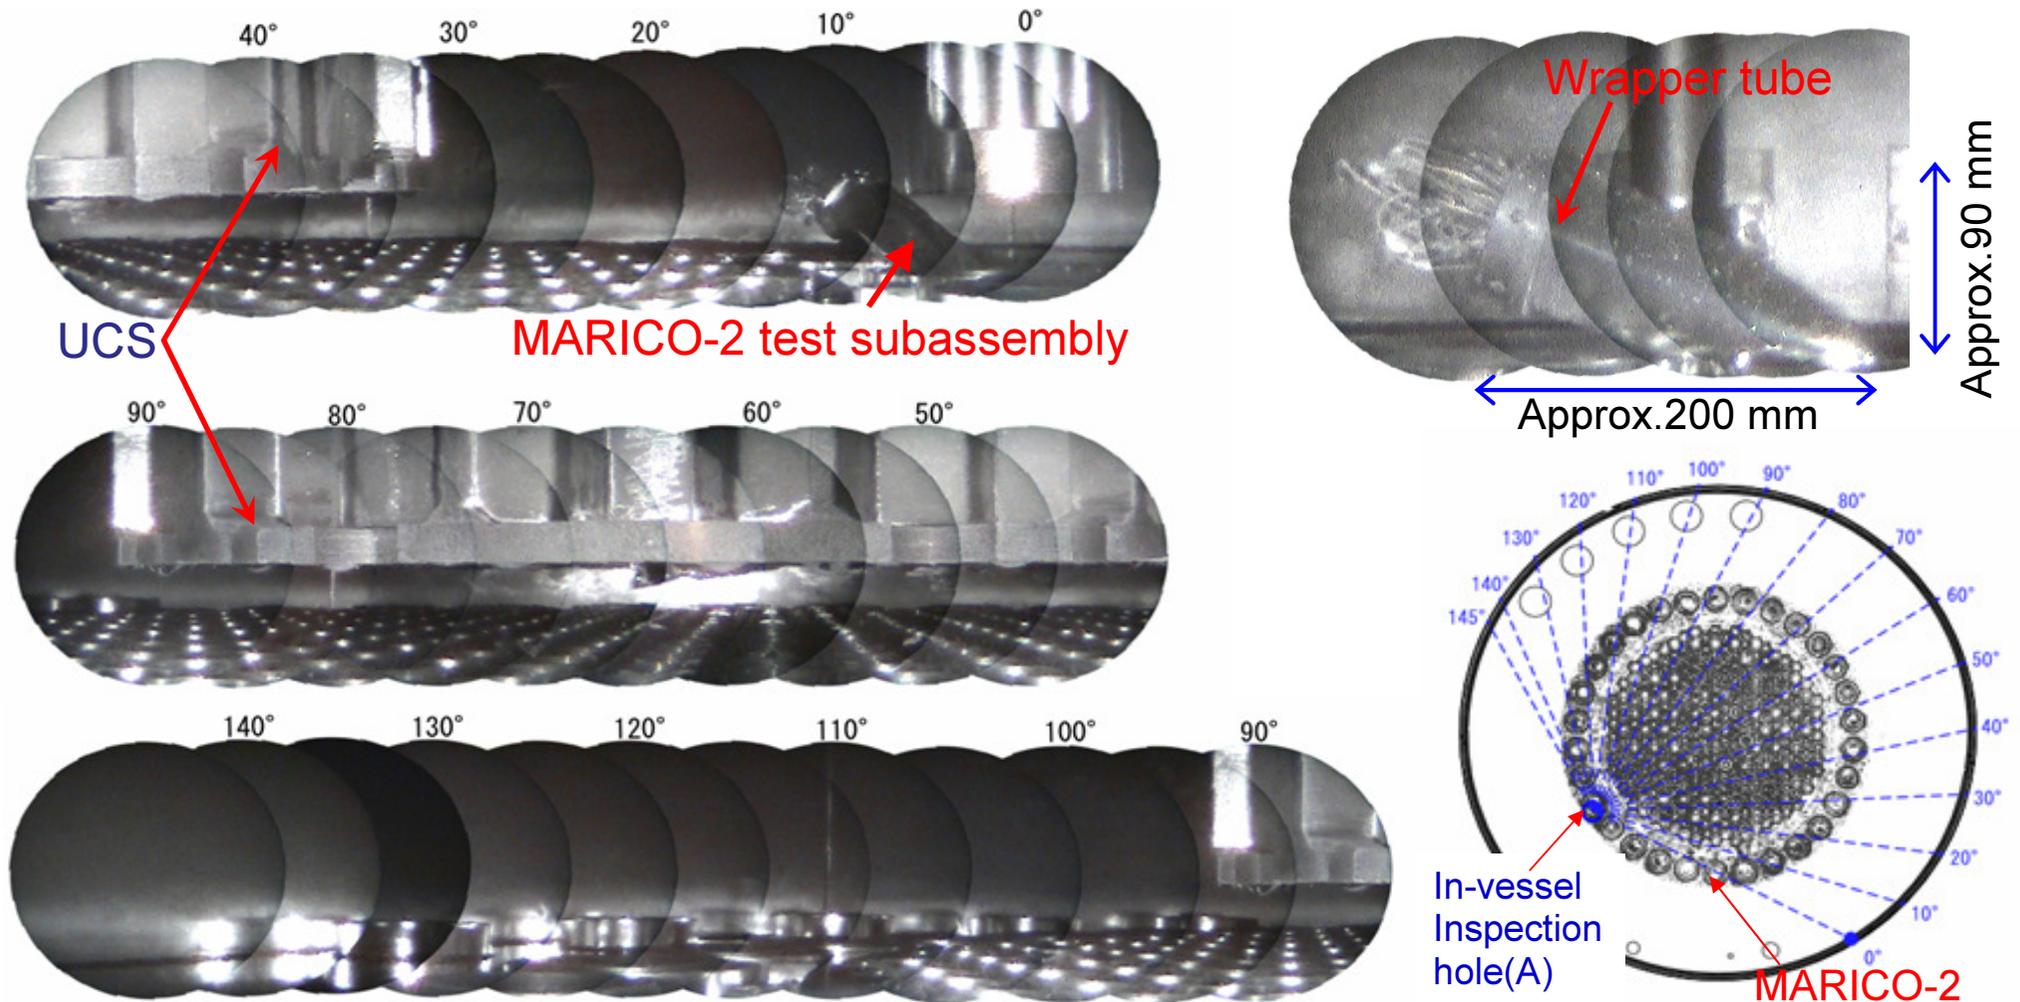
- Clear images were obtained by radiation resistant fiberscope.
- Grasp the condition of the bent MARICO-2.

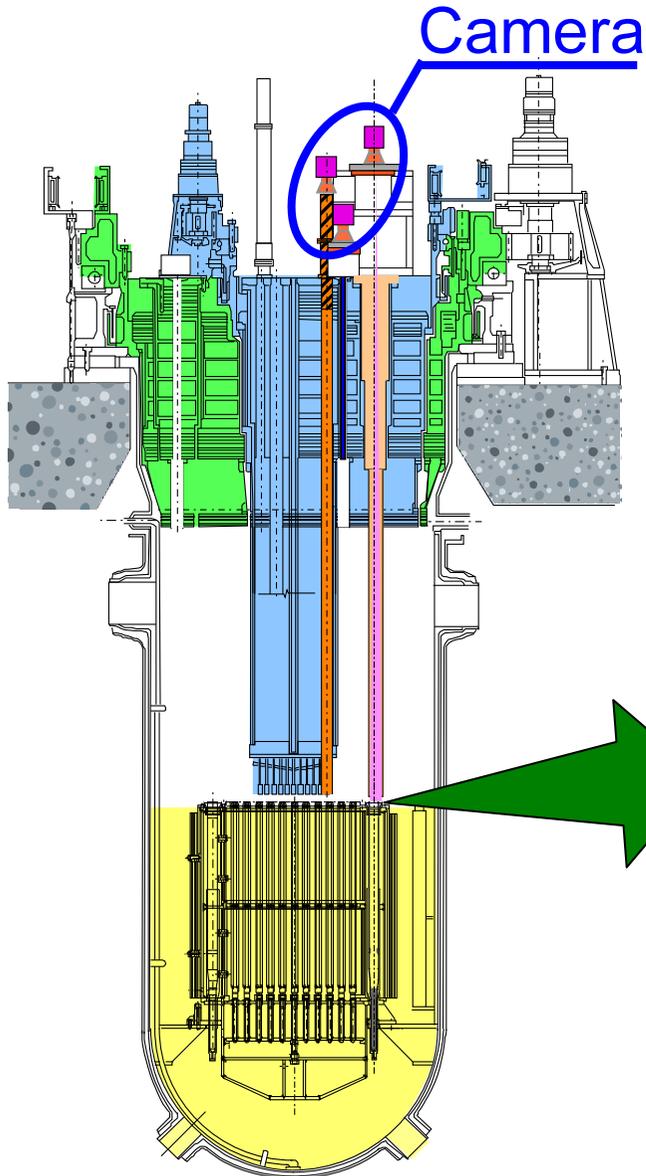
- Grasp the conditions of the transfer pot and the bent MARICO-2.

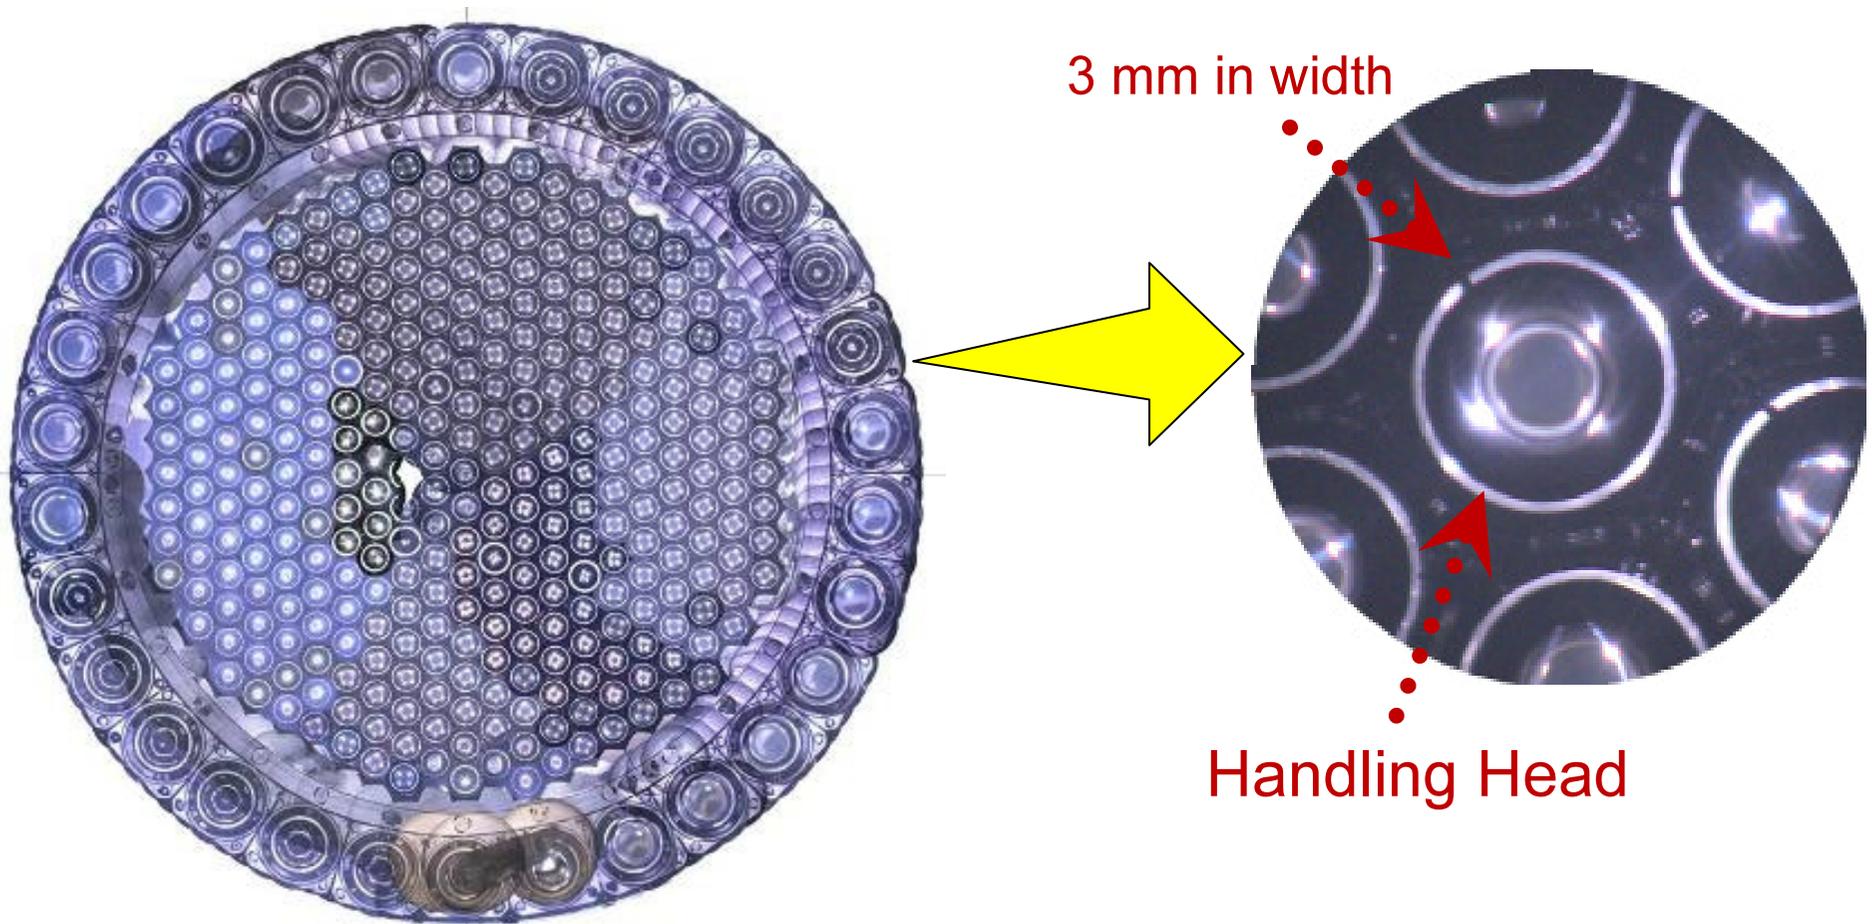
Composite photograph

- No injuries to each handling head of subassembly and in-vessel storage rack

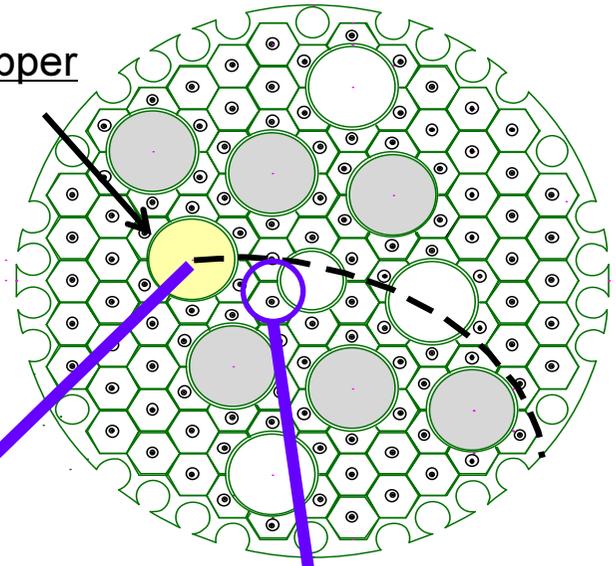
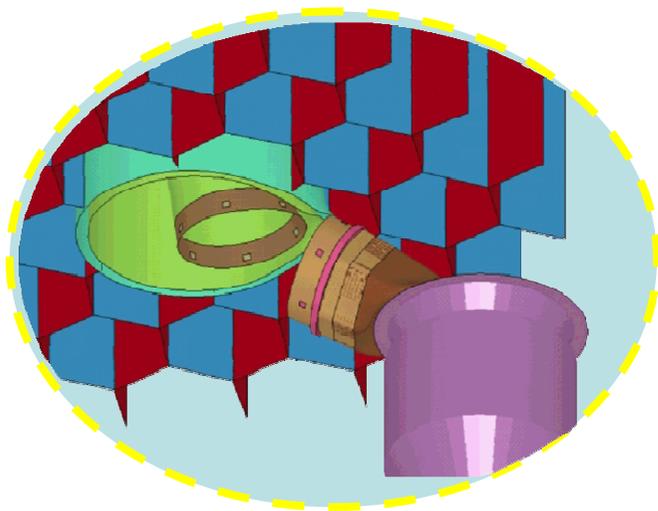
Handling head connected with holding mechanism

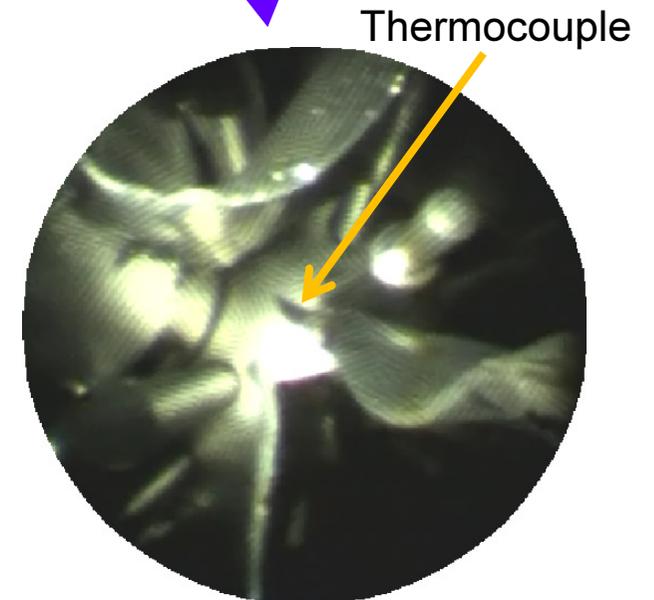
Thermocouple

Deformed regulating grid

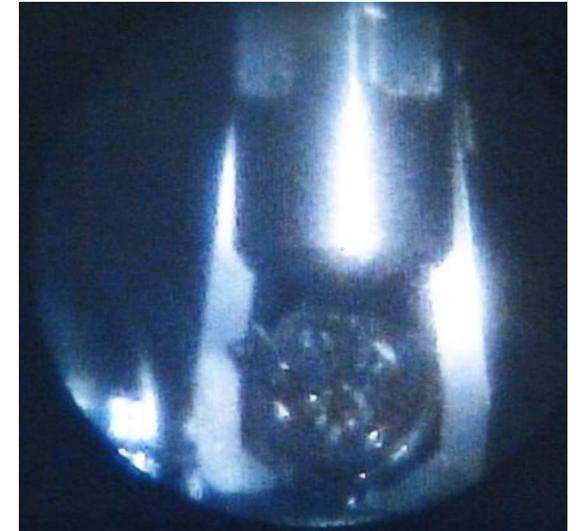
Lifting up test

MARICO-2 was lifted up with the transfer pot.  
MARICO-2 can be retrieved with the transfer pot.
