**AGEING MANAGEMENT PROGRAM OF KARTINI REACTOR
FOR SAFE OPERATION**

**2nd International Conference on Research Reactors:
Safe Management and Effective Utilization
5 – 9 November 2007, Sydney - AUSTRALIA**

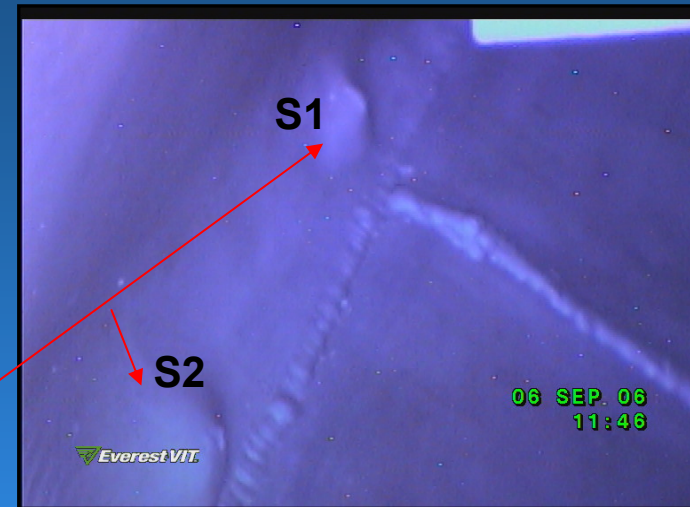
Fig. 2. Swelling features S1 & S2

- **Visual:** indicated defect in the reactor were minor and it was observed swellings profiles (S1& S2) on the bottom tank were reaching a finite size

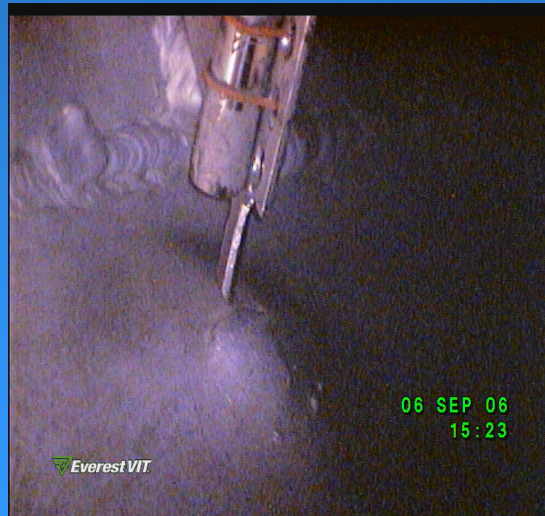
Fig. 3. Thickness measurement

- Thickness measurement of the wall and on the swelling S1 and S2 in ranged between 5.3 – 5.5 mm
- Metal thickness in areas of swelling similar to the wall thickness and to the original metal thickness

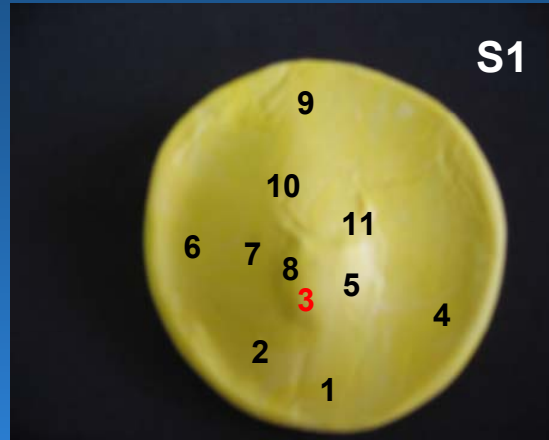
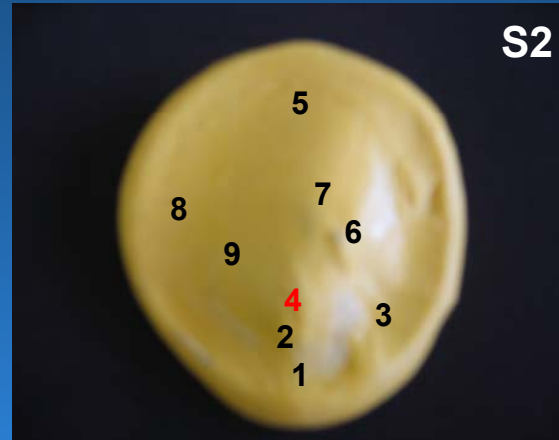
Fig.5. Positive replica of S1 and S2

- Swelling height measurement conducted on the second impression (surface of pos.replica)
- The highest of swelling profiles for S1 in 3, S2 in 4
- Graph of S1 and S2 swelling areas and height as function of time shows in Fig.7.

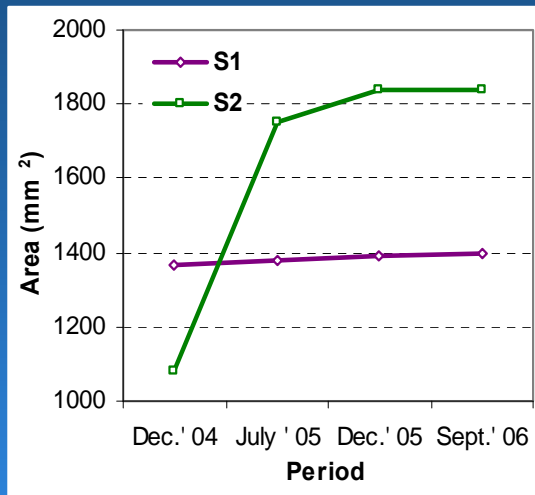
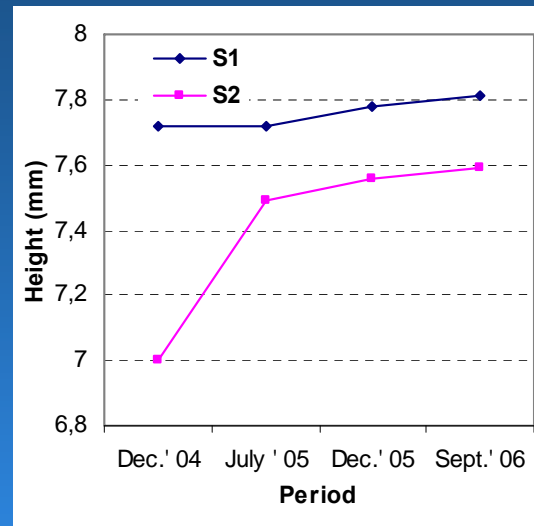
Fig.7. Graph of S1 and S2 swelling areas (a) and height (b) as function of time

- Swelling areas and height had grown slowly in size & relatively stable
- Swelling could not be accounted for by formation of corrosion product due to the low “pilling-bedworth ratio” for Al.
- Occurrence swelling was analyzed as ageing consequence
- Obvious some localized pressure is being exerted on the outside of Al tank to create swelling
- RCA of swelling will be discussed by Mr. Syarip.

- **Swelling has occurred on the bottom as an ageing consequence after 28 years, swelling has shown stopped and has reached its maximum extent on these features**
- **Inspection regime established for Kartini reactor to monitor the condition of the reactor tank & ensure that reactor is in good condition & safe for continues operation**
- **Swelling areas will be monitored every 3 months utilizing visual & 6 months utilizing replica and UT**
