THE RADIOLOGICAL INCIDENT IN HUEYPOXTLA

INTERNATIONAL ATOMIC ENERGY AGENCY VIENNA, 2022

A radiological incident occurred in Mexico in December 2013. A vehicle transporting a teletherapy unit head with a Category 1 cobalt-60 radioactive source from a medical facility in Tijuana to a disposal facility in Santa Maria Maquixco, Mexico, was stolen by a group of armed individuals. A number of individuals who came into contact with the radioactive source received doses in excess of the effective dose limit specified in Mexican regulations.

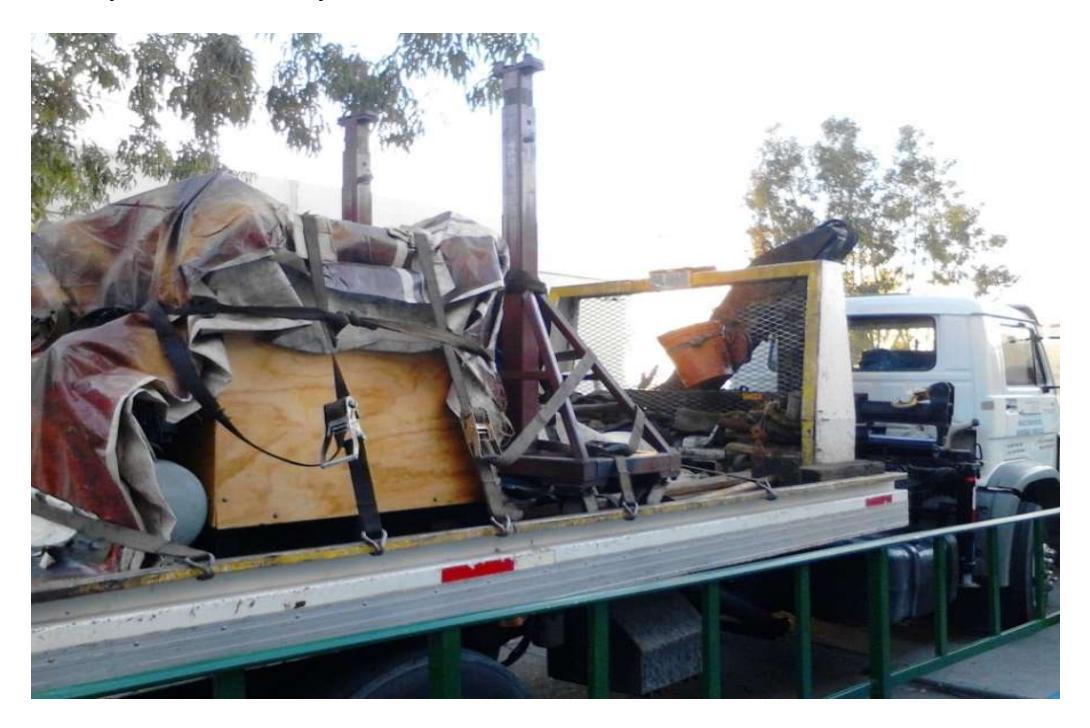
FIG. 3. Transport of the teletherapy unit head with the ⁶⁰*Co source to the waste disposal facility (picture captured prior to the incident) (courtesy of CNSNS).*

- No security was provided to the vehicle that transported the radioactive source;
- The vehicle that was used for the transport of the radioactive material was parked at gas stations where the driver and his assistant made an overnight stop, which is contrary to the provisions of the conditions indicated in the authorization issued by CNSNS for the transport of radioactive material;

- The placards were not visibly displayed on both the sides of the cargo compartment of the vehicle that was used for the transport of the radioactive source. The radiation labels were hidden by the covering blanket and the vehicle was not labelled with radiation placards which is contrary to the provisions of the conditions established in the company's authorization for the transport of radioactive material;

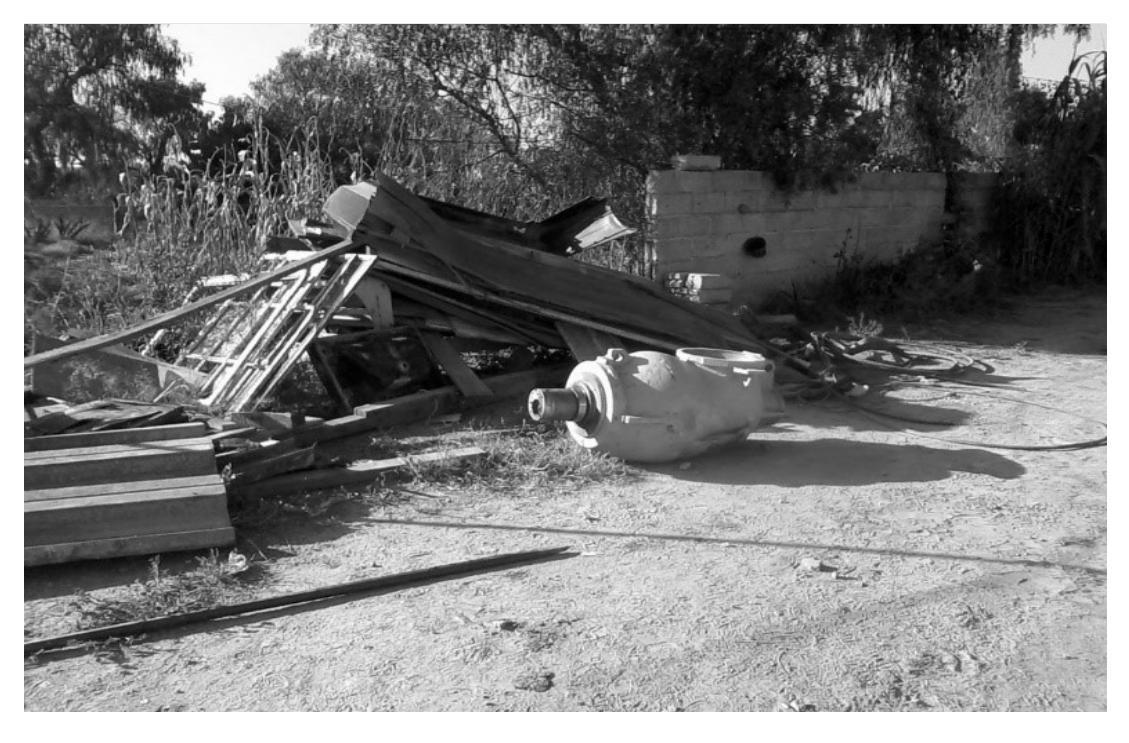
FIG. 5. The empty radioactive source shielding (courtesy of CNSNS).

On arrival at the site, the Federal Police briefed the CNSNS team about the radiation measurements they had conducted and the discovery of the empty teletherapy unit head. The Federal Police guided the CNSNS team to the areas where elevated radiation levels had been detected.

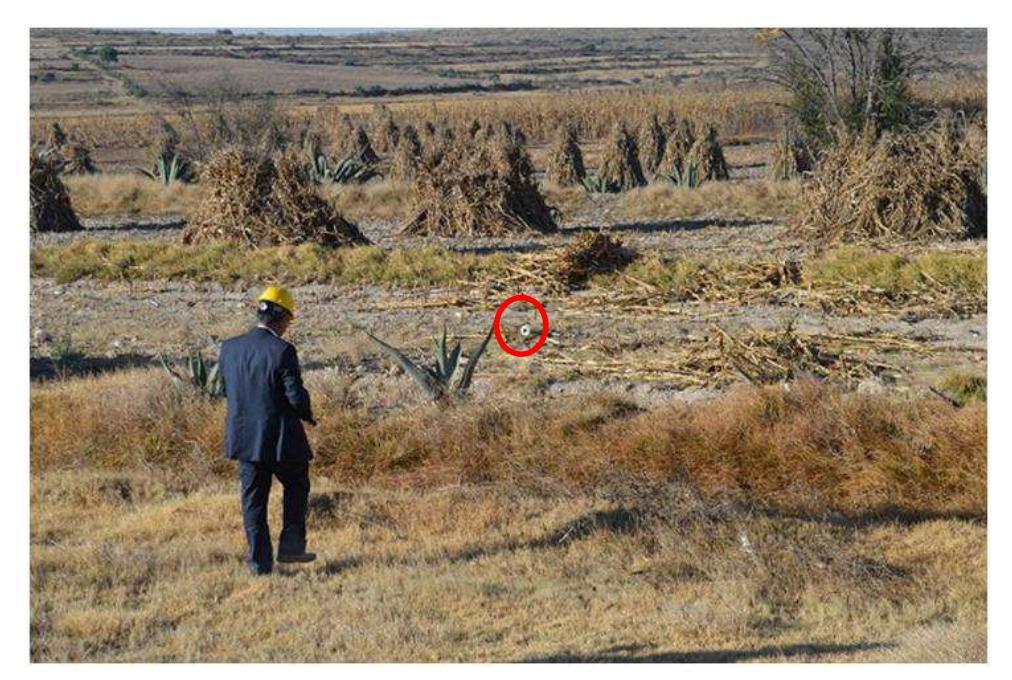
The CNLV team finished the crop removal process and uncovered the source which was hidden in the crops (Fig. 6). It was confirmed that the source was not damaged. Plans for the recovery of the source were discussed in a meeting attended by personnel from SENER, ININ, CNSNS and CNLV. The following options were discussed:

FIG. 6. Exposed radioactive source (courtesy of Federal Commission for Electricity of Mexico).

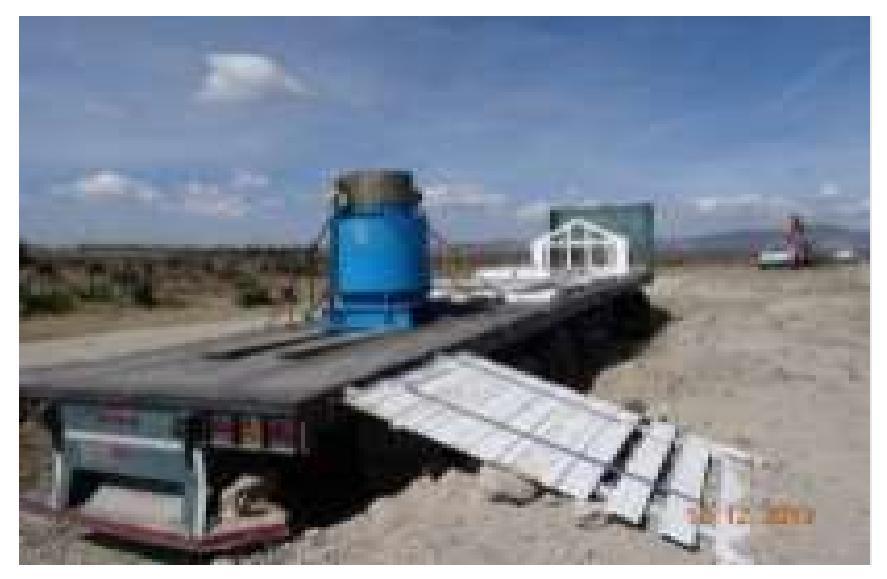
After the robot was repaired, the recovery operation continued. To contain the recovered radioactive source, the modified container was brought by ININ to the site. Images of the source were taken by the robot camera, and it was confirmed that the source was intact. Using the robot, the source recovery operation was initiated and after two attempts, the source was successfully placed in the container (Fig. 7). After placing the recovered source inside the container, the lid of the container was placed and the radiation levels on the surface of the container were measured by the CNSNS team. The radiation levels at the surface of the container were below the safe levels recommended in the IAEA safety standards [4].

FIG. 7. The container with the recovered radioactive source (courtesy of CNSNS).
