Life Extension of the Point Lepreau GS – Powering the Future

**Keith Stratton
New Brunswick - Canada**

October 27 – 30, 2009

International Conference on Opportunities
and Challenges for Water Cooled Reactors
in the 21st Century

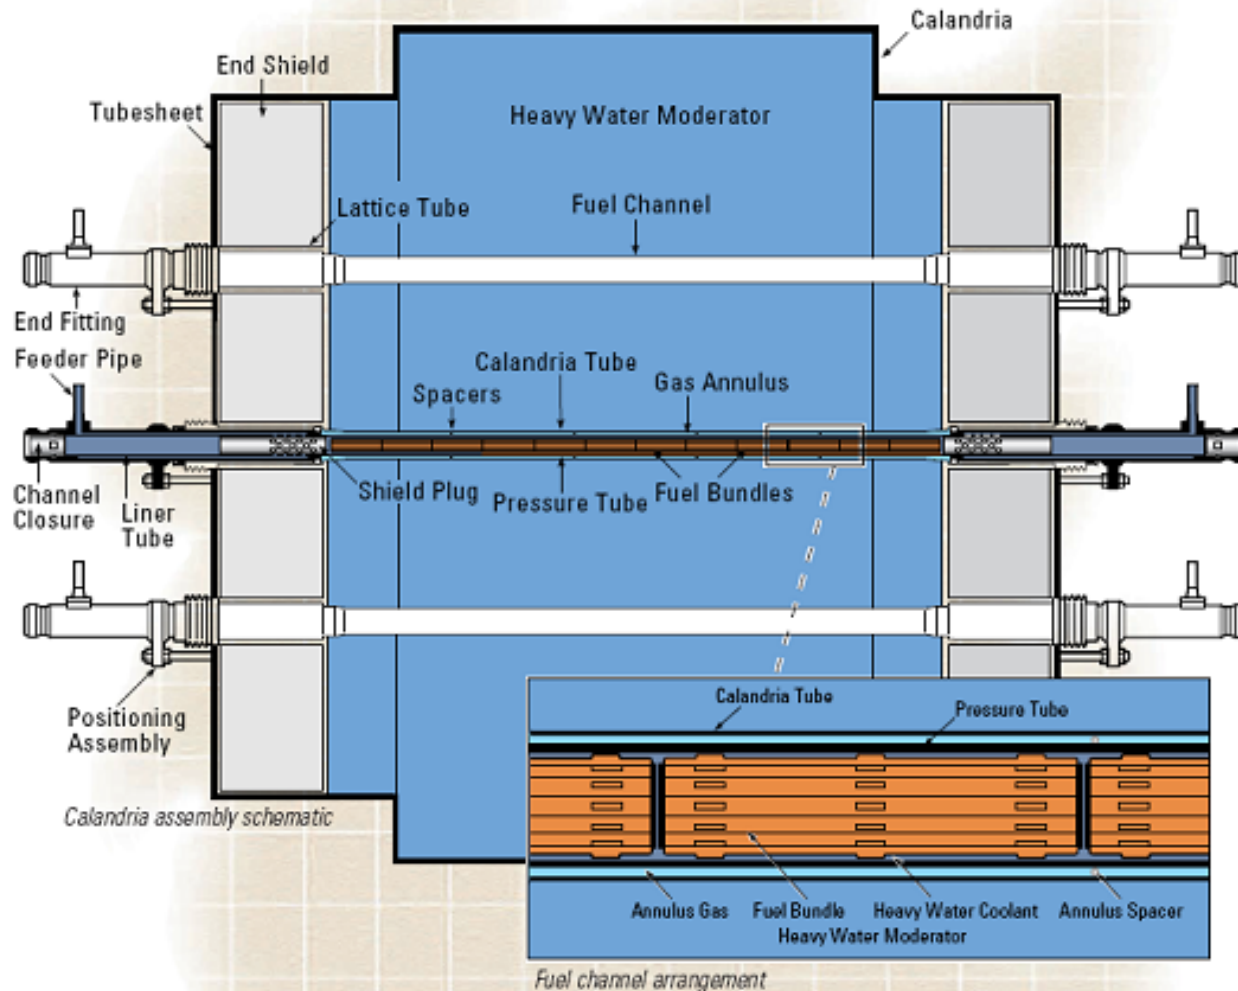
Fuel Channel Assembly

Fuel channels

- Spacer movement
 - Loose fitting spacers may move from design locations
 - Would not operate with contact between cool calandria tube and hot pressure tube – hydride solubility
 - One six-month outage (1995) and subsequent outage extensions
- Pressure tube (PT) diametral creep
 - Redistribution of coolant flow in bundle sub-channels with time
 - Reduction in margin to sheath dryout
 - Reactor derated 1998, ~1% per year (12% cumulative by 2008)

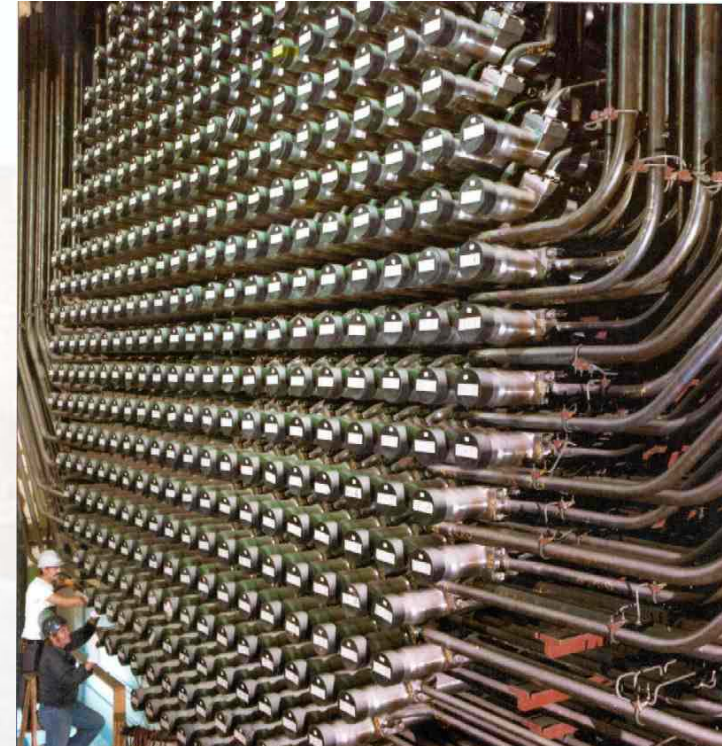
Feeders

· Cracking (outlets)

- Unplanned outages in 1997 and 2001 because of leaks at bends
- Large annual inspection campaign initiated
- Cracks discovered on the ID on bend intrados
- Cracks discovered on the OD on bend extrados
- Cracks grew from undetectable to 75% through wall in one year
- Crack location unpredictable
- Stress corrosion cracking and low temperature creep cracking
- Eighteen bends replaced because of cracking
 - › two through wall
 - › ten partial through wall
 - › six falsely identified

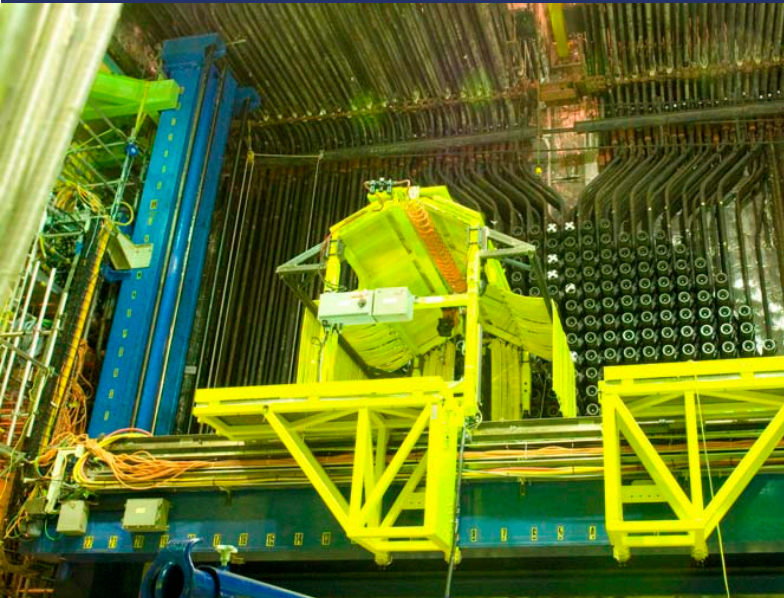
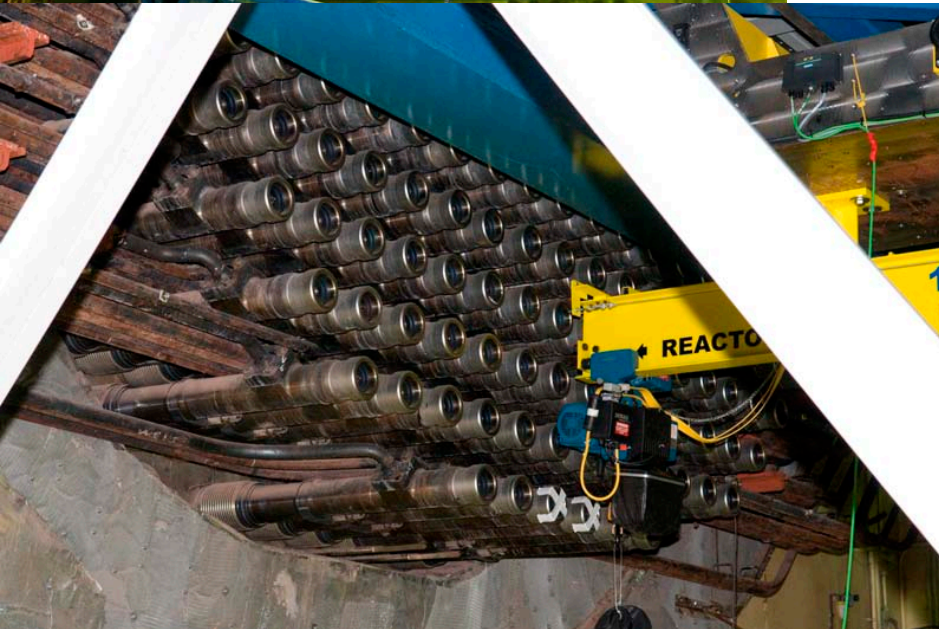
Feeders (continued)

▪ Thinning (outlets)

- Excessive thinning at bends on outlet feeders in 1995
- Large annual inspection campaign initiated
- Predictable rate and location
- Flow Accelerated Corrosion
- Affected bends in six feeders replaced in 2005
