# The Radiological Accident in Ventanilla

# THE RADIOLOGICAL ACCIDENT IN VENTANILLA

INTERNATIONAL ATOMIC ENERGY AGENCY VIENNA, 2019

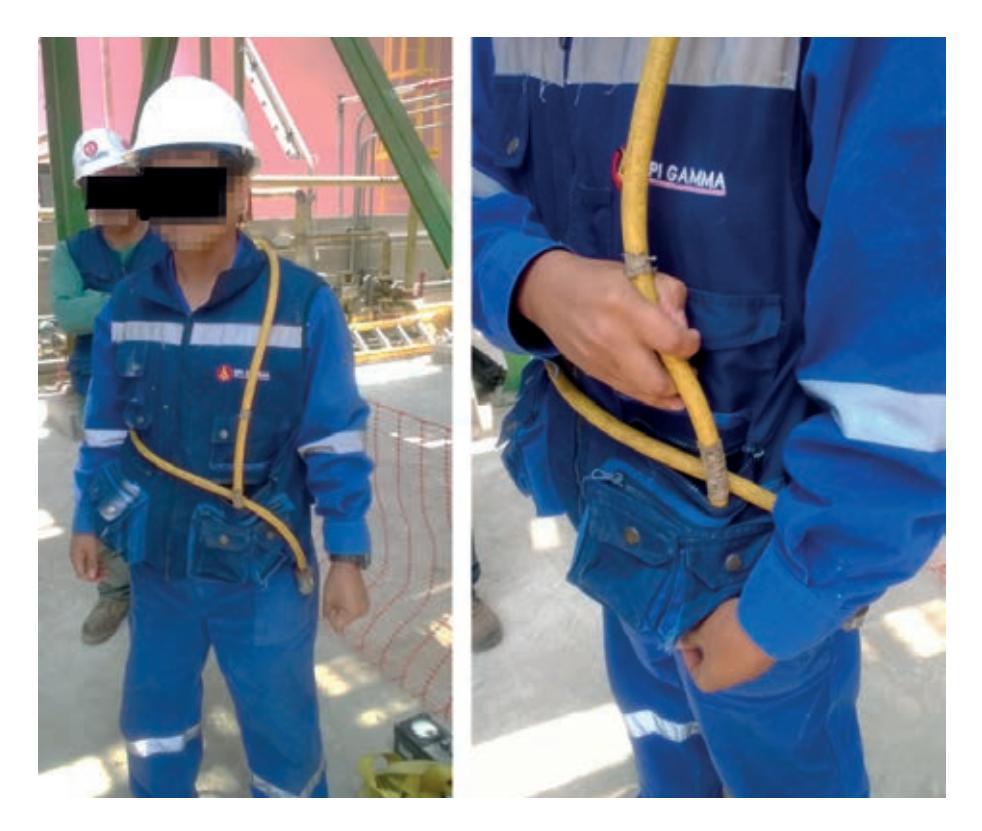
FIG. 1. Worker 1 showing the manner in which he placed the guide tube with the collimator into his vest pocket (photographs courtesy of IPEN [6]).

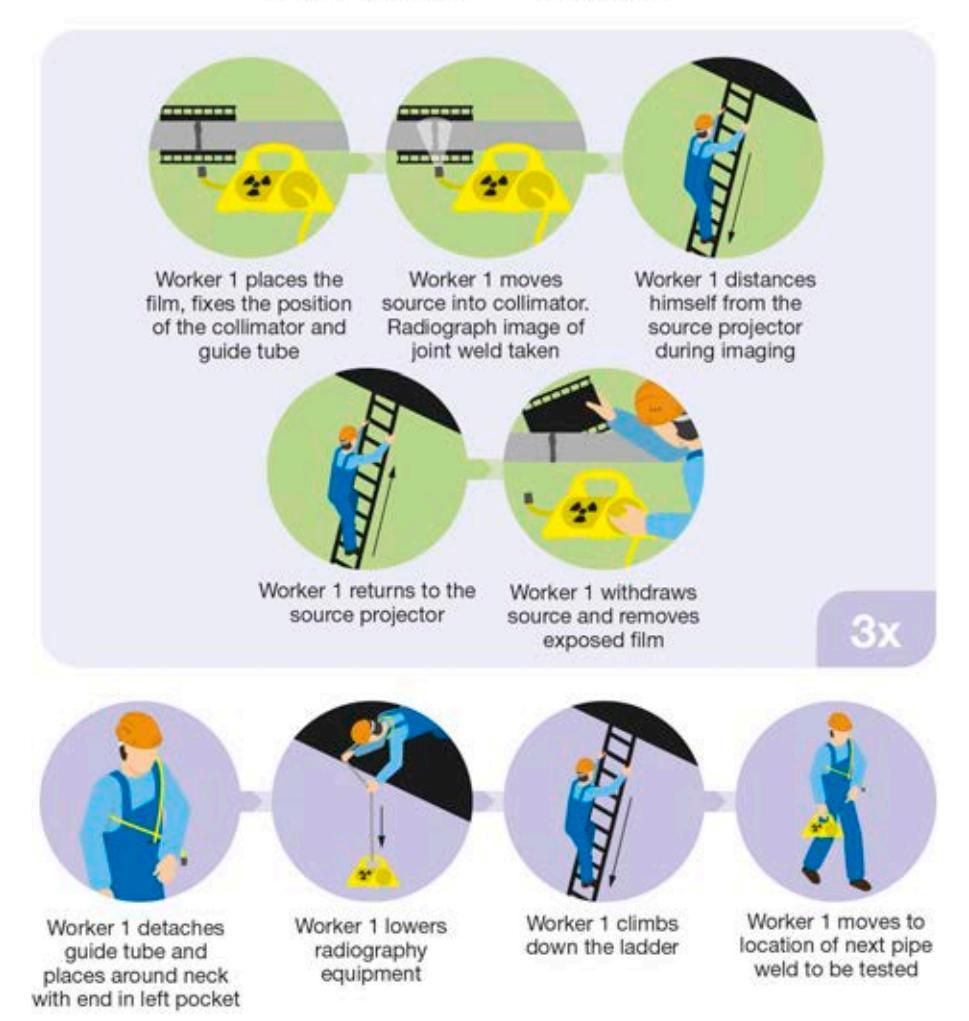
Worker 1 climbs up the ladder with guide tube around the neck with end in left pocket

Worker 1 hoists radiography equipment up to the platform

FIG. 2. Reconstruction of the accident on the premises of the chemical plant.

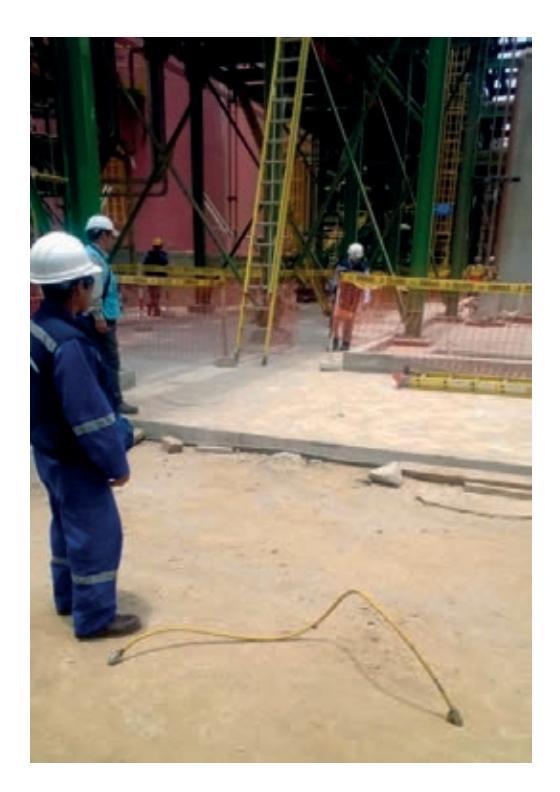
Walking from joint 24 to joint 39 at a slow pace, Worker 1 would have covered about 25 m by the time he heard the continuous sound of the audible alarm from the dosimeter. The time it took to hear the sound was approximately 35 s. At that moment, Worker 1 put the guide tube on the ground (Fig. 8), covered the collimator with the radiography equipment (Fig. 9) and moved about 30 m away.

FIG. 8. Location where Worker 1 heard the continuous alarm sound and dropped the guide tube (photograph courtesy of IPEN [6]).

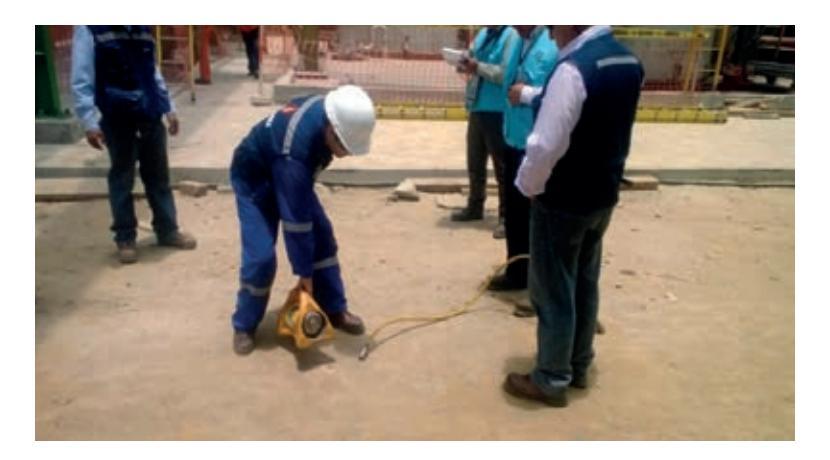
FIG. 9. The position of the yellow guide tube in this photograph shows the location where Worker 1 placed the radiography equipment over the collimator (photograph courtesy of IPEN [6]).

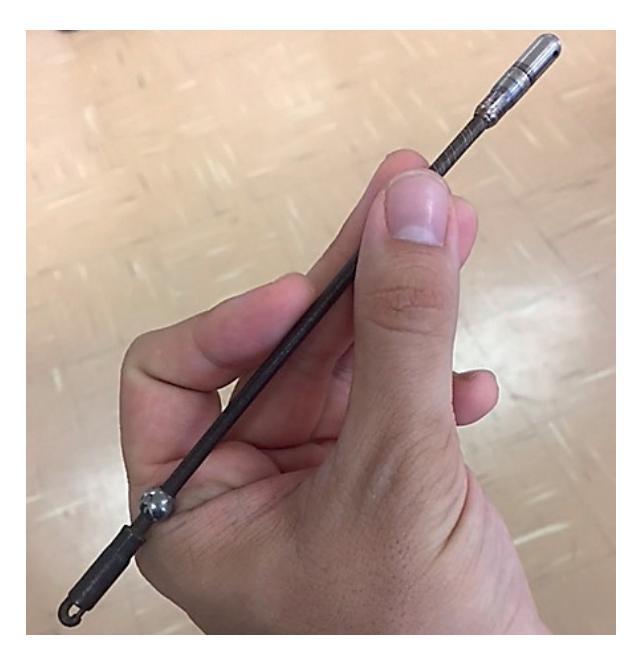
The main factor contributing to the accident was the lack of safety and radiation protection procedures: specifically, the failure of the pigtail to return to the safety position in the radiography equipment. Other factors that contributed to the accident included the inadequate use of portable radiation detector survey meters and, possibly, inadequate use of personal alarm dosimeters.

FIG. 12. A pigtail with no radioactive source.

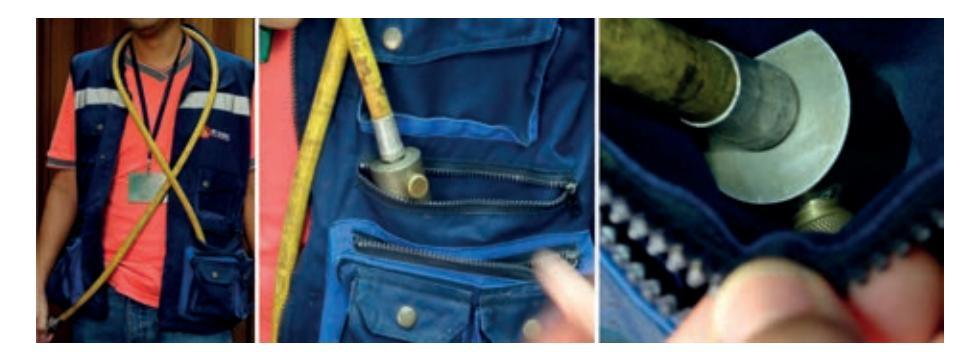
FIG. 13. Left: Worker 1 demonstrating how he carried the guide tube around his neck. Centre: Worker 1 showing how he inserted the collimator into his vest pocket. Right: Position of the collimator in his left vest pocket.

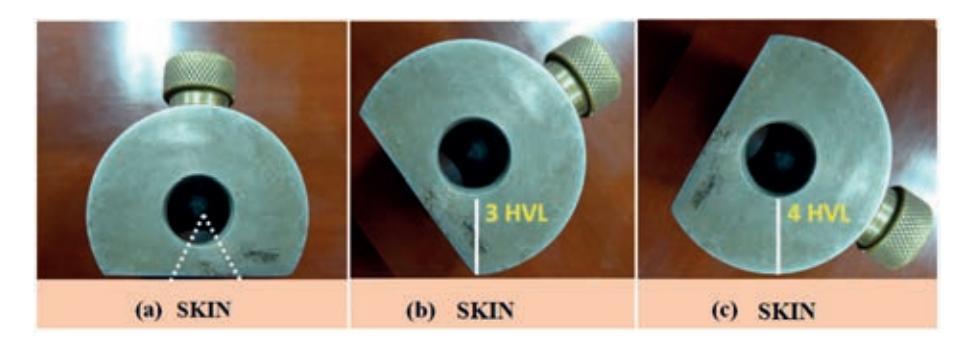
- An exposure duration of 33 min and 39 s;
- Three possible positions of the collimator in the vest pocket of Worker 1 during the performance of his work;
- Local doses estimated at 193 Gy in the position shown in Fig. 14(a), 24 Gy in the position indicated in Fig. 14(b) and 12 Gy in the position presented in Fig. 14(c) [6].

FIG. 14. Possible positions of the collimator inside Worker 1's vest pocket in relation to his skin. The beige area at the bottom of each image represents the skin of Worker 1 in the left hip/upper thigh area.

Considering the clinical signs and the different scenarios established by IPEN, the most likely situation is that the collimator beam was pointing directly at the skin of Worker 1, as shown in Fig. 14(a).

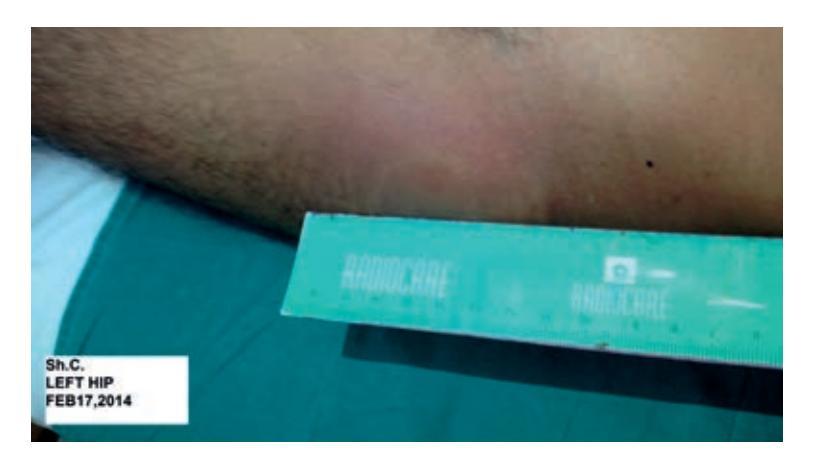
FIG. 15. Worker 1: Erythema developing on day 3 after exposure (17 February 2014) (photograph courtesy of Alberto Lachos, INEN).

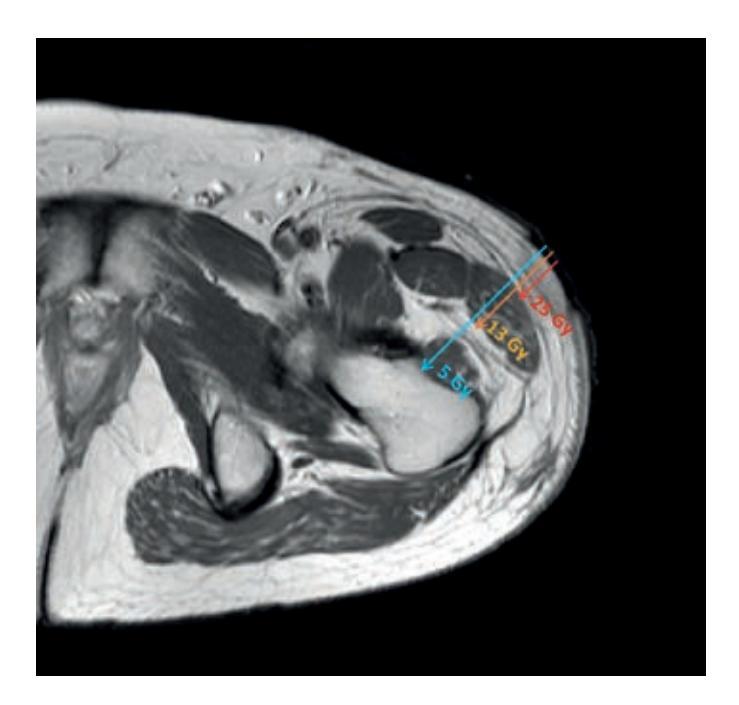
The estimated in-depth doses are given in Table 5. It can be seen that the local skin dose (at the centre of the necrosis area) is lower than that calculated by IPEN because of the different source–skin distances. The threshold dose for necrosis development (20–25 Gy) was estimated to be 2 cm in depth. The absorbed dose to the muscle next to the lesion was estimated to be between 25 Gy (entrance) and 13 Gy (posterior muscular border). The absorbed dose to the part of the femur located next to the lesion was estimated to be 5 Gy (see Fig. 19).

FIG. 19. In-depth absorbed doses reported on a magnetic resonance imaging cross-section of the thigh (3 March 2014) (image courtesy of IRSN [22]).

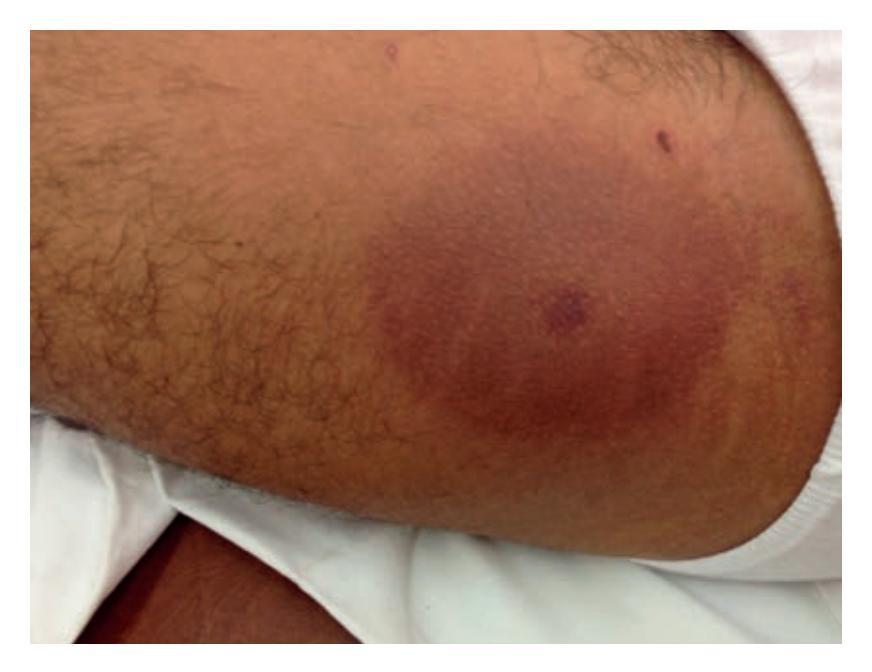
On 26 February 2014 (see Fig. 22), the lesion evolved with a slight brown pigmentation and the diameter reduced to 7.5 cm. However, the pain and the local temperature increased. On this day, an ultrasound of the lesion was performed, demonstrating oedema on the skin and subcutaneous tissues, with no evidence of necrosis [25].

FIG. 22. Evolution of the local radiation injury, 12 days after the accident (26 February 2014) (photograph courtesy of A. Lachos, INEN).

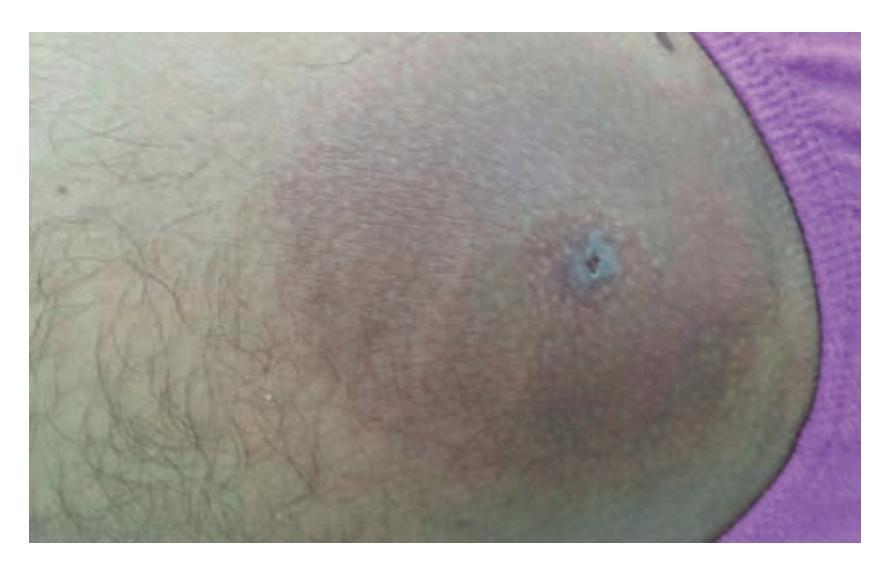
On 27 February 2014 (see Fig. 23), the lesion started to ulcerate in its centre, surrounded by oedema of 5 cm. The pain level increased, especially in the centre of the lesion [24].

FIG. 23. Evolution of the local radiation injury, 13 days after the accident (27 February 2014): Ulceration in the centre of the lesion, the point with the highest absorbed dose (photograph courtesy of A. Lachos, INEN).

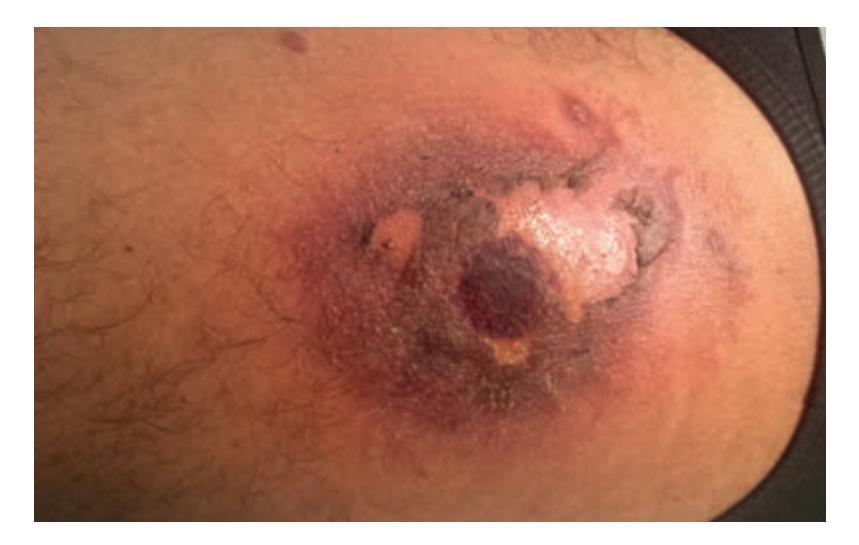
On 10 March 2014 (see Fig. 24), a necrotic area in the centre of the lesion, ulceration, oedema and erythema could be observed.

FIG. 24. Evolution of the local radiation injury, 24 days after the accident (10 March 2014): A necrotic area in the centre of the lesion, ulceration, oedema and erythema (photograph courtesy of A. Lachos, INEN).

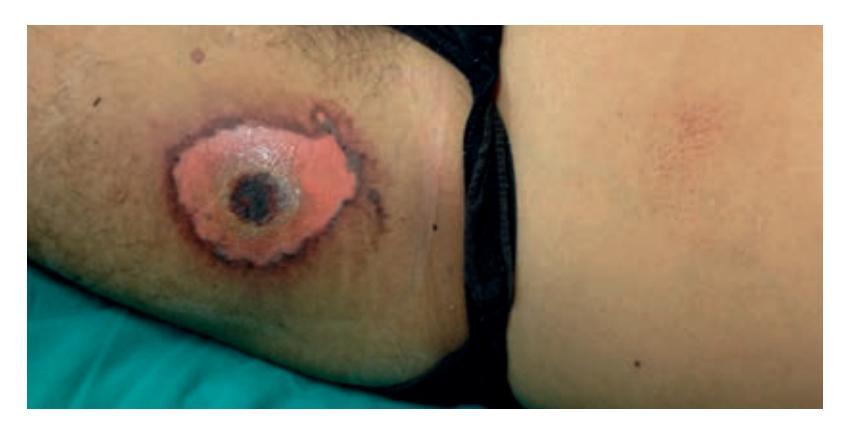
On 13 March 2014 (see Fig. 25), the lesion evolved with a central hyperpigmentation, surrounded by a yellow coloured halo. Significant oedema and signs of necrosis in the central area of the lesion could be observed. A new ultrasound was performed in the left hip/upper thigh area, showing significant oedema on the skin and muscular fascia, associated with mild local muscular oedema.

FIG. 25. Evolution of the local radiation injury, 27 days after the accident (13 March 2014): A necrotic area in the centre of the lesion, ulceration, oedema and erythema can be observed (photograph courtesy of A. Lachos, INEN).

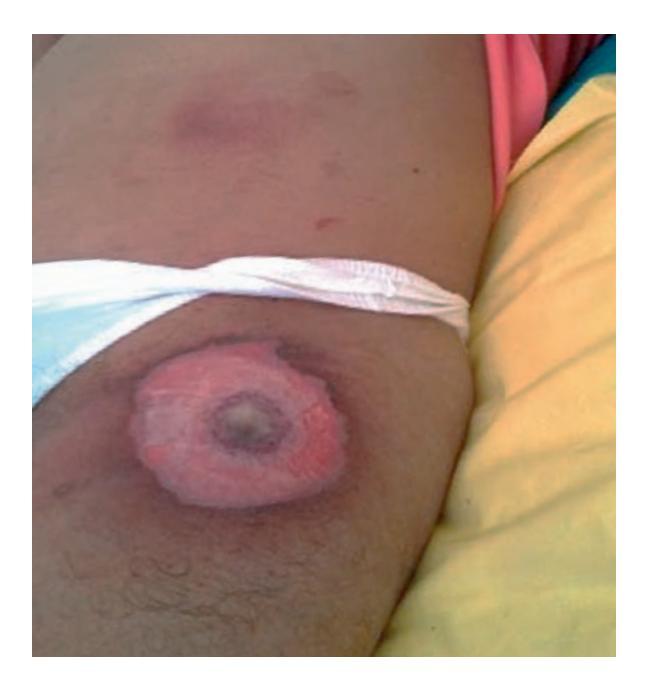
On 19 March 2014 (see Fig. 26), the necrotic area in the centre of the lesion, ulceration, oedema and erythema persisted. The erythema in the abdominal area can also be observed in Figs 26–29.

FIG. 26. Evolution of the local radiation injury, 33 days after the accident (19 March 2014) (photograph courtesy of A. Lachos, INEN).

and local steroids injected in the lesion. The medical staff from IPEN suggested considering surgery and cellular therapy.

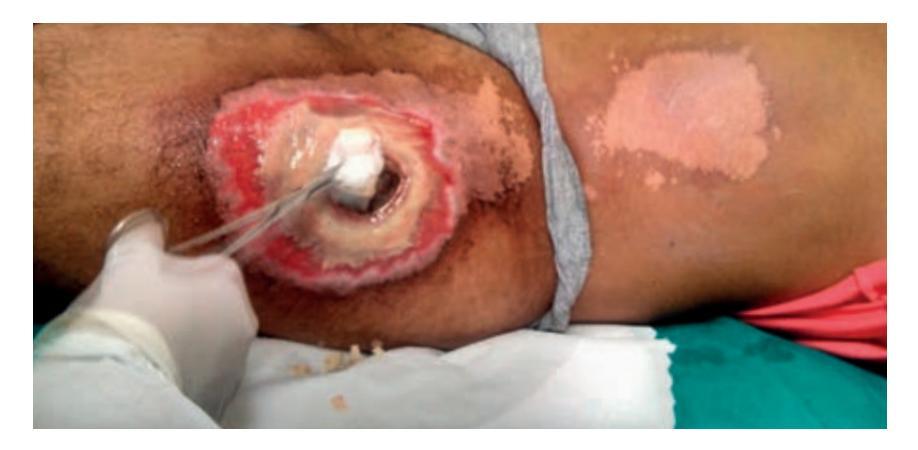
On 7 April 2014 (see Fig. 27), the necrotic area of ulceration of the lesion kept progressing, increasing in size [25]. Local management of the wounds was performed concurrently with oral medication for pain (opioids). The patient was treated as an outpatient.

In Figs 27 and 28, the evolution of the LRI after more than 50 days can be observed, showing a large ulceration that comprised approximately one third of the upper left thigh and the anatomical projection of the left hip, with necrotic tissue in the centre of the lesion. Figure 28 shows how the hypopigmentation and dyschromia of the skin in the left abdominal flank changed in the three days between the two photographs.

FIG. 27. Evolution of the local radiation injury, 52 days after the accident (7 April 2014), showing a local procedure for the cleaning of the wound. The evolution of the desquamated lesion in the abdominal area can also be observed (photograph courtesy of A. Lachos, INEN).

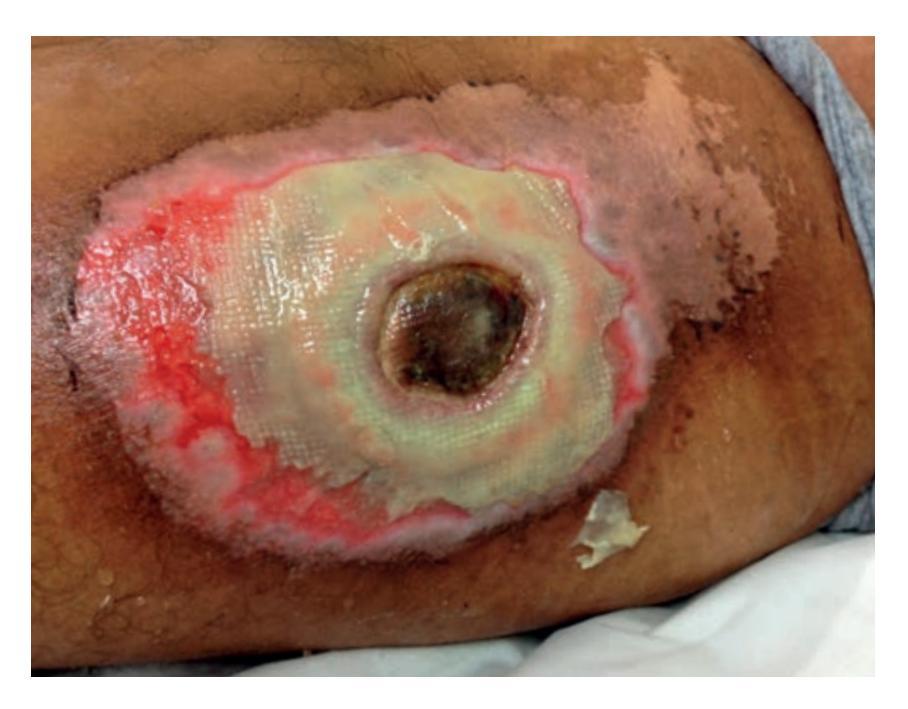
FIG. 28. Evolution of the local radiation injury, 55 days after the accident (10 April 2014): A big ulcer with a necrotic area in the centre of the lesion, hyperaemia and moist desquamation. The changes in pigmentation of the skin can be observed on the thigh and in the abdominal area (hypopigmentation/hyperpigmentation) (photograph courtesy of G. Mendoza, IPEN).

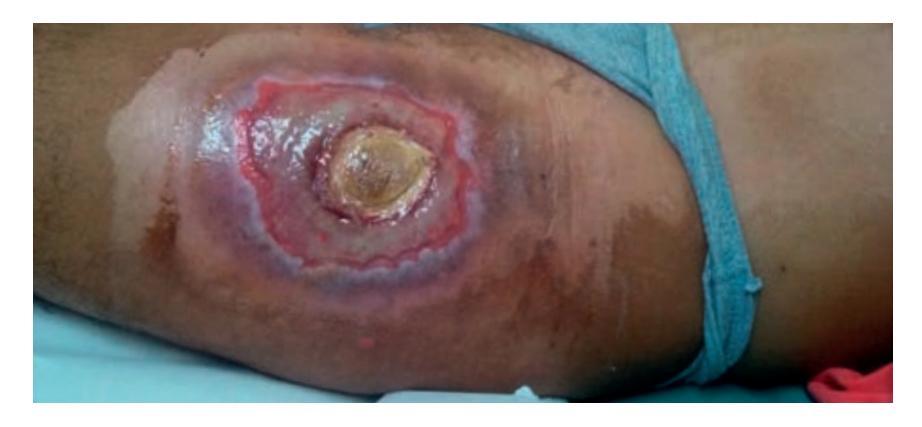
The further evolution of the LRI is shown in Figs 29 and 30. A marked inflammation process, central necrosis and ulcerative process of the lesion, surrounded by hypopigmentation of the skin, can be observed. Seventy days after the accident, the inflammation measured about 14 cm in diameter, and the central necrosis had a diameter of approximately 5 cm (see Fig. 30).

FIG. 29. Evolution of the local radiation injury, 66 days after the accident (21 April 2014) (photograph courtesy of G. Mendoza, IPEN).

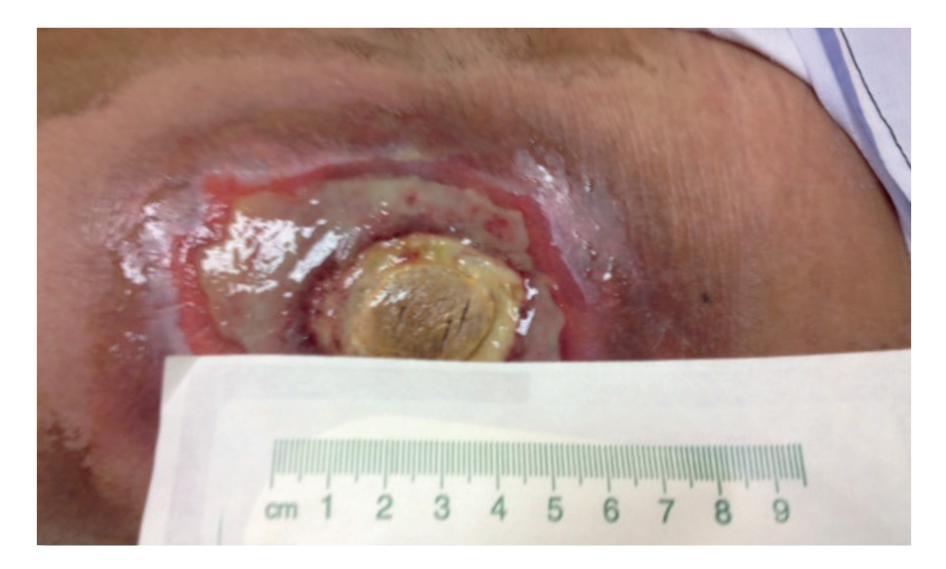
FIG. 30. Evolution of the local radiation injury, 70 days after the accident (25 April 2014) (photograph courtesy of A. Lachos, INEN).

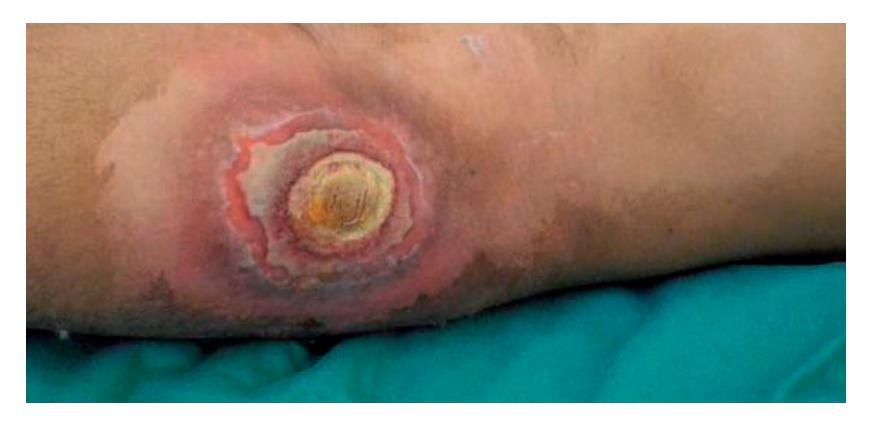
On 30 April 2014, 76 days after exposure, the size of the lesion was 10 cm in diameter, with a central area of necrosis 5 cm in diameter (see Fig. 33). The function of the left hip joint was preserved without pain during passive mobilization. Active mobilization increased pain. The patient presented difficulties standing up and walking and adopted an antialgic position.

Figure 33 shows the clinical status of the LRI on the first day of the IAEA Assistance Mission to Peru. The most recent MRI available was one month old (Fig. 34). When the evolution of the LRI is compared with the condition shown on the MRI, it can be observed that the ulcer affected mainly the adipose tissues and reached the fascia muscularis with no involvement of muscular tissues. For an adequate evaluation, a new MRI was requested in order to be able to compare the evolution since the previous images had been taken.

FIG. 33. Worker 1, 76 days after exposure; lesion in the left upper thigh and inguinal area (30 April 2014).

The Assistance Mission team observed that Worker 1 had developed a severe and painful LRI. In view of the severity of the lesion (extensive radionecrosis), the experts recommended a surgical procedure combined with autologous cell therapy as the only reliable approach [14]. A blood sample from the patient was obtained for a second biological dosimetry, which was performed by the IRSN in France [17].

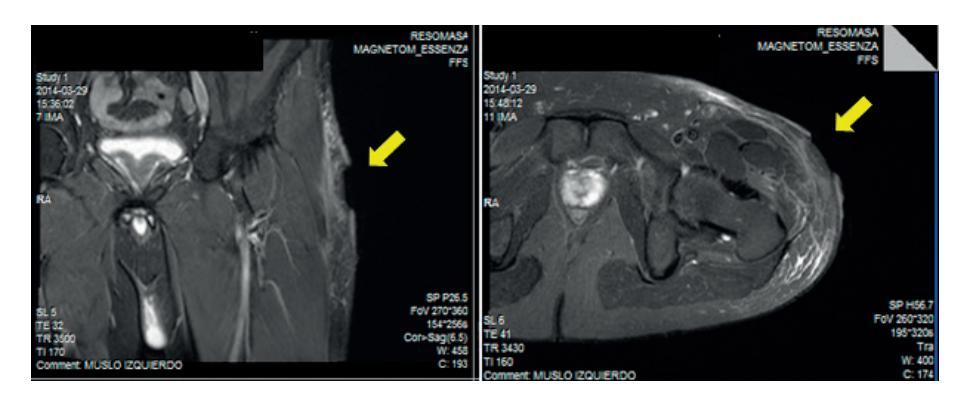
FIG. 34. Second magnetic resonance imaging of Worker 1 (29 March 2014). Yellow arrows show the lesion; the muscular plane is respected (images courtesy of INEN).

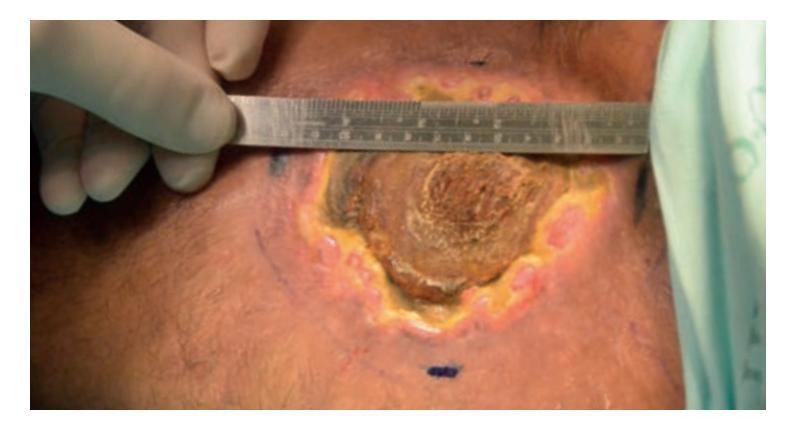
FIG. 39. The local radiation injury of Worker 1 before surgery measuring 14 cm  $\times$  9 cm (7 August 2014). A central necrotic area and a hyperaemic area of 1.5 cm around the lesion can be observed (photograph courtesy of HNMD).

On 7 August 2014, preparations for the surgery based on the clinical observation and the dose assessment were carried out (Fig. 39). The surgery was successfully performed on the same day, involving full resection of the

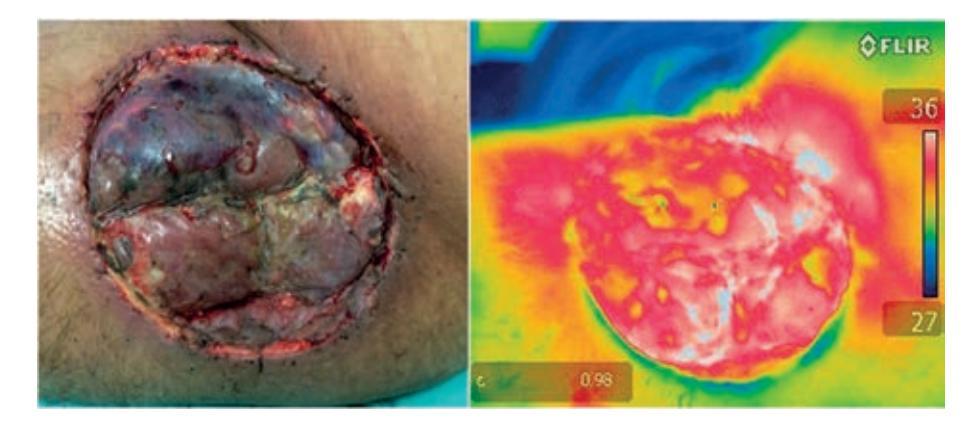
FIG. 43. LRI after the first surgery and respective thermography image. When compared with Figs 35 and 36, necrosis is not observable after the first surgery (photograph and image courtesy of HNMD).
