## Decommissioning and Remediation after a Nuclear Accident, 3 Case Studies

# **Sellafield Ltd and INES**

# Caesium Extraction Plant Event INES Level 3 Event

Pile One Chimney INES Level 5 Event

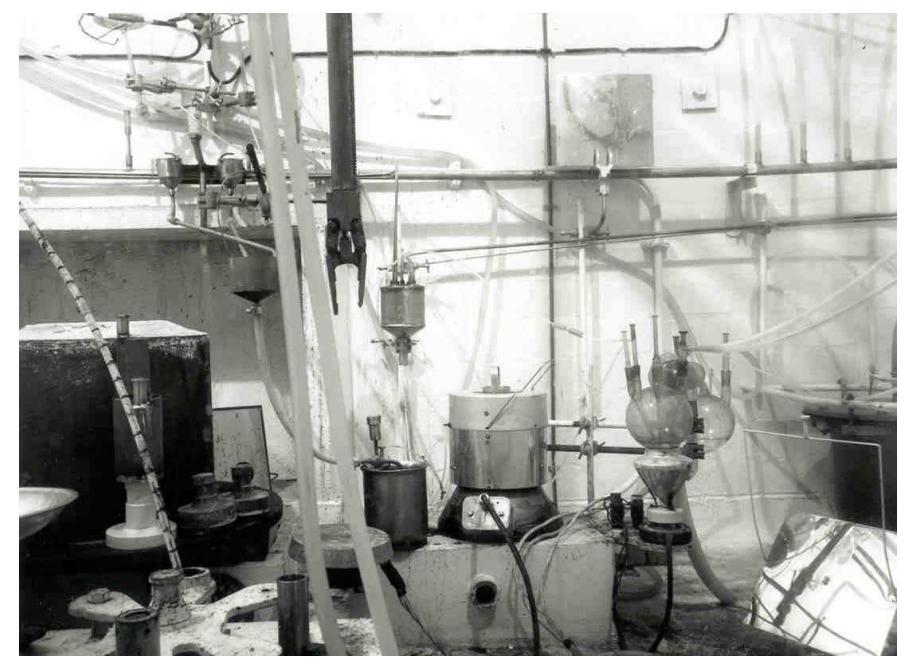
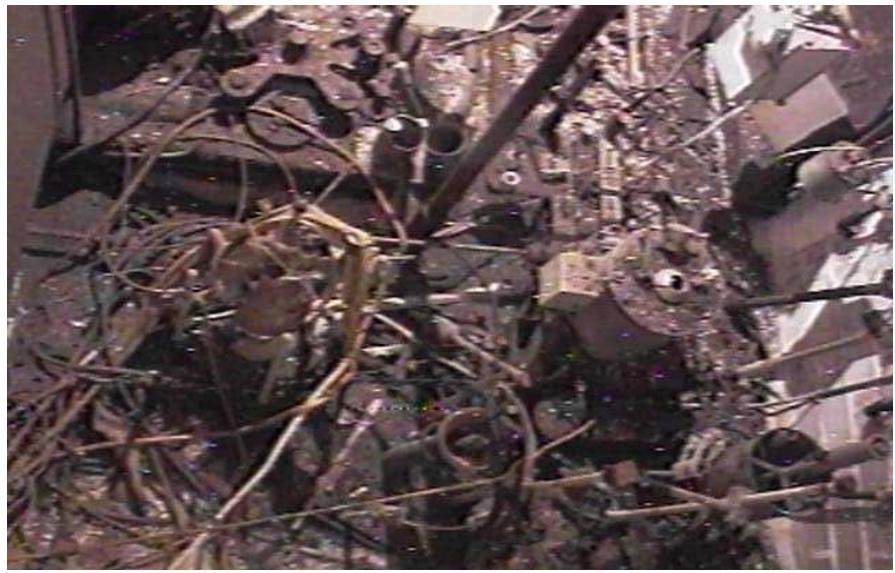
### **Accident in Cell 3**

• Cell 3 contained furnaces used to concentrate the caesium source and encapsulate into a platinum container.

- An in cell explosion resulted in significant levels of Caesium and other debris being released to the cell area.
- Other 'non standard' wastes were also created mercury contaminated materials etc.

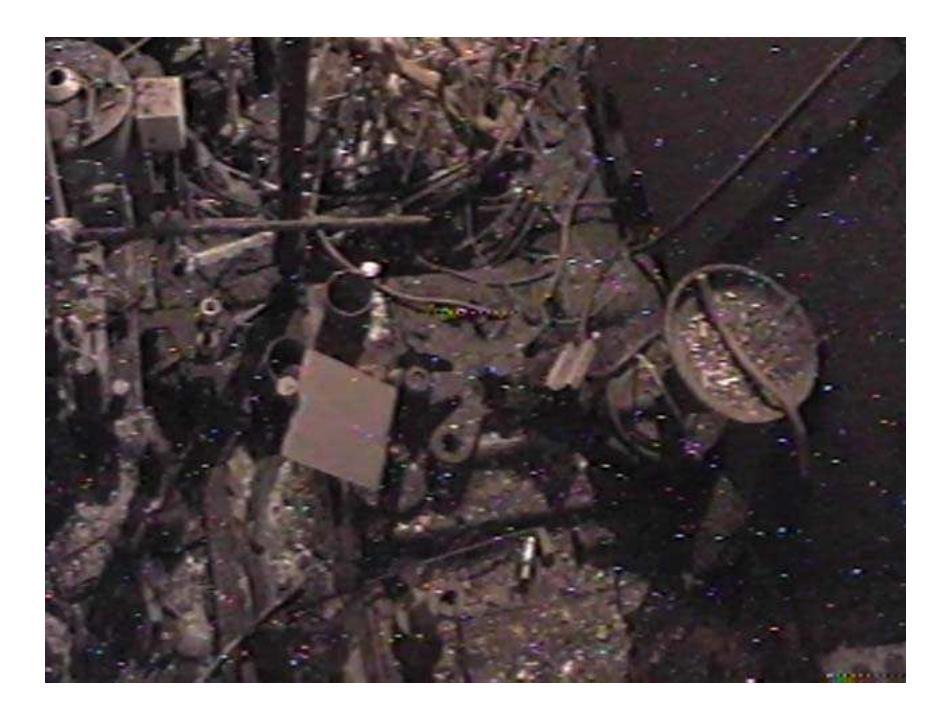
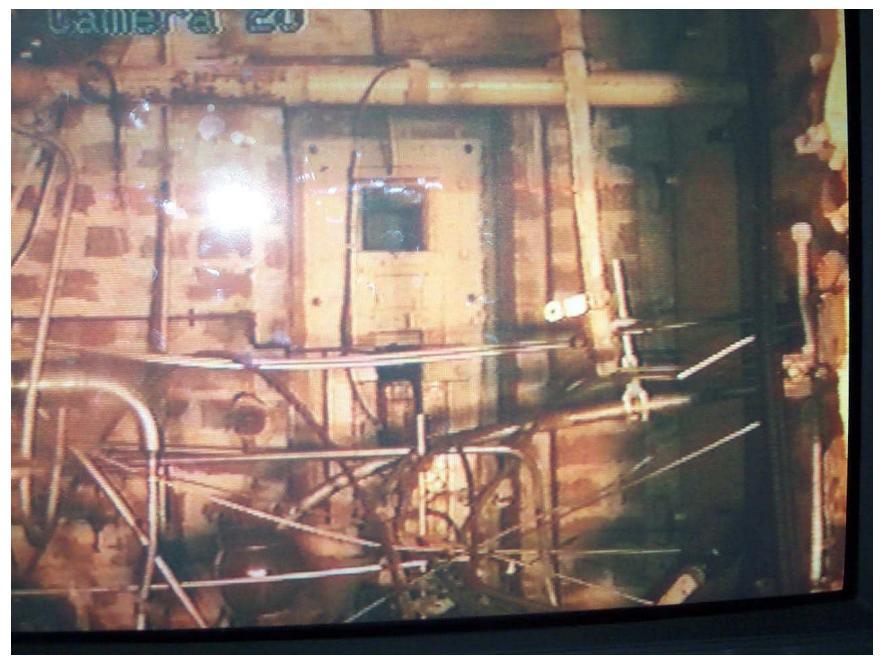
#### **Accident in Cell 3**

- High Radiation Levels
  - LEVELS OF UP TO 7 Sv/Hr Gamma were present within the cells and up to 100mSv/hr in the void areas surrounding the cells.
  - Man entry was only possible for very limited periods of time and only within certain void areas.
- High levels of loose contamination
- Poor building condition
- Poor building ventilation

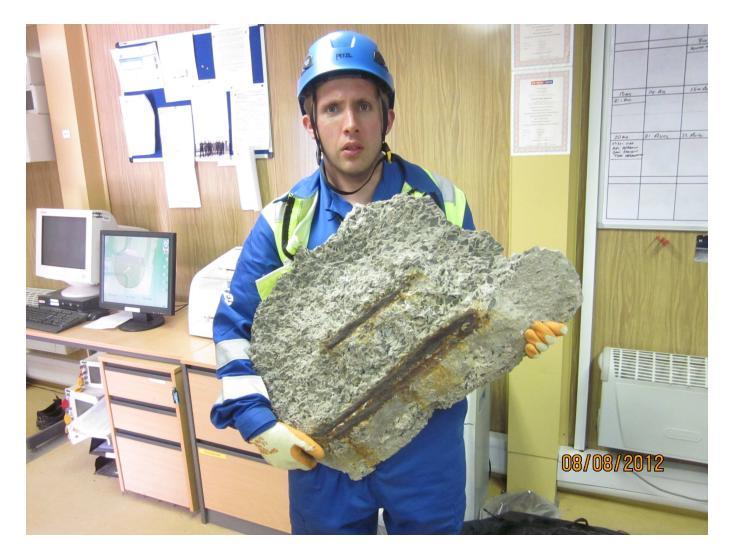
### **Physical Characteristics**

- The Filter Gallery & Diffuser section do not meet modern design seismic event criteria (0.125g)
- Deteriorating condition of the chimney with spalling of concrete leading to safety concerns and increased asset care costs
- Structures in support of the chimney are deteriorating rapidly (RMD, head gear platform etc)

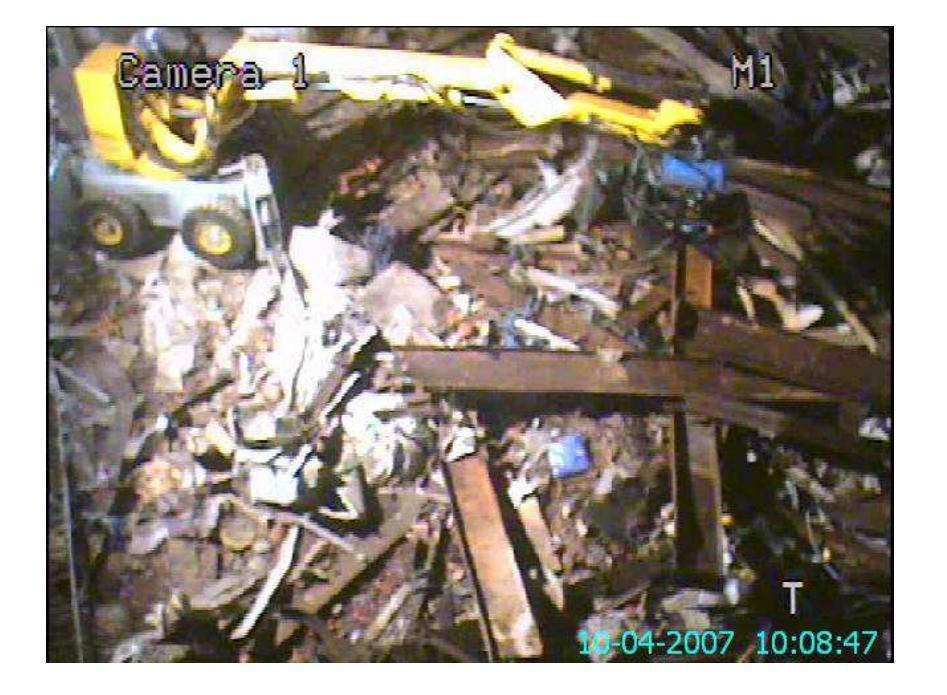
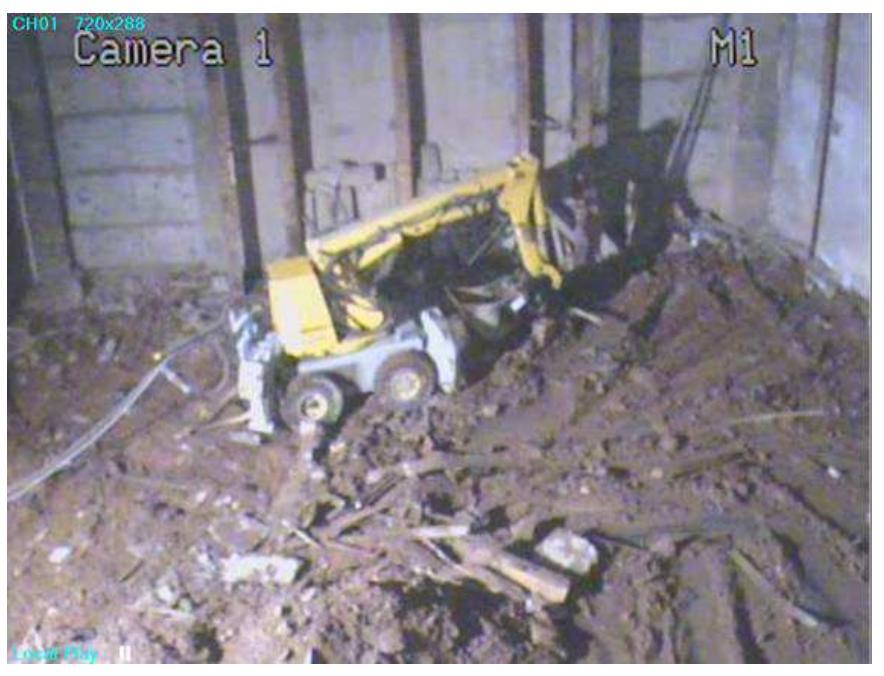
### **Inside the Chimney - Bottom**

- Restart of decommissioning 2007
  - 78 tonnes steelwork, rubble, lead and aluminium within chimney base
  - Remote retrieval of debris required
