IAEA Nuclear Energy Series

No. NP-T-3.5

Ageing Management of Concrete Structures in Nuclear Power Plants

International Atomic Energy Agency

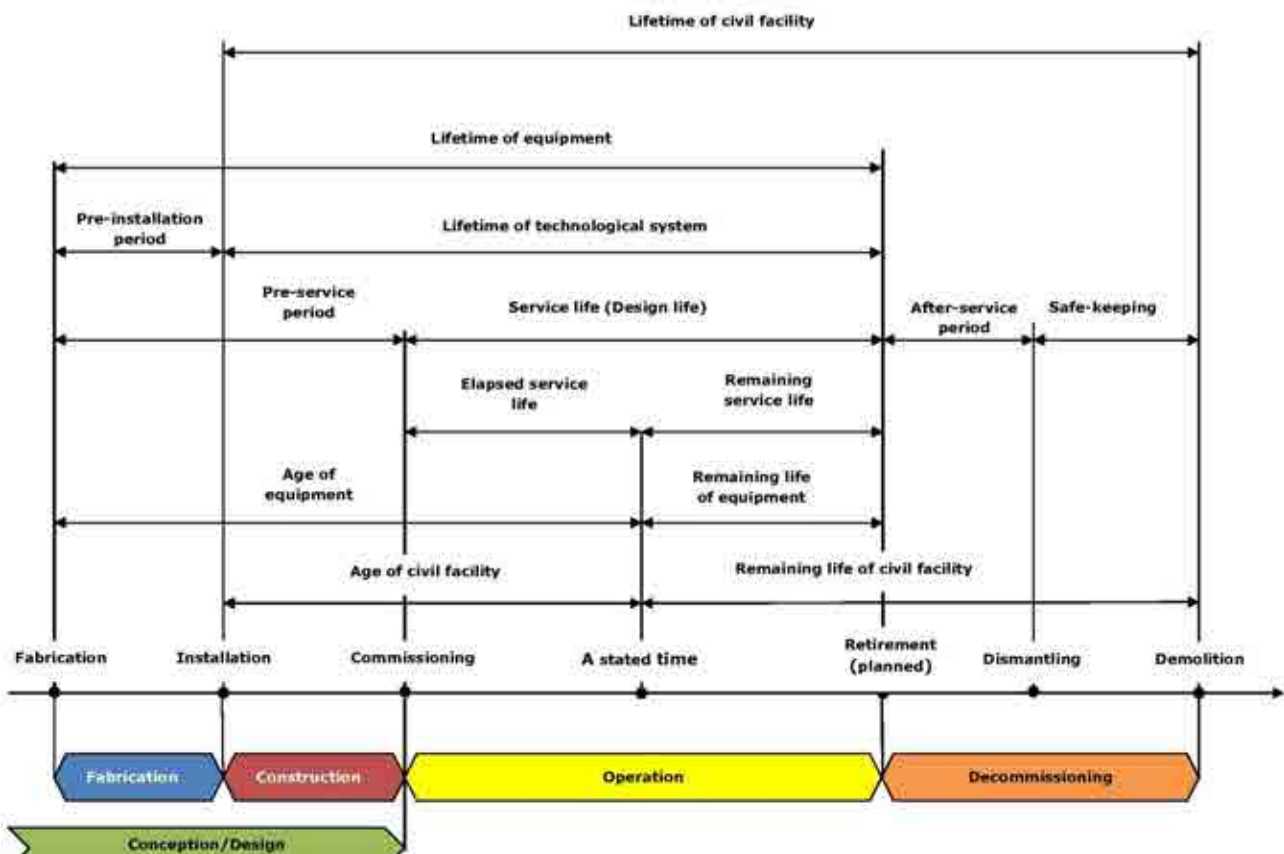
FIG. 2. Visual representation of the terms associated with the lifetime of structures, systems and components [4].

Figure 2 shows the relationships among the terms used to describe the lifetime of structures, systems and components. This publication focuses on the service life of SSCs.

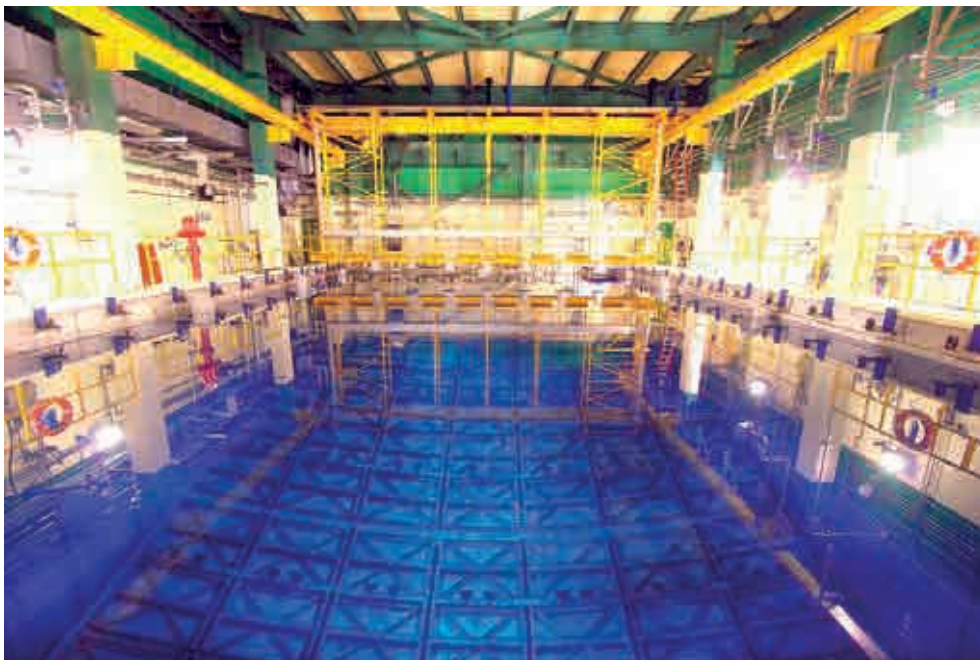
FIG. 7. CANDU 6 SFP.

SFPs for Canadian natural deuterium uranium (CANDU) PHWRs (see Fig. 7) have a variety of pool designs and storage capacities. Single unit stations are usually designed to have a series of interconnected pools with one main pool for spent fuel storage. Multiunit stations usually have primary and secondary storage pools with additional dry storage cask facilities. The water filled, reinforced concrete pools are built in ground or out of ground and are fitted with fibreglass reinforced non-metallic or stainless steel liners.

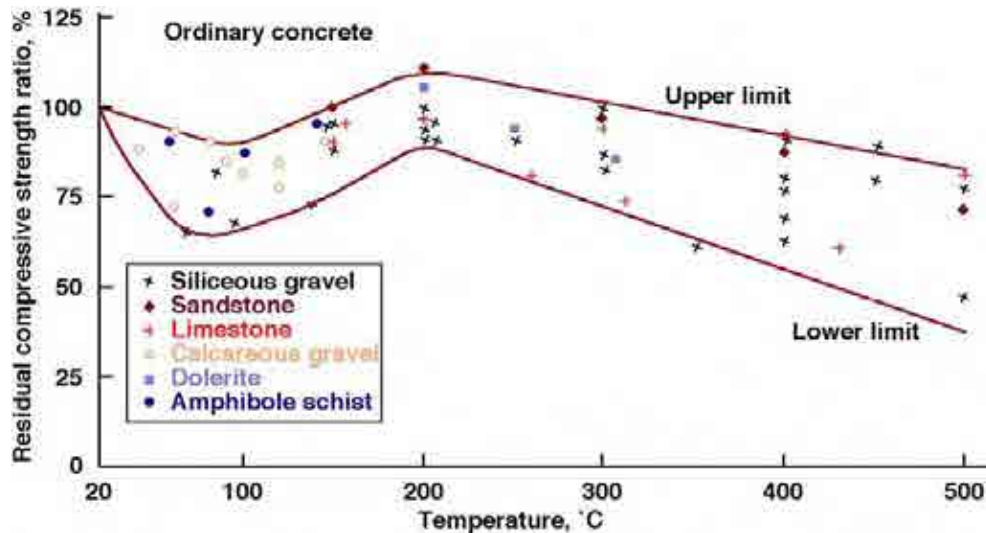
FIG. 29. Effect of temperature on residual compressive strength: unsealed specimens [100].

Thermal cycling, even at relatively low temperatures (i.e. 65°C), can negatively impact concrete mechanical properties (i.e. compressive, tensile and bond strengths and modulus of elasticity are reduced) [106]. Daily thermal cycling due to ambient environmental temperature changes is accounted for in designs (e.g. by adding rebar concrete). At higher temperatures (200–300°C), the first thermal cycle causes the largest percentage of damage,

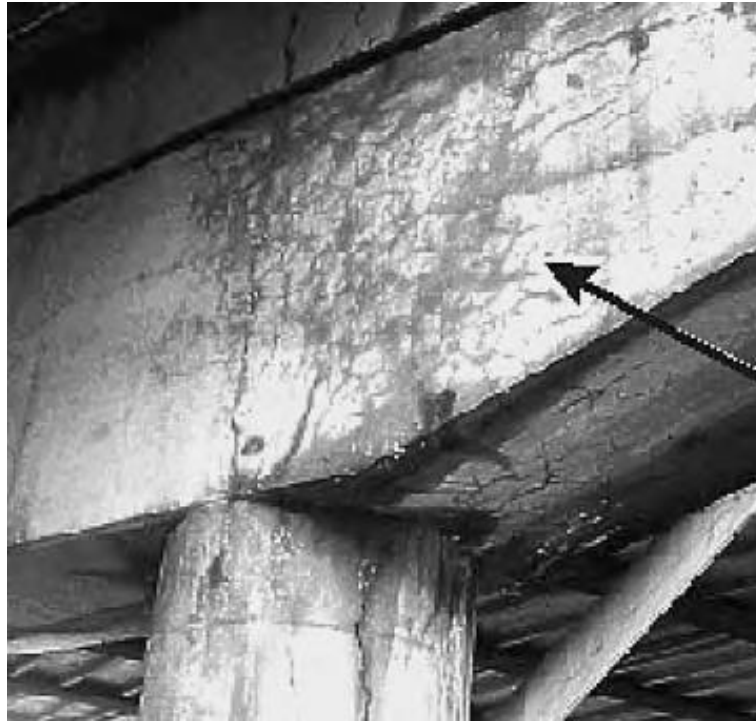
FIG. 35. Cracking damage in a concrete structure due to DEF [131].

Neither the mechanisms involved in DEF, nor their potential consequences relative to concrete durability are completely understood. The DEF process leads to degradation of mechanical properties such as compressive strength, and can promote increased permeability. Figure 35 shows cracking damage due to DEF.

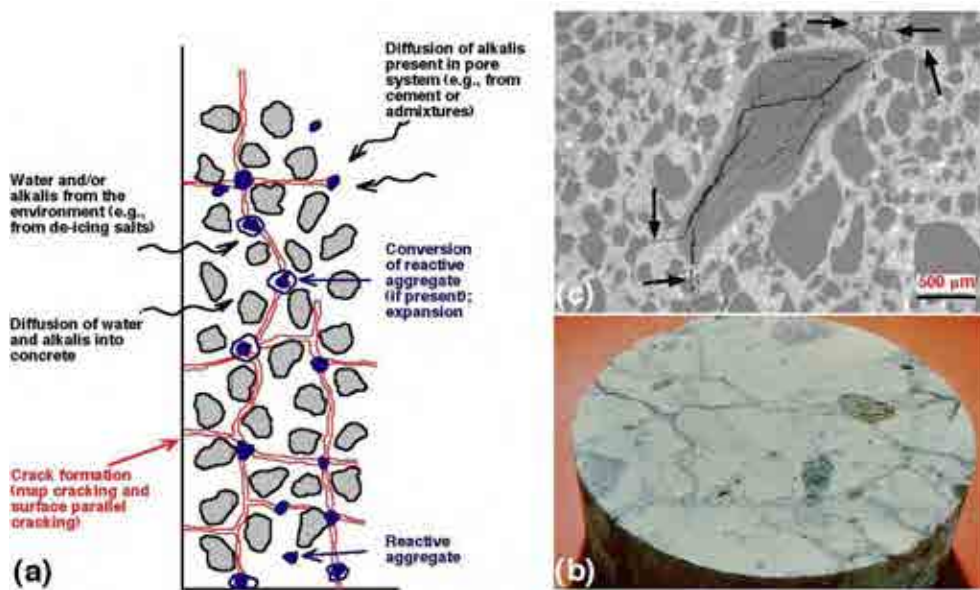
FIG. 37. Concrete cracking due to ASR: (a) mechanism [87]; (b) resulting gel that causes expansion and cracking [98]; (c) polished section of concrete showing chert particle with extensive internal cracks extending from aggregate as noted by arrows [136].

ASRs begin with extremely fine cracks, and thus may go unrecognized for years. If the concrete member is unrestrained, damage becomes visible as small surface cracks exhibiting an irregular pattern (or map

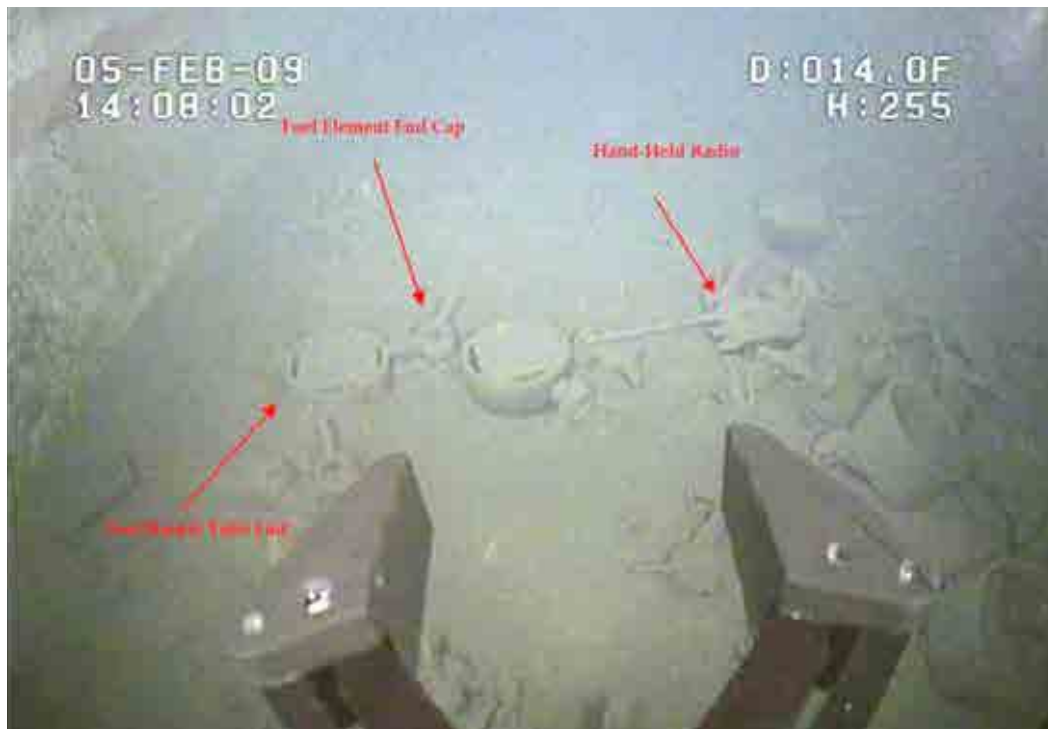
FIG. 60. Remotely operated vehicle photograph of debris in spent fuel pool during decommissioning work (courtesy of Atlantia Marine).

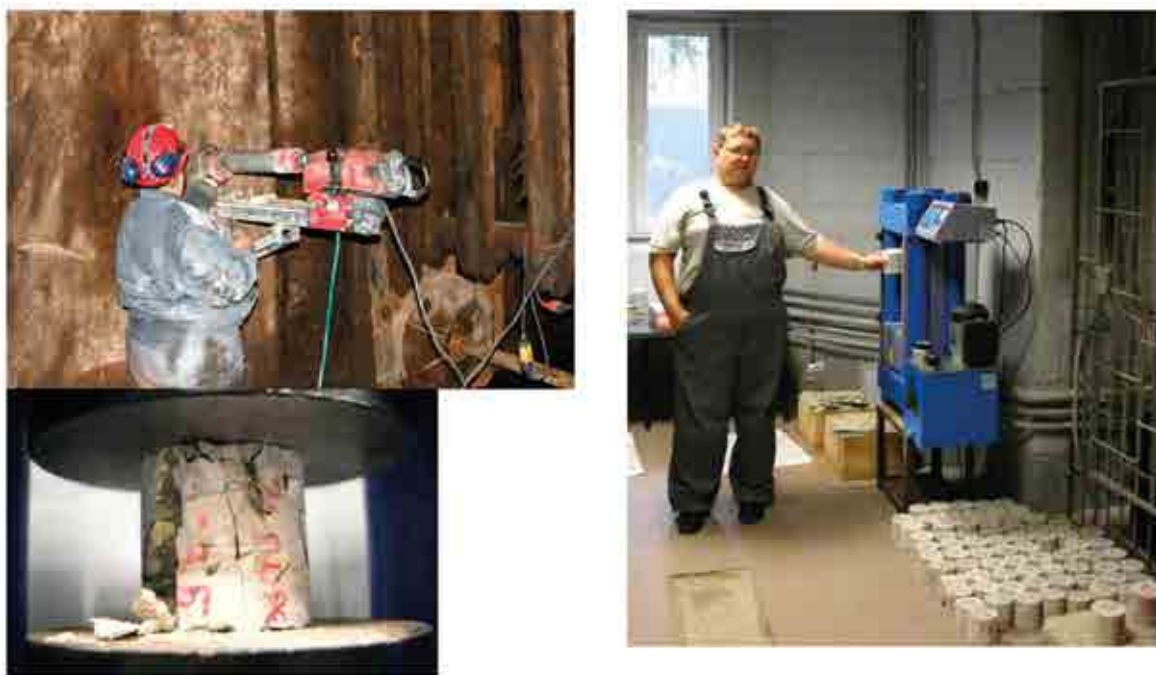
FIG. 86. Obtaining and compression testing a concrete core sample [391].

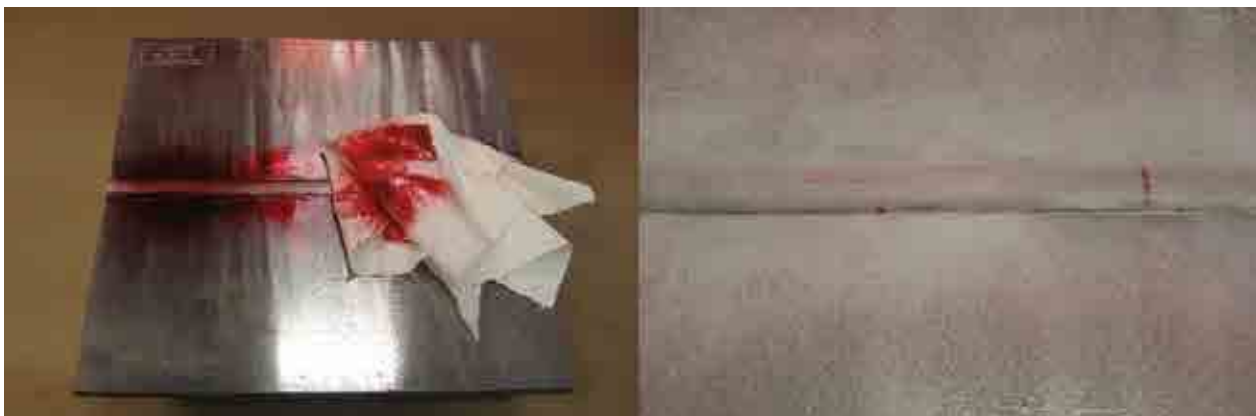
FIG. 114. Flaw revealed by liquid penetrant testing [450].

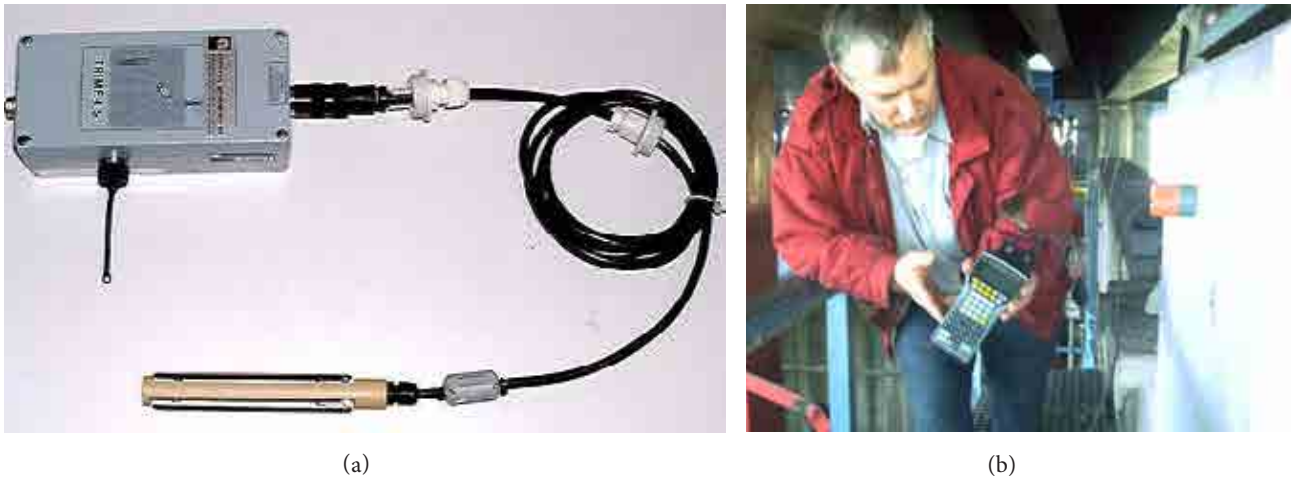
FIG. 134. Application of dielectric measurements to indicate concrete moisture content: (a) TRIME (Time domain Reflectometry with Intelligent MicroElements) sensor for moisture determination (IMKO GmbH); (b) measuring concrete dielectric properties [485].

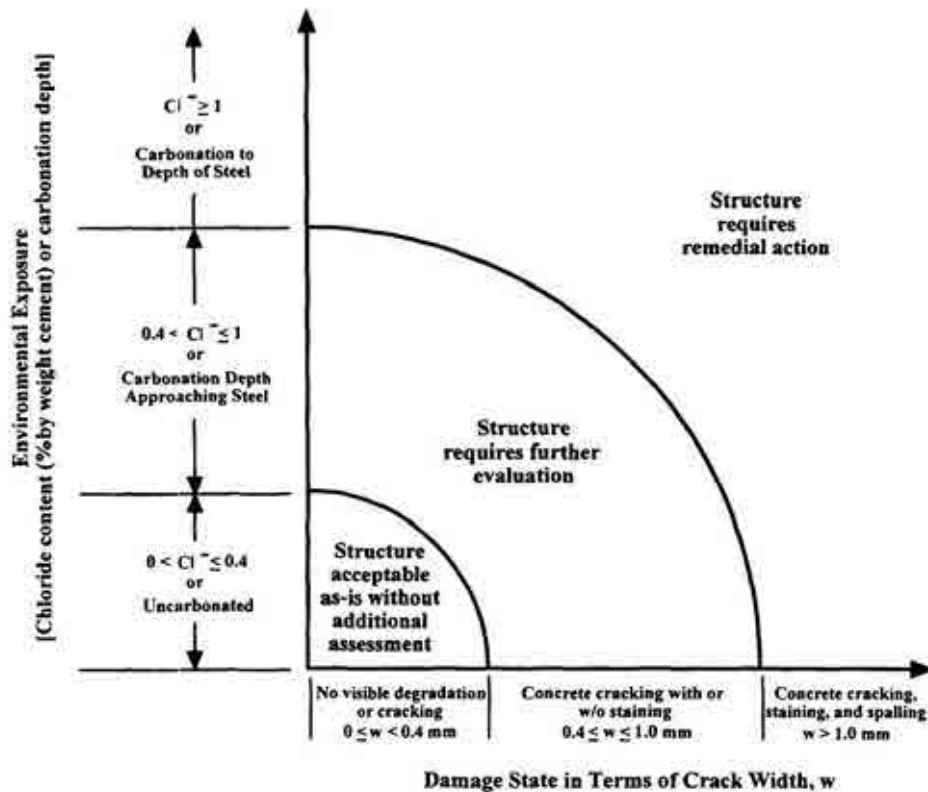
FIG. 153. Damage state chart relating environmental exposure, concrete crack width and necessity for additional evaluation and repair [318].

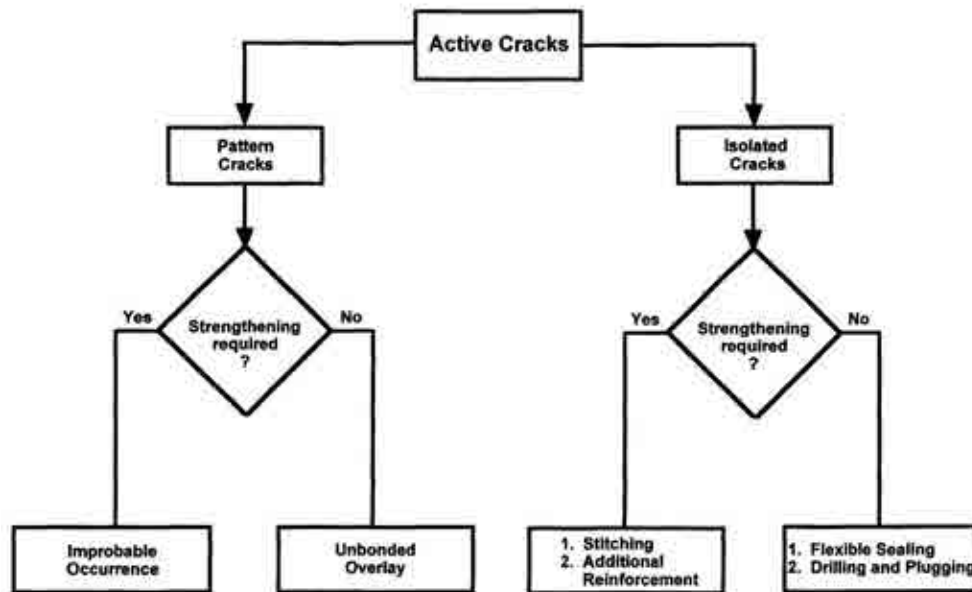
FIG. 158. Selection of repair techniques for active cracks [53].

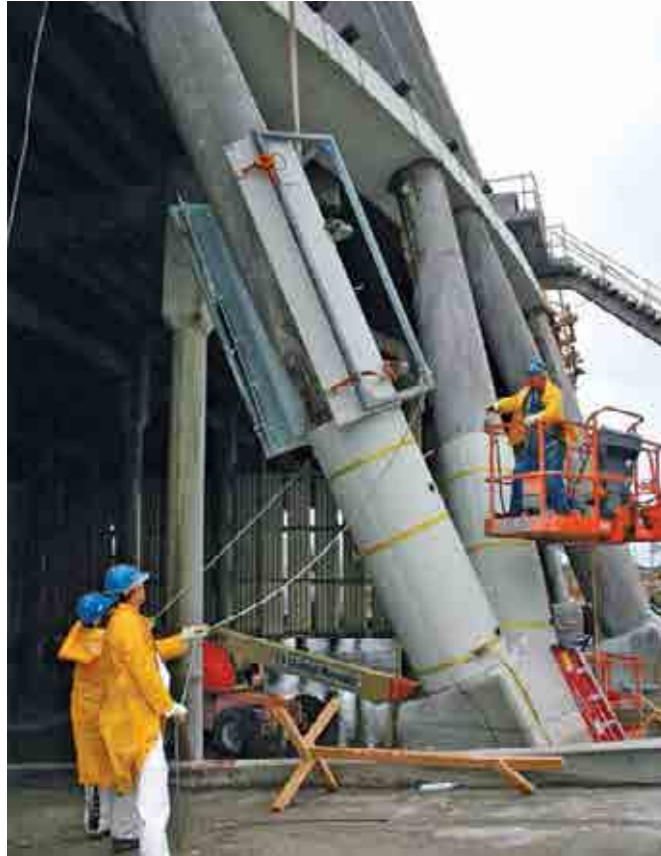
FIG. 162. Cathodic protection system being installed as part of cooling tower concrete repair [555].

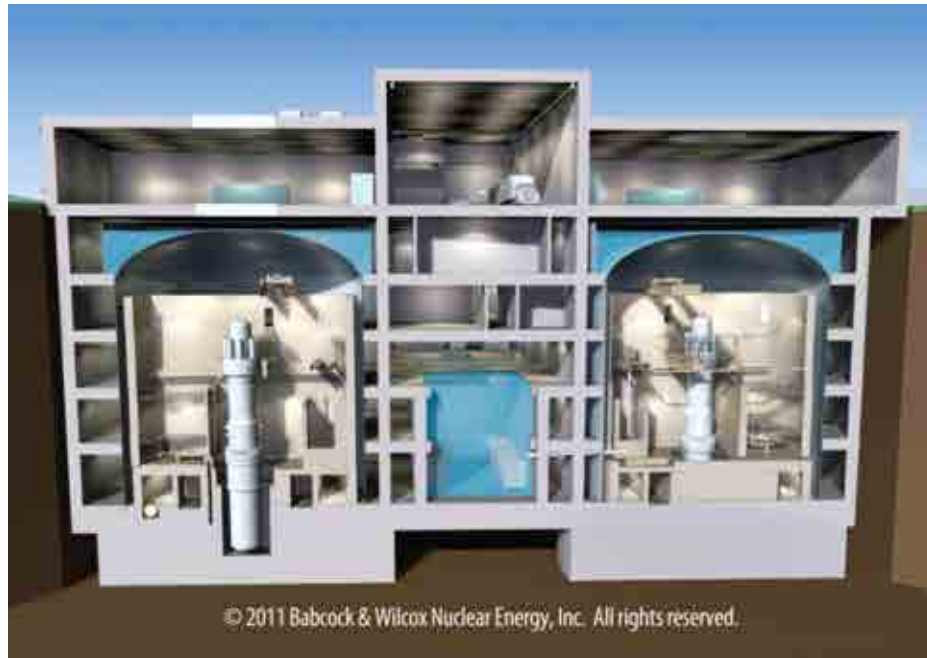
FIG. 188. Babcock and Wilcox mPower small modular reactor containment (courtesy of Babcock & Wilcox).

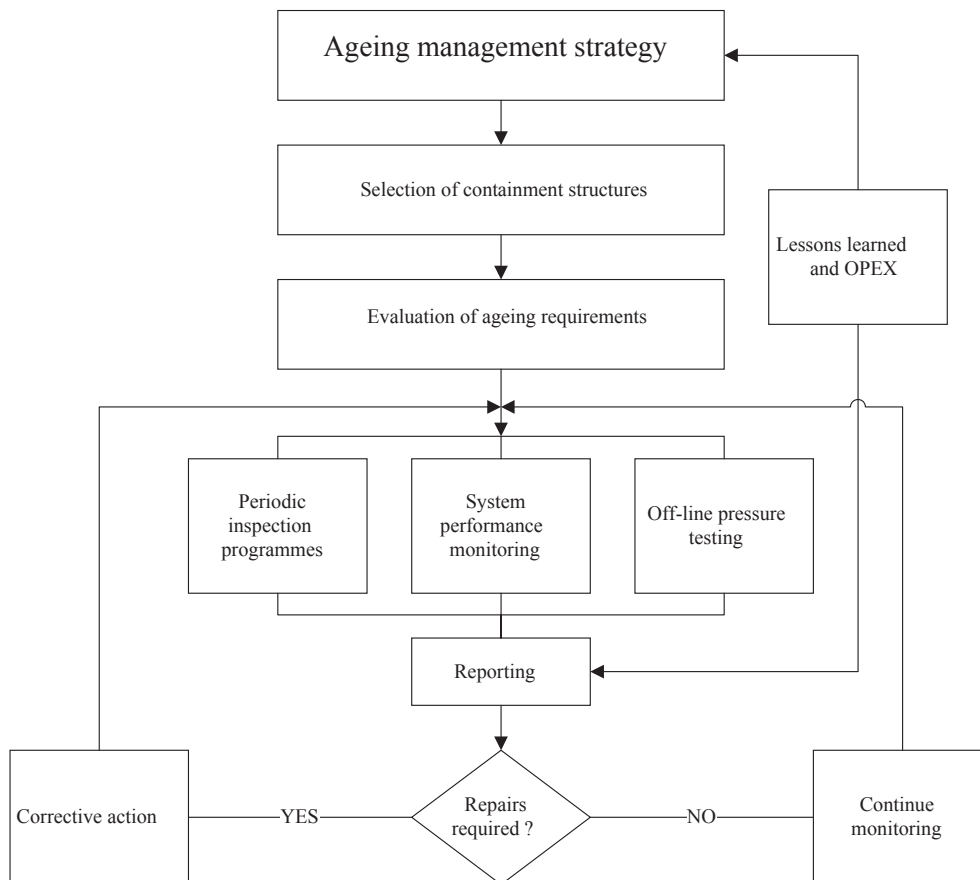
FIG. 190. OPG ageing management strategy.

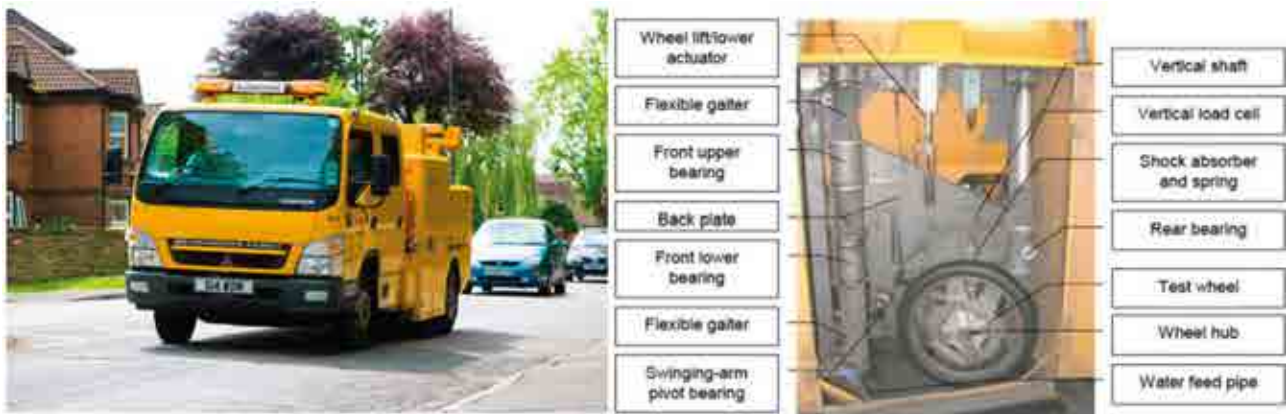
FIG. 191. SCRIM test vehicle (left) (courtesy of W.D.M. Ltd) [708]; test wheel (right) (courtesy of TRL Ltd) [709].

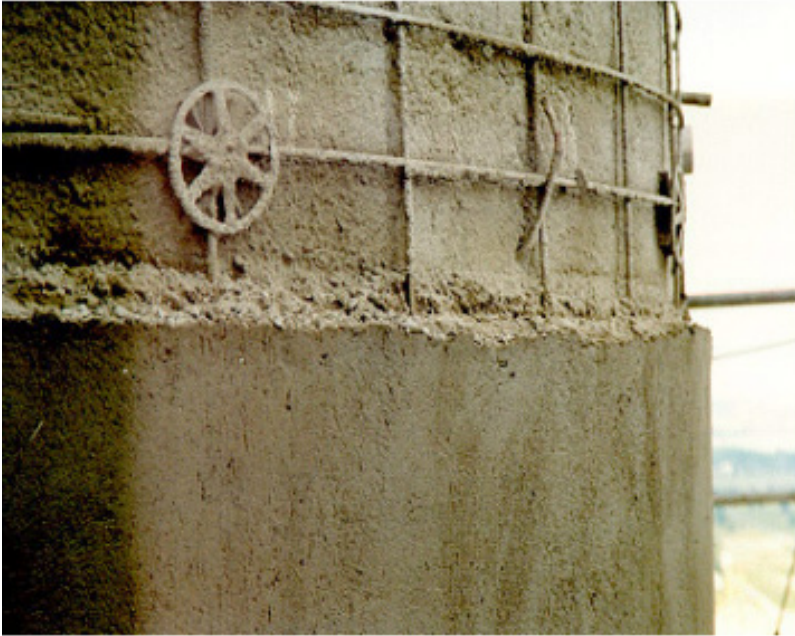
FIG. 203. Condition during repair.

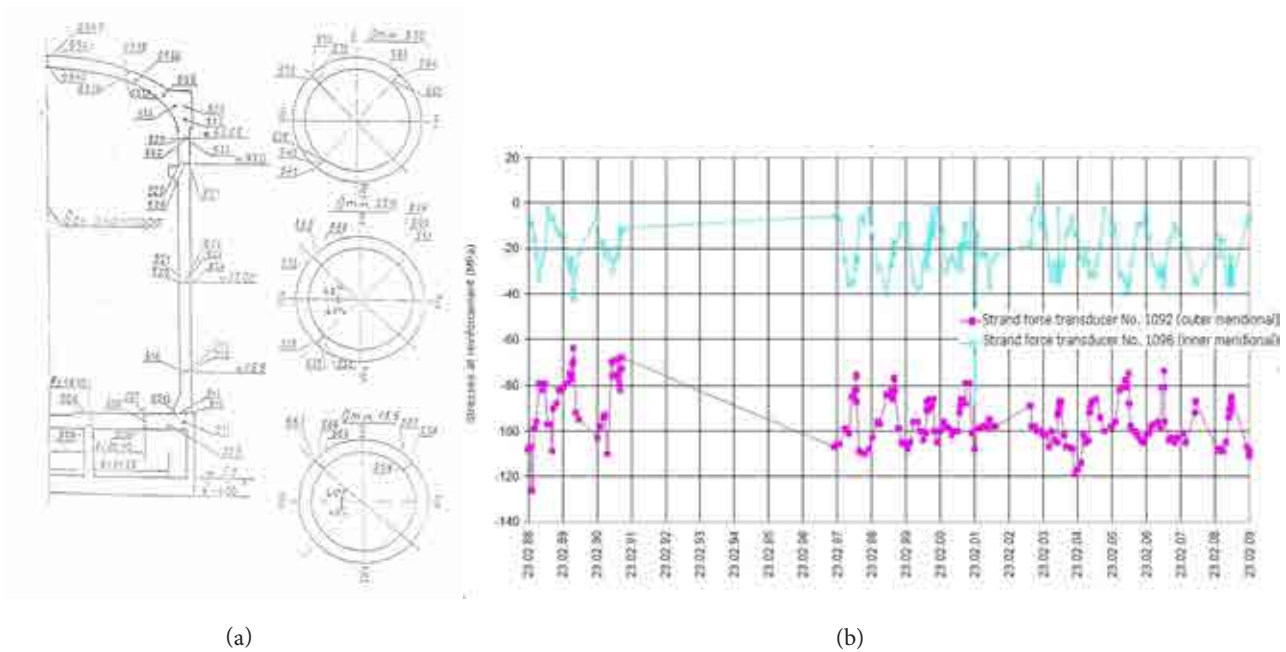
FIG. 206. (a) Layout for control and measuring equipment sensor; (b) plot for meridional and circular stresses at reinforcement for an operating time of 30 years (courtesy of CMSLM Ltd).
