The Radiological Accident in Chilca

INTERNATIONAL ATOMIC ENERGY AGENCY
VIENNA, 2018

STI/PUB/1776

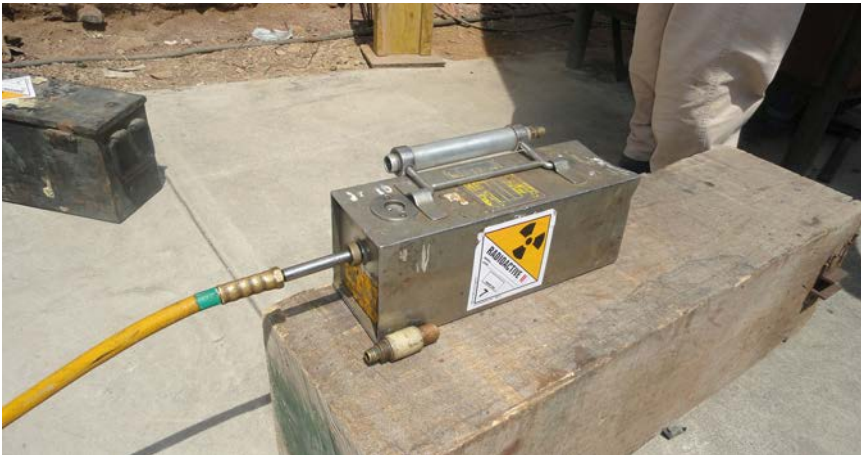
FIG. 1. The radiography camera involved in the accident.

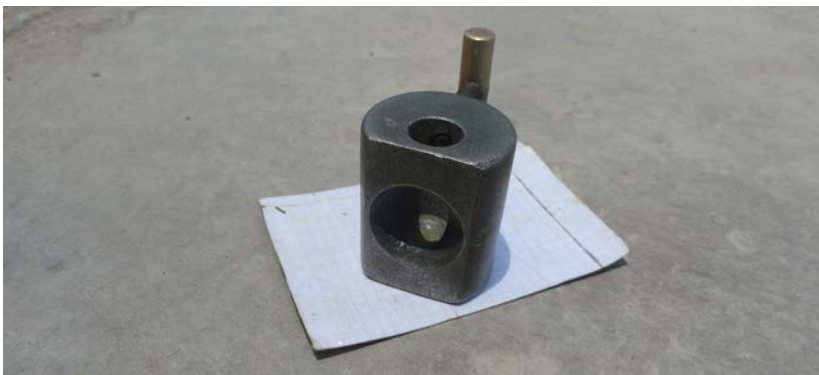
FIG. 2. Collimator used during radiography of the pipes.

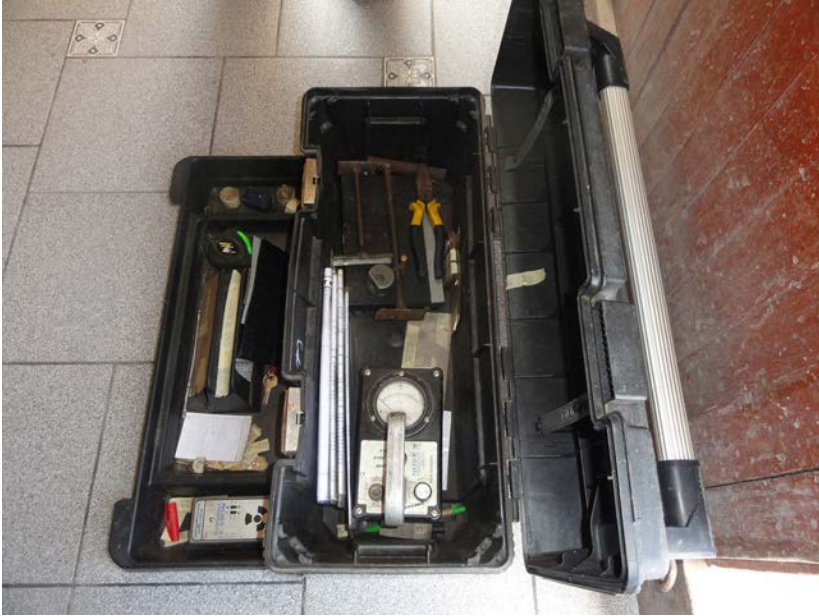
FIG. 3. Kit of equipment and tools associated with the camera.

There is an accompanying tool kit (Fig. 3), which contains the tools and equipment necessary to operate the camera.

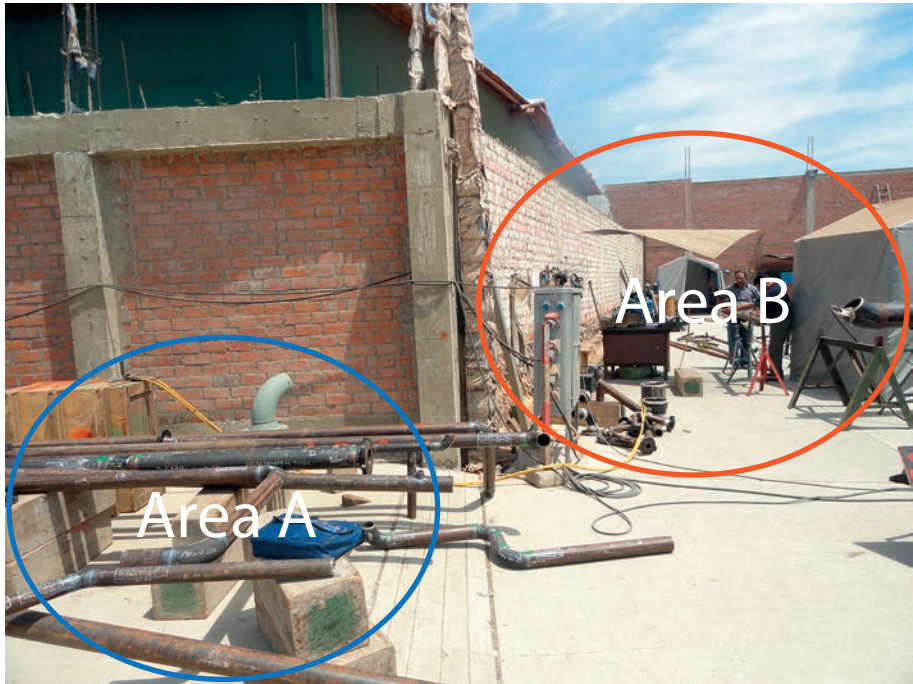
FIG. 4. Working areas A and B.

The work being carried out was the radiographic examination of pipes with diameters of 2, 3 and 4 in (5.1, 7.6 and 10.2 cm, respectively). Each of the 2 in (5.1 cm) pipes required two exposures; the other two required three exposures each. Consequently, there were two set-ups for this work. In the first set-up (referred to as 'area A', shown in Figs 4 and 5), the 2 in (5.1 cm) pipes were taken to the area, and in the second set-up (referred to as 'area B', shown in Figs 4 and 6), the radiography camera was taken to the location of the 3 and 4 in (7.6 and 10.2 cm) pipes.

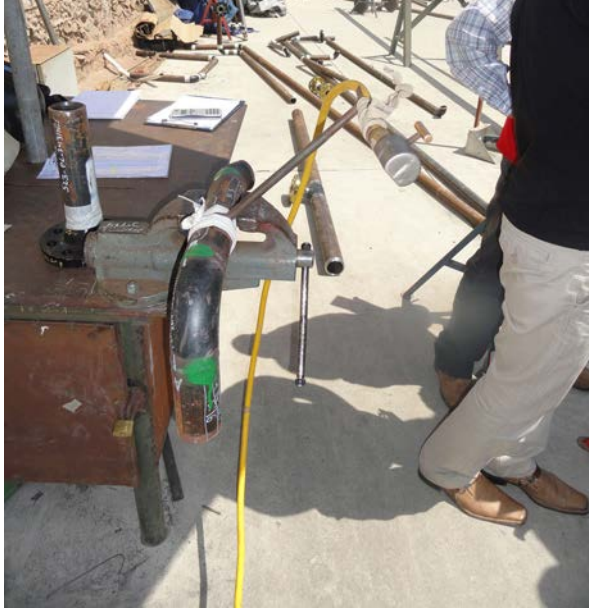
FIG. 5. Set-up for the test of the 2 in (5.1 cm) pipes, area A.

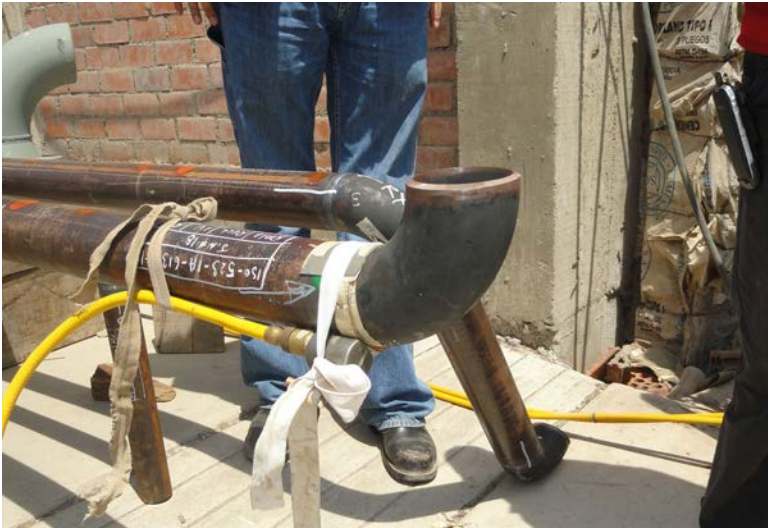
FIG. 6. Set-up for the test of the 3 and 4 in (7.6 and 10.2 cm) pipes, area B.

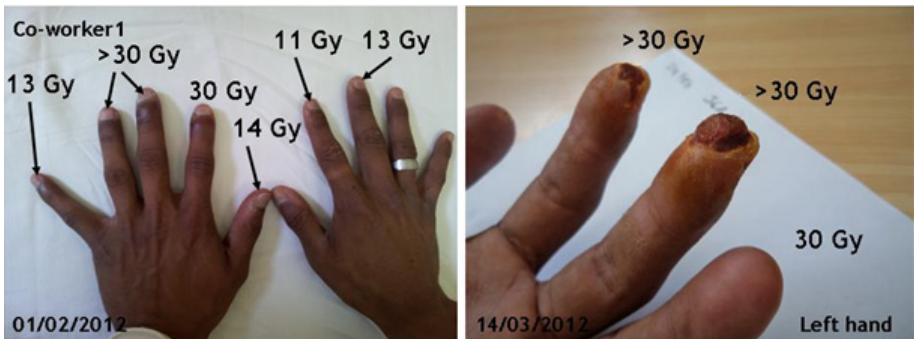
FIG. 11. Dose measured by electron paramagnetic resonance spectroscopy on fingernails for Co-worker 1. (Courtesy of the IRSN.)

The dose to the fingernails was estimated to have ranged from about 10 Gy to more than 50 Gy. Figures 10–12 show the distribution of the dose on the fingernails as measured using the EPR technique for Worker 1, Co-worker 1 and Co-worker 2. The margin of error was estimated to be about 10 Gy for these data. Results are given in terms of kerma in the tissue. The dose to the toenails of Worker 1 was estimated to be lower than 10 Gy. This estimated dose was consistent with the hypothesis that the source was inside the collimator between radiography exposures.

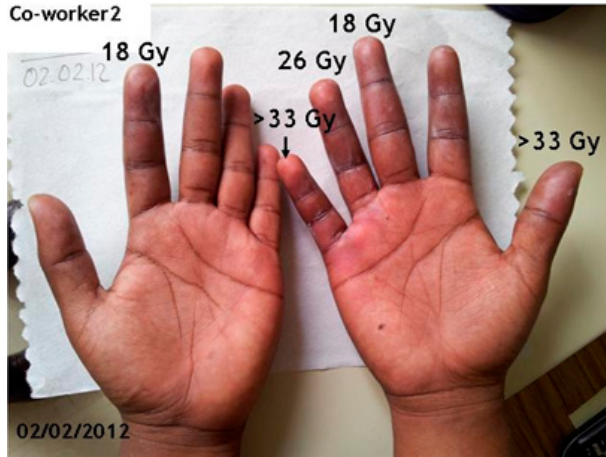
FIG. 12. Dose measured by electron paramagnetic resonance spectroscopy on fingernails for Co-worker 2. (Courtesy of the IRSN.)

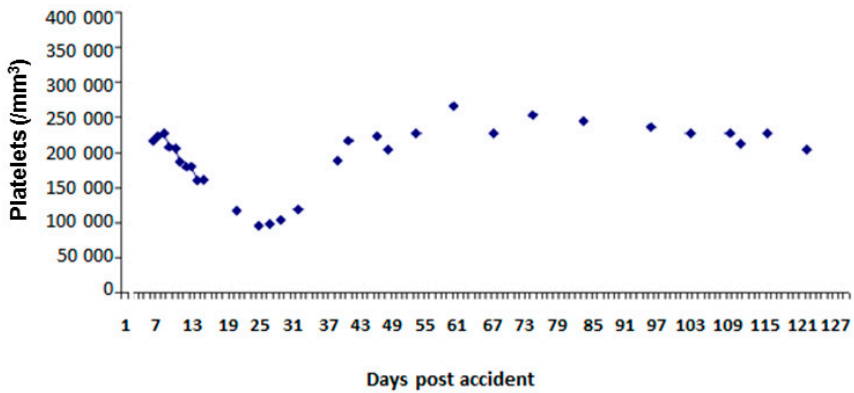
FIG. 17. Platelet counts of Worker 1 (HIA Percy–IRSN data).

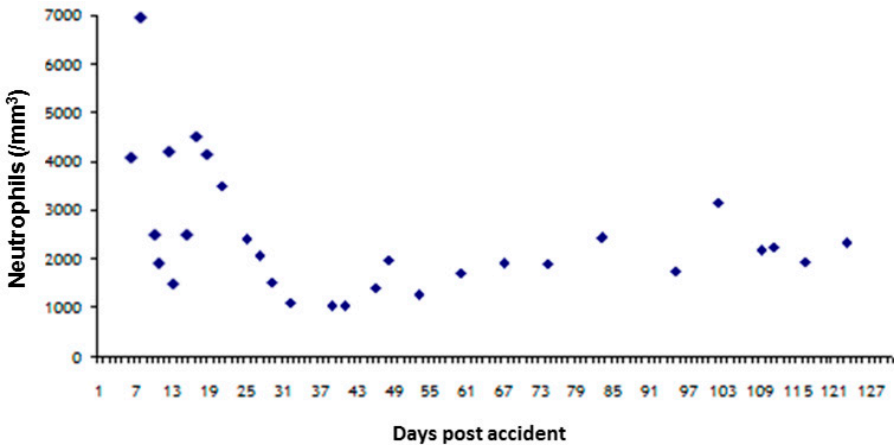
FIG. 18. Neutrophil counts of Worker 1 (IPEN and HIA Percy–IRSN data).

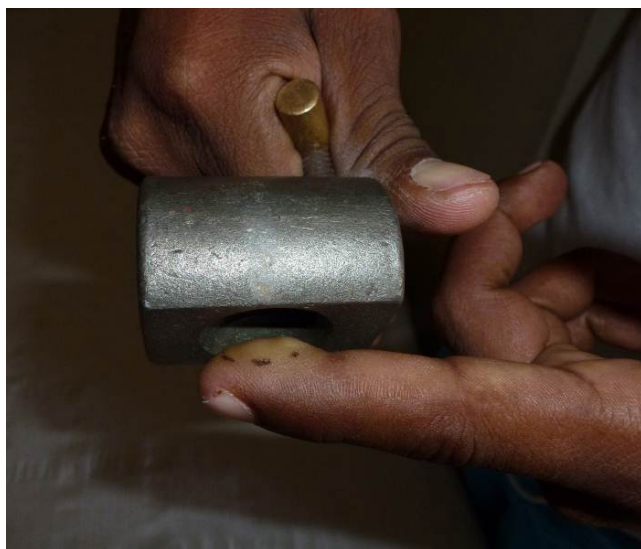
FIG. 24. Reconstruction showing the position of the index finger of the left hand of Worker 1 on the orifice of the collimator. It was estimated that the distance of the skin from the source was 0.5 cm. (Courtesy of IPEN.)

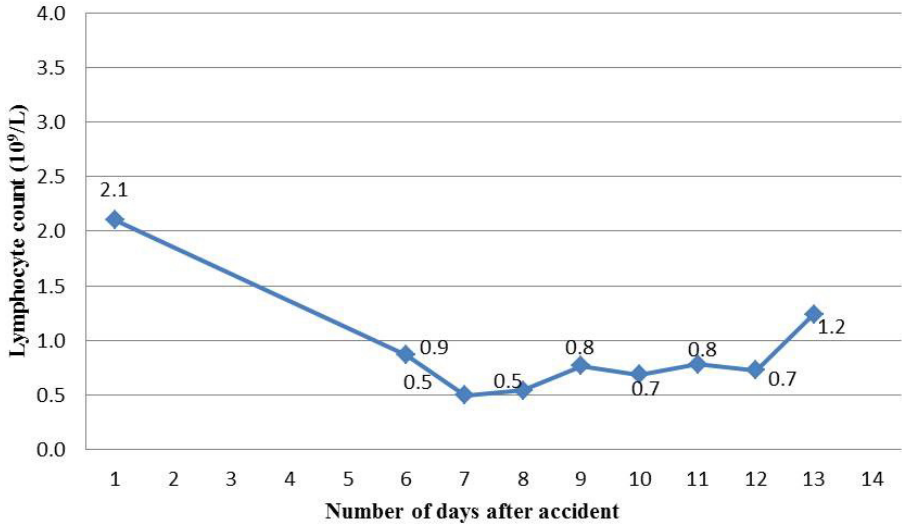
FIG. 30. Lymphocyte count ($10^9/L$) for Worker 1.

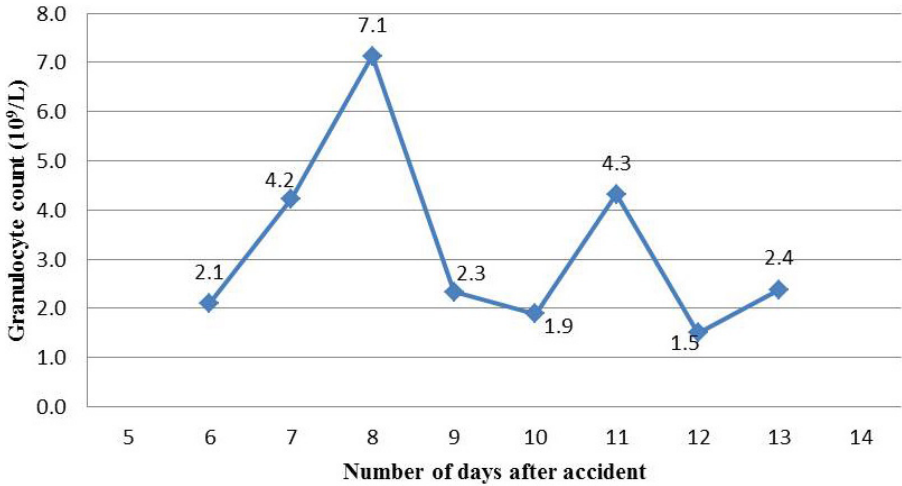
FIG. 31. Granulocyte count ($10^9/L$) for Worker 1.

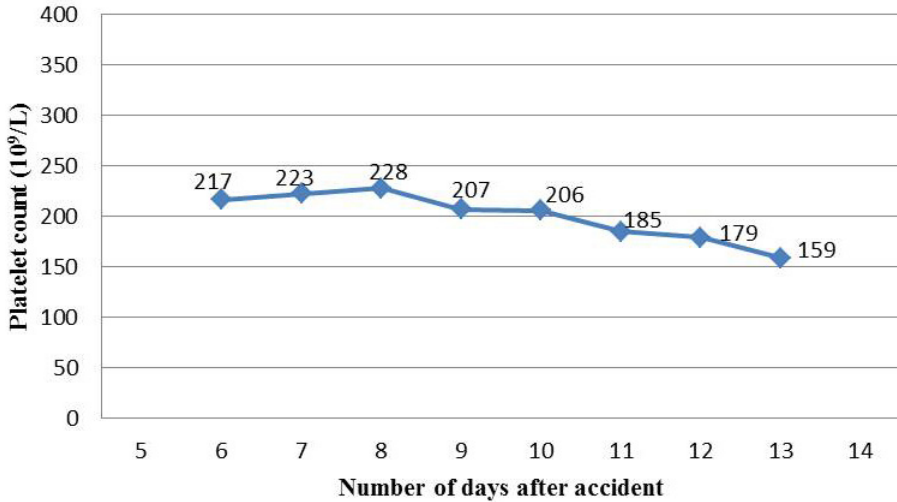
FIG. 32. Platelet count ($10^9/L$) for Worker 1.
