IAEA Nuclear Energy Series

No. NW-T-2.6

Decommissioning of Pools in Nuclear Facilities

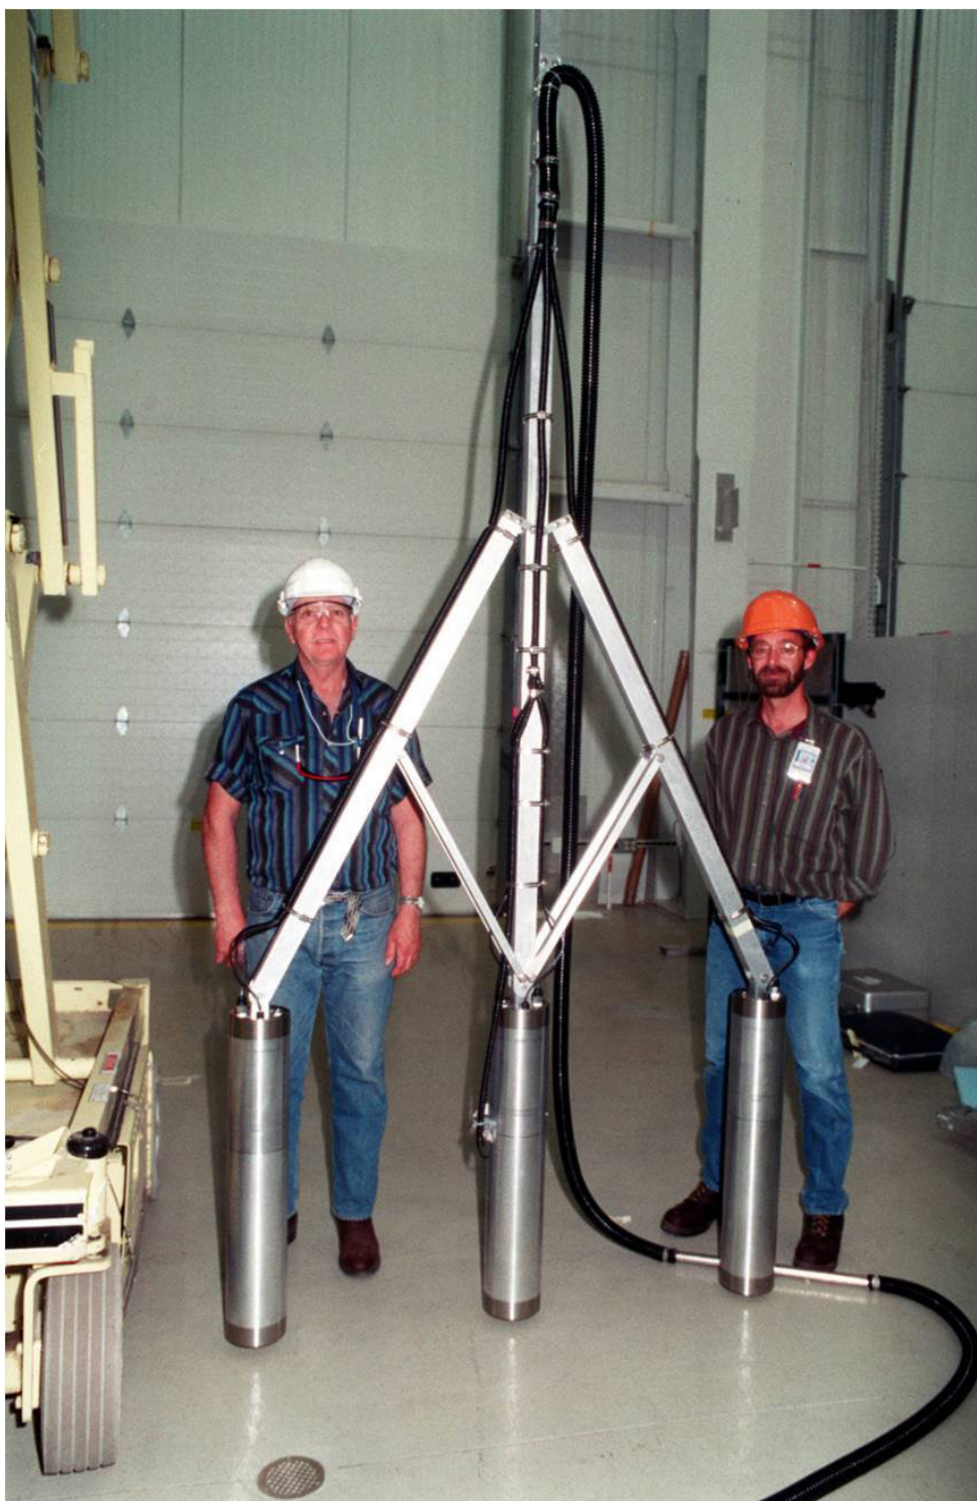
FIG. 4.2. Remotely operated pool characterization and scanning device at Idaho National Laboratory, United States of America (courtesy of R. Demmer, Idaho National Laboratory).

There are many pools and silos at Sellafield that contain a wide range of historic wastes, and characterization of the inventories is essential. An example is an extensive survey on the FGMFSP at Sellafield using a submersible remotely operated vehicle [4.11] (see Fig. 4.3).

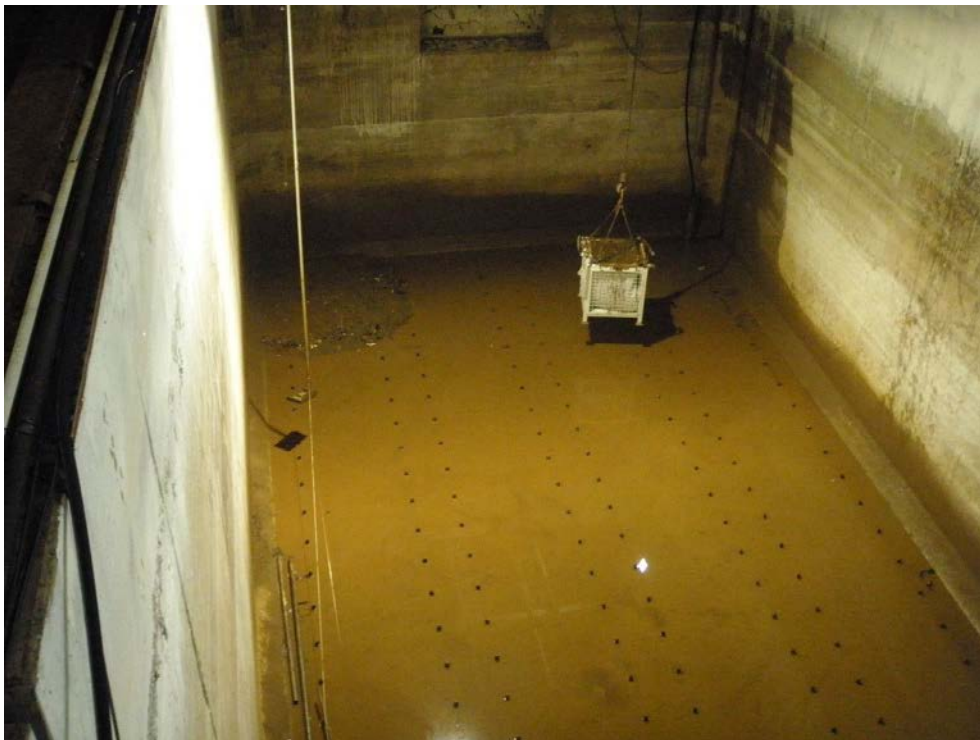
FIG. 4.4. Dounreay, United Kingdom, fast reactor pond sludge removal (February 2011) (courtesy of Dounreay Site Restoration Ltd).

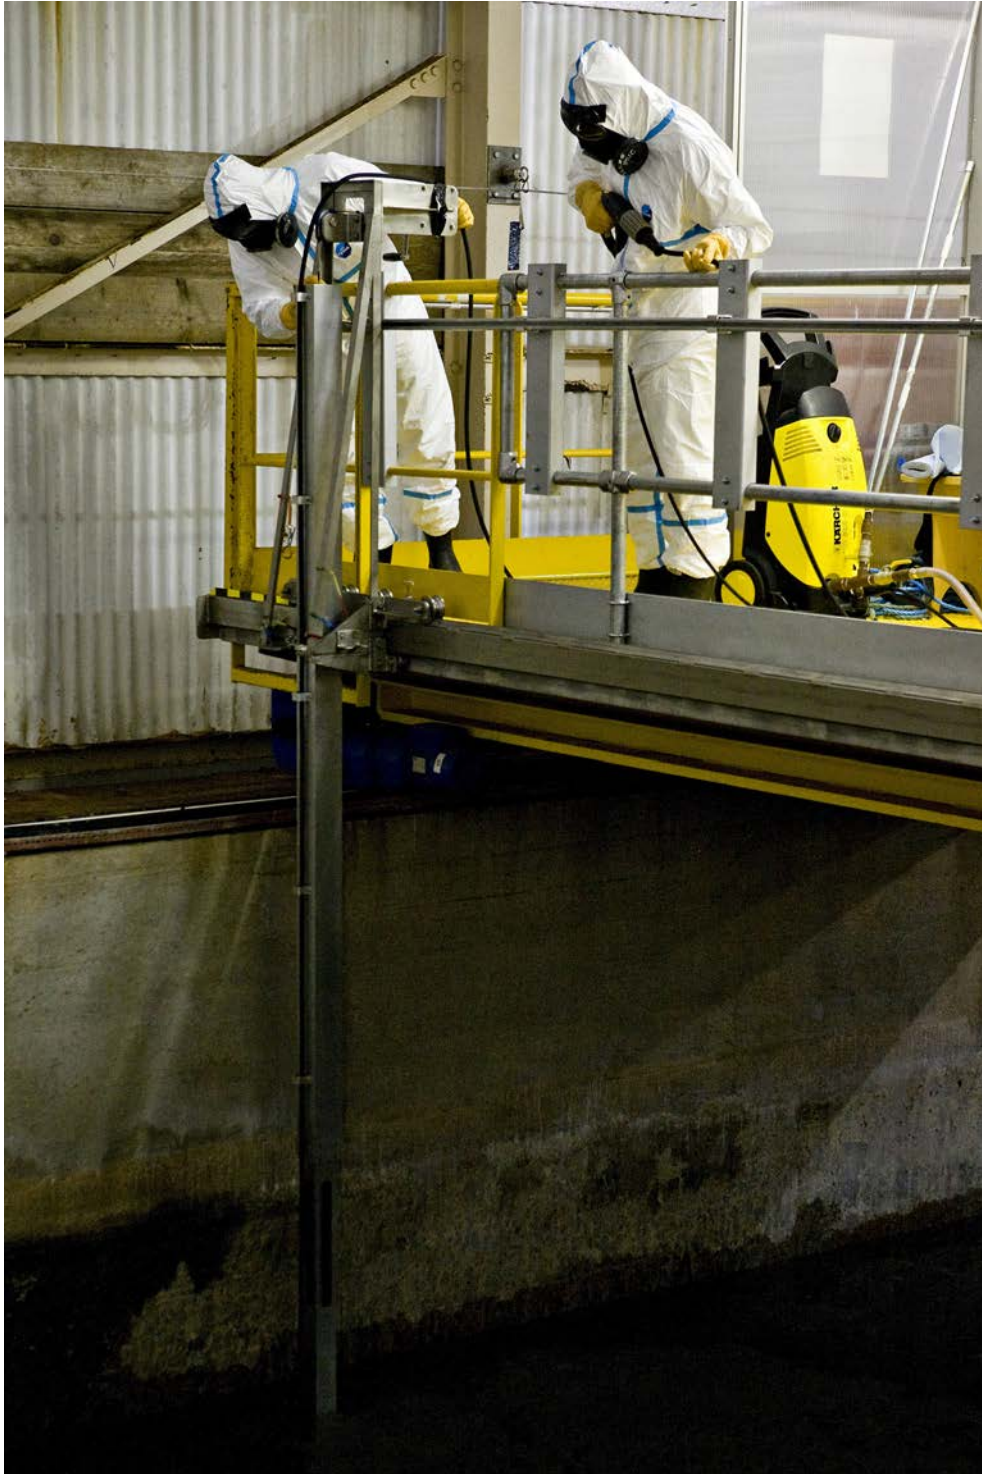
Note: Once the sides of the pond are decontaminated, the water level will be gradually lowered until it can be completely emptied.

FIG. 5.2. Fast reactor pond high pressure water jet submerged below water level Dounreay, United Kingdom (courtesy of Dounreay Site Restoration Ltd).

Dounreay fast reactor pond workers in protective clothing scrubbed the sides of the redundant Dounreay fast reactor fuel pond using a high pressure water jet submerged below water level. Additional information about pool decommissioning projects at Dounreay is given in Refs [7.50, 7.51].

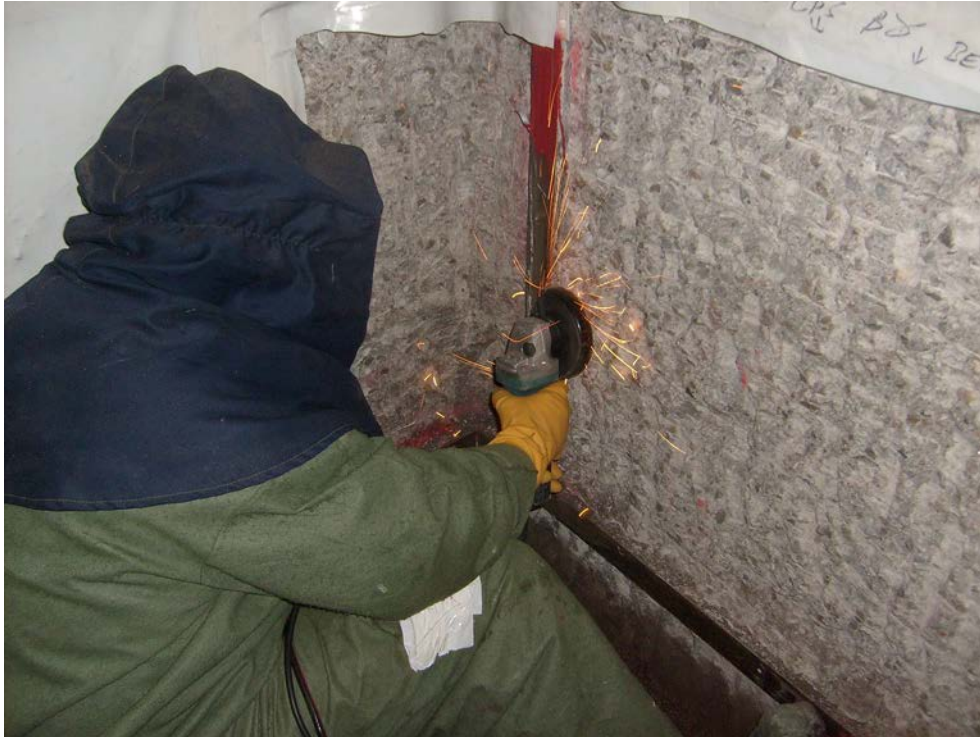
FIG. 5.3. D9814 pond concrete decontamination, Dounreay, United Kingdom (courtesy of Dounreay Site Restoration Ltd).

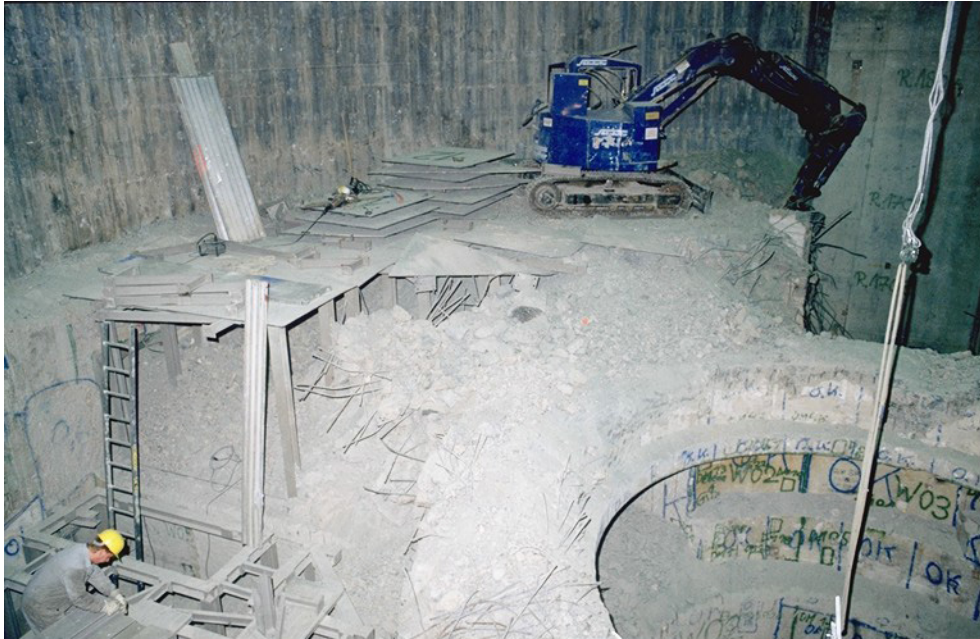
FIG. 6.2. Demolition of the reactor pool at the Karlstein superheated steam reactor, Germany, using a remote excavator (courtesy of L. Valencia).

Section I-1 describes experiences of the demolition of the superheated steam reactor spent fuel pool at Karlstein, in Germany. A good illustration of an excavator in operation is provided in Fig. 6.2.

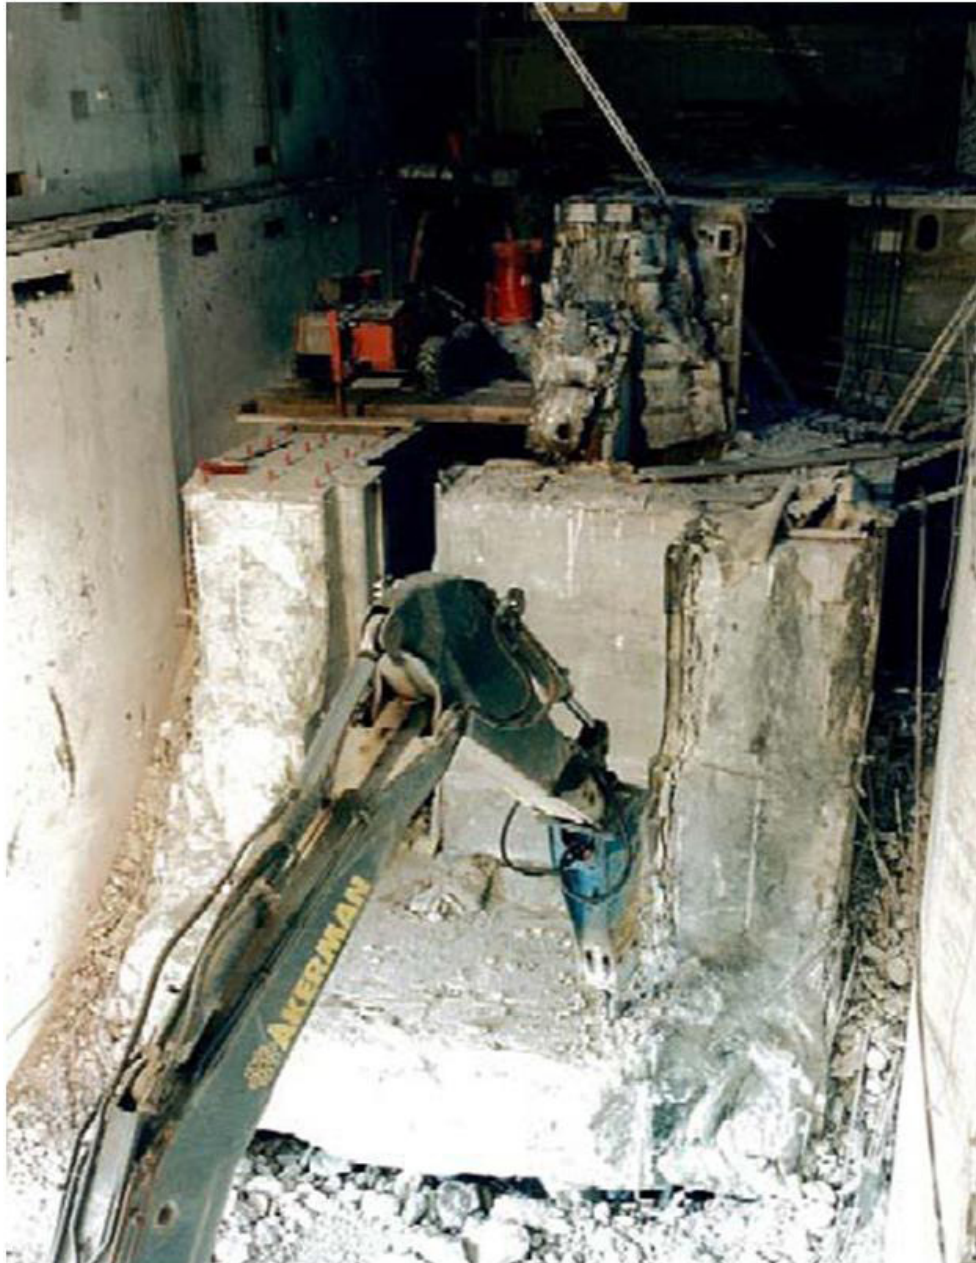
FIG. 6.3. Demolition of FR-2 spent fuel pond, Germany (courtesy of L. Valencia).

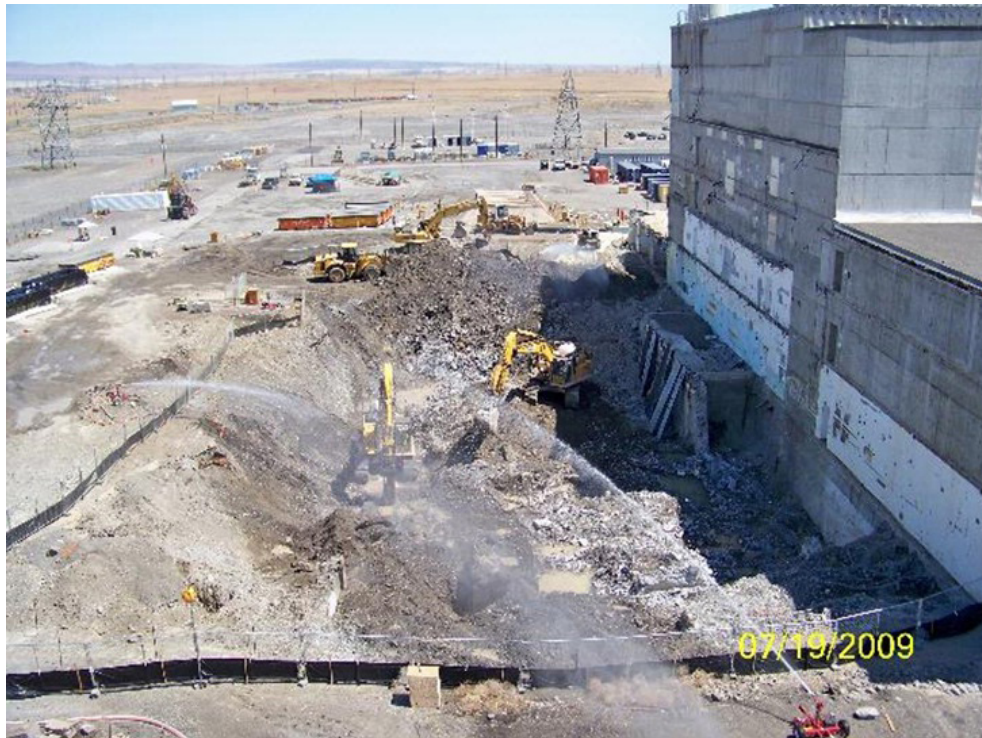
FIG. 6.4. Use of water as a dust suppressor during demolition of the 224-U facility, Hanford, United States of America (courtesy of US Department of Energy).

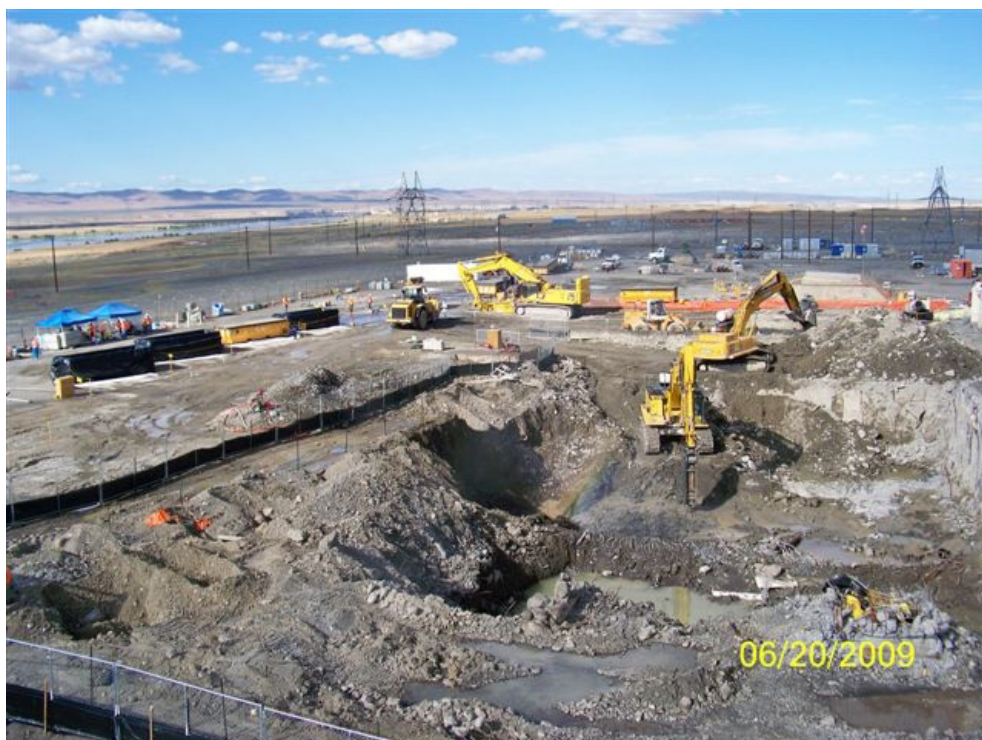
FIG. 6.5. Demolition of Hanford K east basin substructure, United States of America (courtesy of US Department of Energy).

The Hanford K east basin was demolished and the rubble removed (see Fig. 6.5) in 2009. Reference [6.2] illustrates the highlights of the project.

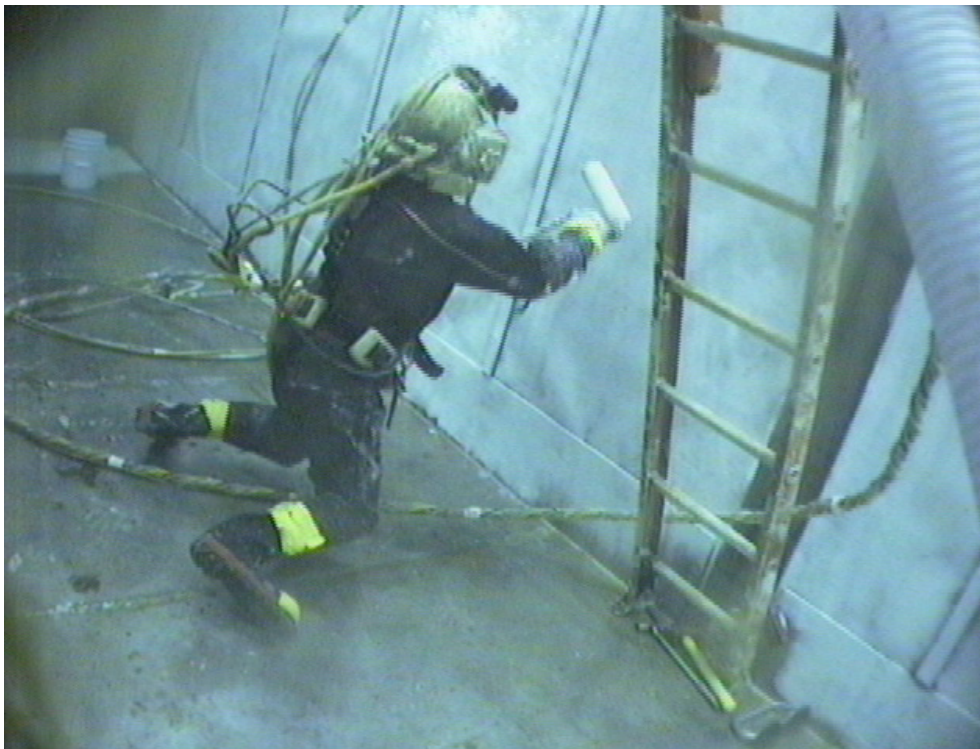
FIG. 7.3. Underwater epoxy coating of the Materials Test Reactor pool at Idaho, United States of America (courtesy of R. Demmer, Idaho National Laboratory).

Extensive preparation had to be done before applying the underwater coating technique [7.85], and a survey and characterization of the pool were necessary [7.86]. The spent fuel had been removed previously, and the water could be cleaned in the adjacent pool operating systems as far as possible. Water cleanup was the biggest task.

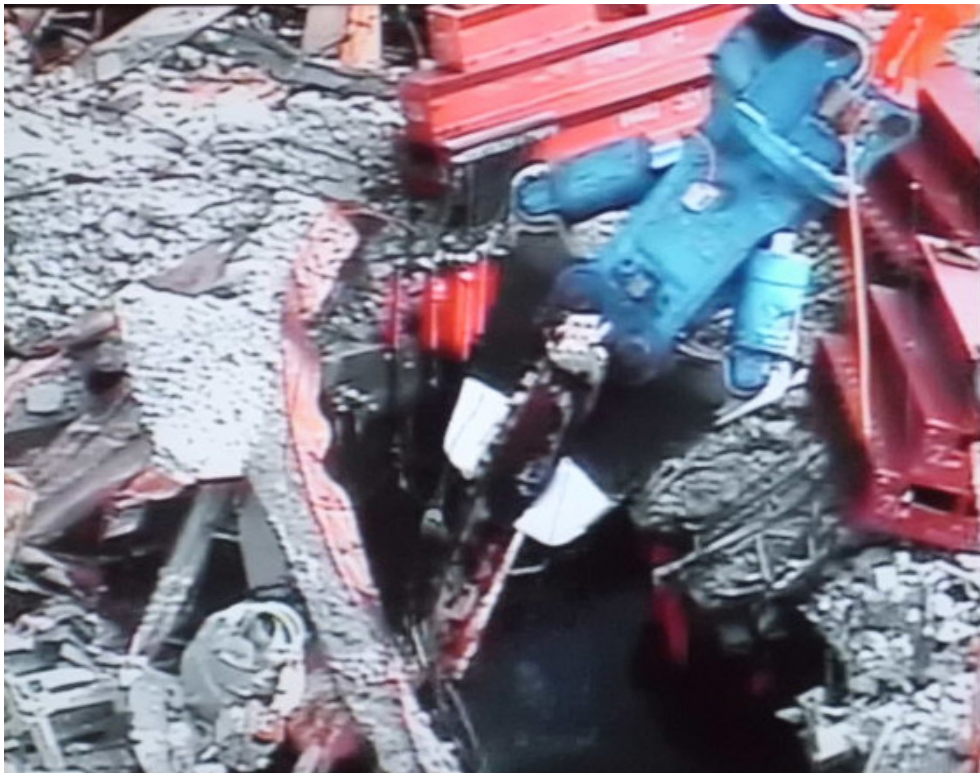
FIG. A.2. Debris removal from the upper part of Unit 3 reactor building: Removal of the steel beam that fell into the pool (when being lifted) (courtesy of TEPCO).

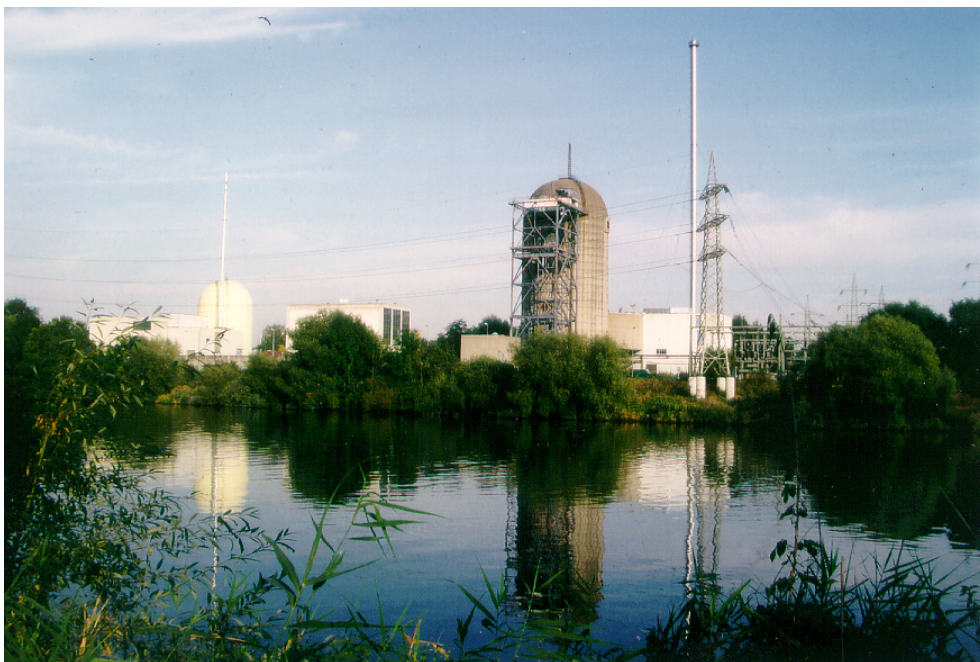
FIG. I-1. Superheated steam reactor at Karlstein, Germany.

The reactor was a boiling water reactor (BWR) with a thermal power of 100 MW. Superheated steam at a temperature of 460°C was generated by means of core internal superheating, at a pressure of 7.4 MPa. The steam was then supplied to the 25 MW turbine of the adjacent coal fired power plant Dettingen, which was located on the same site. A station was provided on-site for the reduction of the steam parameters to those required by the turbine, and therefore a machine hall was not required.

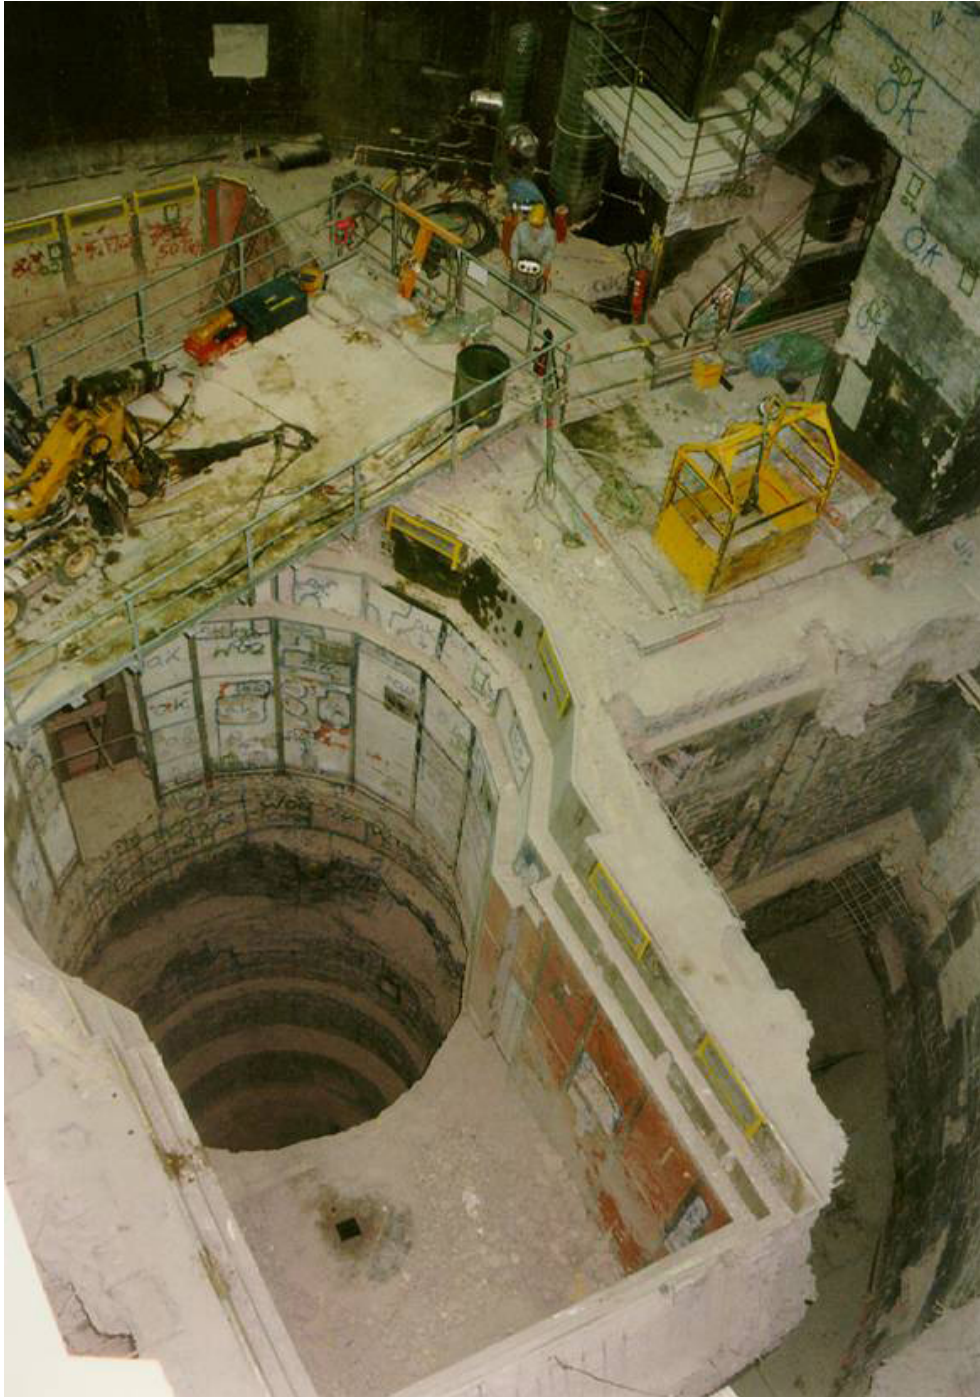
FIG. I-5. View into the reactor pool after liner removal and clearance measurements.

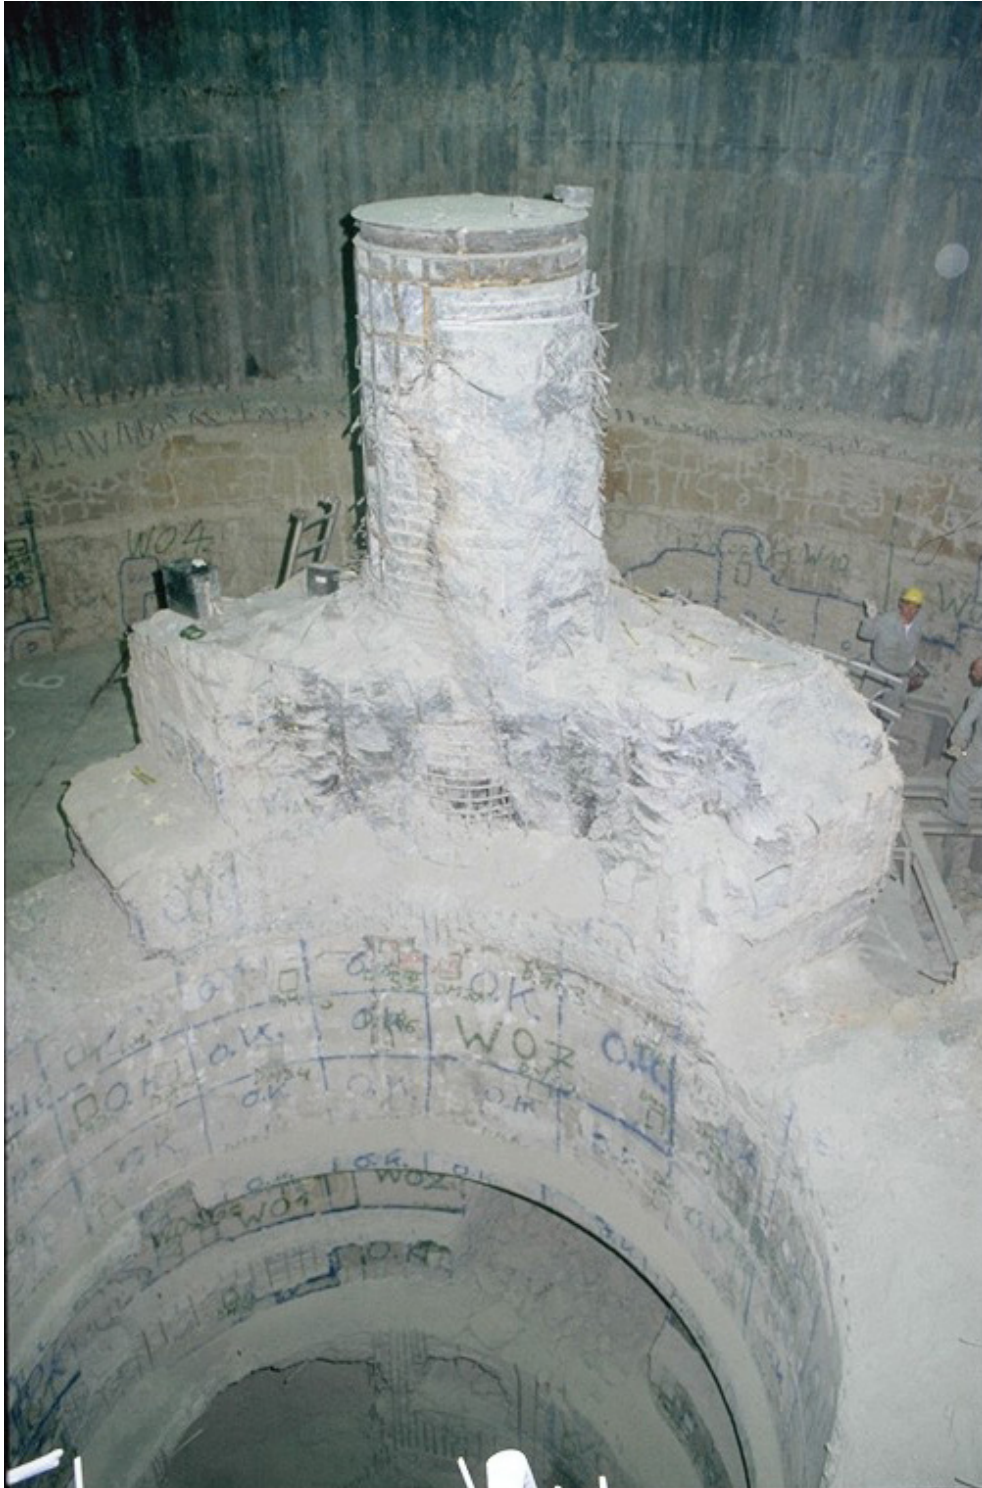
FIG. I-7. Sump of the Karlstein superheated steam reactor pool containing hot spots with fuel remnants.

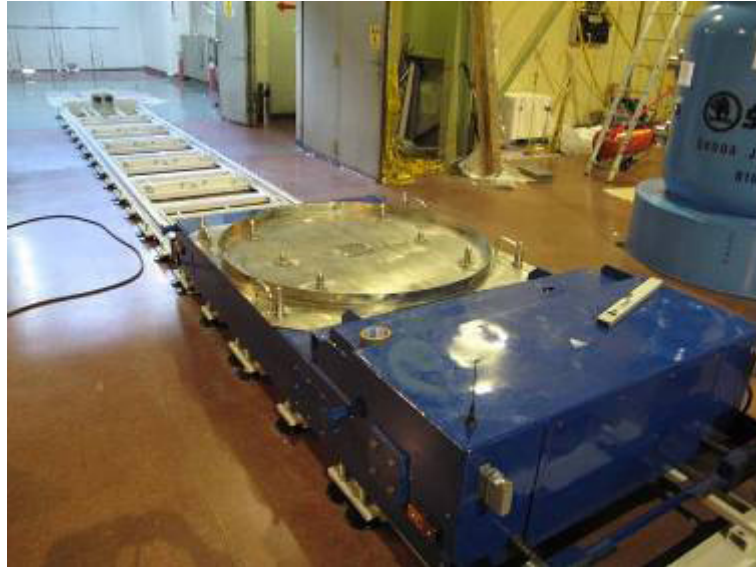
FIG. I-13. Rail transfer system (courtesy of O. Šotić).

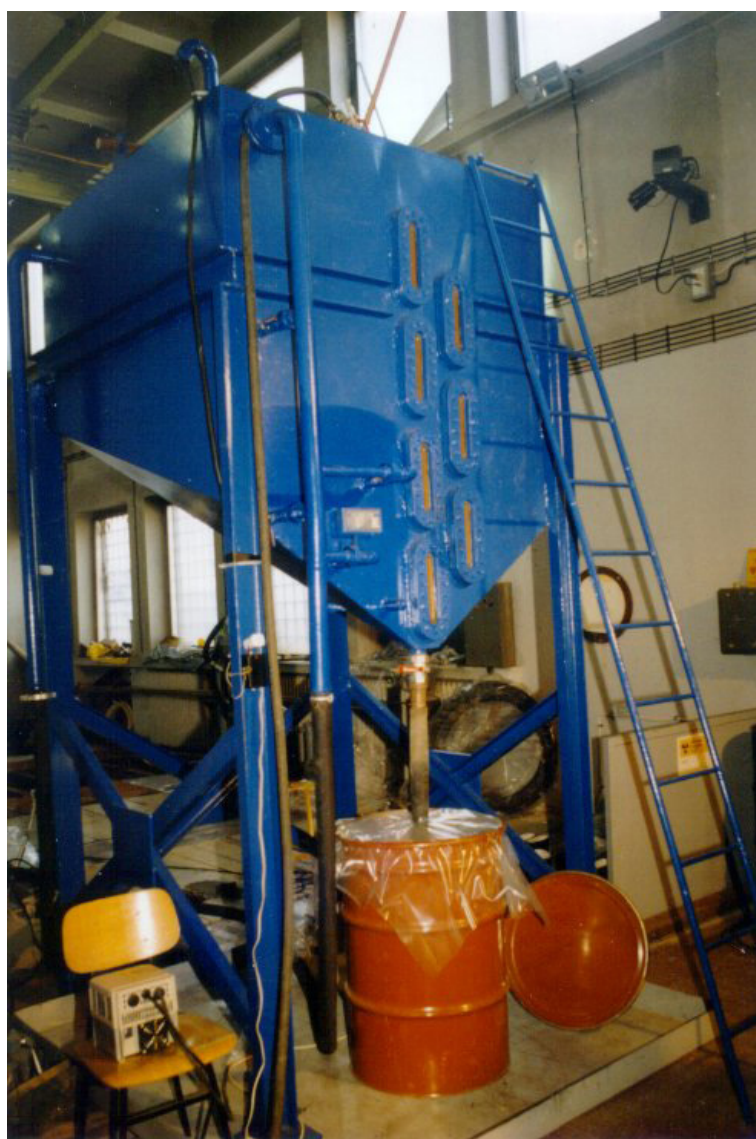
FIG. I-15. Sedimentation tank (courtesy of O. Šotić).

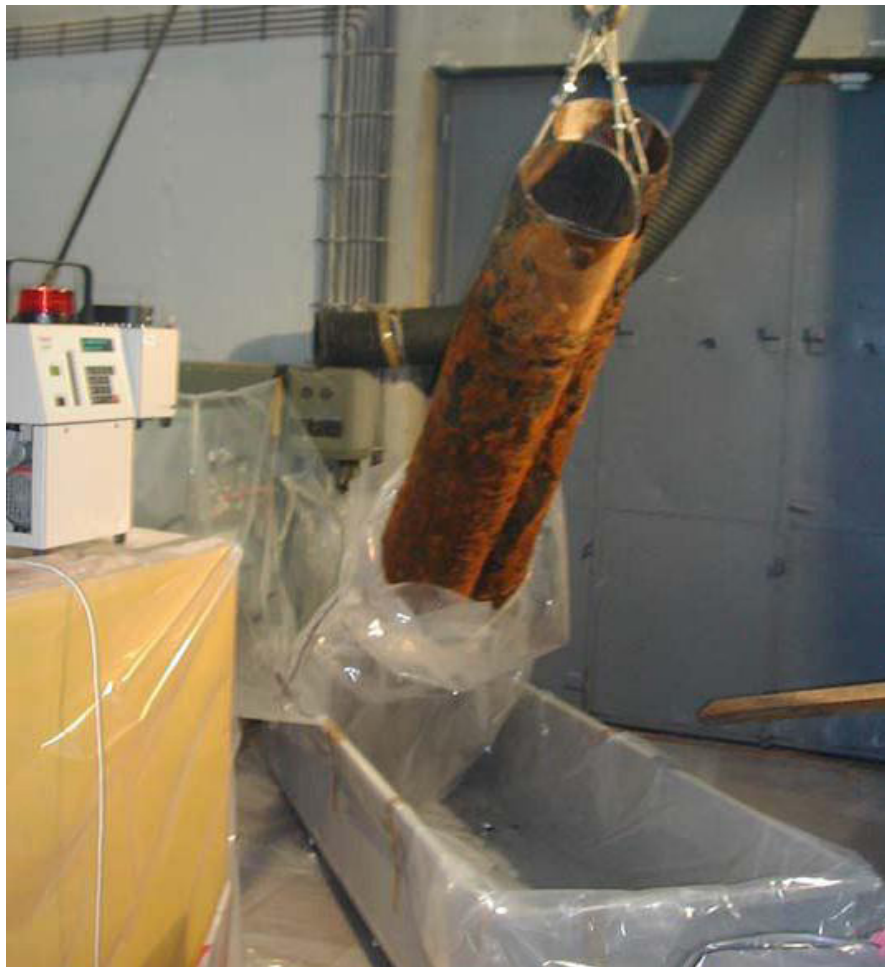
FIG. I-18. Removing the tube block (courtesy of O. Šotić).

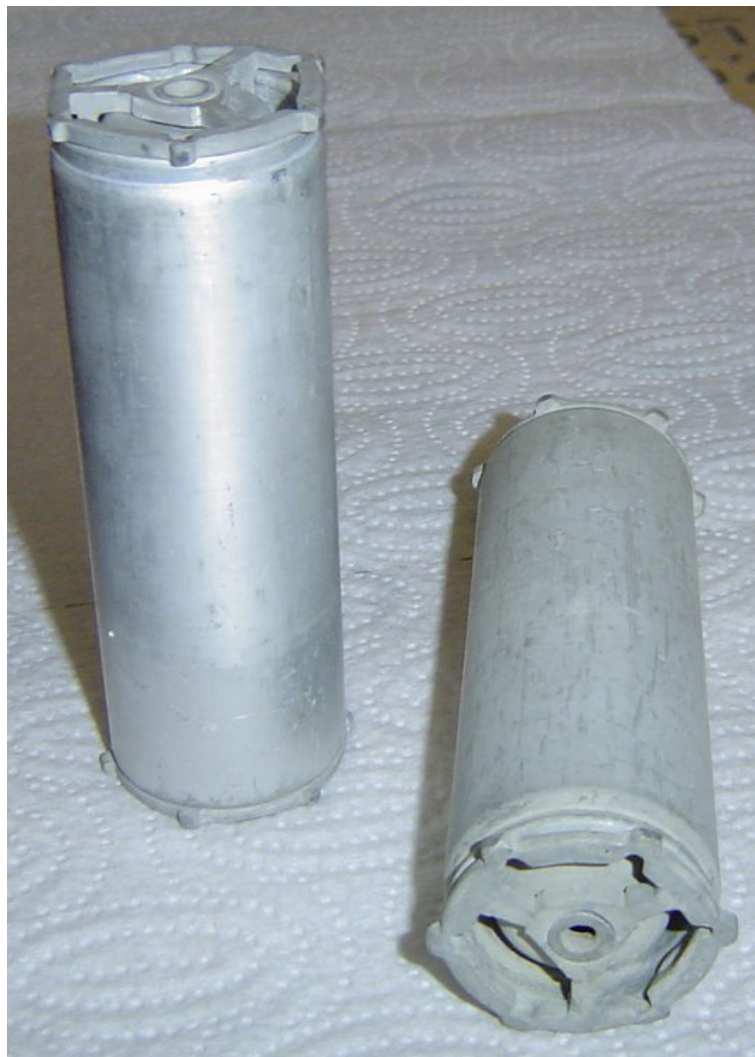
FIG. I-19. TVR-S fuel element (courtesy of O. Šotić).

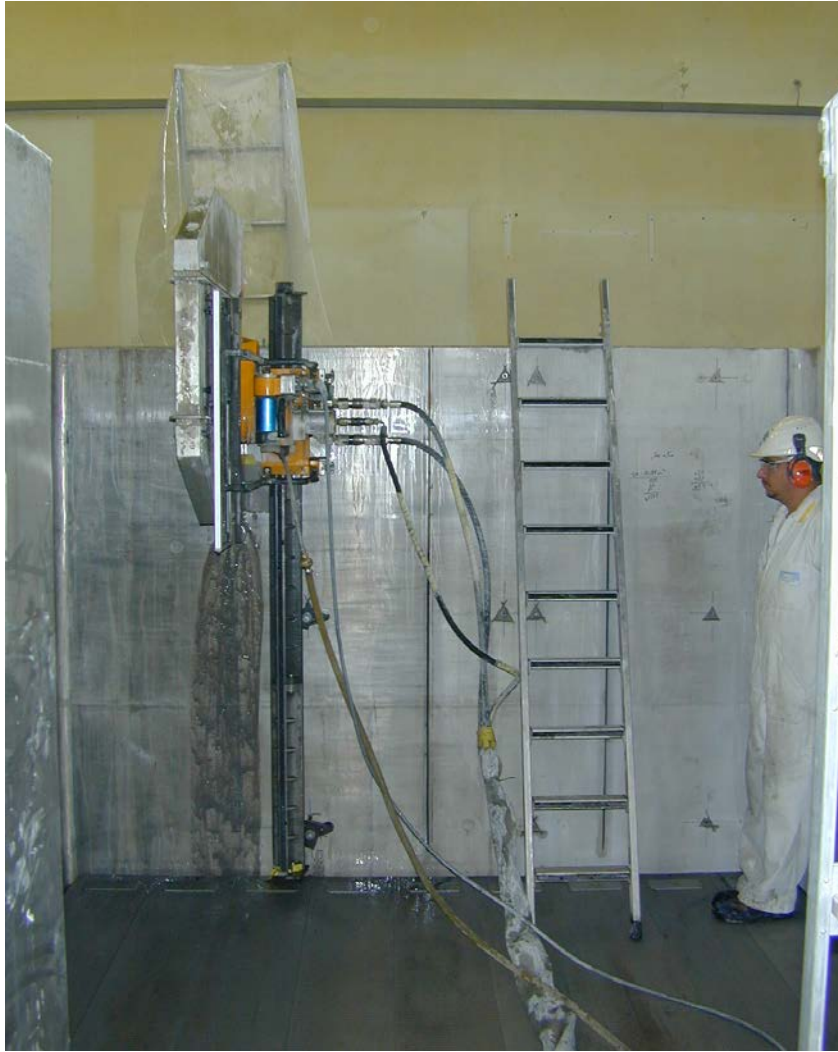
FIG. I-44. Circular saw cutting of the pool wall (courtesy of Paul Scherrer Institute).

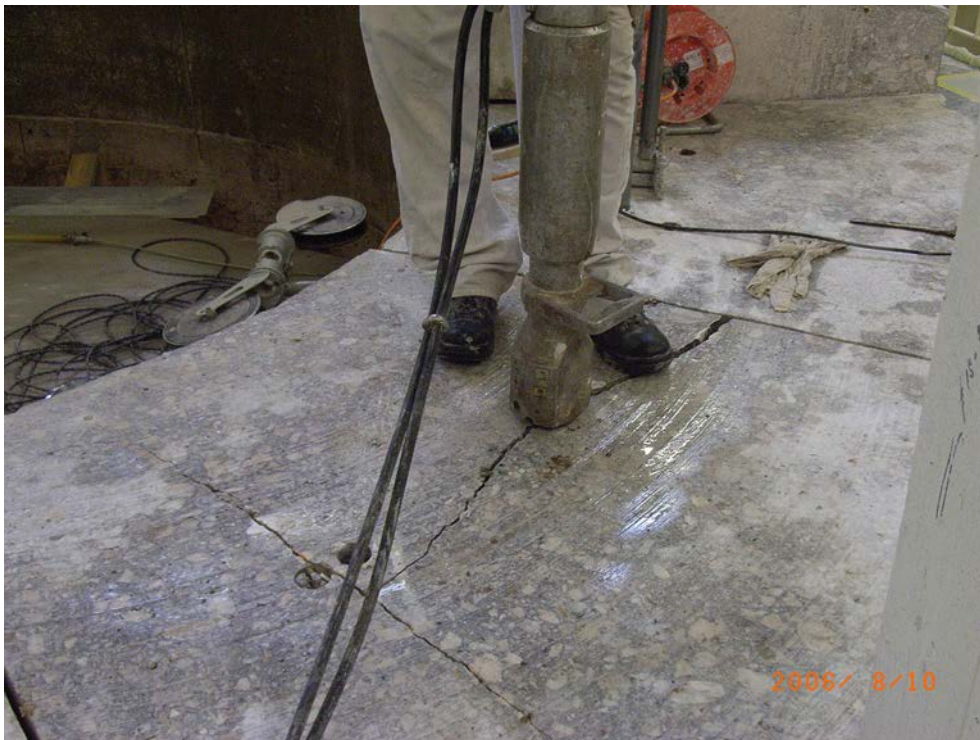
FIG. I-47. Concrete splitter in action (courtesy of Paul Scherrer Institute).

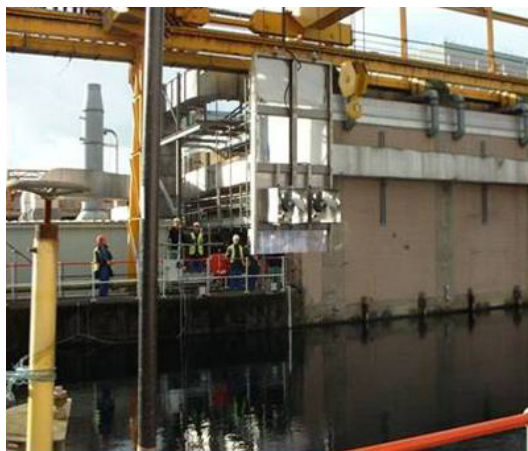
FIG. I-57. Flowmaker and bay desludging operations (courtesy of Sellafield Ltd).

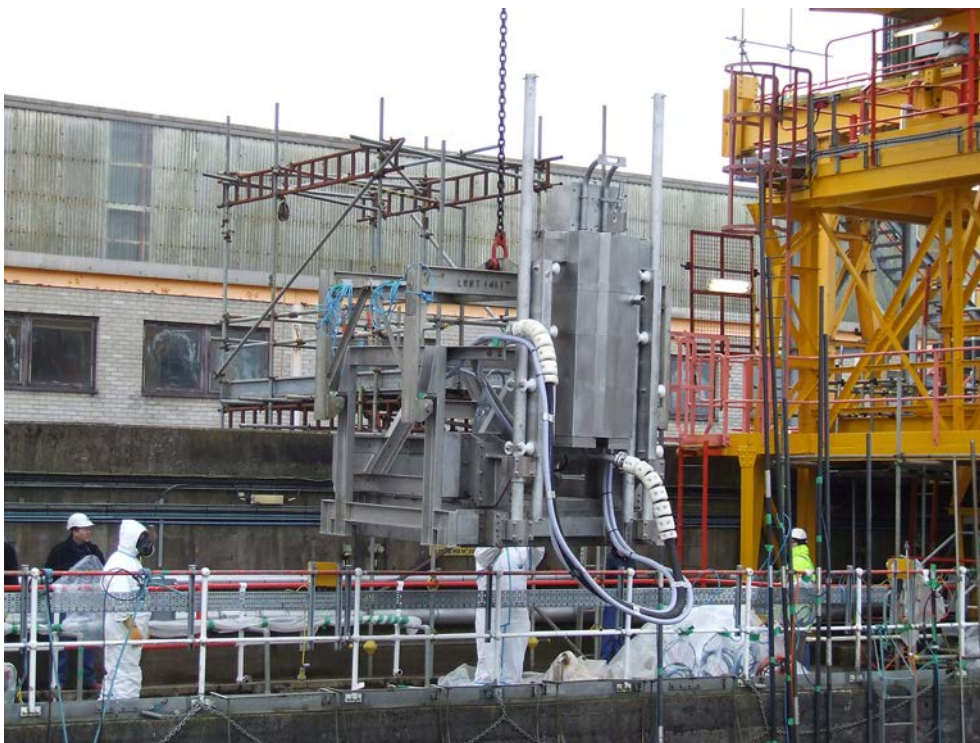
FIG. I-60. Sludge hood installation (courtesy of Sellafield Ltd).

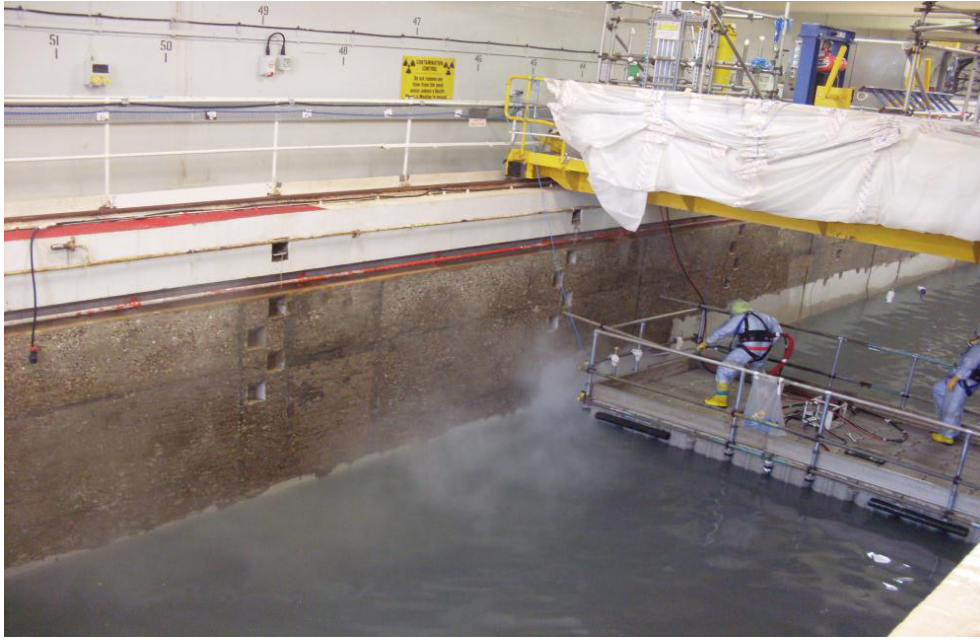
FIG. I-77. Manual hydrolasing of pond walls from pontoon platforms (courtesy of Magnox Ltd).

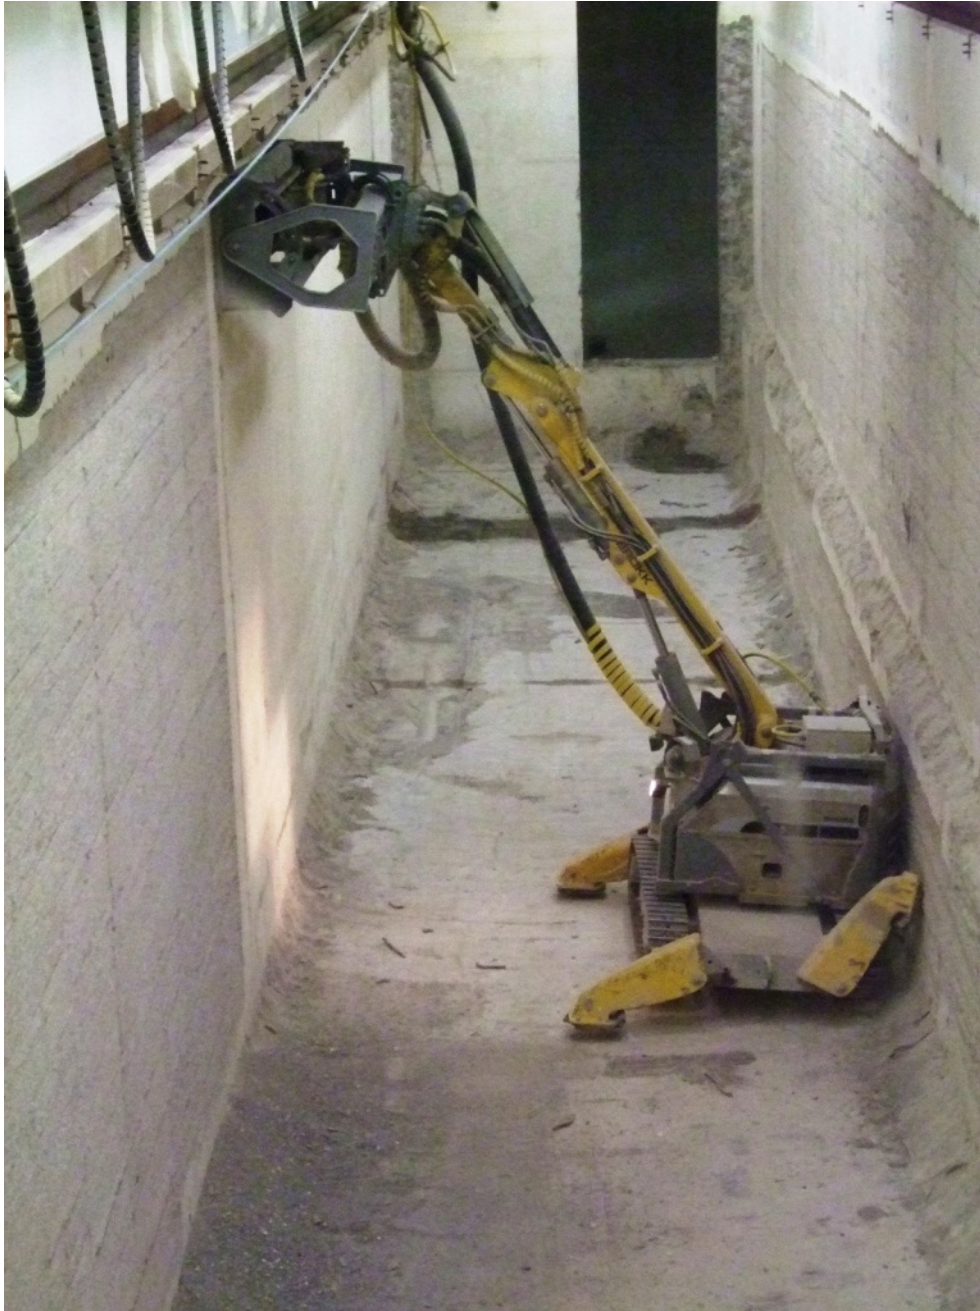
FIG. I-81. Dry scabbling of Trawsfynydd pond lanes (courtesy of Magnox Ltd).
