IAEA Nuclear Energy Series

No. NW-T-2.8

Managing the Unexpected in Decommissioning

INTERNATIONAL ATOMIC ENERGY AGENCY
VIENNA, 2016

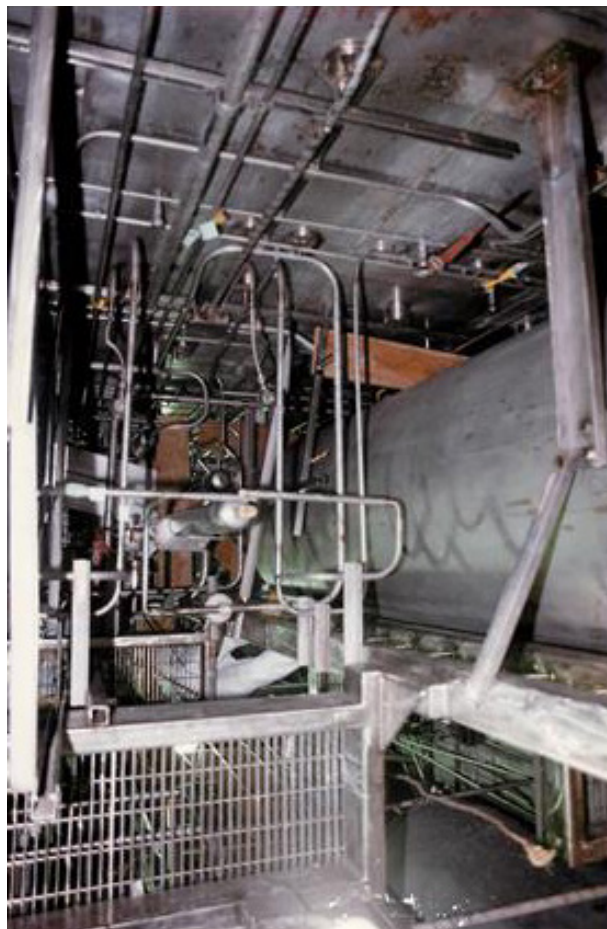
FIG. 5. Example of congested room layout posing difficulties for decommissioning.

Another common source of unexpected events during decommissioning is associated with highly congested services in a room (see example in Fig. 5). Often, cables, pipes and vessels are located close to one another to minimize the space required. However, during decommissioning, this can lead to difficulties because it may not be easy to identify which pipe, cable or vessel is isolated and available for decommissioning. During the design phase, consideration should be given to the ease with which such services can be identified to ensure that they can be isolated and decommissioned without danger. In the case of pipes, vessels, pumps and valves, which may contain radioactive fluids, it is possible that one item shields another, thus making it difficult to be certain which one represents the radiation source.

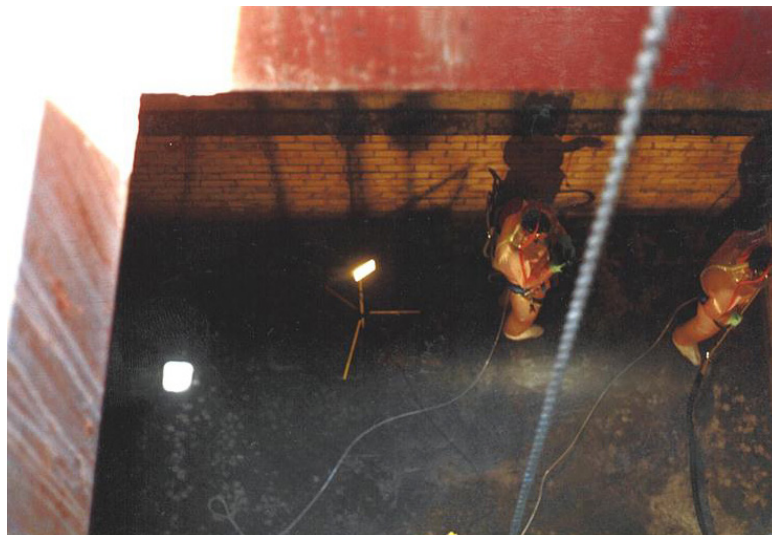
FIG. 7. Dismantling of a graphite silo, Vandélos 1 nuclear power plant, Spain. Photograph courtesy of Enresa.

In some cases, operational wastes have been created for which there are no straightforward disposition routes. Examples of this are the core and fuel element graphite for the Magnox reactors and advanced gas cooled reactors (AGRs) in the UK and high-power channel-type (RBMK) reactors in other locations. Until the disposition route for this material, which has an extremely long half-life, is identified, the core graphite is being retained inside the reactor pressure vessel. This is one of a number of factors that govern the deferred dismantling strategy for these reactors. The fuel element graphite (e.g. sleeves) is typically being stored in on-site temporary intermediate level waste stores (see example in Fig. 7).

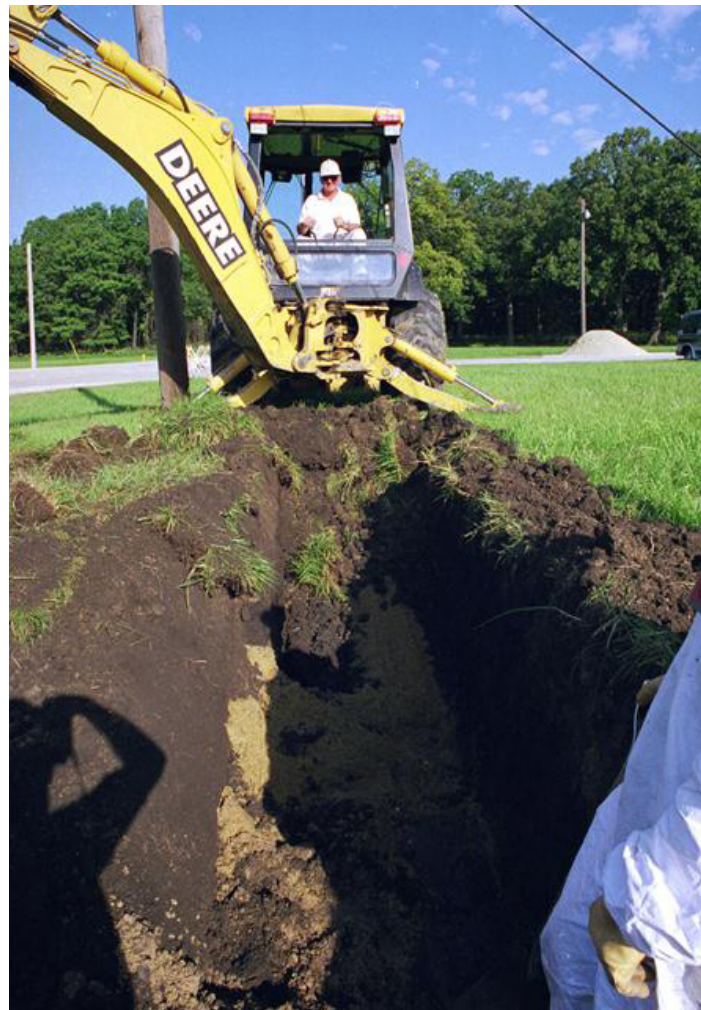
FIG. 11. Removal of underground structures, Argonne National Laboratory, United States of America.

Inaccessible rooms, channels, canals and underground structures are difficult to characterize because it may not be possible to take samples prior to actual removal of the component in question (see example in Fig. 11).

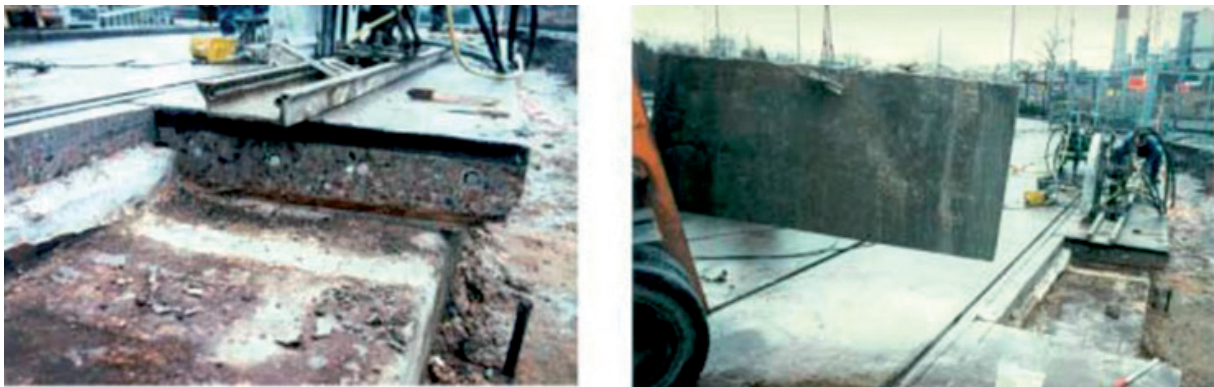
FIG. 16. Segmentation of the HDR superheated steam reactor road to remove contamination.

During the characterization of soil and roads of a site, special attention must be paid to areas where accumulations of contamination can occur, for example, the seals of roads and drains. In such areas, an intense sampling programme should be considered to prevent unforeseeable delays [47].

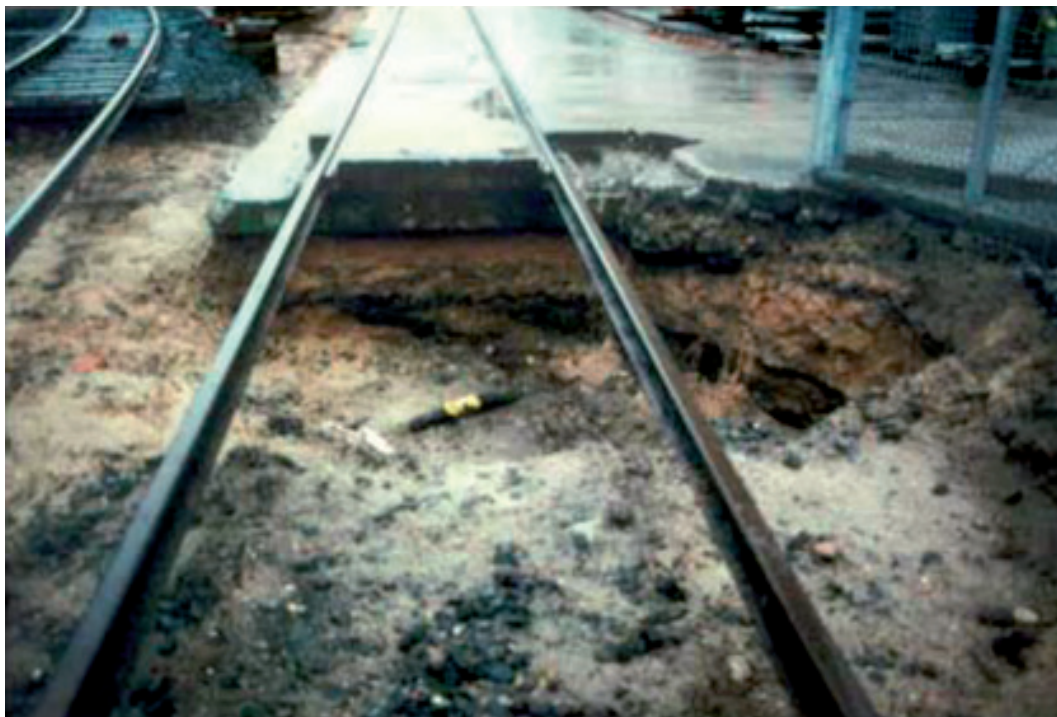
FIG. 17. View after remediation measures at the HDR superheated steam reactor.

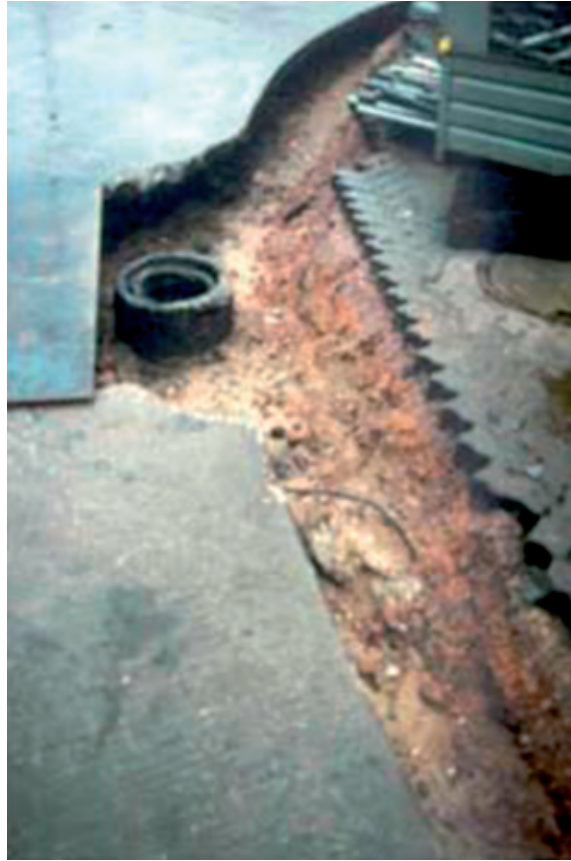
FIG. 18. Control measurements of drains at the HDR superheated steam reactor.

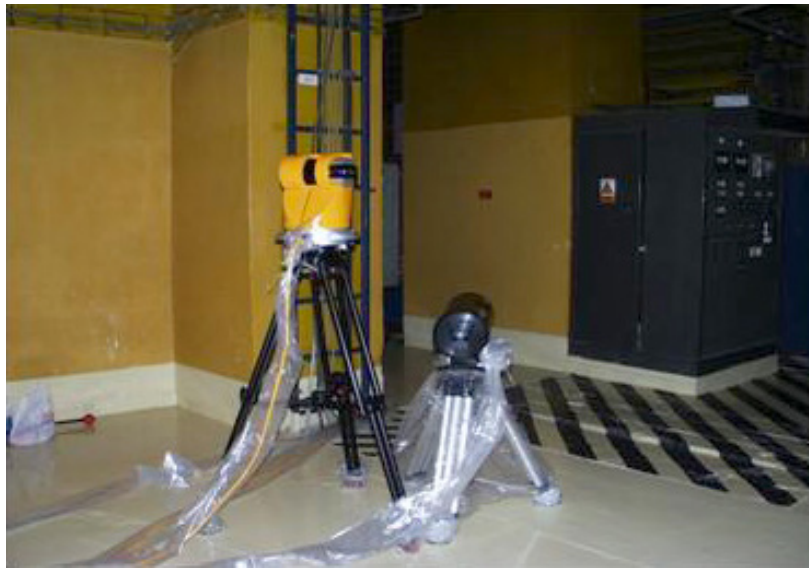
FIG. 21. Laser scanners used to support characterization for the decommissioning of the A1 nuclear power plant, Slovakia. Image courtesy of VÚJE.

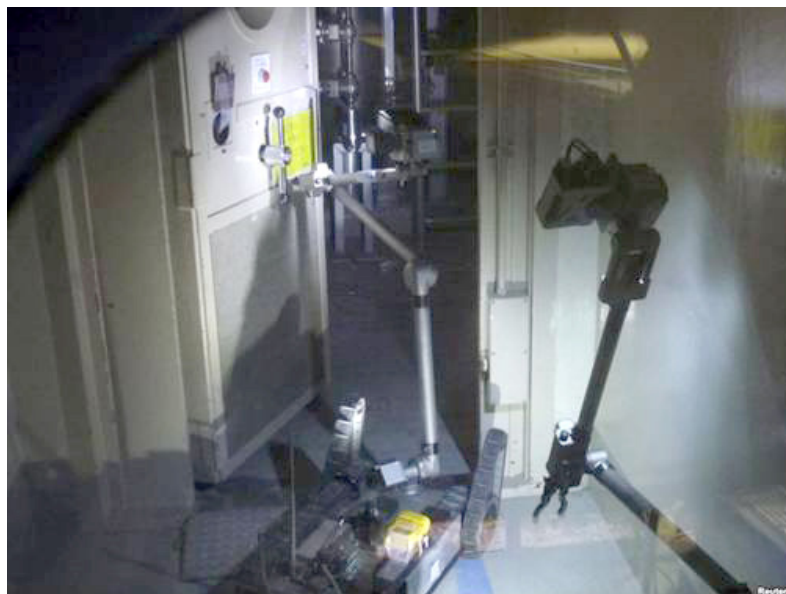
FIG. 23. A Packbot robot at work inside Fukushima Daiichi Unit 3, Japan. Image courtesy of TEPCO.

Robots from the USA were used to enter the Fukushima Daiichi buildings and provide initial views inside. Two Packbot robots were used in early efforts to ascertain the full extent of the wreckage inside the units (see Fig. 23).

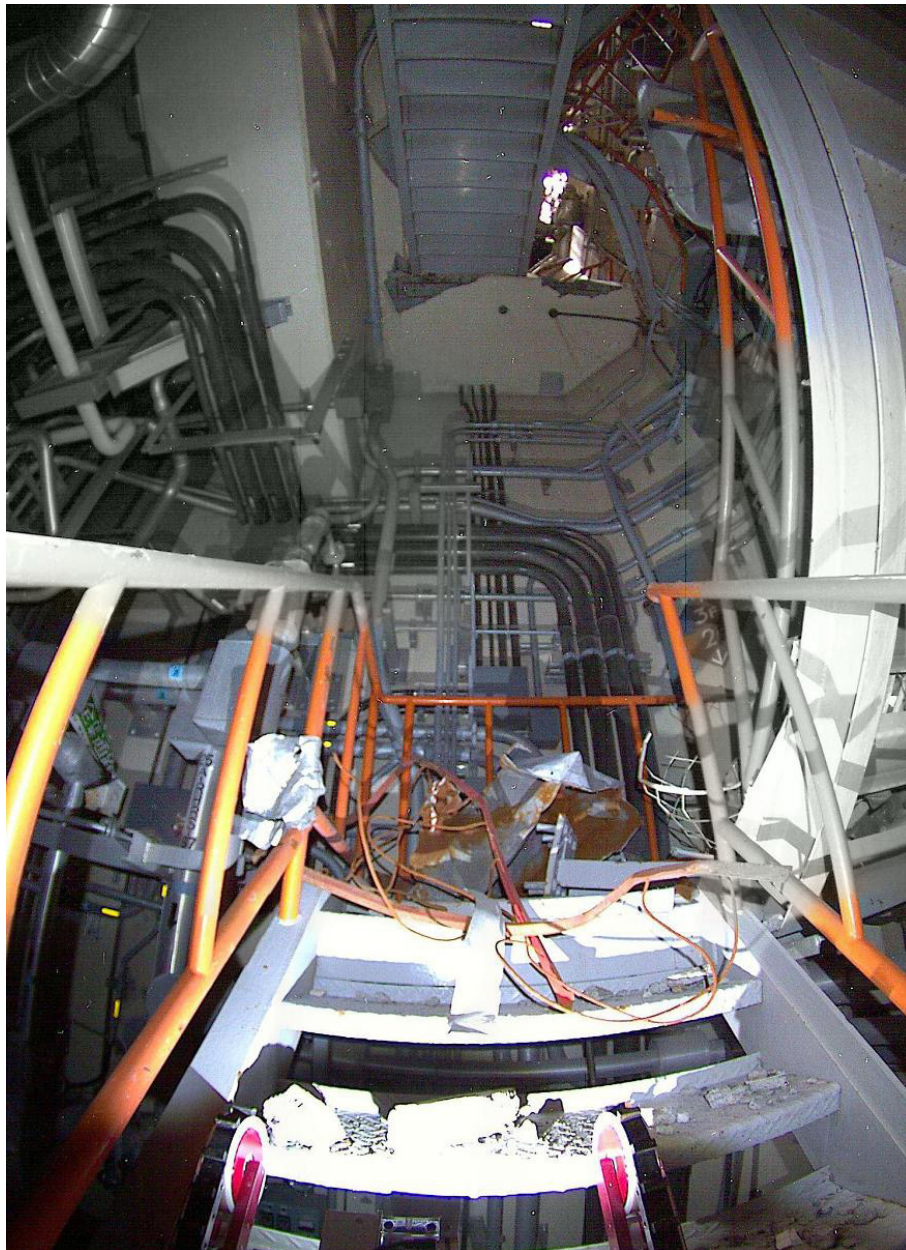
FIG. 24. Image of Fukushima Daiichi Unit 3, staircase from second to third floor, taken by the robot Quince on 26 July 2011. Photograph courtesy of TEPCO.

Another Japanese robot used at Fukushima Daiichi was the robot Quince, developed by scientists at the Chiba Institute of Technology and other universities. The robot had been reinforced with new radiation protection features to make it suitable for use at Fukushima Daiichi, and was used in six missions between 24 June and 20 October 2011. An example image taken by the robot is shown in Fig. 24.

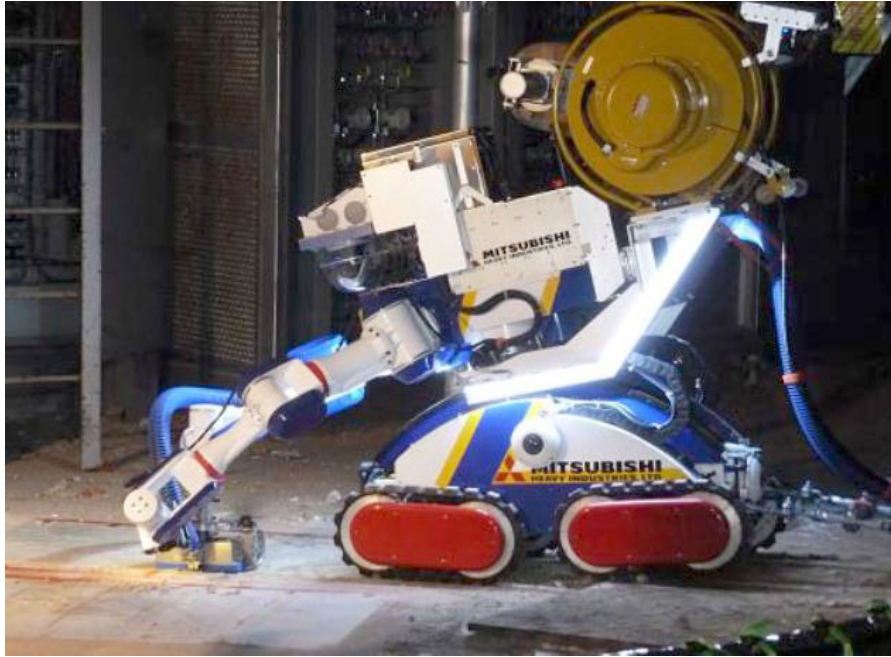
FIG. 26. Remote controlled decontamination device. Photograph courtesy of TEPCO and Mitsubishi Heavy Industries.

The latest examples of advanced robots developed for difficult tasks of the Fukushima Daiichi decommissioning are shown in Figs 25 and 26. Several decontamination robots are to be used to apply various decontamination techniques [101].

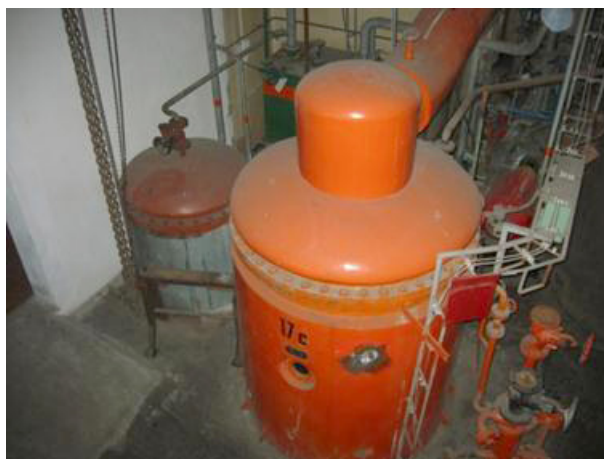
FIG. I-3. Old evaporator (heater and separator).

An old evaporation system used for the treatment of liquid waste consisted of a steam based heater (diameter 1.4 m, height 4.2 m) and a separator (diameter 1.4 m, height 4.2 m) (see Fig. I-3). The separator was partially dismantled by oxyacetylene cutting before removal (see Fig. I-4), because it was too large to be removed as a single item. It was encased in concrete, which was not as per the original design documentation. The heater was removed in one piece.

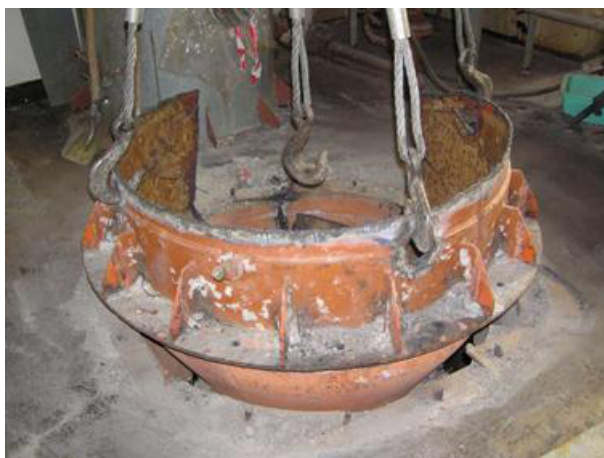
FIG. I-4. Removing the separator after partial segmentation.

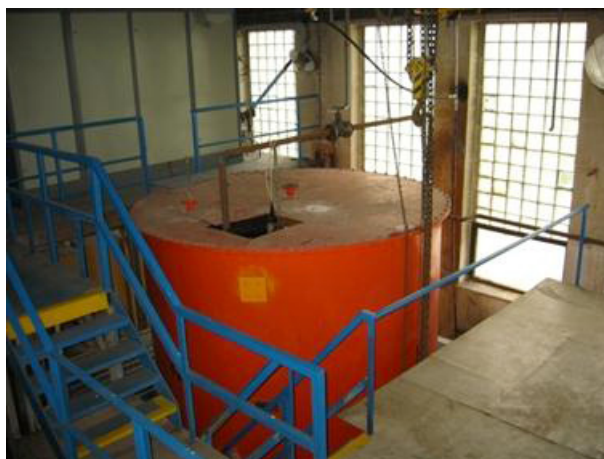
FIG. I-5. Sedimentation tank before dismantling.

Two sedimentation tanks, each of volume 25 m³, were used for sedimentation of liquid radioactive waste during chemical pretreatment (see Fig. I-5). After sludge removal, the tanks underwent preliminary decontamination by high pressure water jetting before being partially dismantled by a nibbler and using oxyacetylene cutting. This was necessary because it was not possible to remove them in one piece owing to their encapsulation in concrete, which was in contrast to the design documentation (see Fig. I-6).

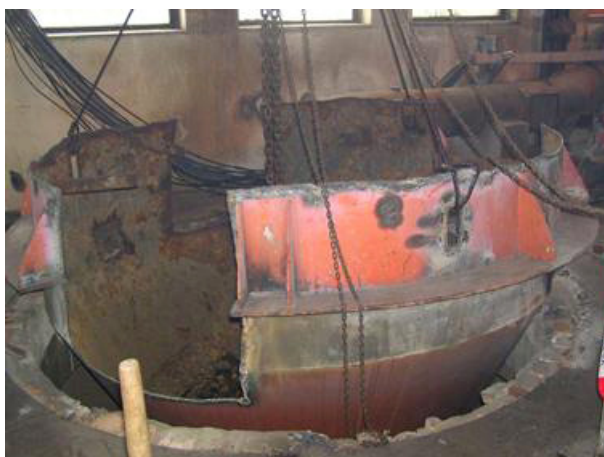
FIG. I-6. Removal of the rest of the sedimentation tank.

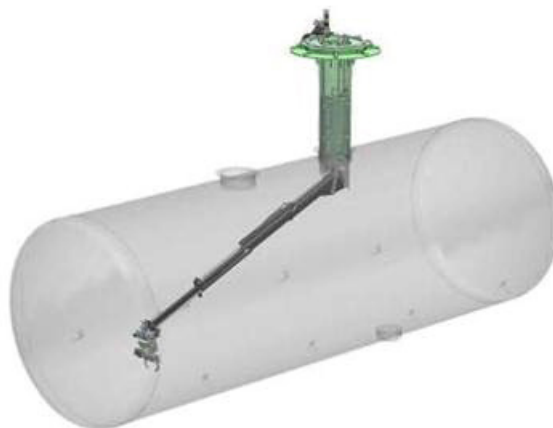
FIG. I-14. Remote controlled manipulator inside the tank.

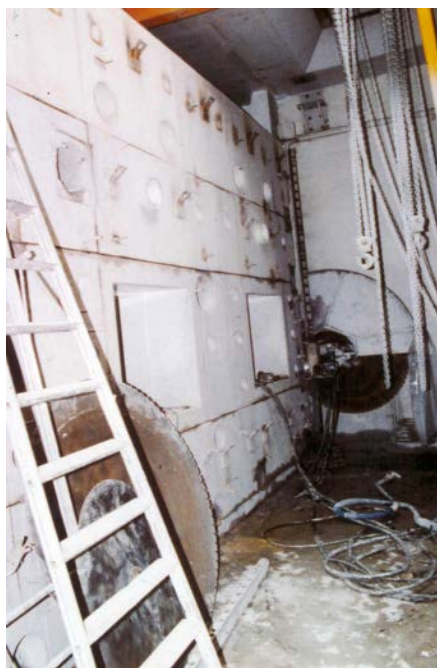
FIG. II-3. After cleaning, walls were cut into blocks (of weight 2–3 t), radiologically checked and sent to ANDRA for disposal.

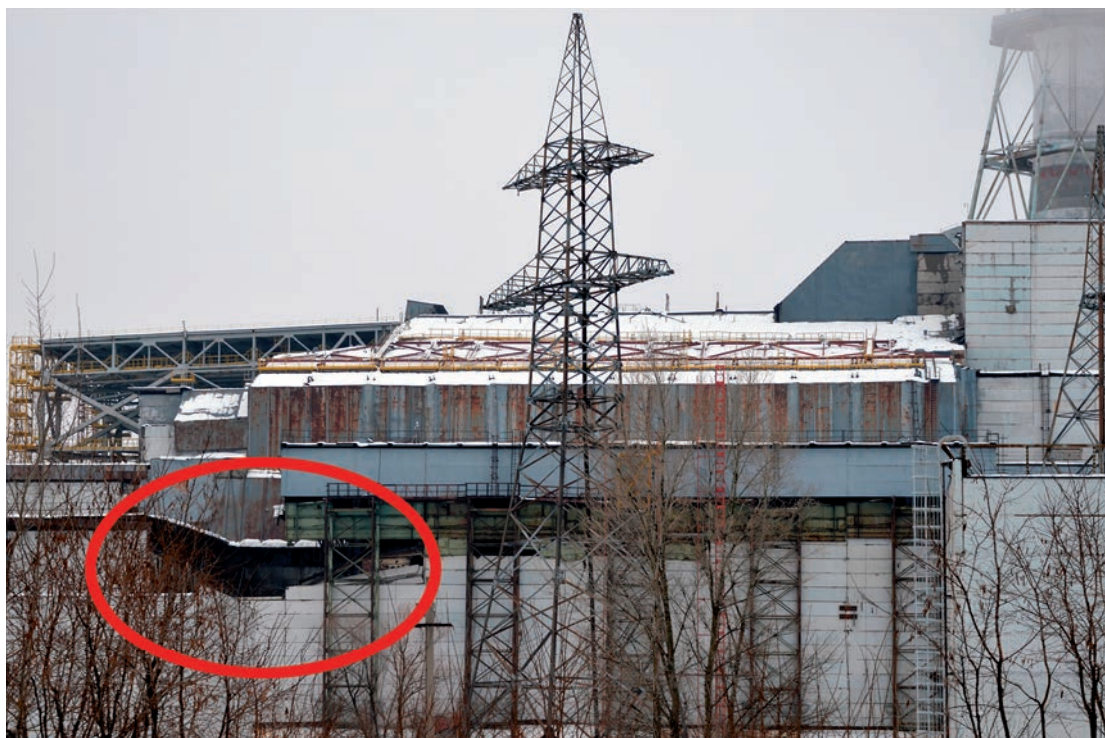
FIG. III-4. Collapse of part of the roof over Chernobyl nuclear power plant unit 4 turbine hall.

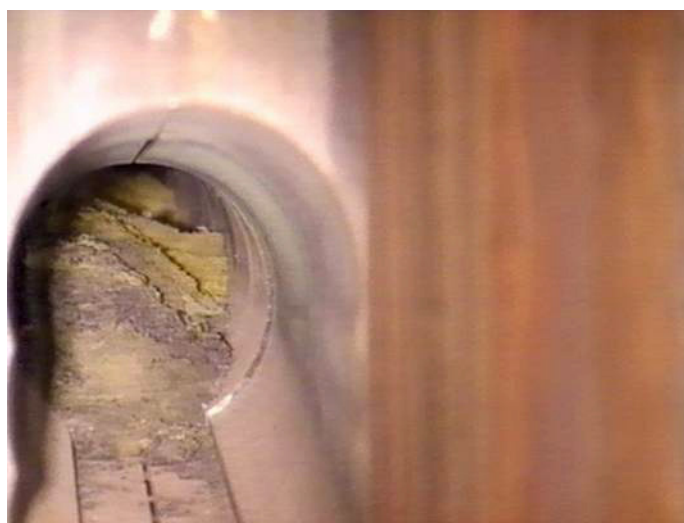
FIG. IV-3. Fuel element debris within the fire affected zone fuel channel.

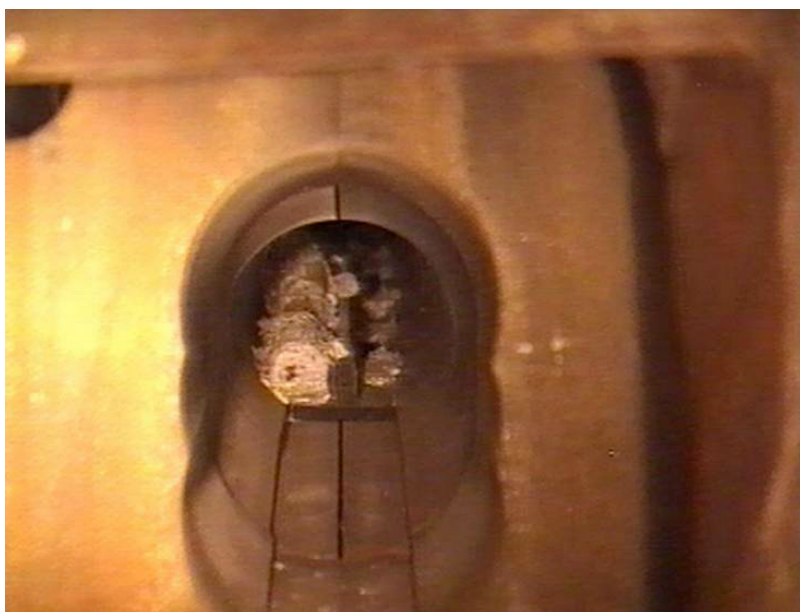
FIG. IV-4. Fire damaged fuel element displaced from its graphite boat.

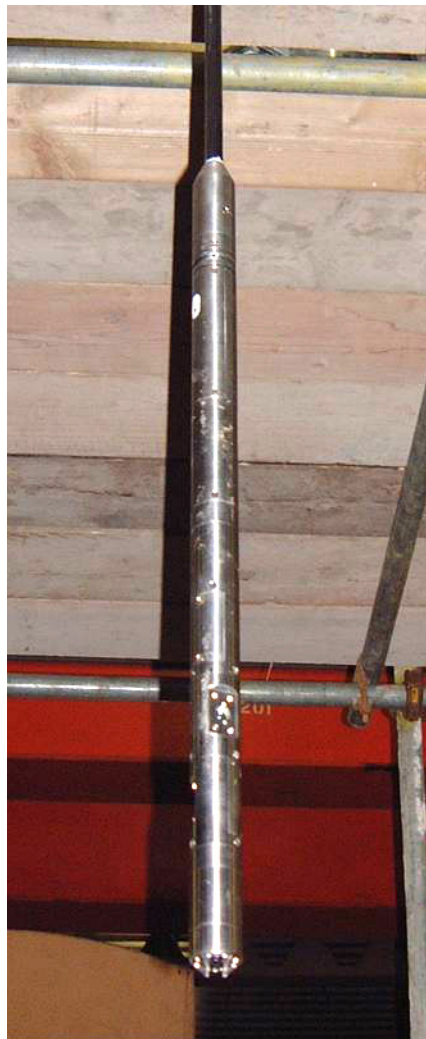
FIG. IV-5. Intrusive inspection equipment for foil hole examination at Windscale pile 1 and spring debris.

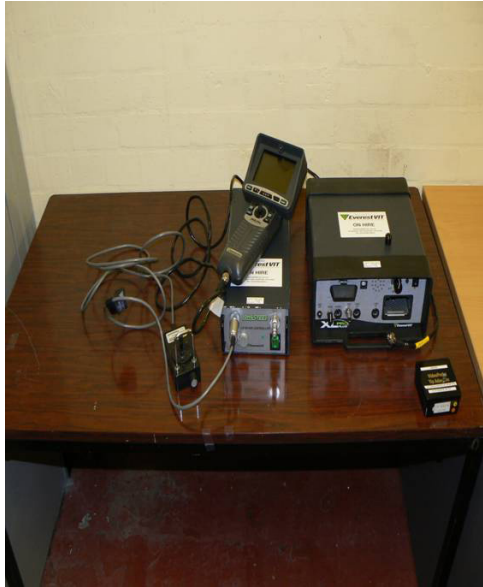
FIG. IV-7(a). Endoscope equipment for fire affected zone inspection at Windscale pile 1.

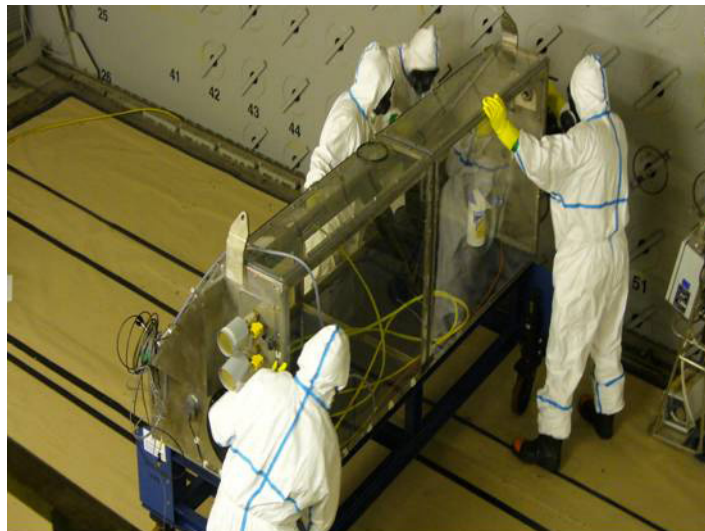
FIG. IV-7(b). Interfacing the endoscope with the Windscale pile 1 charge face.

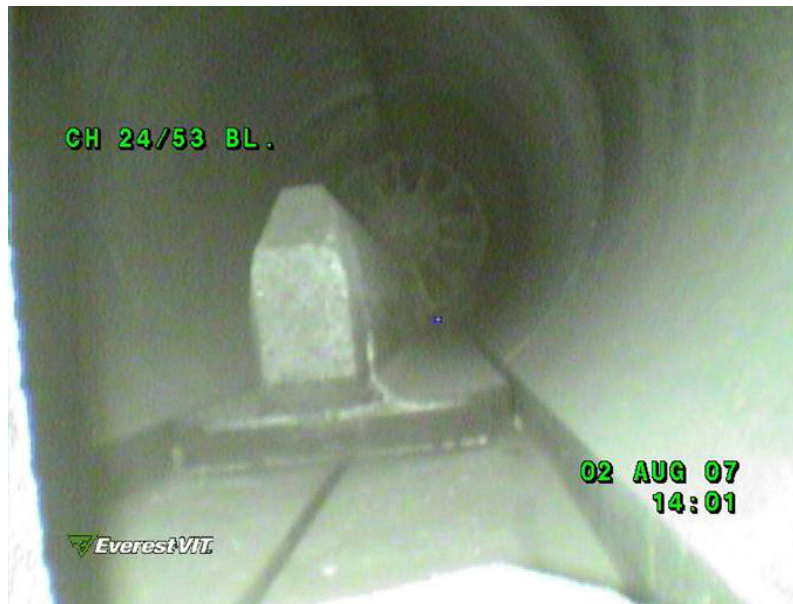
FIG. IV-8(a). Fuel channel 24/53 BL internals showing a fuel element displaced from a graphite boat.

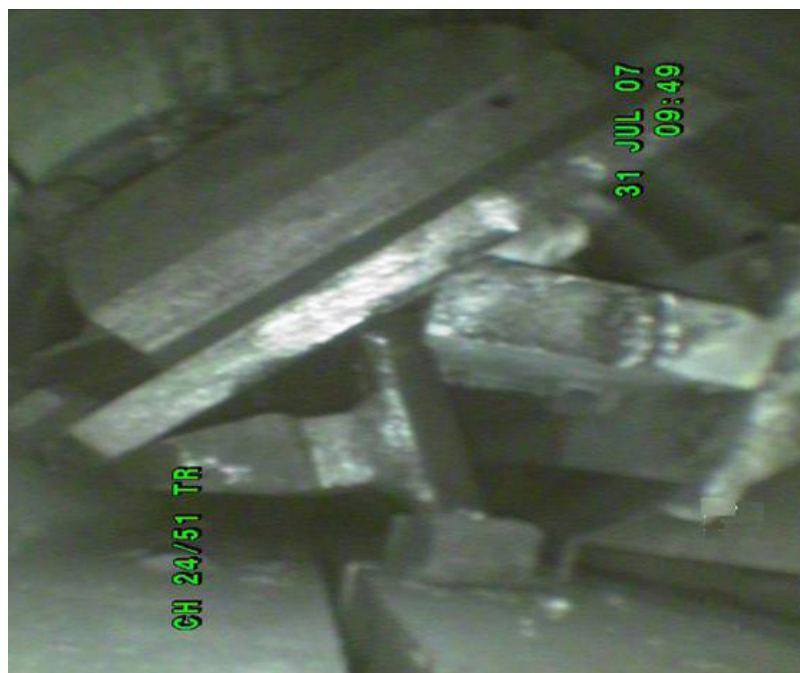
FIG. IV-8(b). Damaged graphite boats in channel 24/51 TR.

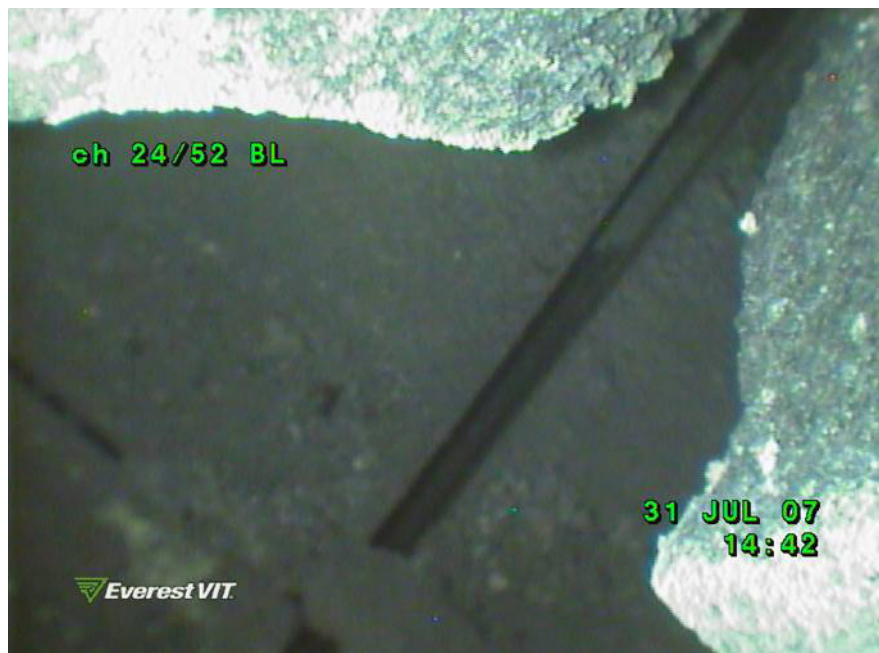
FIG. IV-10. Oxidation damage to the graphite structure at channel 24/52 BL.
