***Iodine induced stress
corrosion cracking of Zircaloy
fuel cladding materials***

IAEA-TECDOC-1185

This report documents the work performed by the Co-ordinated Research Project (CRP) on Stress Corrosion Cracking of Zirconium Alloy Fuel Cladding. The project consisted of out-of-pile laboratory measurements of crack propagation rates in Zircaloy sheet specimens in an iodine containing atmosphere. The project was overseen by a supervisory group consisting of experts in the field, who also contributed a state of the art review.

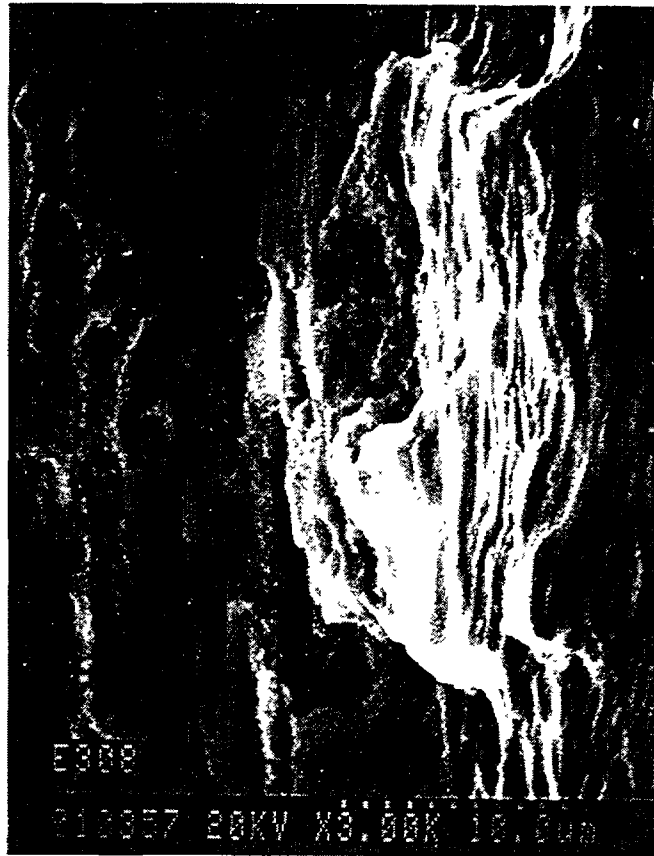
FIG. 2.14. Specimen E308 showing ductile tearing of material between cracks proceeding on different planes.

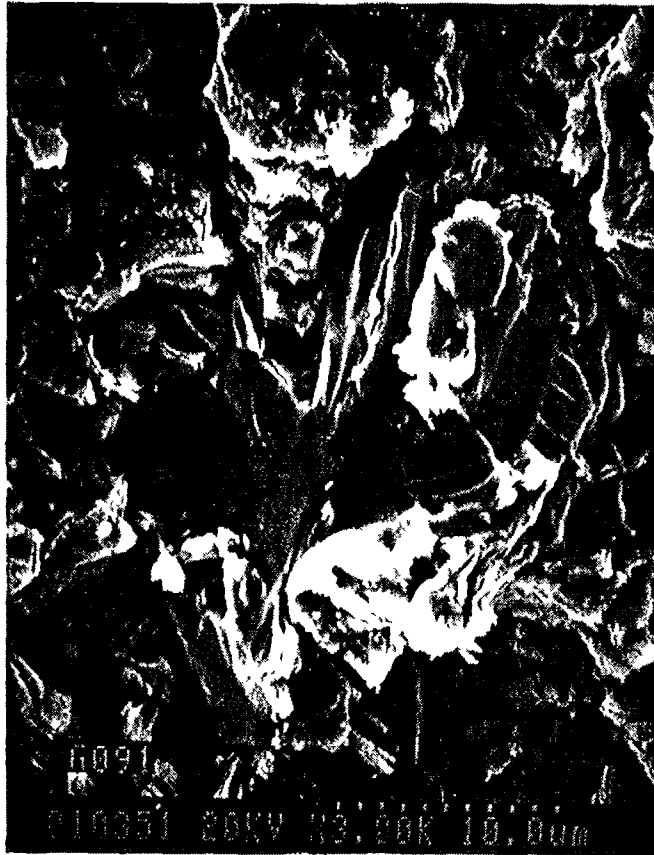
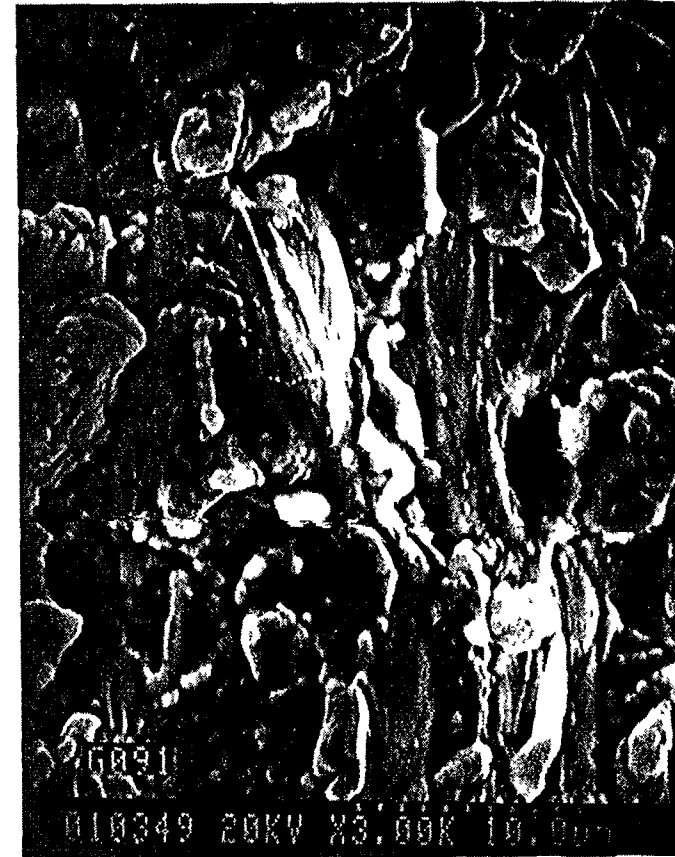
FIG. 2.15. "River patterns" left and "fluting" right on the fracture surface of specimen G091, a stress-relief annealed Zr-4 specimen (material OM41) tested at 350 °C with 100 Pa of iodine.

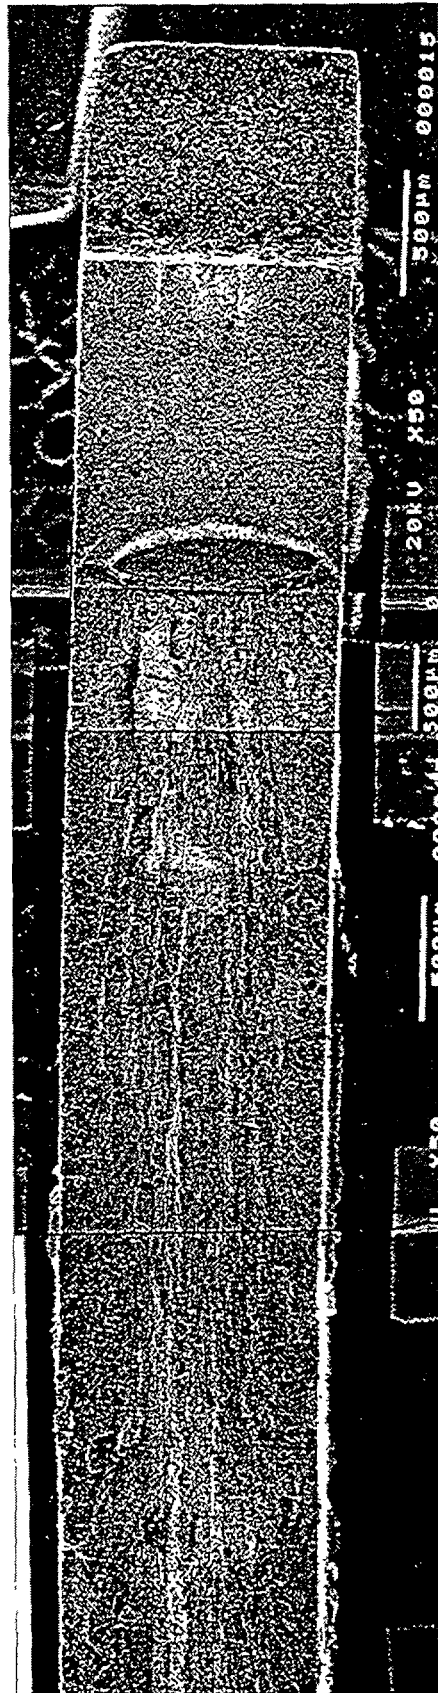
Fig. 6.20. Fracture surface of E246.
