Anthropogenic analogues for geological disposal of high level and long lived waste

Final report of a coordinated research project 1999–2004

IAEA, VIENNA, 2005
IAEA-TECDOC-1481
ISBN 92-0-113105-4
ISSN 1011-4289

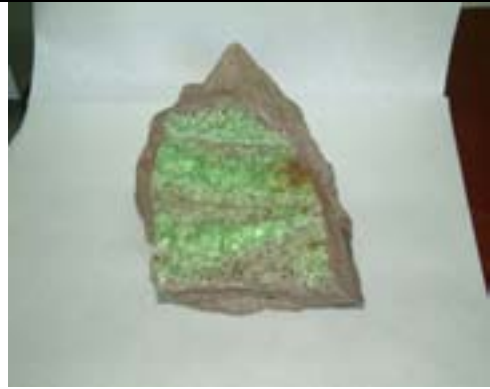
FIG. C-4. Uranium glass attached to furnace liner.

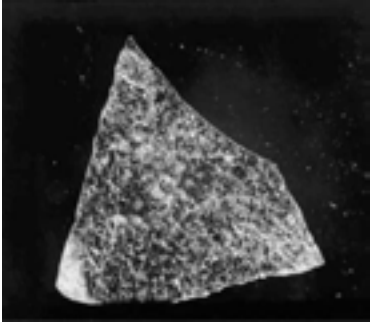
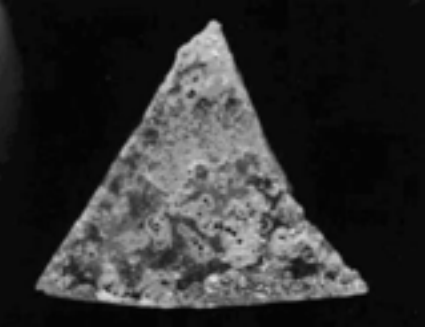
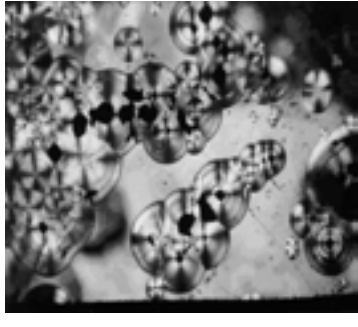
<p><i>FIG. D-2. Glass sample (SP-132/17, ×2).</i></p>	<p><i>FIG. D-3. Glass sample (SP-149/21, ×2).</i></p>	<p><i>FIG. D-4. Thin glass section in transmission polarization light (glass sample SP-164/1, ×250, crossed nicols).</i></p>

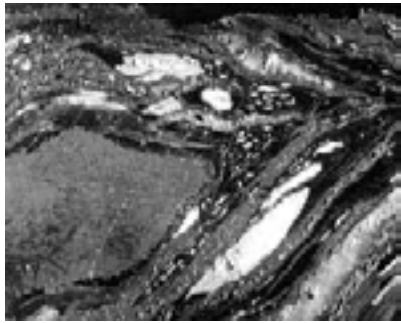
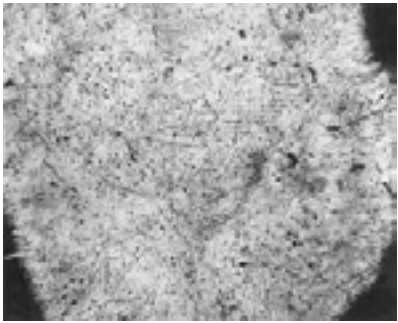
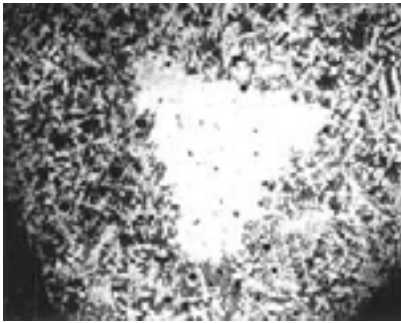
<i>FIG. D-11. Mineralised surface of coin's cross-section (No. 9); Cu, with 17% Sn; corrosion layer ~3.7-4.5 mm.</i>	<i>FIG. D-12. Cross-section structure of wire ring sample (No. 7); Cu with 6% Sn; corrosion layer ~50-70 μm.</i>	<i>FIG. D-13. Cross-section structure of sample No. 2; Cu with 23% Sn and 3% Pb; corrosion layer ~30-40 μm.</i>

It is well known that the phenomenon of inverted segregation, sometimes called a “tin sweat”, is often observed on tin bronze castings, especially when these casting were manufactured by using sand-clay moulds. In such cases, Sn content in the “tin sweat” could be 2–2.5 times higher than the average content in the alloy [12].
