***Fuel failure  
in normal operation of water reactors:  
experience, mechanisms  
and management***

*Proceedings of a Technical Committee Meeting  
held in Dimitrovgrad, Russian Federation, 26–29 May 1992*

**IAEA-TECDOC-709**

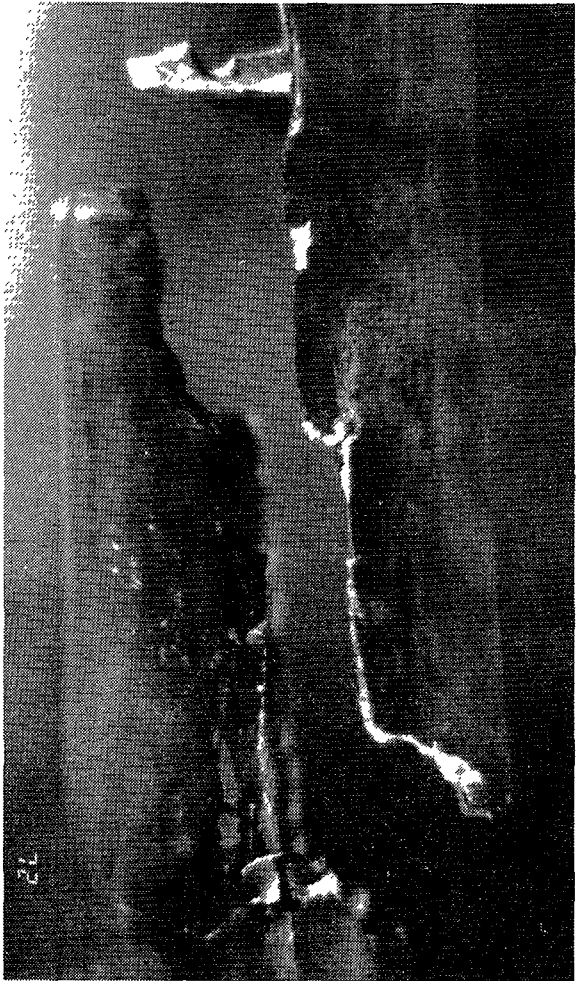
FIG. 2. Untight fuel element within the upper rupture of cladding.
