THE RADIOLOGICAL ACCIDENT IN THE REPROCESSING PLANT AT TOMSK

INTERNATIONAL ATOMIC ENERGY AGENCY

Printed by the IAEA in Austria
October 1998
STI/PUB/1060

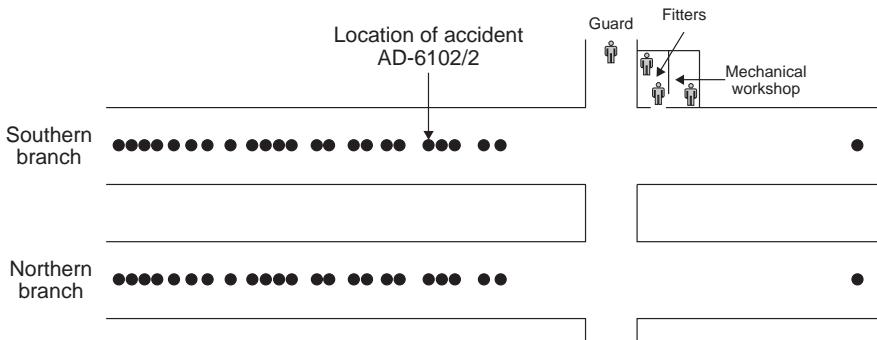
FIG. 8. Location of Installation AD-6102/2 in Building 201 at the RCW, where the accident occurred.

AD-6102/2, a vessel used to prepare the solution prior to reprocessing. Figure 8 shows the position of this installation relative to the other vessels in Building 201, together with the location of personnel who were in the building at the time of the accident. Installation AD-6102/2 comprised a stainless steel vessel with a volume of 34 m³ incorporating a steam heating and cooling sleeve, and was fitted with a number of sensors for process control. These sensors included two level indicators, a thermometer, a 'PIT OPEN' warning device, a pressure transducer, a flow rate transducer for bubbling control and radiometric control sensors.

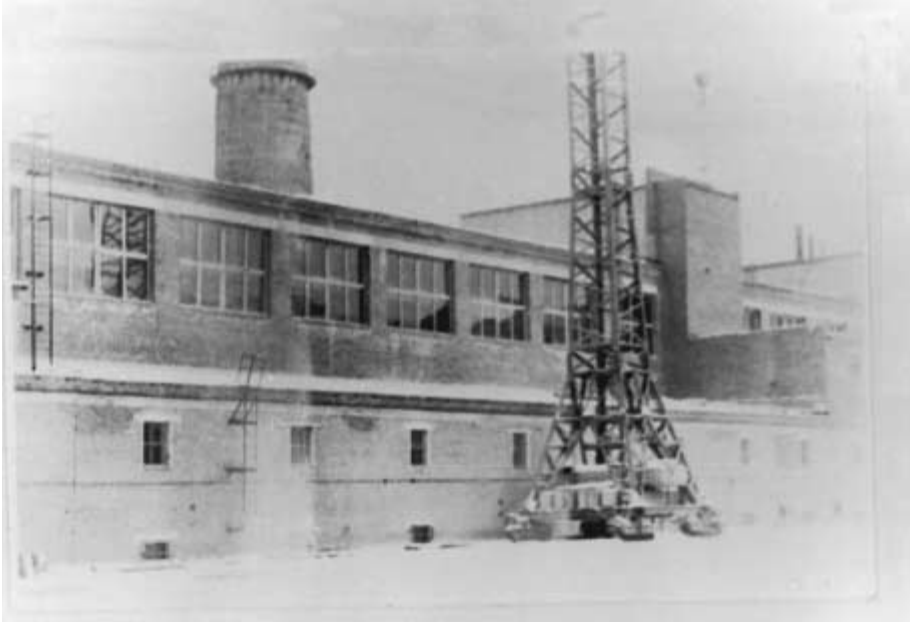
Photo 4. View of Building 201 after restoration.
