## Organizational and Managerial Aspects of Decommissioning after an Accident

Miroslav Božik, Peter Gerhart JAVYS, Plc. Slovak Republic

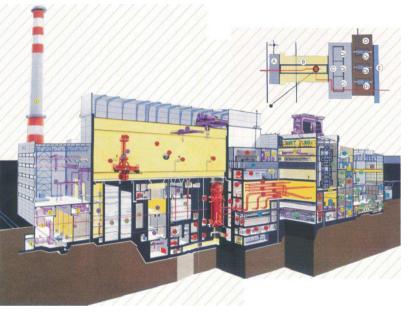
Reactor type: NPP type: Fuel: Moderator: Coolant: KS-150 HWGCR natural uranium (24 600 kg) D<sub>2</sub>O (57 200 kg) CO<sub>2</sub> (max. press 6,5 MPa)

**Characteristic feature - refuelling during operation.**

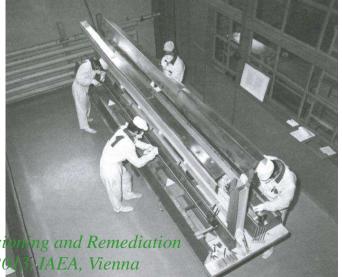
- on 22<sup>nd</sup> February 1977
- in installing a fuel assembly
- causing by human factor
- loaded fuel assembly was defunctioning
- local overheating in reactor core
- damaging of reactor inner channel
- penetration of heavy water to cooling fluid CO<sub>2</sub>
- through untightness in steam generator to secondary circuit
- damaging of most of fuel assemblies in reactor core
- level 4 according to the INES

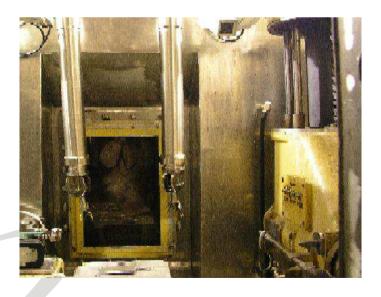
#### 2. Main production building

- Decommissioning of long term spent fuel storage (from which was stored fuel earlier transported to Russian Federation).
- Proposal for a hot cell management.
- Decontamination of A1 NPP rooms and equipment, mainly long term spent fuel storage (LTSP) and reactor hall.

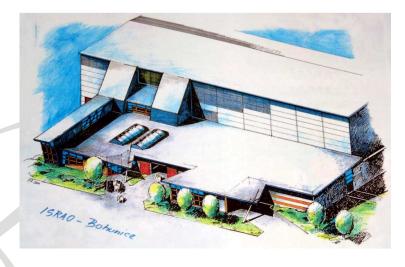
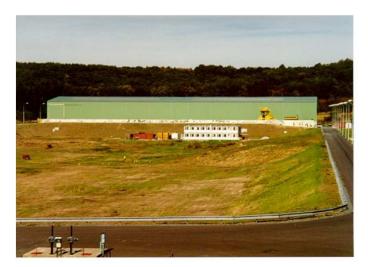
- ✓ Interim storage of RAW
- ✓ Metallic RAW melting facility
- ✓ VLLW repository
- ✓ Structures for disposal of RAW (the third double row)
- ✓ Enlarge the capacity of processing lines (e.g. decontamination, fragmentation)
- ✓ Extend the capacity of monitoring workplaces for free release (into environment)
