# Efforts for the restoration at Fukushima Daiichi Nuclear Power Plants

January 31, 2013

**TOSHIBA CORPORATION**

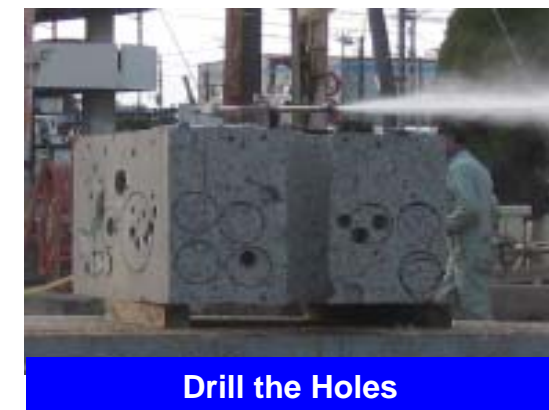
### ◆ Avoidance of hydrogen Explosion

- Drill the roof of reactor building  
(Water jet and core drill)
- Mock up test before explosion of Unit 3

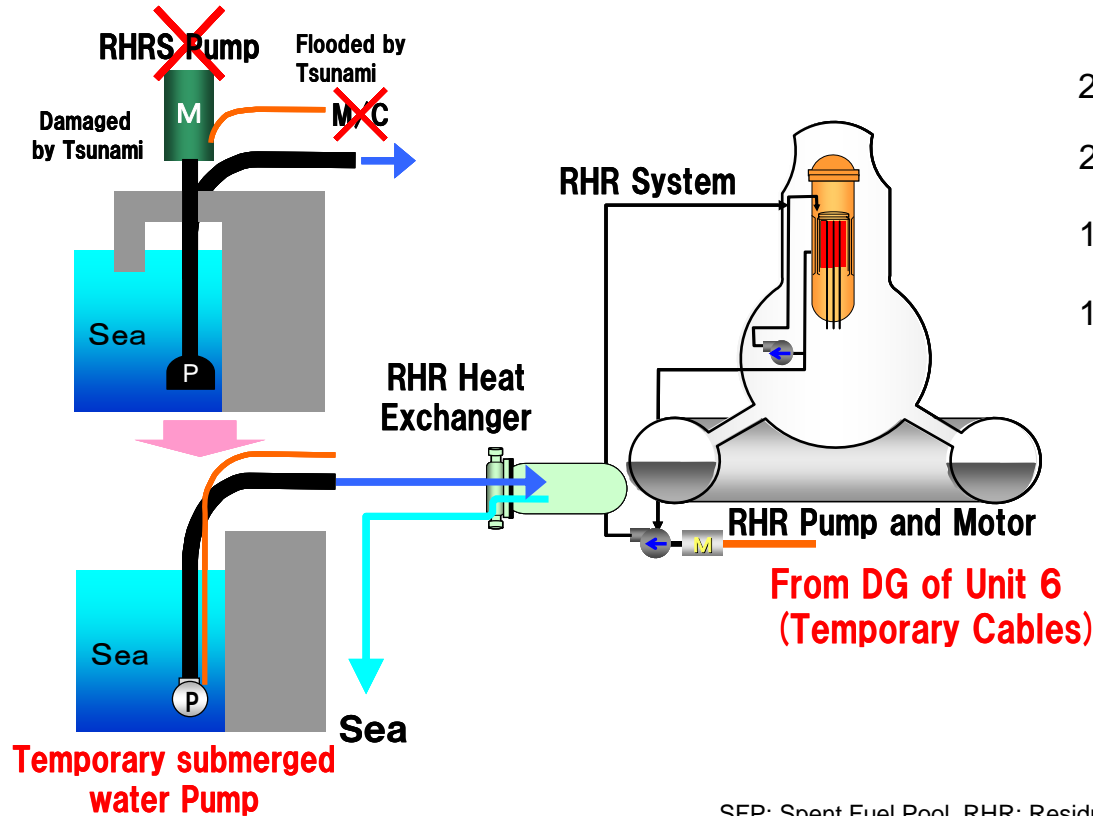
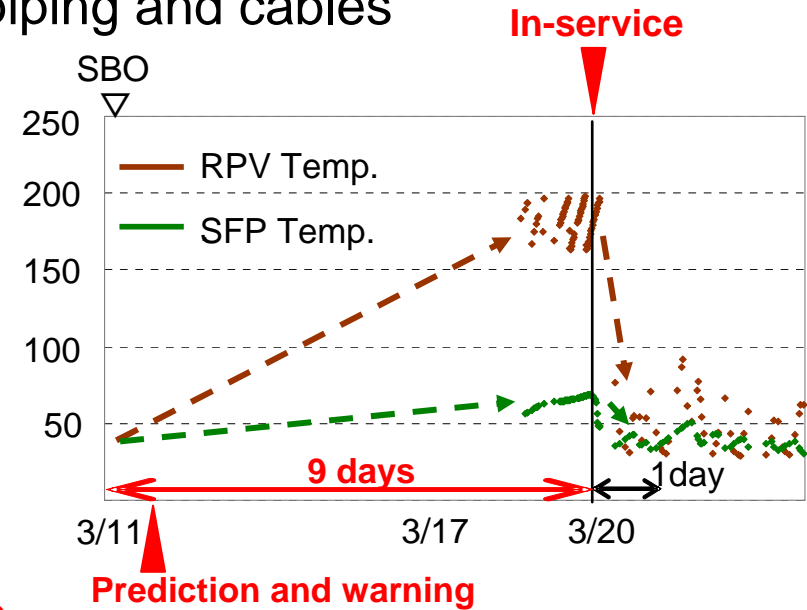
- ◆ Observed and understood the plant condition and predict future trend considering current plant condition
- ◆ Predicted the risk of core and spent fuel damage
- ◆ Designed and installed components, piping and cables

With the installed system operation, temperature began to fall on the first day

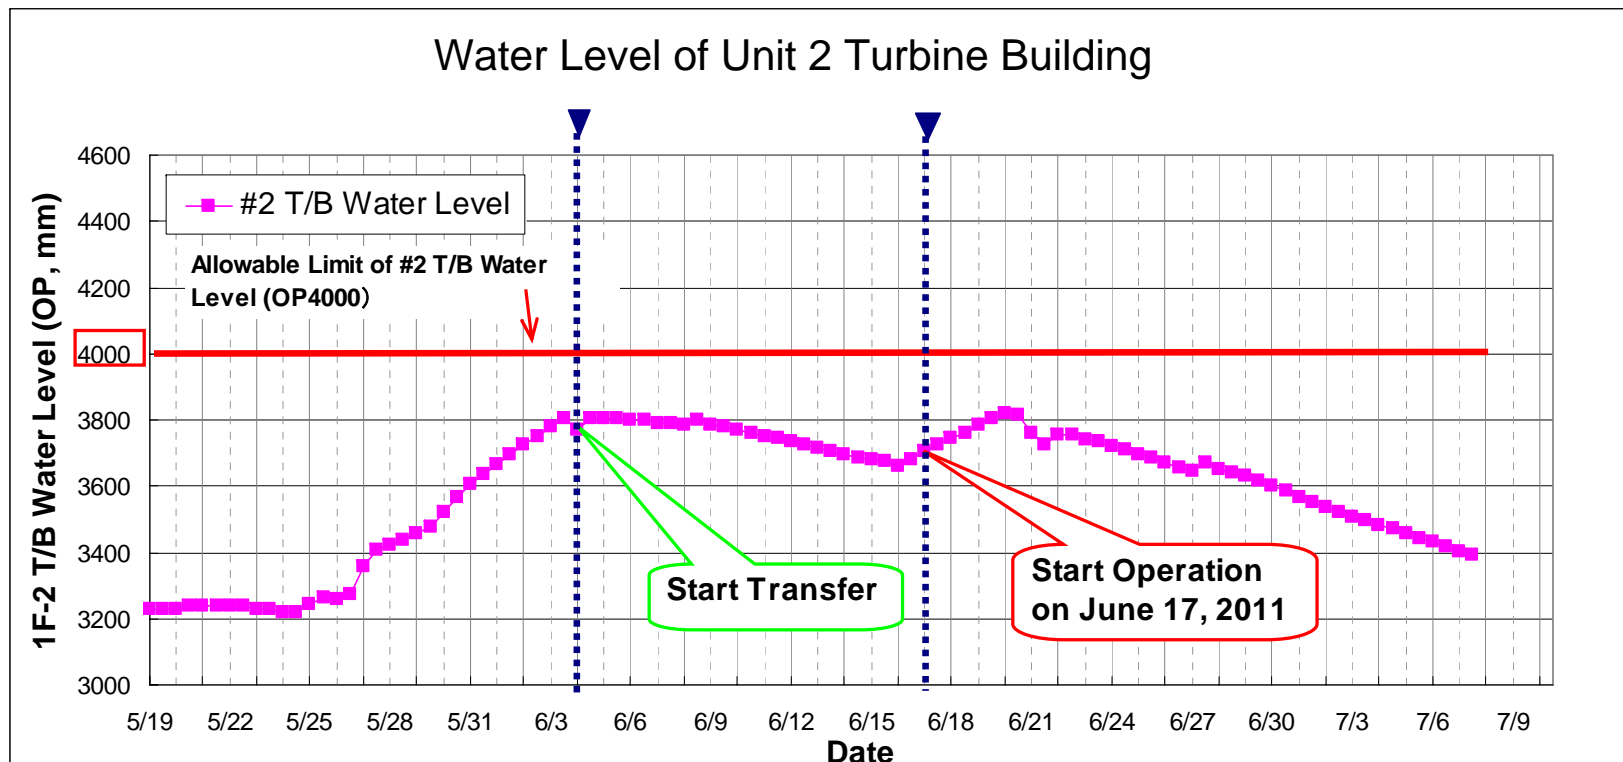
- ◆ KURION & AREVA systems was integrated by Toshiba site work
- ◆ 24-hrs-a-day work to meet schedule

- ◆ Designed started on April 11, and delivered on June 17

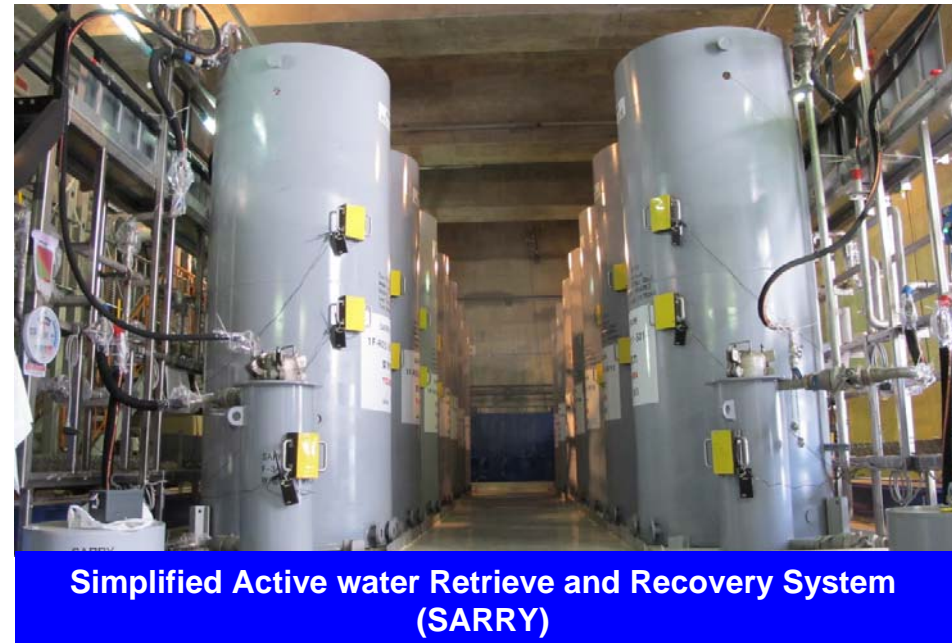
- ◆ Increase the stability and redundancy
- ◆ Ready for operation within only 2.5 months from proposal under severe conditions
- ◆ Major role among water treatment systems since October, 2011

- ◆ Reduction of media changes
- ◆ Shielding design for workers
- ◆ Improvement of DF
- ◆ Stable operation

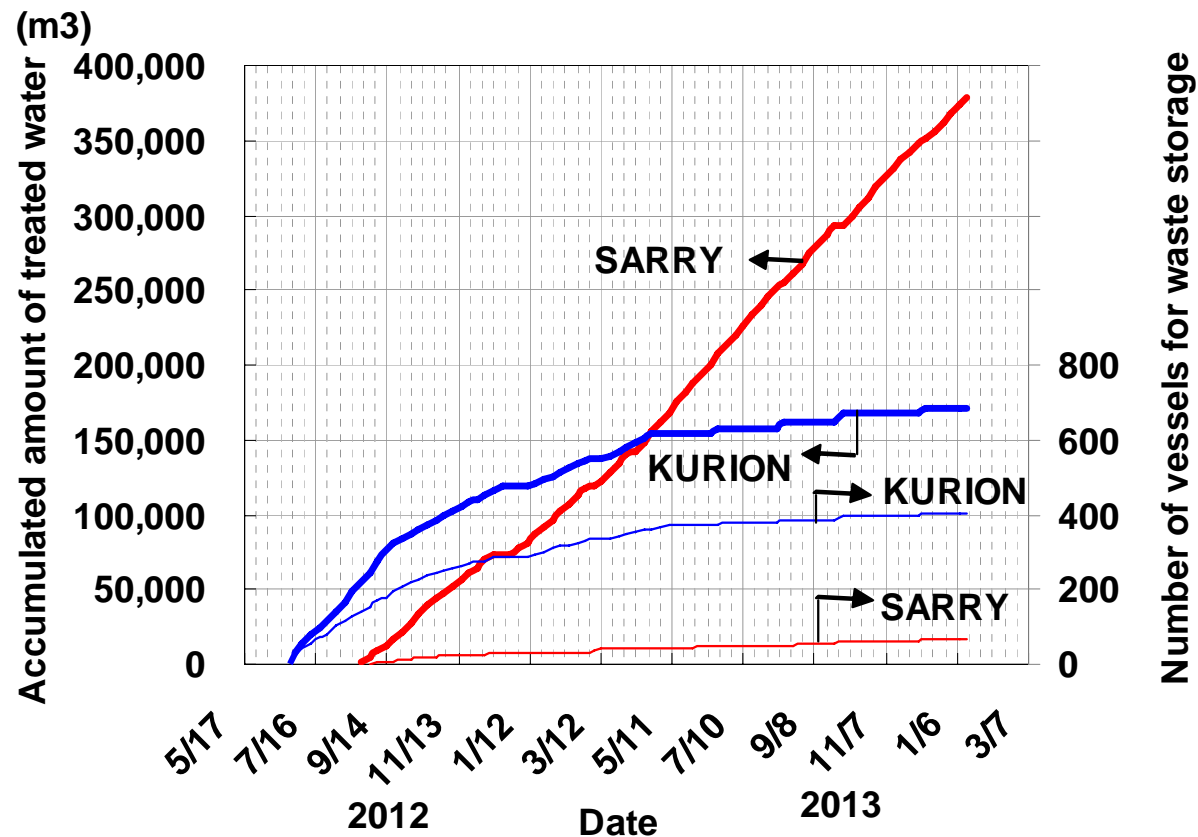
SARRY	KURION	AREVA
Cesium Removal DF	$1 \times 10^6$	$1 \times 10^{2\sim5}$	$1 \times 10^3$
Treated Water/Vessel	5,568 m <sup>3</sup> /vessel	425 m <sup>3</sup> /vessel	-
Max Radiation Exposure*	<1mSv/h	30mSv/h	-

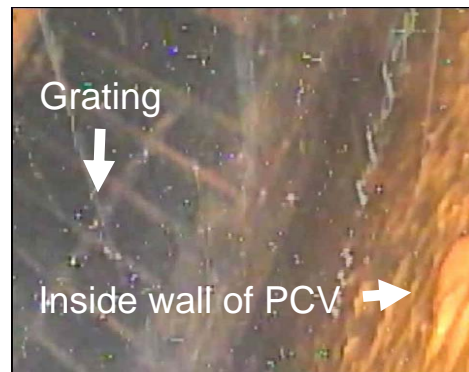
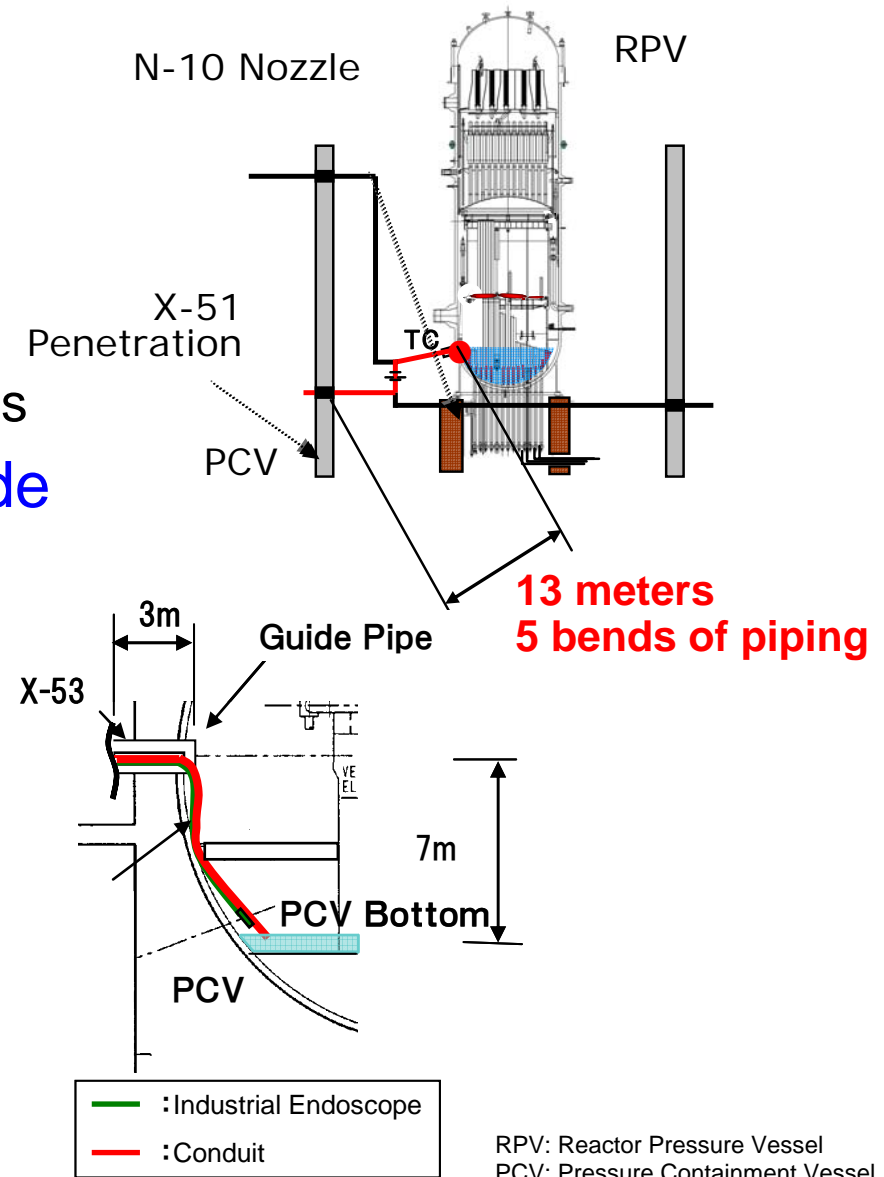
**Photo of PCV inside in Unit 2**

- ◆ Existing thermocouples of RPV have been broken in Unit 2
- ◆ Installed alternate thermocouple under severe radiation conditions

- ◆ Industrial endoscope
- ◆ Performed 1<sup>st</sup> and 2<sup>nd</sup> entry into PCV of Unit 2
- ◆ Evaluated water level within the PCV

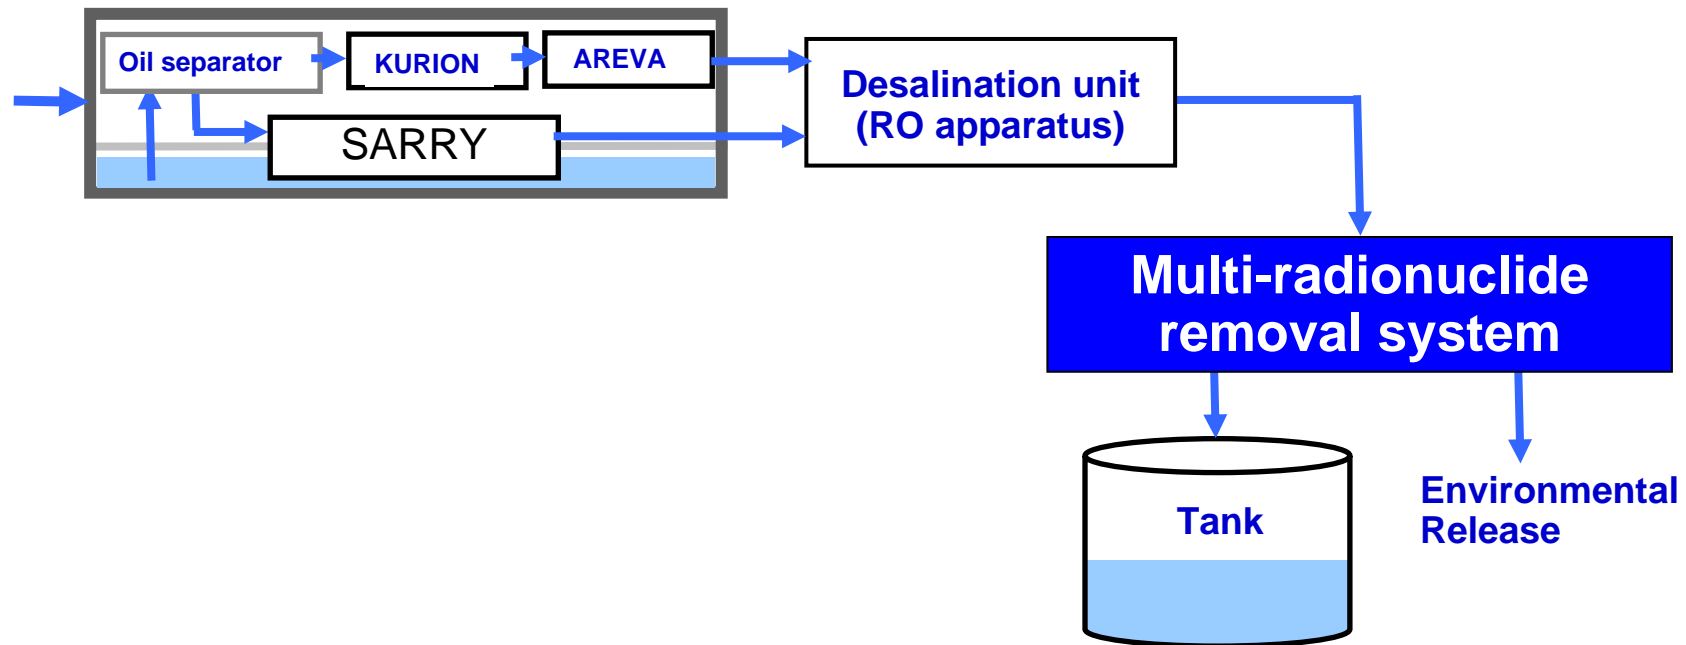
- ◆ Increase of accumulated amount of treated water
- ◆ Expect further risk reduction of stored water

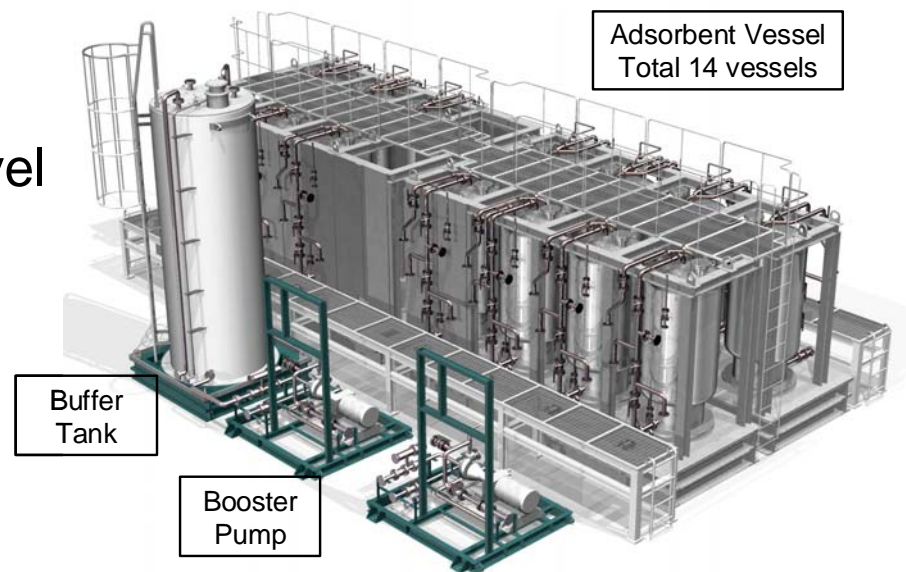
- ◆ Conceptual design by EnergySolutions
- ◆ Detailed design and manufacturing by Toshiba

- ◆ Remove all residual radioactivity to below non-detectable level (less than about 1Bq/L depending on nuclide)
- ◆ Strontium was identified as the major nuclide
- ◆ With MRRS, the radioactivity level will become lower by two order of magnitude.

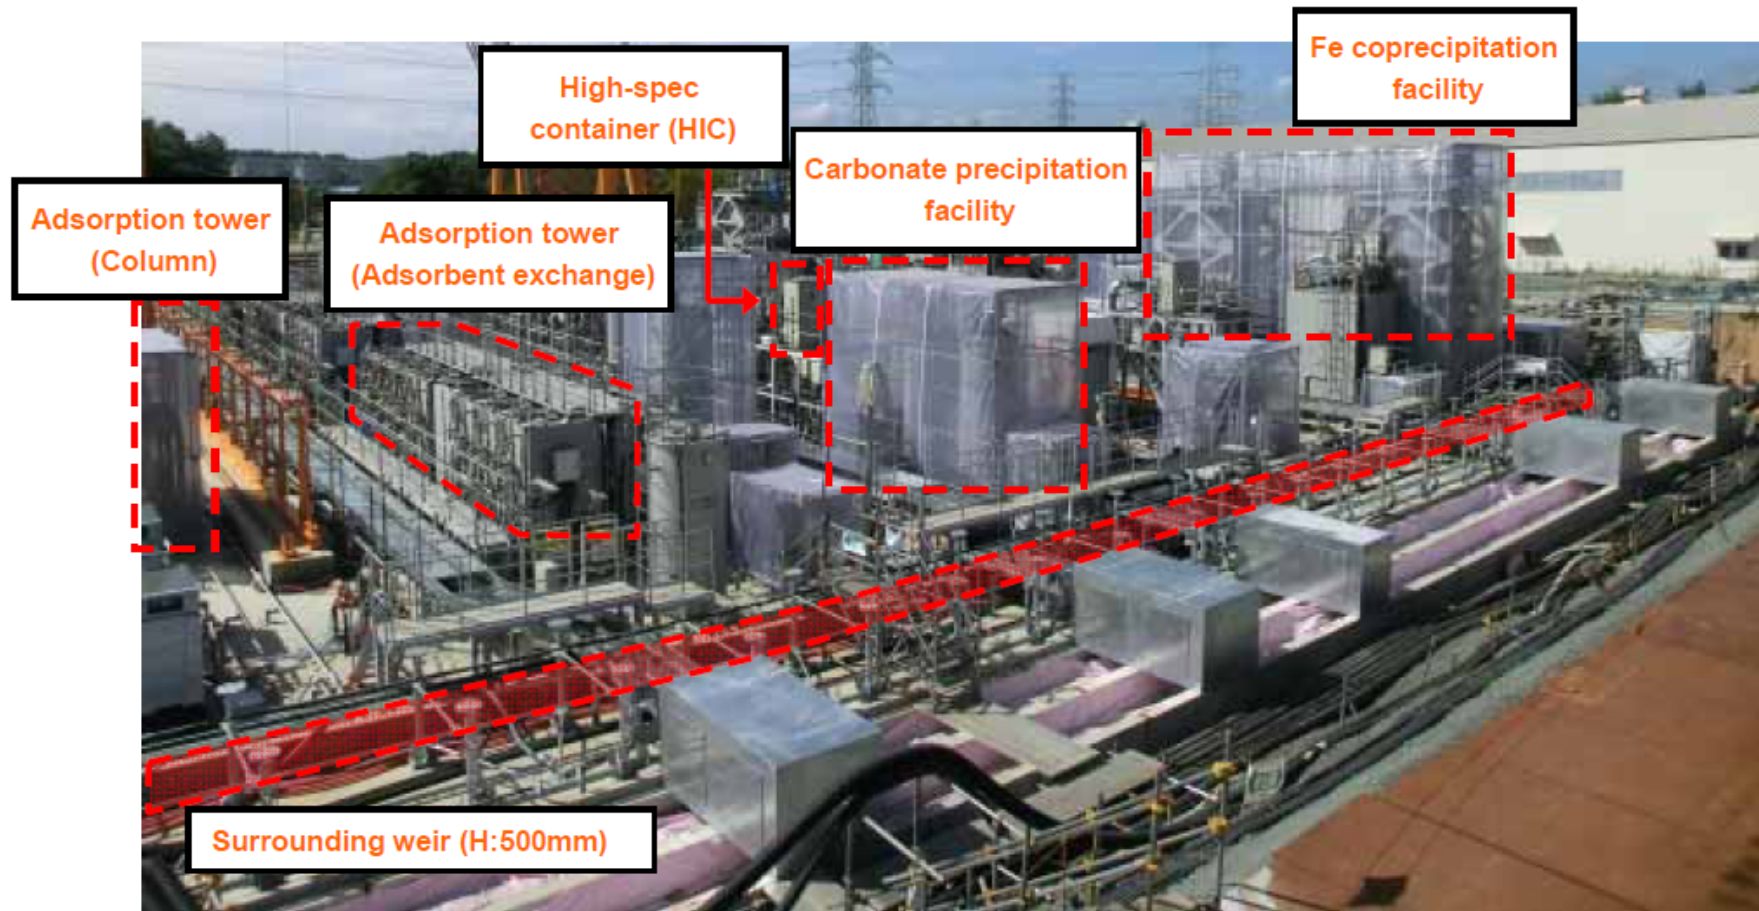
# Overview of MRRS

- The system has already been installed at the Fukushima site, and is now waiting for approval by NRA

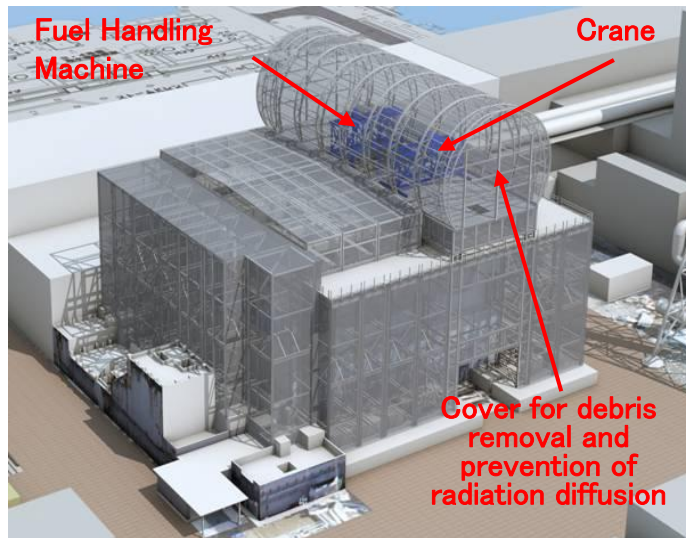
Fuel Removal System of Unit 3

- ◆ Collaborate with U.S. team, e.g., Westinghouse and U.S. vendors
- ◆ Develop remote control fuel handling machines, crane and transfer vessel
- ◆ Radiation condition: over 800mSv/h at a maximum
- ◆ Removal work to be started from the end of 2014

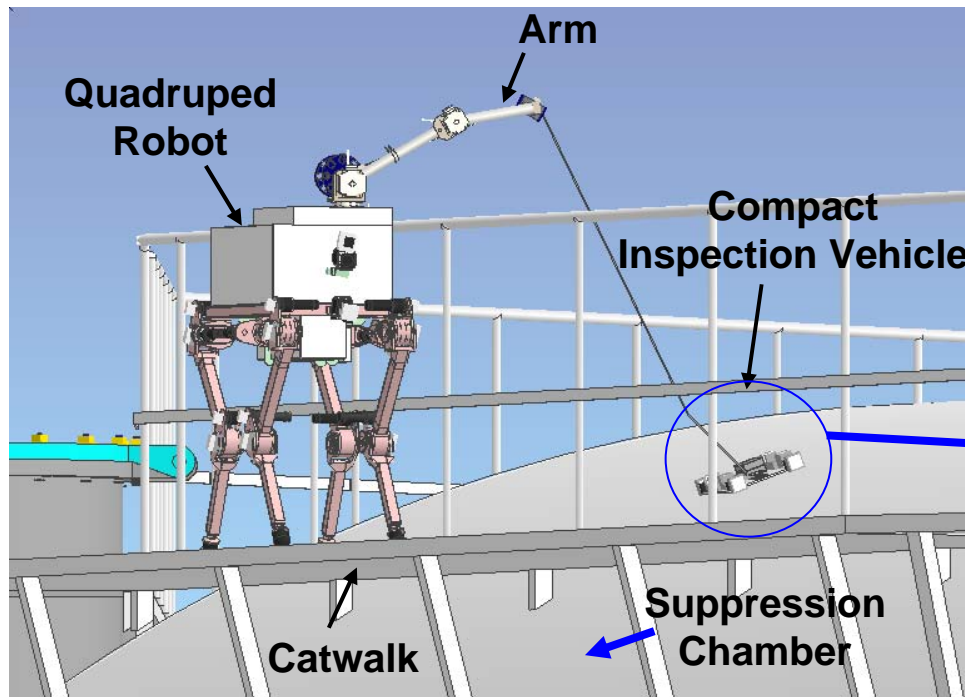
Image of vent pipe inspection by Quadruped Robot for Unit 2

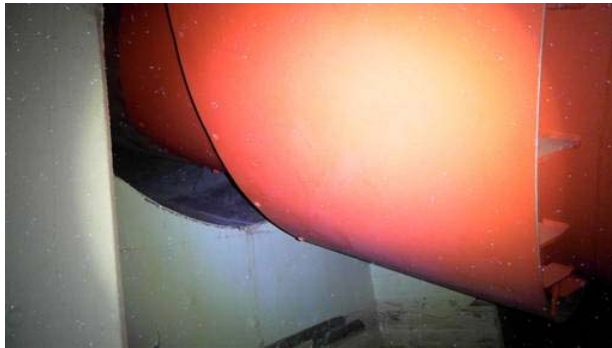
- ◆ Inspected vent pipe of PCV in Unit 2 on December 11, 2012
- ◆ No leakage was found
- ◆ Seven other vent pipes will be inspected in the near future

Edge of vent pipe sleeve

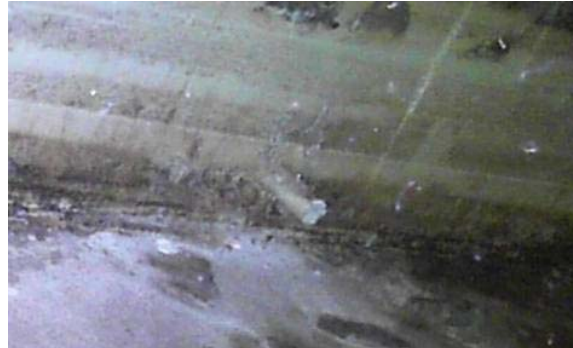
Edge of sand cushion drain pipe

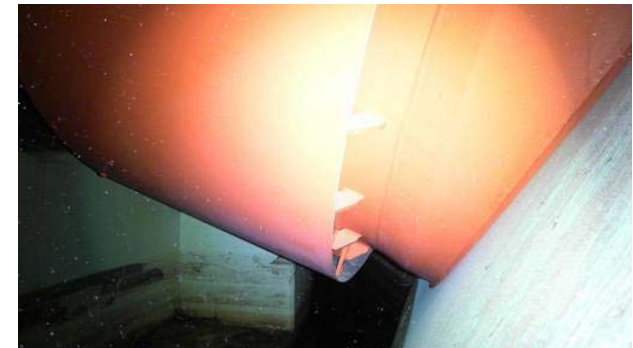
Lower part of vent pipe bellows cover
