Spent Fuel Storage at Fukushima Daiichi NPP

*International Conference on
Management of Spent Fuel from
Nuclear Power Reactors - An
Integrated Approach to the Back-
End of the Fuel Cycle
17th JUN 2015, Vienna*

Unit 4 Spent Fuel Removal Project

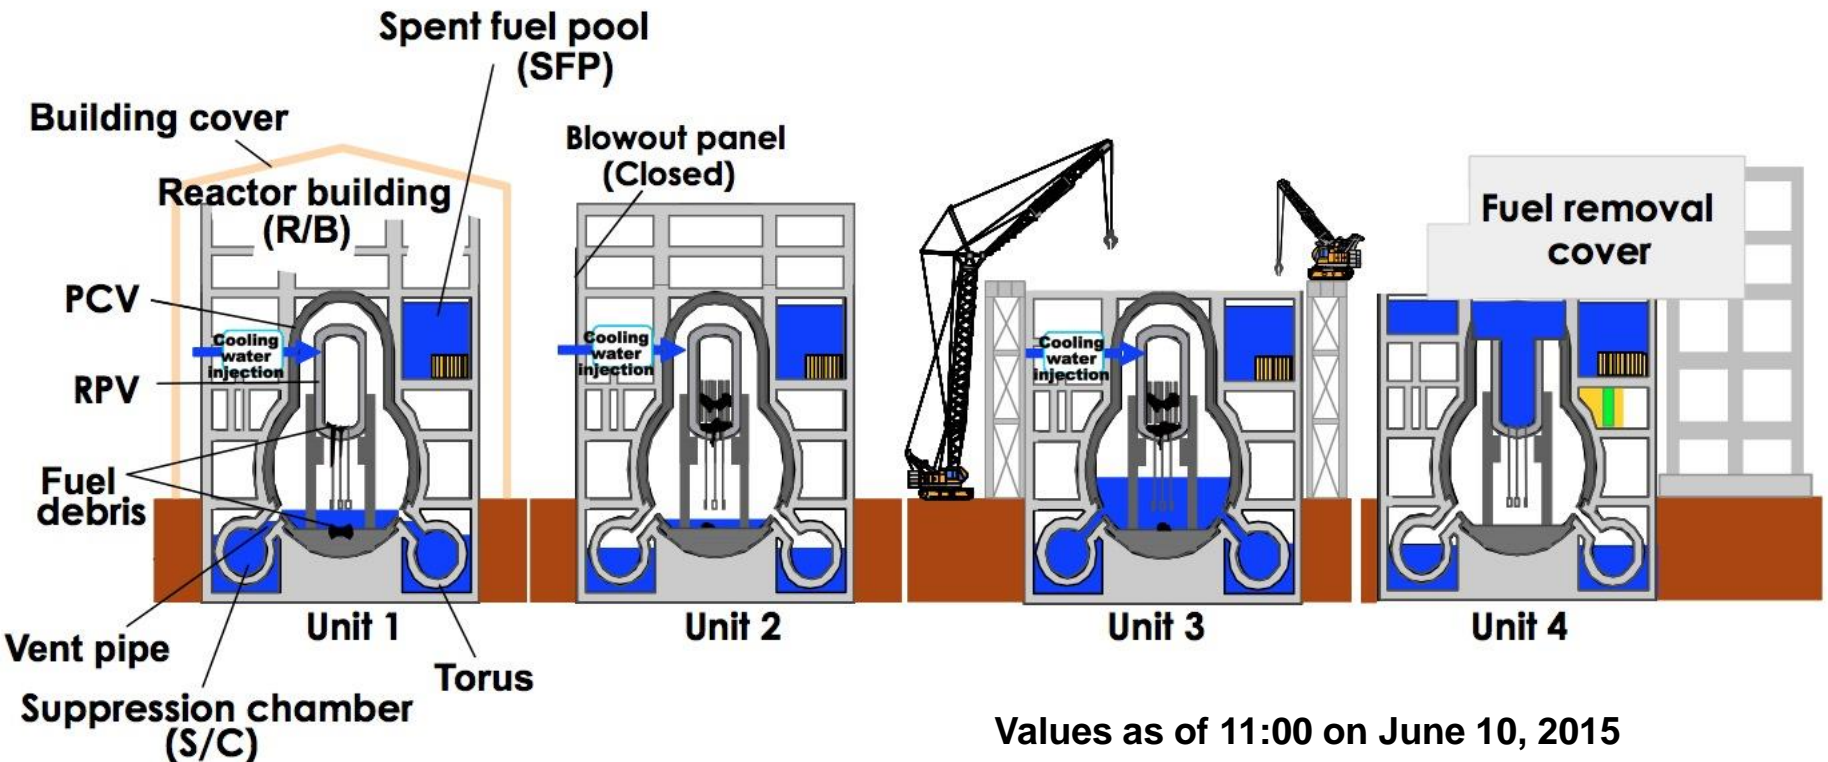
All Units maintain cold shutdown

Values as of 11:00 on June 10, 2015

RPV bottom temp.	PCV internal temp.	Fuel pool temp.
Unit 1	~23°C	~23°C	~24°C
Unit 2	~30°C	~31°C	~27°C
Unit 3	~27°C	~26°C	~22°C
Unit 4	No fuel, so monitoring not required	No fuel, so monitoring not required	~21°C

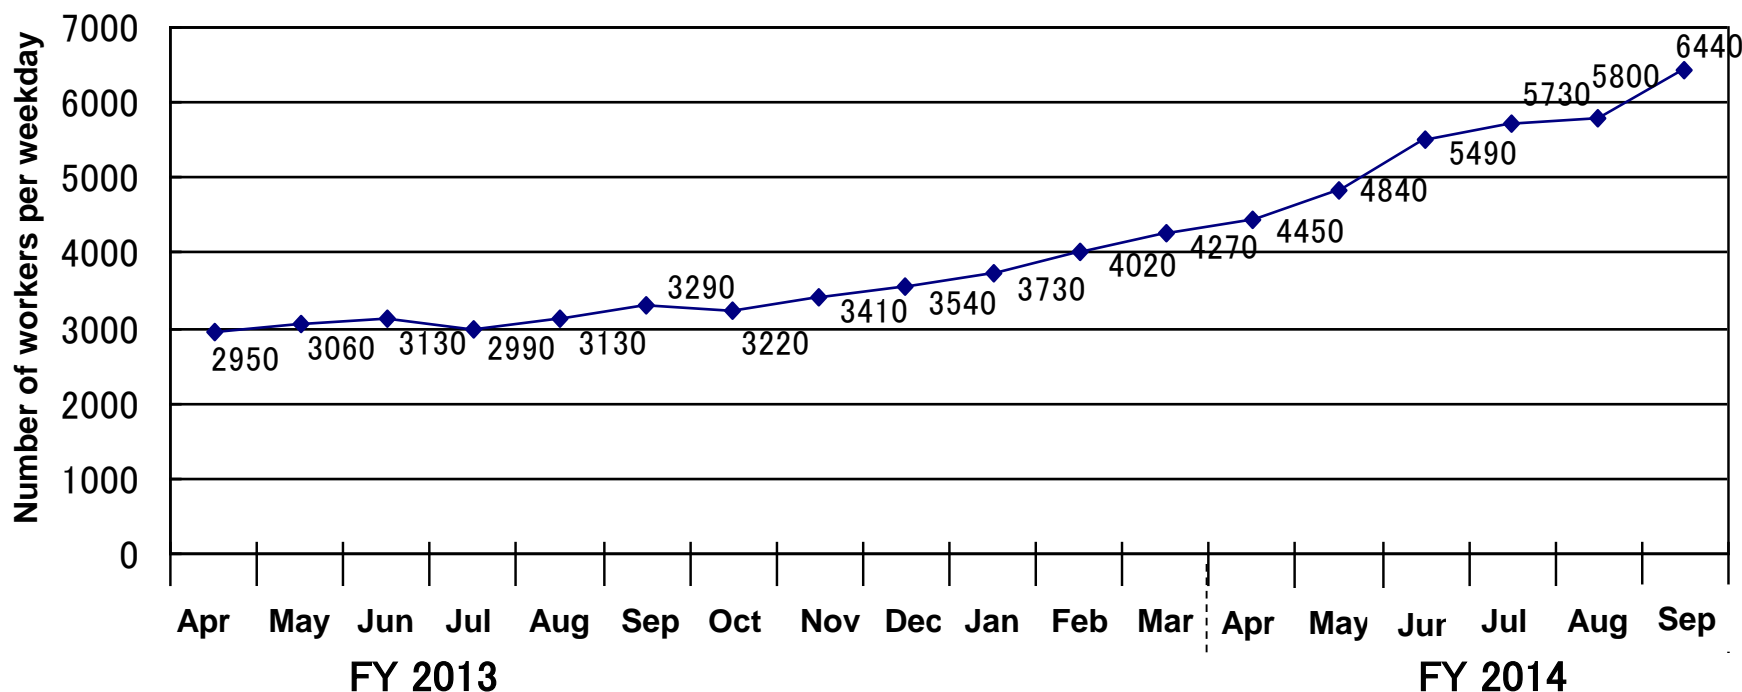
Trend in the average number of workers per weekday (FY 2013 and 2014)

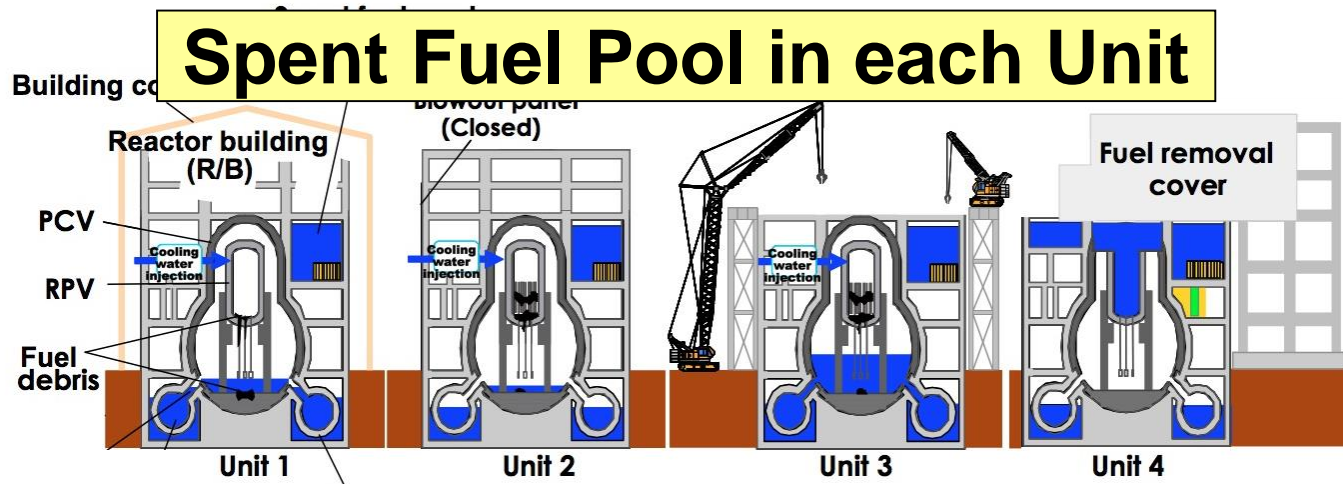
[Unit4 Chronology]

11th MAR 2011

SF1331 + FF204 in SFP (DH2.26MW)

Loss of Cooling Function by SBO

15th MAR 2011

Hydrogen Explosion

20th MAR 2011~

Raw Water Injection by Water Canon Vehicle

22nd MAR 2011~

Sea/Pure Water Injection by Concrete Pump Vehicle

31st JUL 2011~

Recovered Cooling Function by Alternative water Circulation System

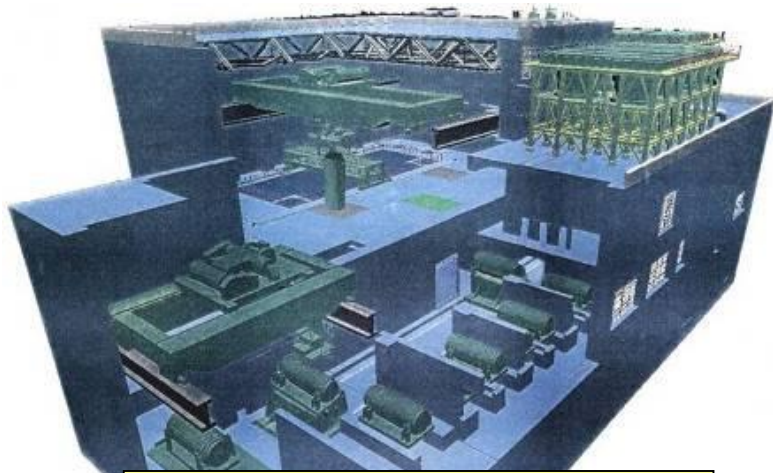
**Common Fuel
Storage Pool**

[Chronology]	
11 th MAR 2011	SF6375 in SFP (DH1.13MW) Loss of Cooling Function by SBO
18 th MAR 2011	Sufficient Water Level confirmed
24 th MAR 2011~	Recovered Cooling Function by Water Circulation System with Temporary AC Power

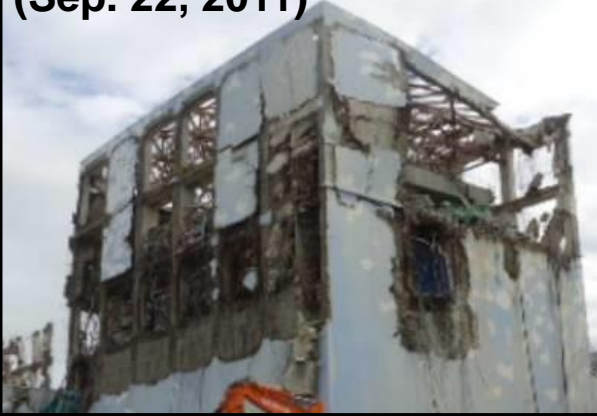
① Prior to Removal of debris
(Sep. 22, 2011)

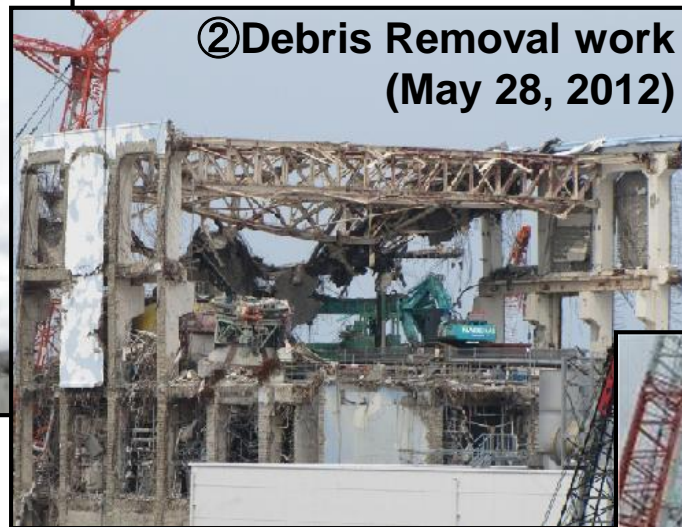
② Debris Removal work
(May 28, 2012)

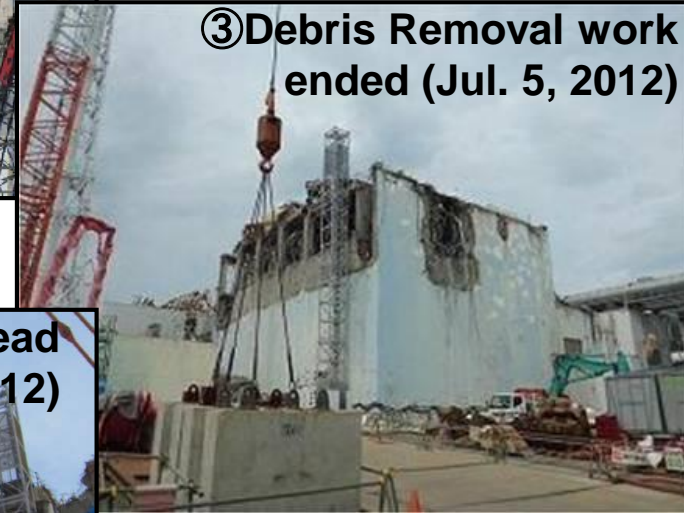
③ Debris Removal work
ended (Jul. 5, 2012)

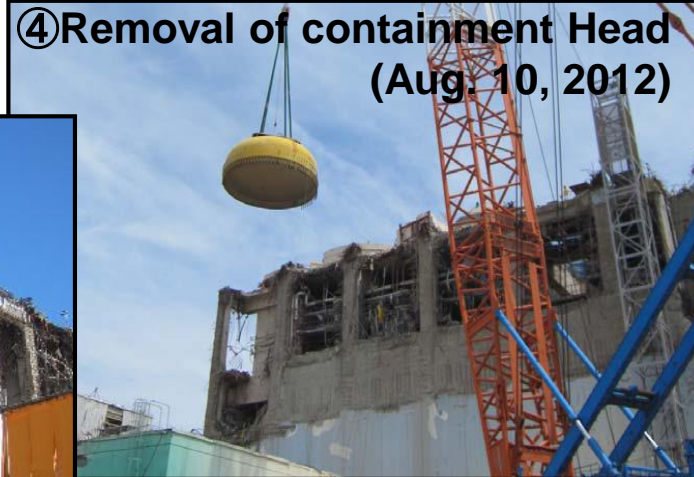
④ Removal of containment Head
(Aug. 10, 2012)

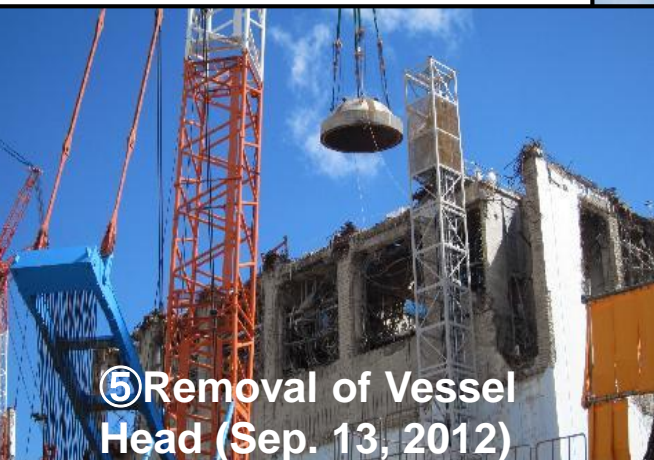
⑤ Removal of Vessel
Head (Sep. 13, 2012)

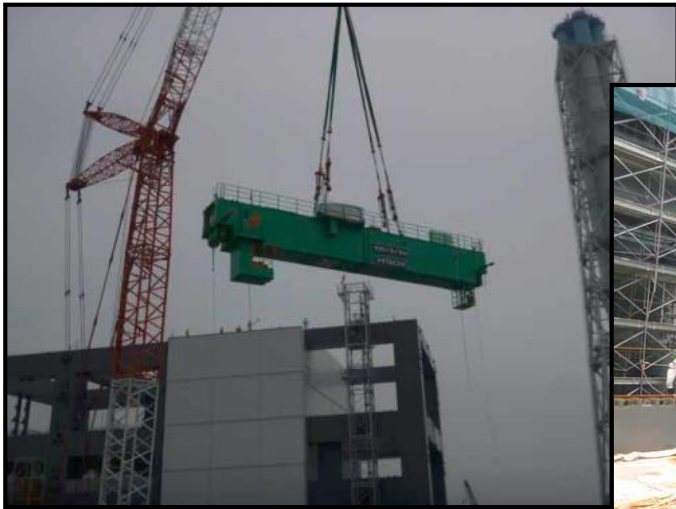
⑤ Hoisting of Crane Structure (Jun. 7, 2013)

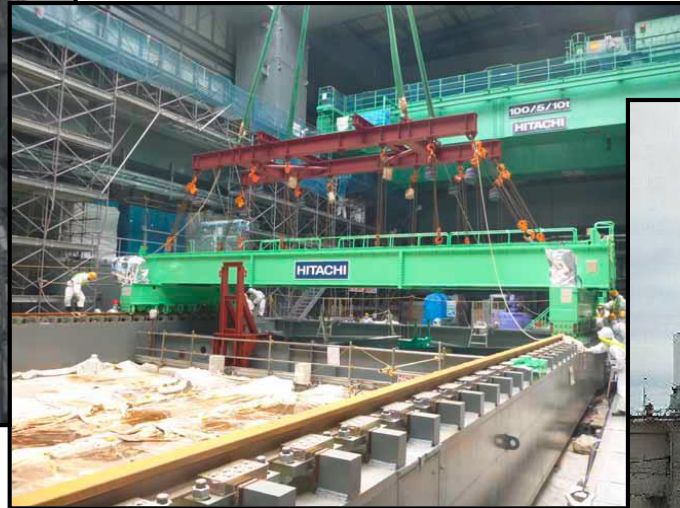
⑥ Fuel Handling Machine installed (Jul. 10, 2013)

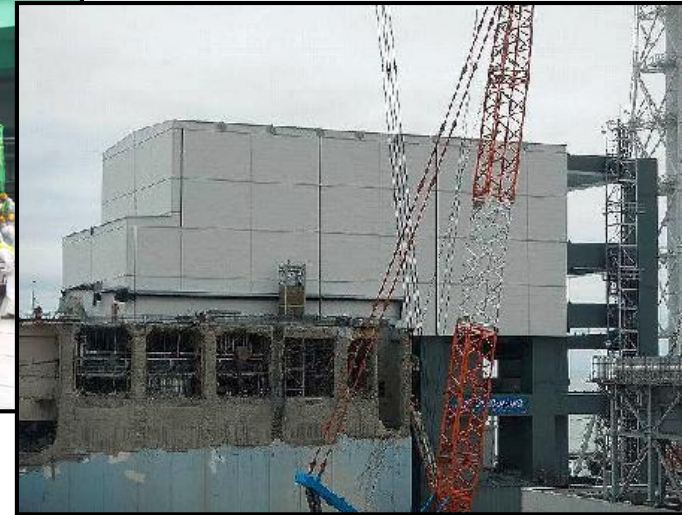
⑦ Construction almost Completed (Jul. 20, 2013)

- Construction period: 11month
- Gross Weight : Approx. 4,900 ton
- W69m × L31m × H53m
- Safety Functions and Reliability similar to the existing plant fuel had been established

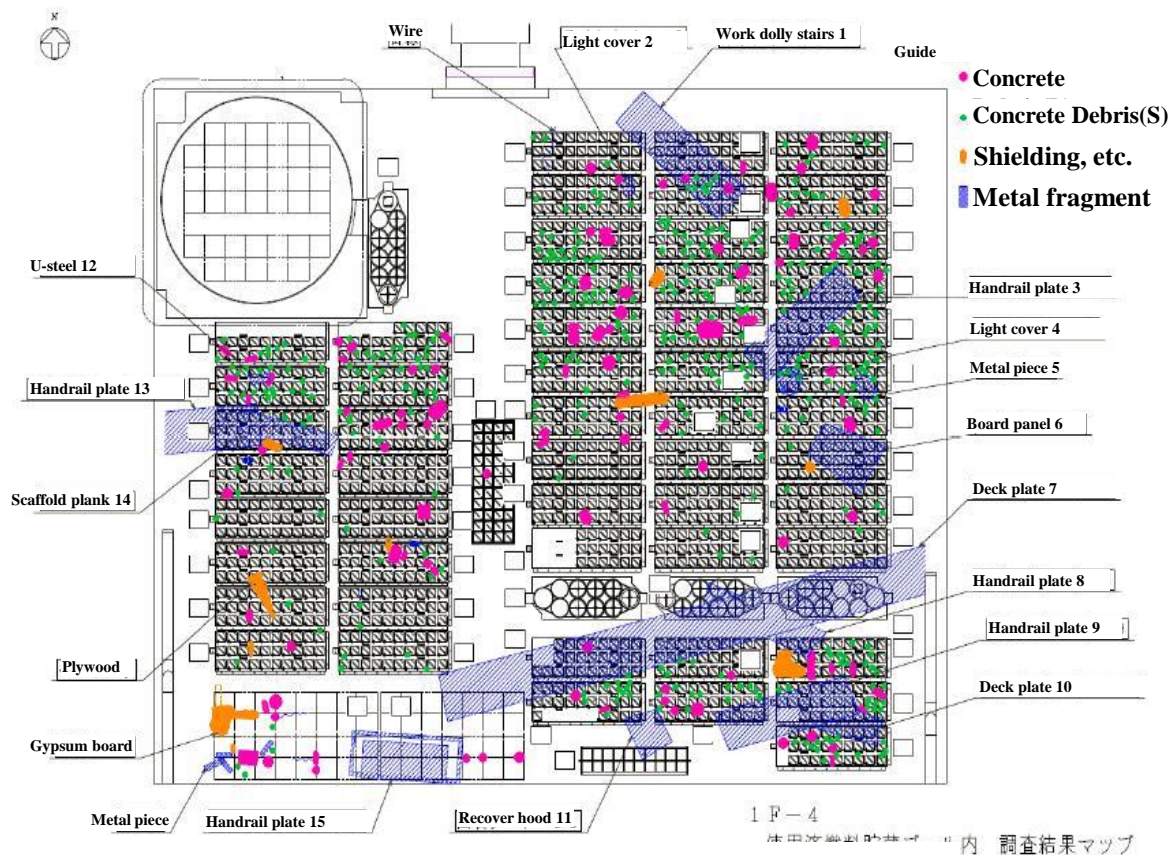
Scattered Debris inside SFP

- Underwater Surveys
- Debris Removal one by one
- Various tools were used

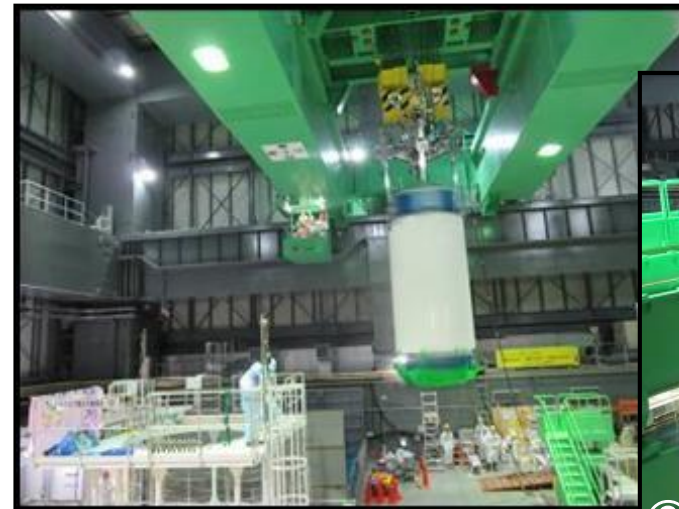
① Cask transferred to SFP
(Nov. 18, 2013)

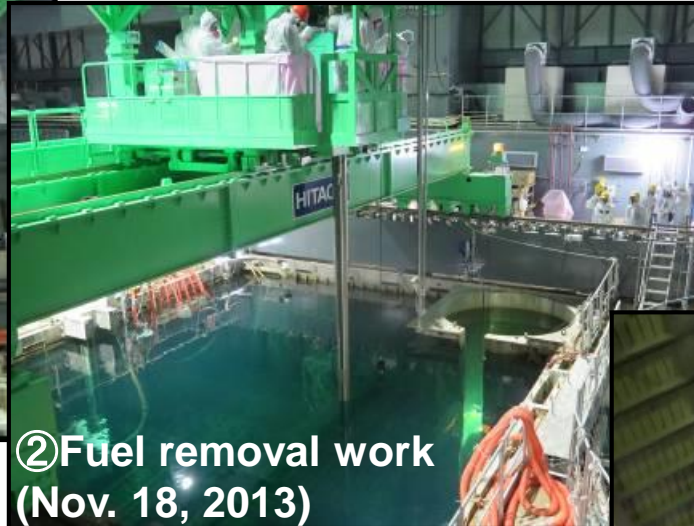
② Fuel removal work
(Nov. 18, 2013)

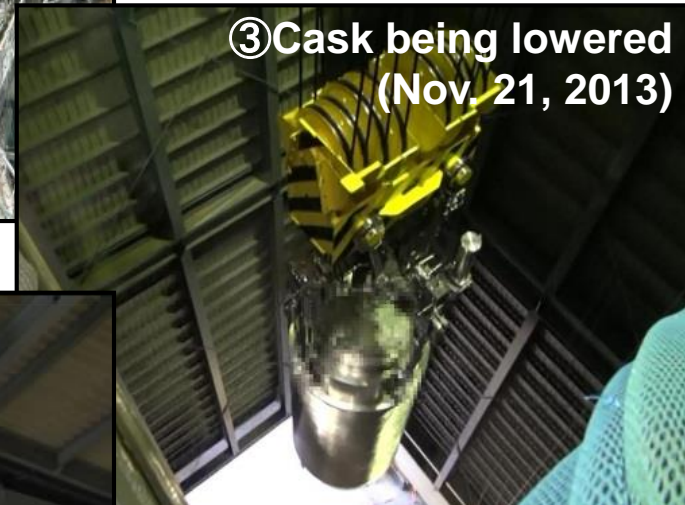
③ Cask being lowered
(Nov. 21, 2013)

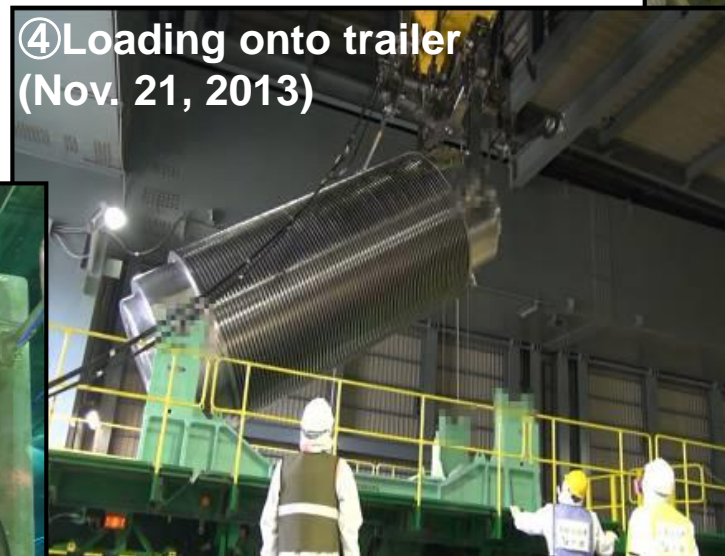
④ Loading onto trailer
(Nov. 21, 2013)

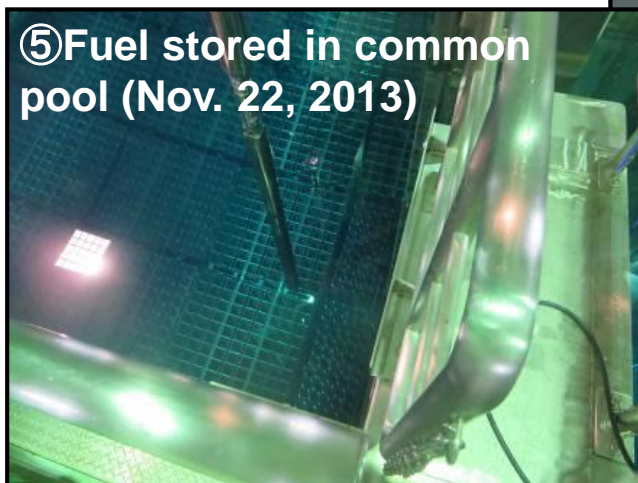
⑤ Fuel stored in common
pool (Nov. 22, 2013)

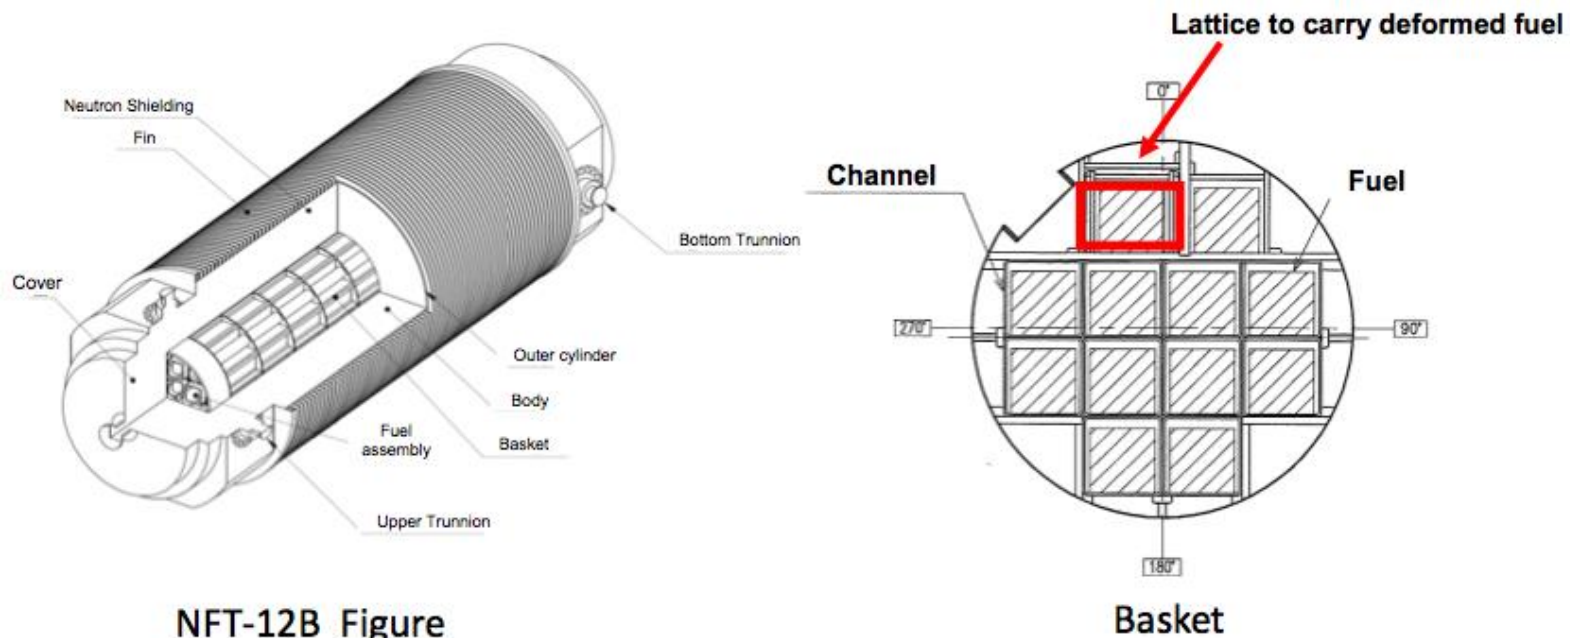
NFT-12B Figure

- Performed carefully while conditions checked using an underwater camera or other devices.
- Fresh fuel was first transported to verify the procedures before SF removal
- 2 Leaking fuel assemblies and a deformed fuel assembly, which has been since before 3.11, were safely transferred by appropriate methods

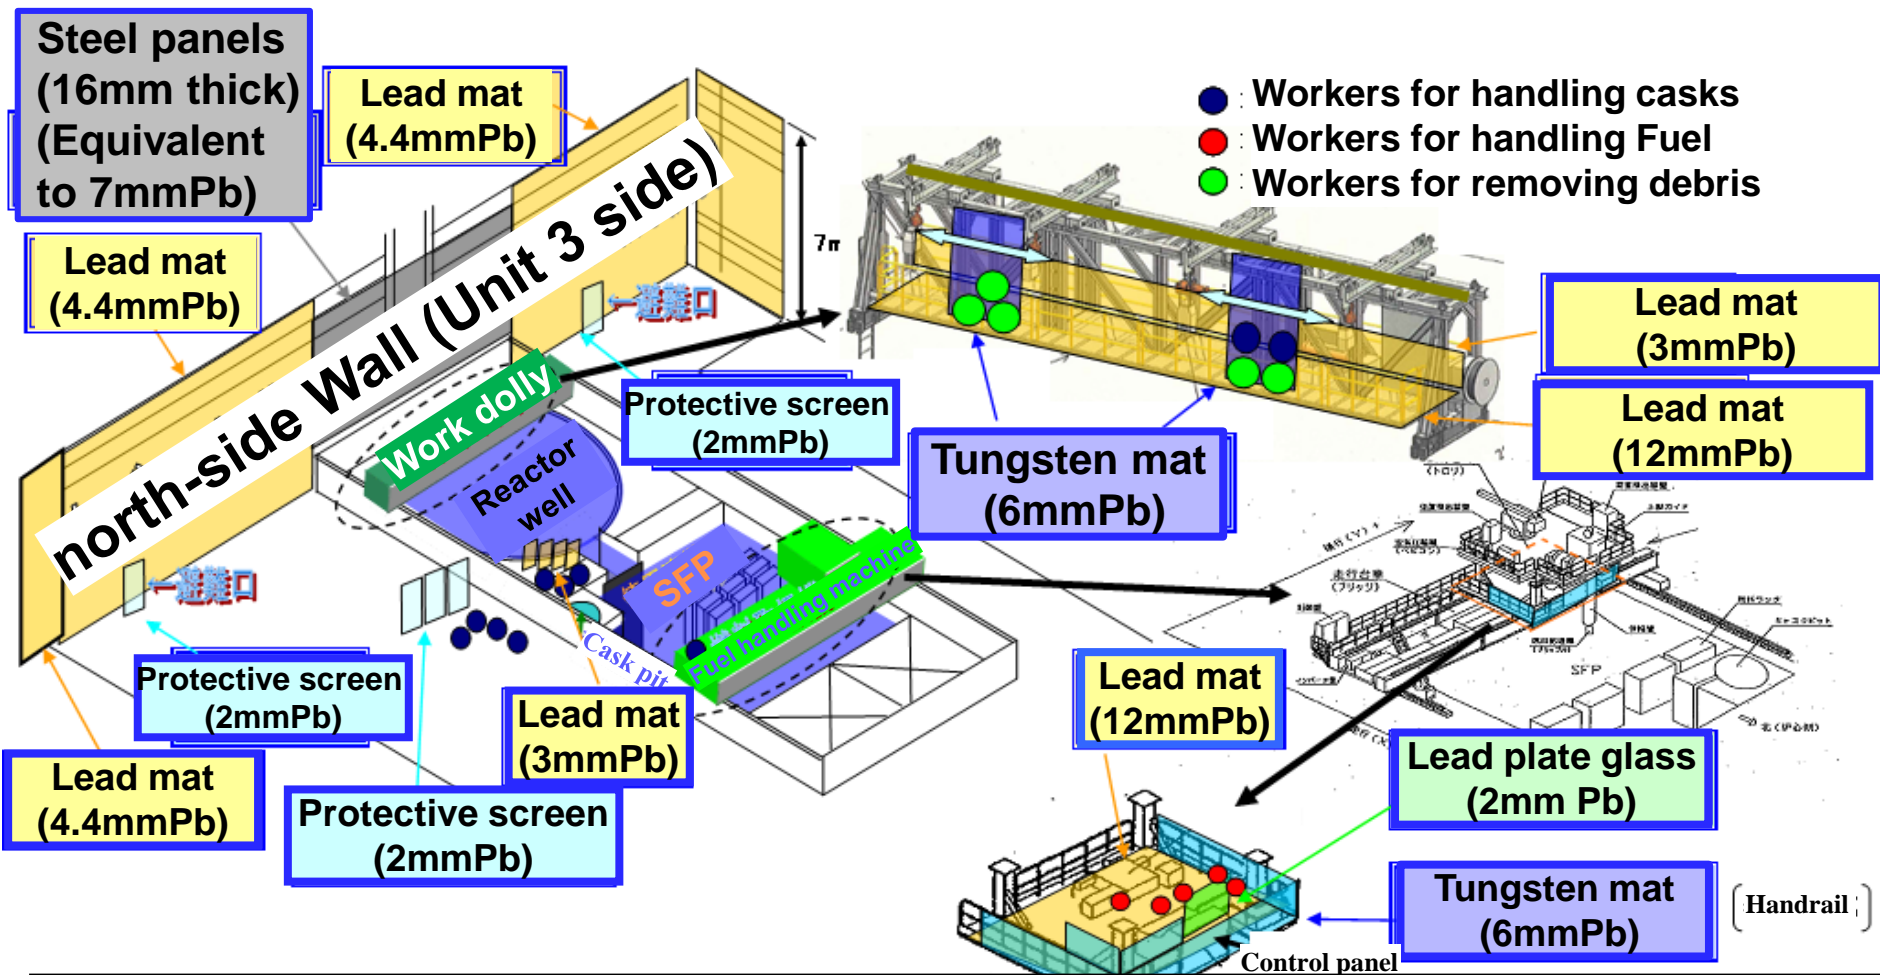
Dose Reduction Countermeasure

- Effective locations for the installation of shielding examined and those built.
- Finally could reduce the dose exposure of workers to a target level (one-third of the initial value)

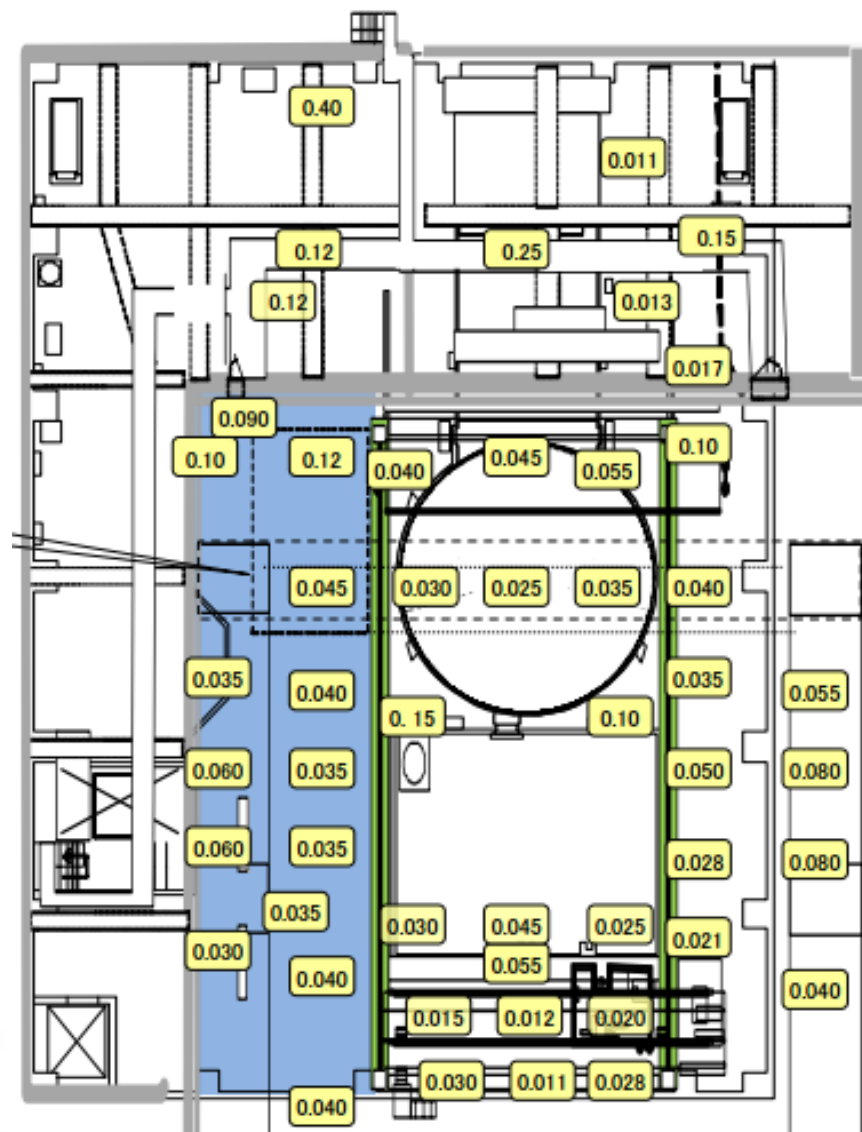
Unit 4 Reactor Building 5F

(Ref) Dose difference between Unit 4 and 3

Measured : Feb. 2014 ~ Mar. 2015

Unit: mSv/h

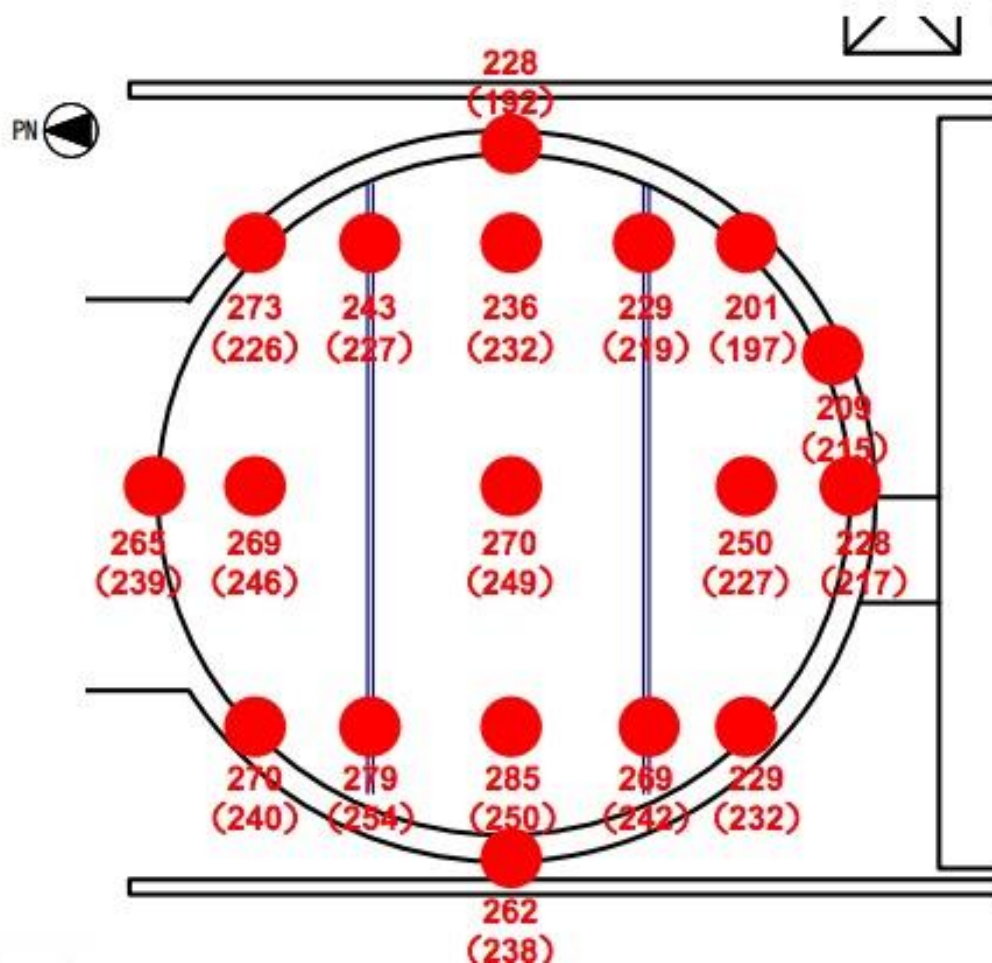
Figure in the upper line:
Atmosphere dose rate at 5 m (mSV/h)
measured on December 14, 2013
Figure in parenthesis in the lower line:
Atmosphere dose rate at 5 m (mSV/h)
measured on January 27, 2014

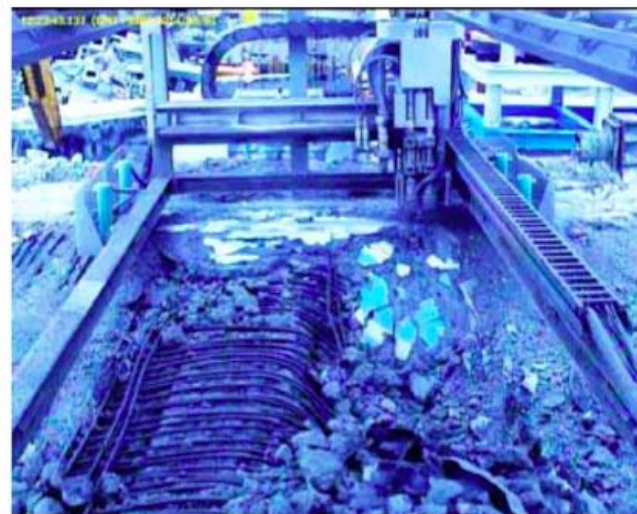
Photo ③ Damage to concrete surface

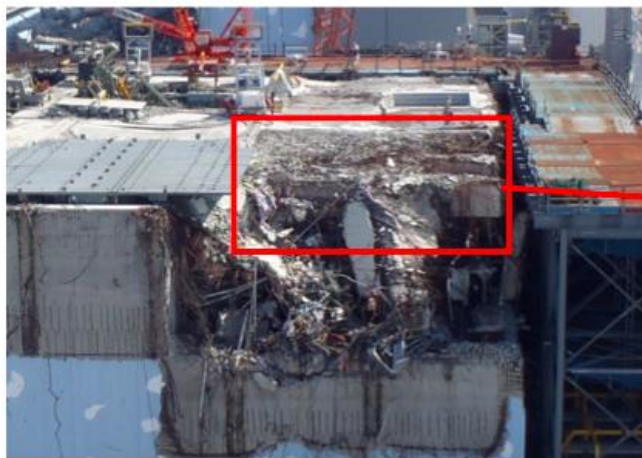
Photo ① North side of R/B

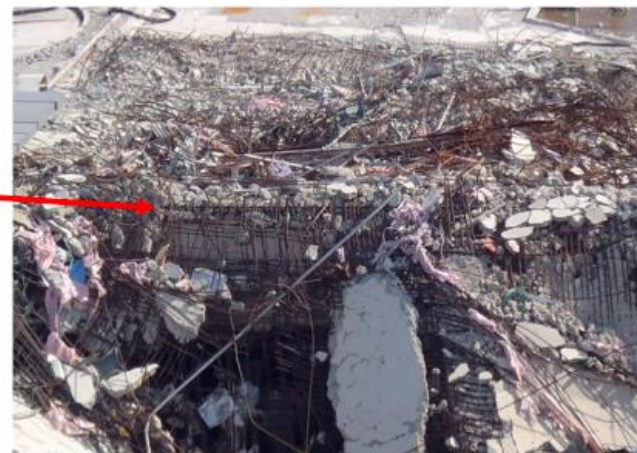
Photo ② Northwest collapsed portion
