Technological Development to Support a Change in the United Kingdom's Strategy for Management of Spent AGR Oxide Fuel

John Kyffin & Andy Hillier

Sellafield Ltd.

International Conference on Management of Spent Fuel from Nuclear Power Reactors

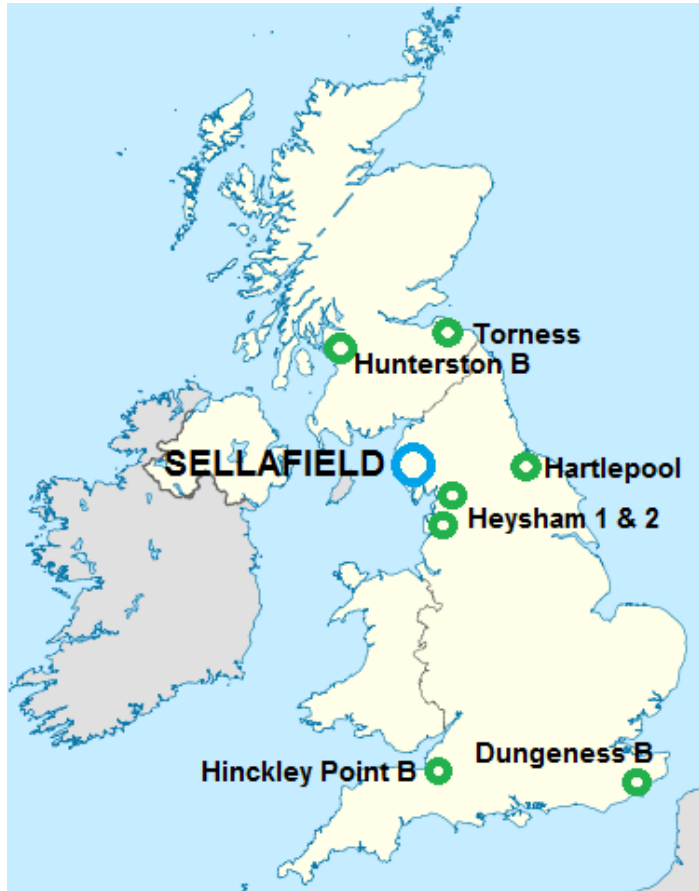
Nuclear Decommissioning Authority Oxide Fuel Strategy: Timeline

2014 - 2018	THORP reprocessing: → Complete non-UK fuel reprocessing contracts → Reprocess 'optimum quantity' of AGR fuel
2019 - 2040	Interim storage of AGR fuel (plus limited quantities of other fuels, e.g. WAGR, PIE cans, certain water reactor fuel assemblies)
2040 - 2075	Long term storage
2075 - 2086	Emplacement of fuel in geological disposal facility

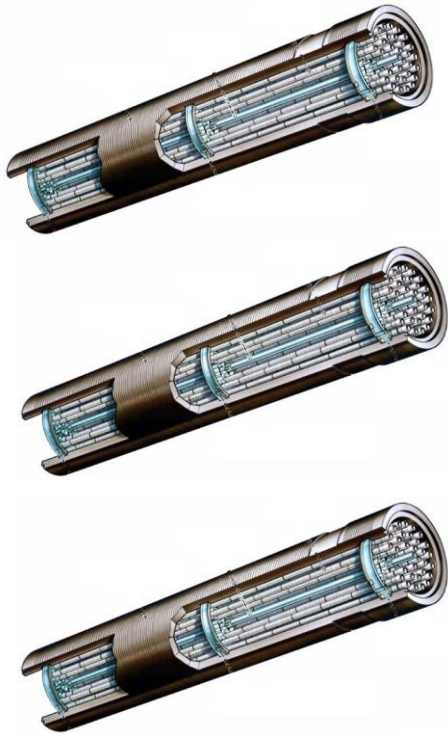
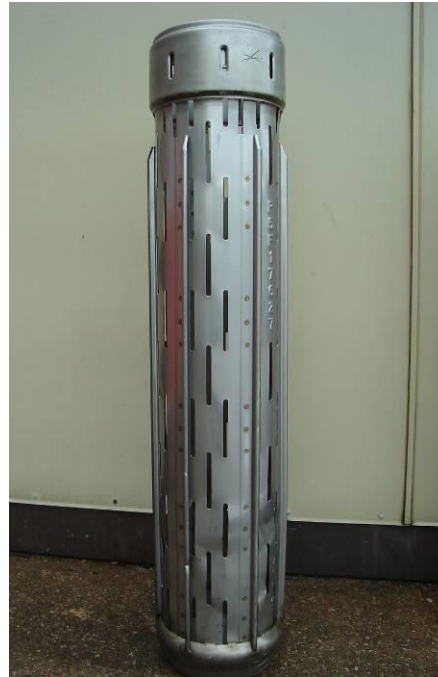
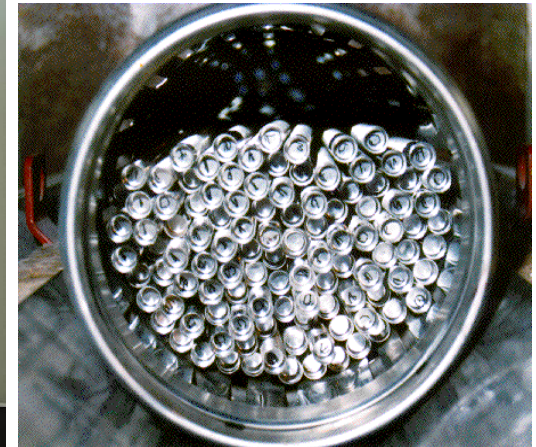
AGR Fuel Dismantling

1 x Slotted can = Pins from 3 x Elements

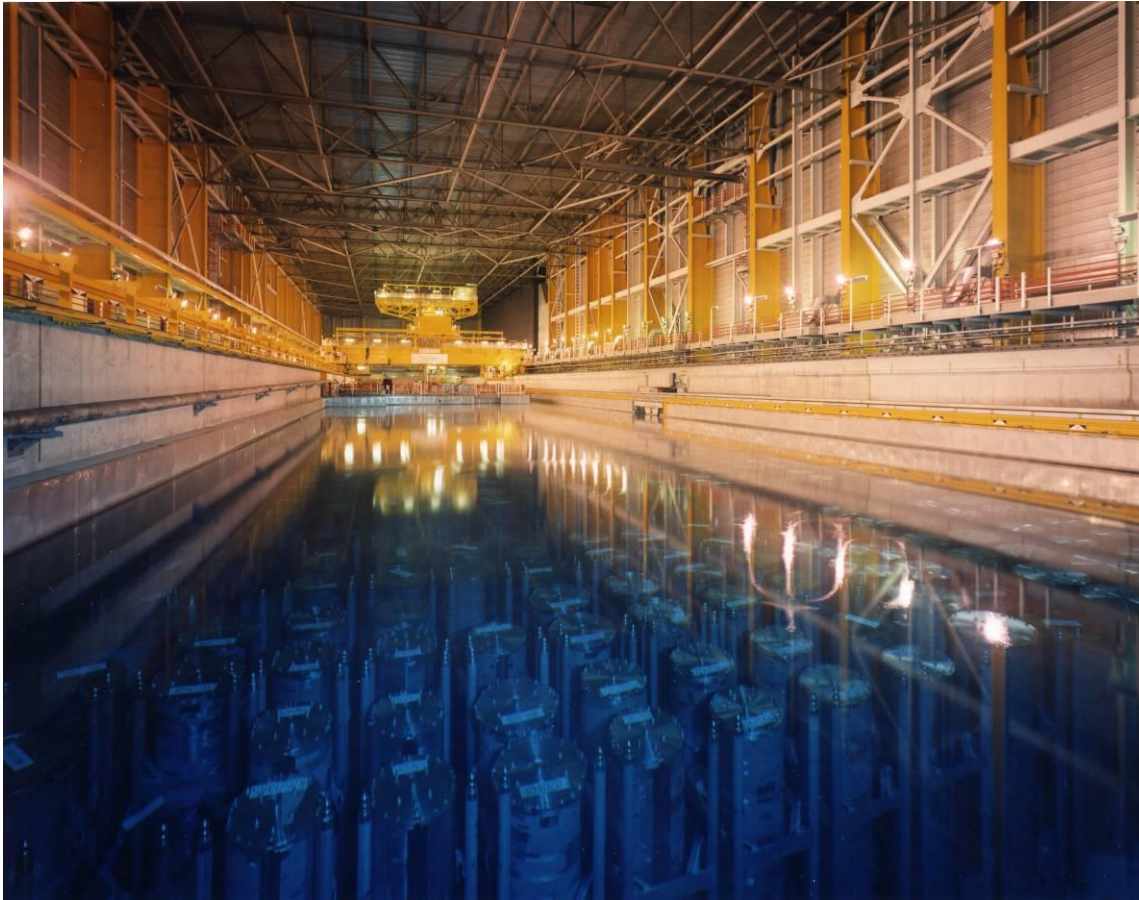
Outline of AGR Interim Storage

- Convert TR&S from reprocessing buffer store to interim store
- Pond water dosed with pH 11.4 sodium hydroxide (caustic) – inhibit IGA of sensitised cladding
- AGR fuel stored dismantled in 20e and new 63e containers

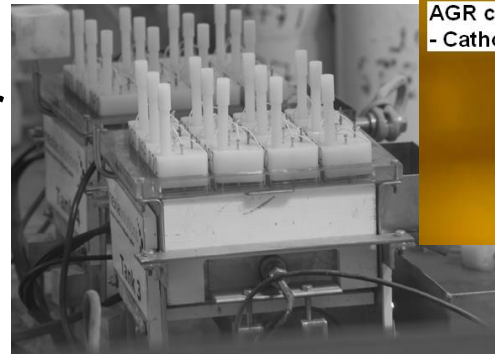
Experimental set-up

- Irradiated brace testing – differences from original work: taken from high burn-up fuel ($<38 \text{ GWd.t}^{-1}$); use of ZRA so no pre-treatment required; and at $T \leq 50 \text{ }^\circ\text{C}$.
- IGA arrested by pH 11.0 in solution of 2 ppm Cl^- at $50 \text{ }^\circ\text{C}$
- Characterisation of samples demonstrated sensitisation but chromium depletion not increased compared to lower burn-up cladding examined in the 1980s

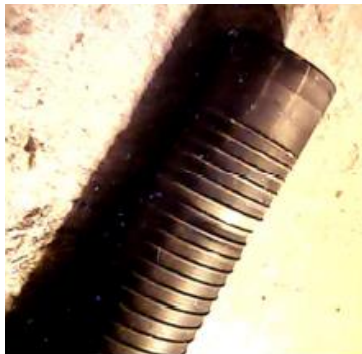
- Fuel pins grouped by element number by visual examination. Confirmed by gamma scan results.
- No corrosion damage to the slotted can was noted
- Macroscopy not revealed corrosion damage. Occasional minor abrasion marks & loss of the carbonaceous deposit

e1 top end cap & cladding surface [NNL]

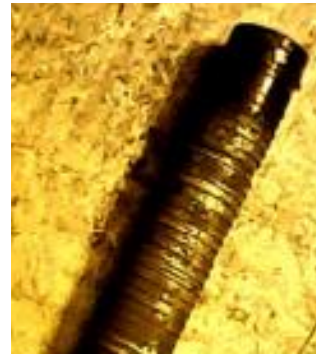
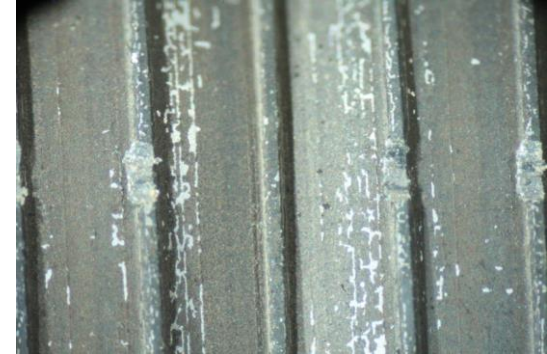
e6 top end cap & cladding surface [NNL]

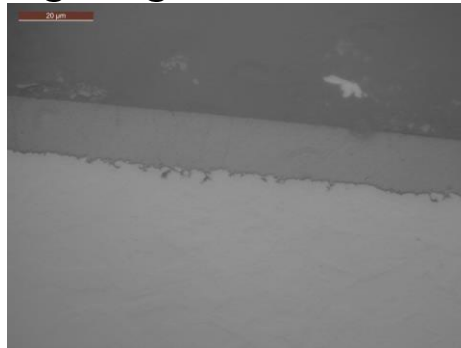
- Metallography of element 1 pin:
 - No degradation of the cladding condition beyond that typically observed during post irradiation examination (PIE)
 - Etching revealed a microstructure consistent with sensitisation
- *Further work currently ongoing*

e1 transverse section
(scale bar 20 µm) [NNL]
