EXPERIENCE IN ELIMINATING THE CONSEQUENCES OF THE 1957 ACCIDENT AT THE MAYAK PRODUCTION ASSOCIATION

G.Sh. Batorshin, Y.G. Mokrov, Mayak PA, Russia

*International Experts' Meeting on Decommissioning and Remediation
After a Nuclear Accident*

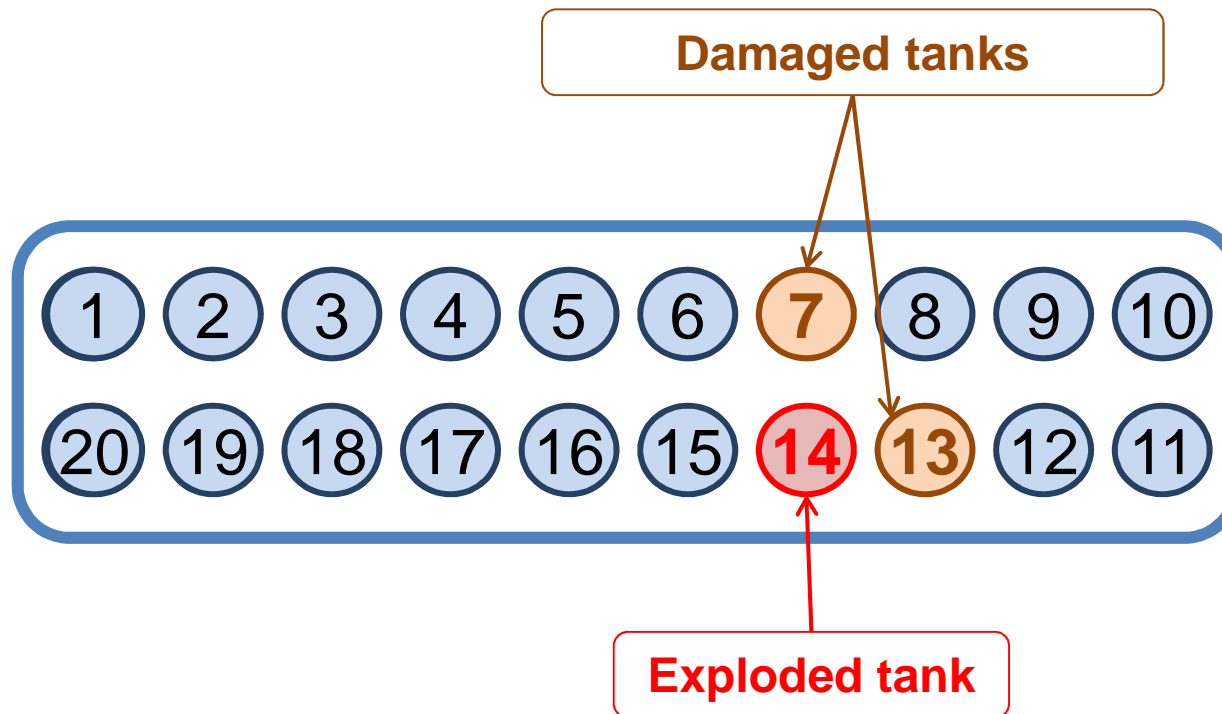
Main Consequences of the Explosion for Waste Storage Facility

- Tank 14 was completely destroyed
- Overhead covers of neighboring cells 7 and 13 were partially damaged
- Total C-3 cooling system broken
- Buildings, roads, territory, vehicles contaminated
- No deaths

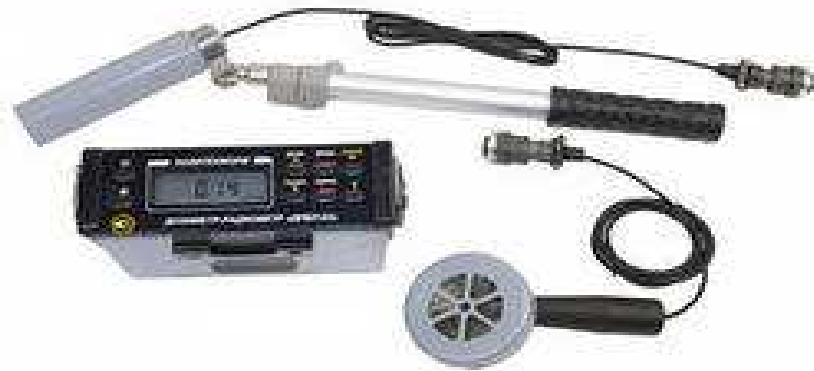
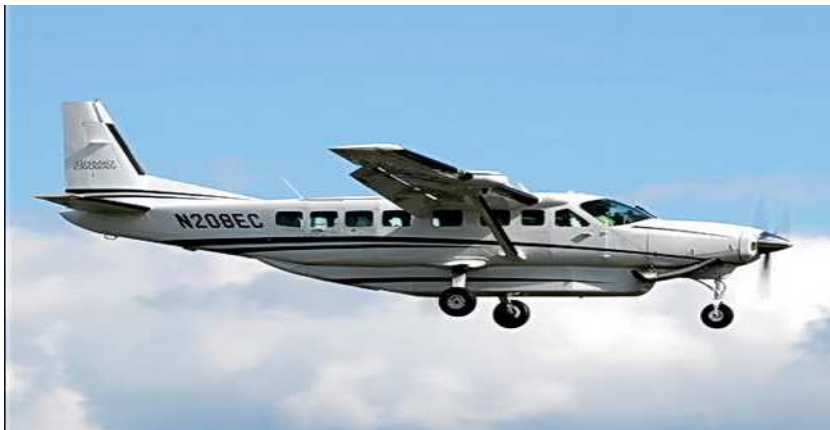
Estimation of Accident Consequences in Terms of Contamination Levels through the Facility Adjacent Areas

- Next day after the accident major consequences were assessed in terms of adjacent areas contamination levels. Radiation measurements were carried out with portable radiometers
- Seven radiation measurements of territory were carried out within the first year after the accident (four with motor vehicles and three with airplanes)

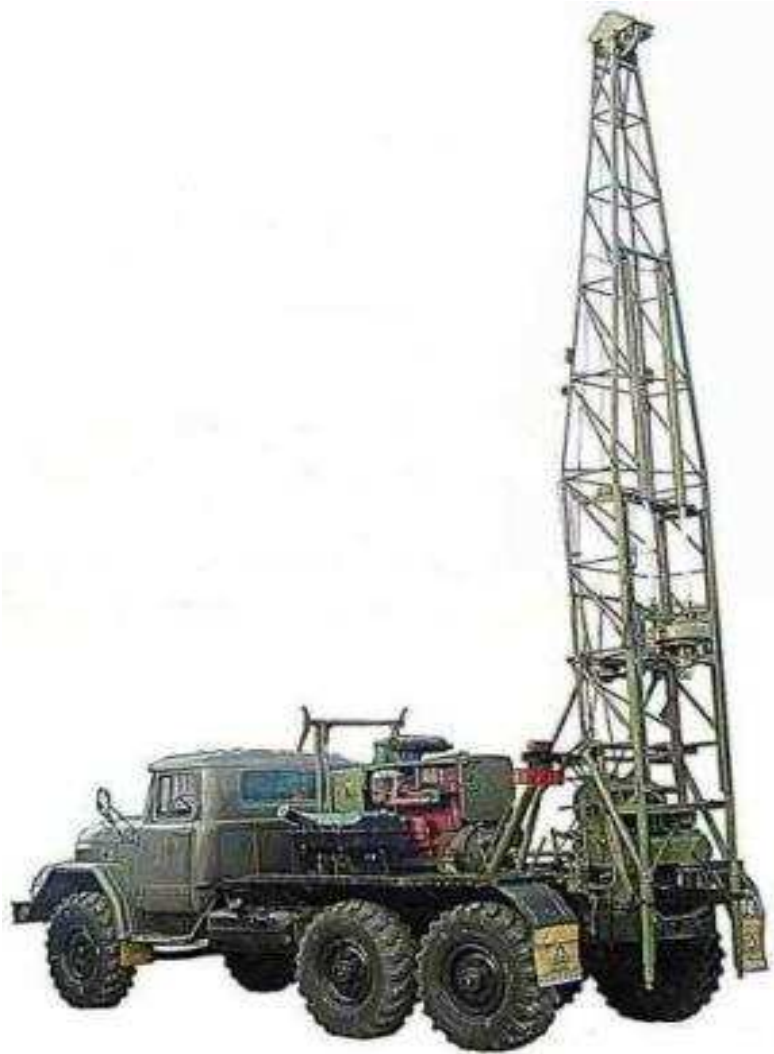
Restoration of Ventilation, Cooling and Monitoring Systems of the Damaged Complex

- The Waste storage complex ventilation, cooling and monitoring systems were restored by urgent drilling of special boreholes, in which tubes for water supply and temperature monitoring sensors were installed
- The spots for drilling had been preliminary covered with a protective layer of uncontaminated soil up to 1.5 m thick
- All activities for the complex restoration were completed within 2 to 3 months

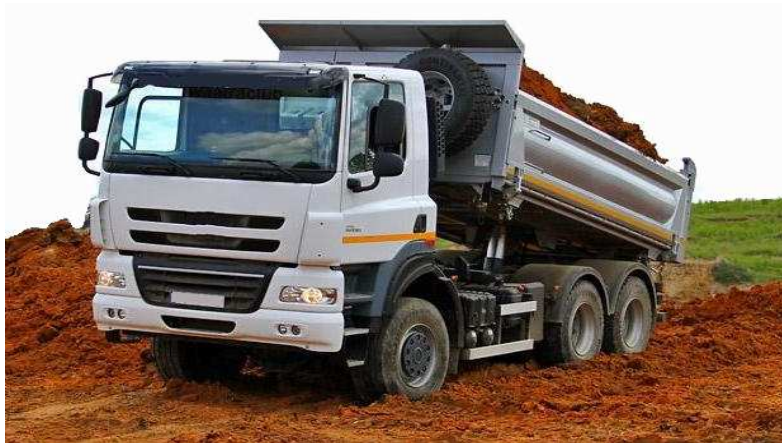
Decontamination of the Territory in the Accident Area

- Heavily contaminated areas were covered with 1-meter thick soil layer, this decreased dose rate by 100 times and fixed radionuclides
- Less contaminated areas were decontaminated by removing the contaminated soil to the lower parts of the terrain (abandoned construction pits, ditches, etc.)
- About 320,000 m³ of soil were removed and disposed of

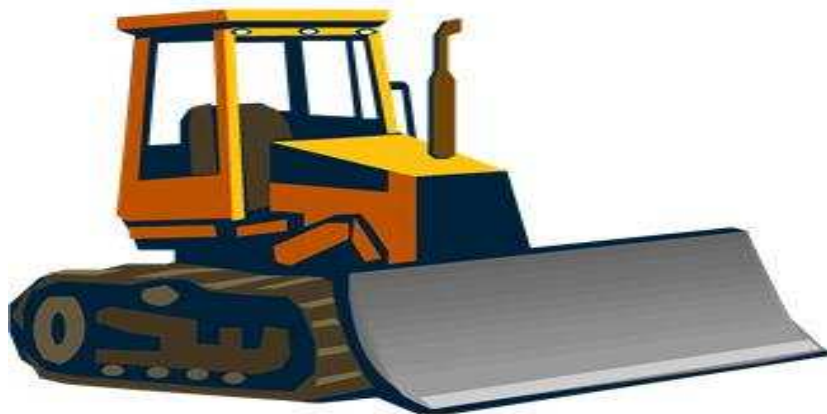
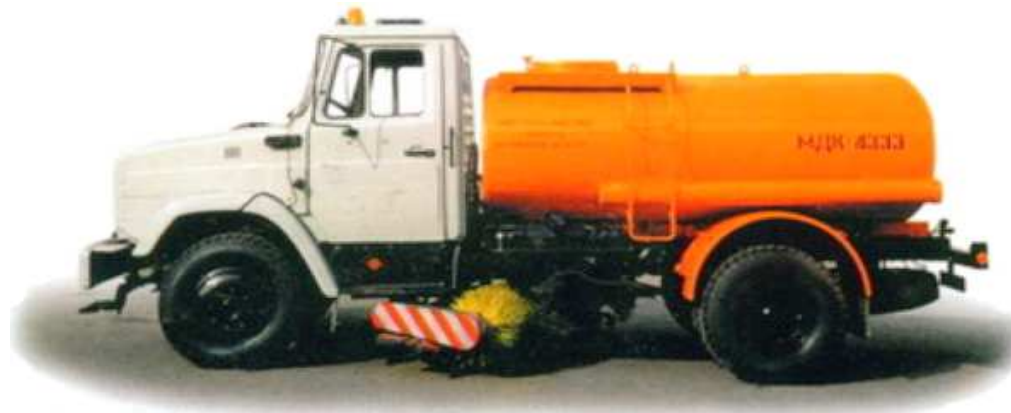
- Decontamination of the roads was performed by washing them with water
- After cleaning the sides of the roads and the adjacent areas were contaminated considerably worse than before
- To reduce the external radiation the upper soil layer (~10 cm) was removed aside by 25 meters.
- The resultant bank of soil provided additional shielding for the traffic

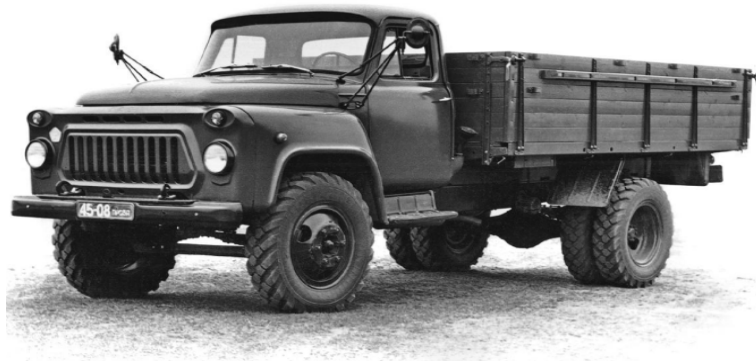
Decontamination of the Motor Vehicles and the Railway Cars

- Decontamination of the motor vehicles and the railway cars was performed on the basis of the specially developed technique with the use of decontaminating, rinsing and fixing solutions

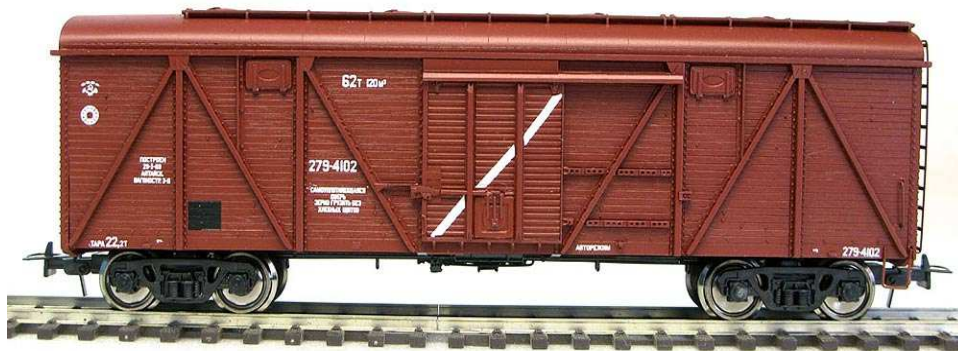
- Decontamination of the railway was carried out by intense washing of the entire railway track with water. In the most contaminated area the railway bed and the slopes were additionally covered with 10 cm thick soil

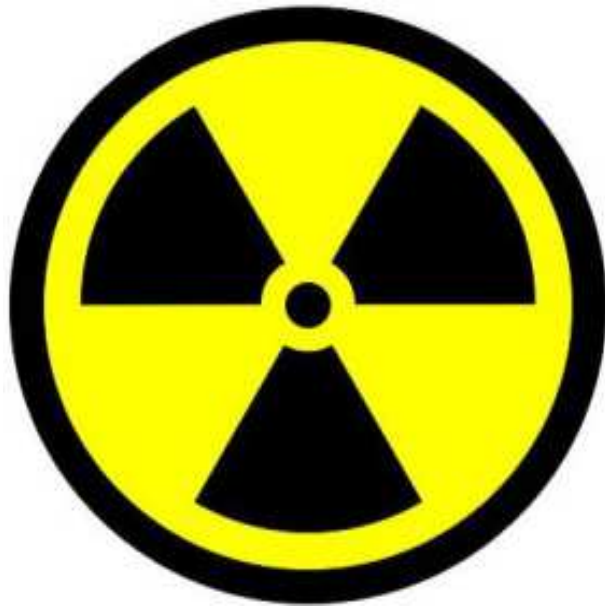
- All the activities were performed applying strict radiation monitoring with fixed duration of work. Sometimes the work shift lasted for only 15 to 30 minutes
- With the permissible dose of professional exposure being 0.15 Sv per year at that period of time (or 0.2 mSv per shift), admissions to perform the cleanup activities were granted on the basis of single admissible radiation exposure of 8 to 10 mSv
- Maximum doses of the cleanup workers during 1957-1958 were as high as 0.6-1.2 Sv

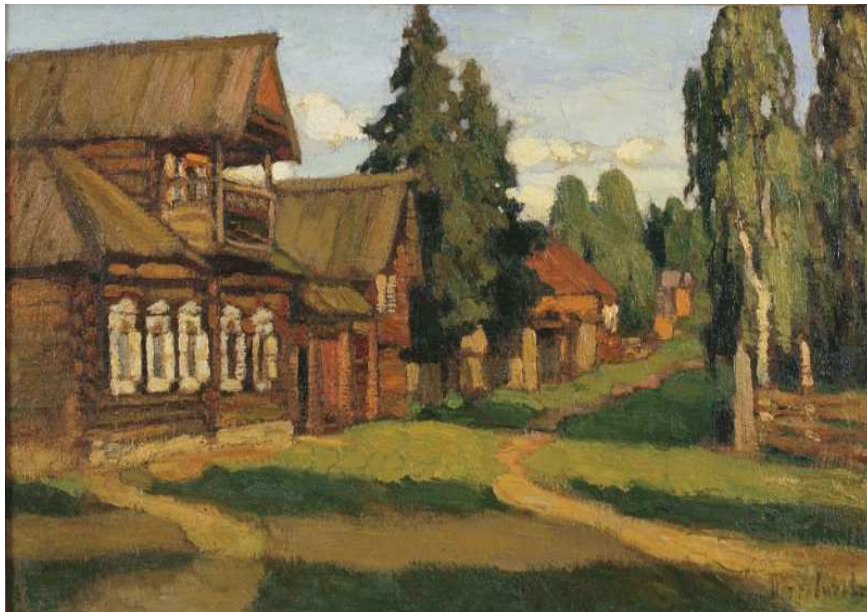
Radiation remediation of the contaminated territory outside the industrial site

- **More than 200 populated areas including several towns and workers' communities was contaminated**
- **Immediately after the receipt of the radiation monitoring data the USSR Minsredmash took first decision on urgent evacuation of the population inhabiting the area within 23 km from the explosion site with contamination density of more than 2 Ci/km² in terms of strontium-90**
- **Later on the Kyshtym accident of 1957 was ranked as Level 6 of the INES as a serious accident required implementation of the planned countermeasures**

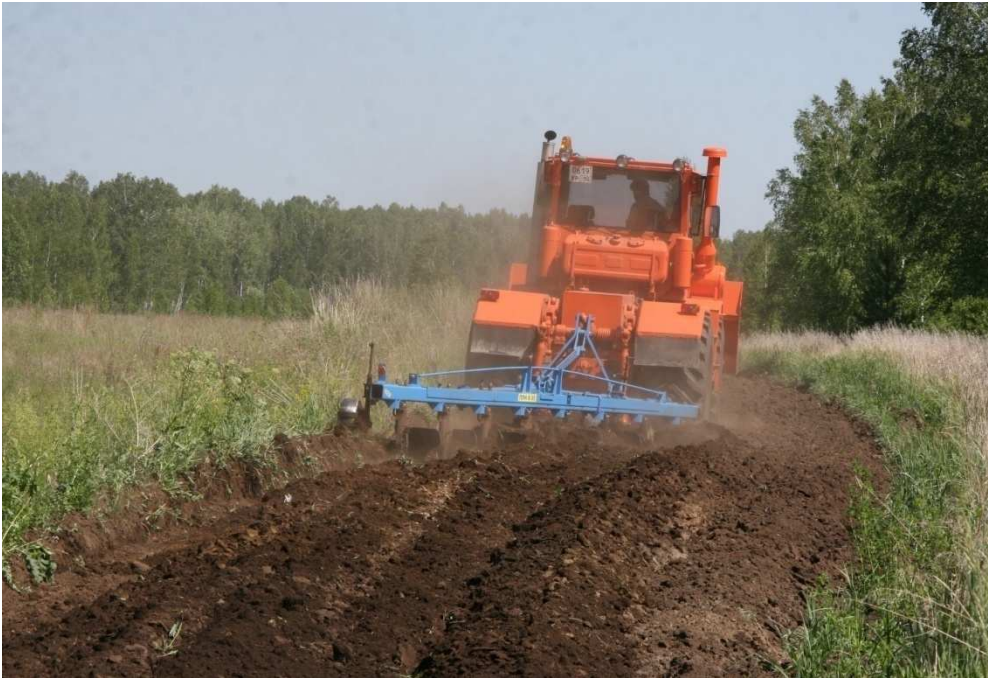
The Use of the Contaminated Areas

- By 1982 about 87, 000 ha (or 82%) of the lands contaminated during the accident of 1957 were brought back to use for agricultural purposes

- The EURT area is isolated, protected from unauthorized entry and used only to perform genetic and general ecological studies
