Plant Life Management Activities for Long Term Operation of the Argentinean Water Cooled Reactors

Comisión Nacional de Energía Atómica
Buenos Aires, Argentina

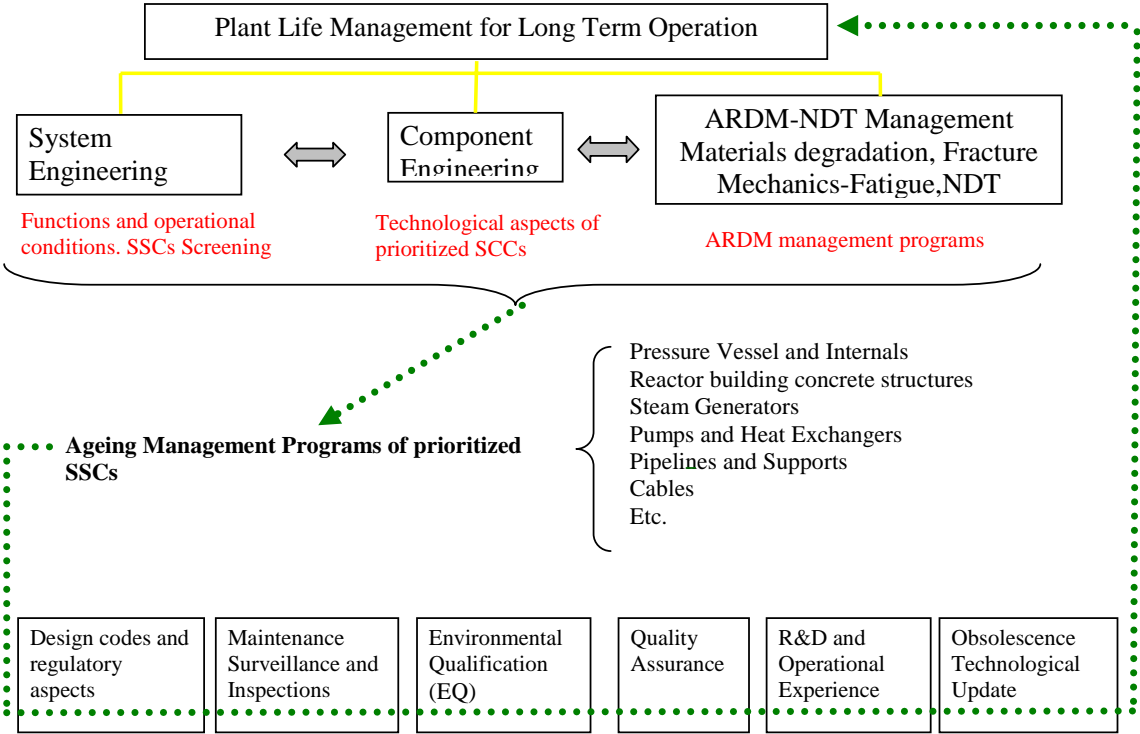
Fig. 1. Design of the of the information path flow in the PLIM program

This stage of the program has been started designing the flow information path required for the establishment of the Plant Life Management Program (Figure 1) and developing a Screening and Scoping Procedure. This procedure will be reviewed by IAEA experts within the frame of ARG/4/093 project.

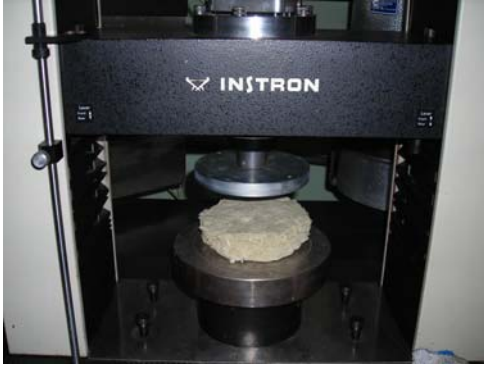
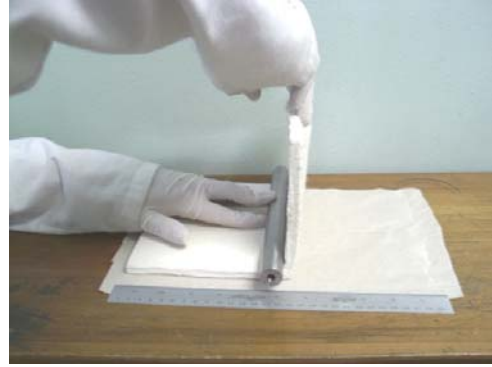
Fig. 5. Compressive test and flexibility of thermal insulator blankets

A new material based on a silica aerogel reinforced with a non-woven glass-fiber batting, was proposed to replace the conventional stone wool blanket. The PLIM department has studied the radiation damage and the possible changes in radiological activity after the exposure of both materials to neutrons. The irradiations were performed in the R.A 1 research reactor, radiological activity of the samples was measured in a multichannel detector Teletector FH FN3. The irradiated material was tested in compression under the guidelines of ref [10], also flexibility test were performed under the guidelines of ref [11]. Pictures of the mechanical test are shown in the following figure:

The main conclusion of this test was that radiological activity of aerogel after neutron exposure was lower than the stone wool and the mechanical properties of aerogel were not affected at the applied doses.
