# Plant Life Management Activities for Long Term Operation of the Argentinean Water Cooled Reactors

J. Ranalli, M. Marchena, J. Zorrilla, E. Antonaccio, G. Vega, R. Versaci

*COMISION NACIONAL  
DE ENERGÍA ATÓMICA*

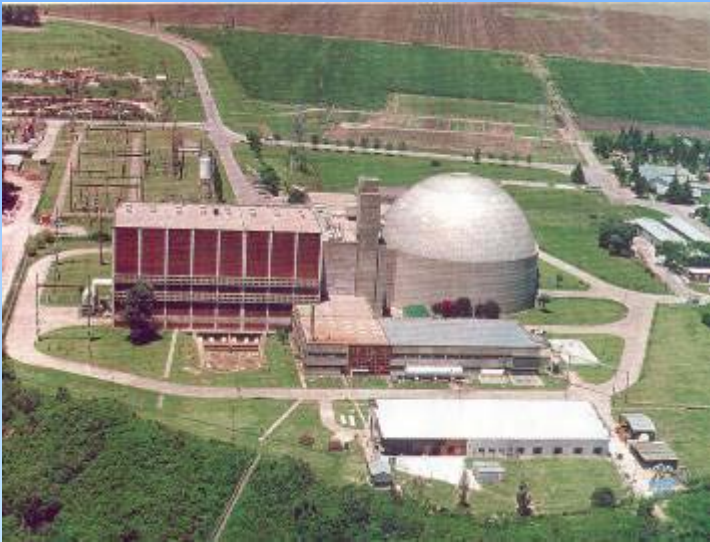
### Atucha I

Pressure Vessel – PHWR Unique! (except for Atucha II)

252 vertical fuel channels

In service refuelling

357 Mwe Gross Power

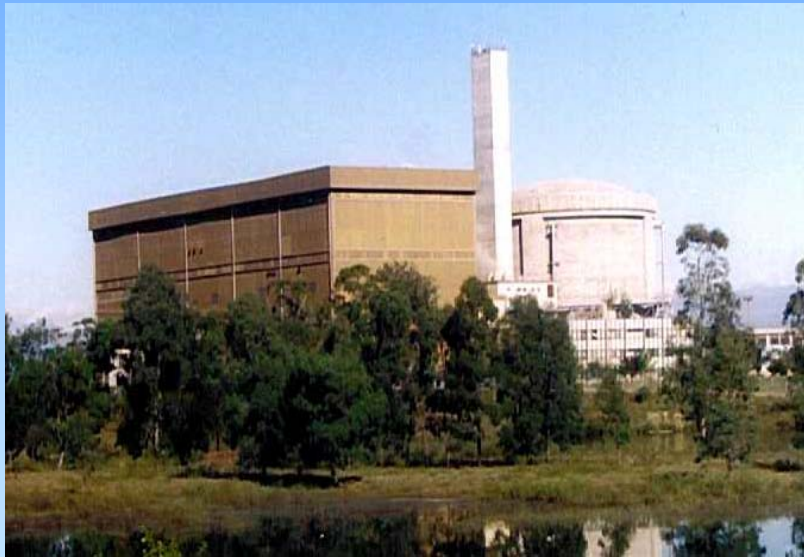
### Embalse

PHWR CANDU - 6

380 horizontal Pressure Tubes

On line refuelling

648 Mwe Gross Power

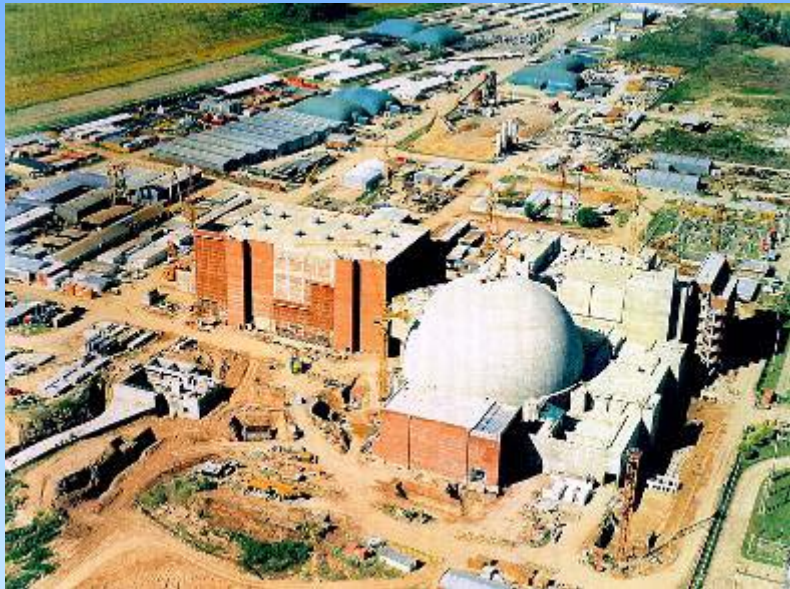
### Atucha II

Pressure Vessel - PHWR

451 fuel channels – On line refuelling

740 Mwe Gross Power

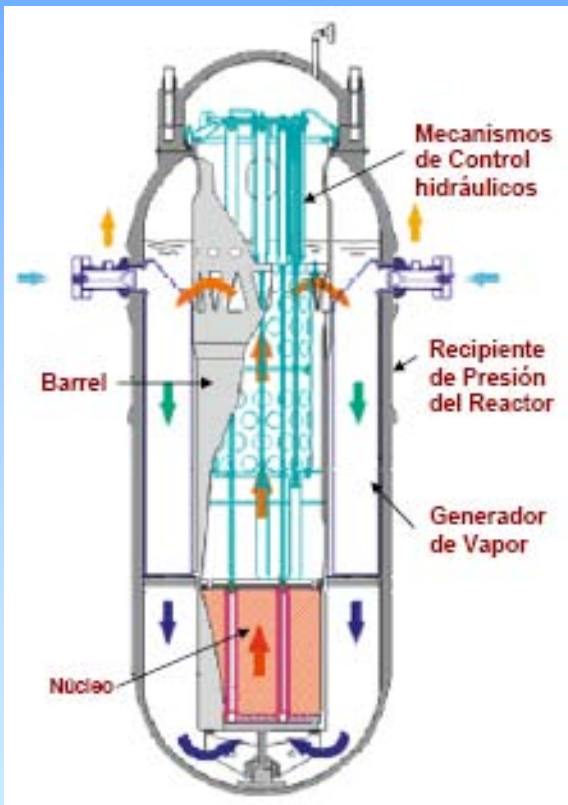
### CAREM

Innovative Prototype Reactor - Natural Convection

Integrated Design with In-vessel Steam Generators

25 Mwe Nominal Power - Scalable

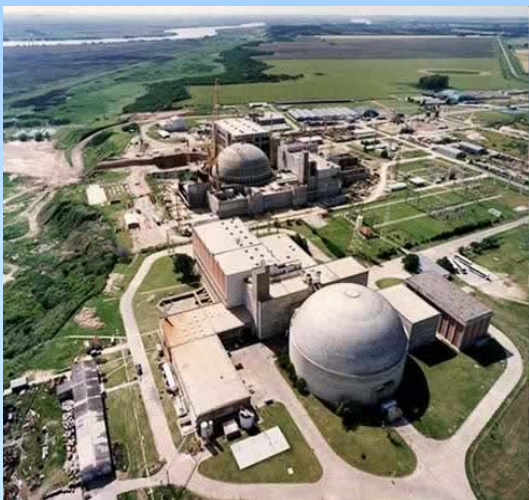
Currently this NPP has neither EQ program nor cable condition monitoring Program. Maintenance activities are performed on a corrective basis

Most of the cables insulation material are PVC and SiR

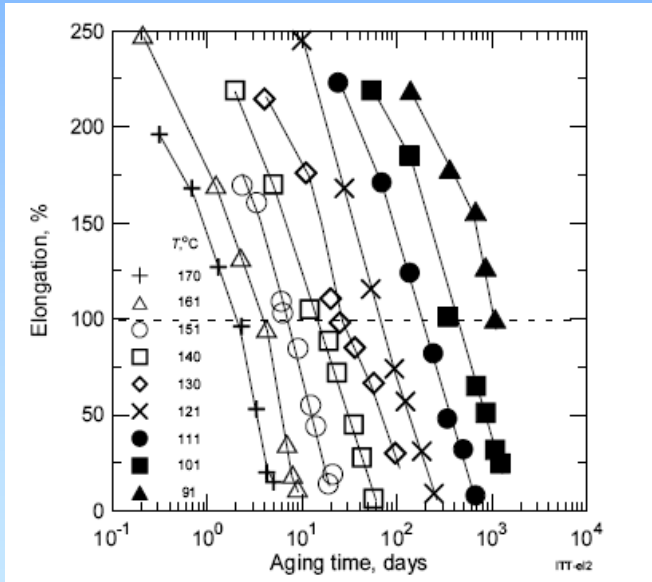
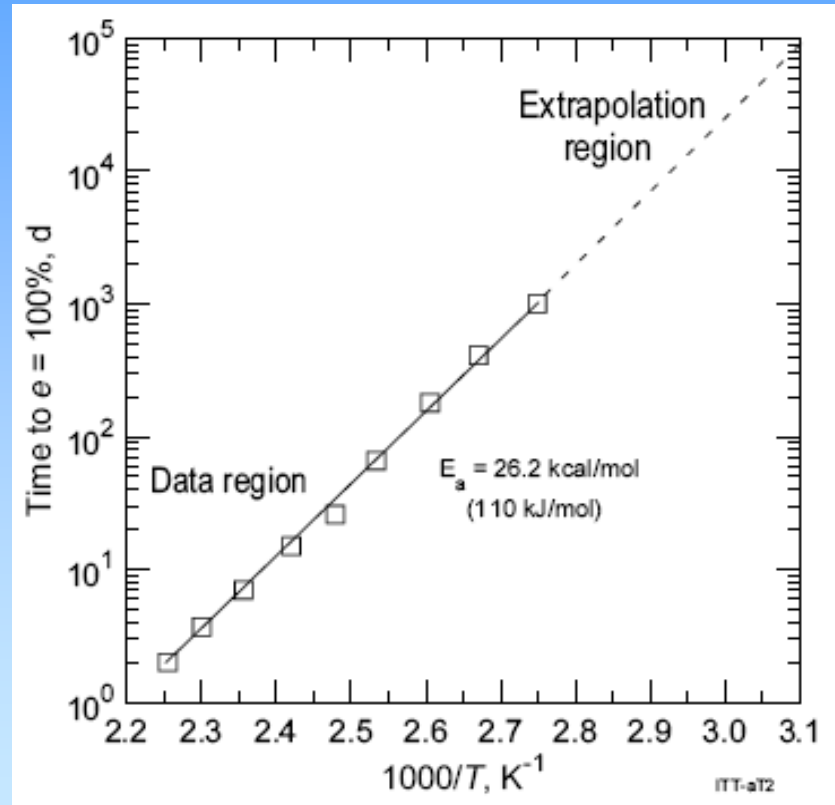
## Activation energy

**IEC 60216** Guide for the determination of Thermal Endurance Properties of Electrical Insulating Materials.

**IEEE 98** IEEE Standar for the Preparation of Test Procedures for the Thermal Evaluation of Solid Electrical Insulating Materials

**XLPO** SAND2005-7331 Nuclear Energy Plant Optimization (NEPO) Final Report on Aging and Condition Monitoring of Low Voltage Cable Materials

- *Activation energy*
- Plastizer lost
- Elongation at break
- Development of master curves of elongation at break at different temperature and correlation of elongation at break with non destructive essay properties (indenter test, under development)

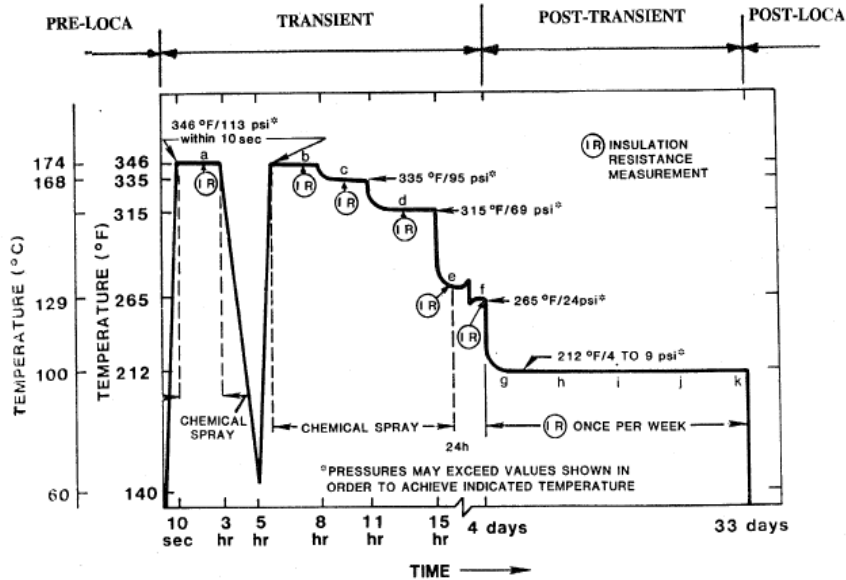
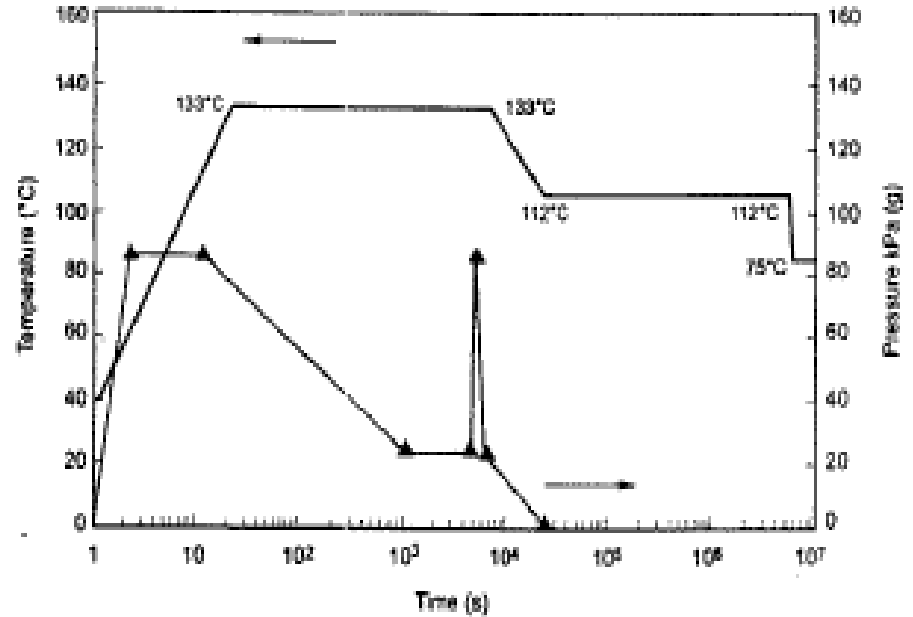
## Development of LOCA tests

Measurement of relevant properties under LOCA conditions and after LOCA cycle (i.e. Insulation resistance)

*Development of LOCA Test (in progress)*

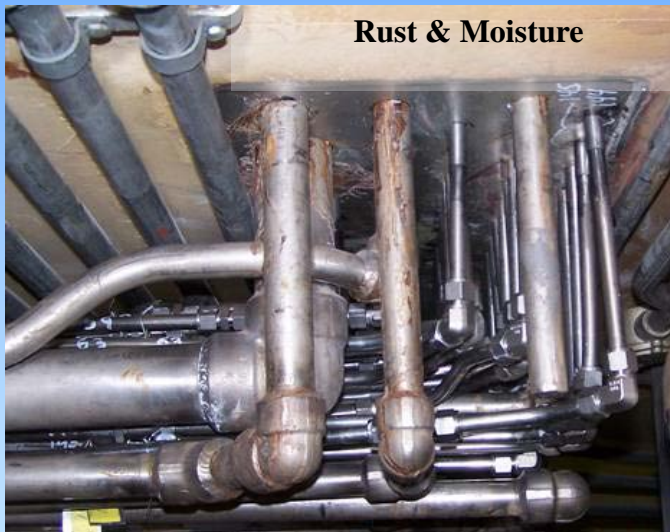
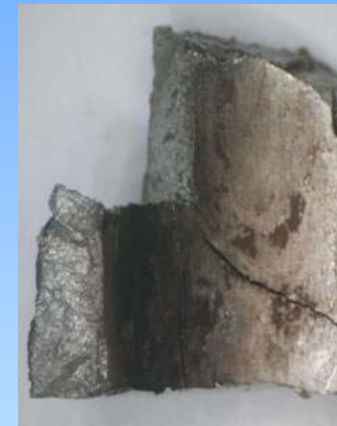
### Case 1: Non containment penetration

Outer surface: Pits

Inner surface: No damage

The failure has been found on a non-containment mechanical penetration, the leaking pipe was an AISI-304 pipe. The penetration is formed by two carbon steel plates. The pipes are welded to the upper plate and ilmenite sand is used as filler and as a shielding element. The samples shown signs of pitting in outer surface.

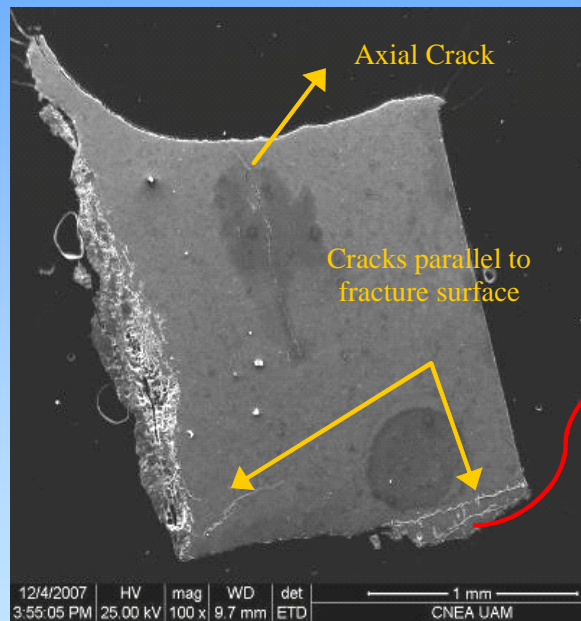
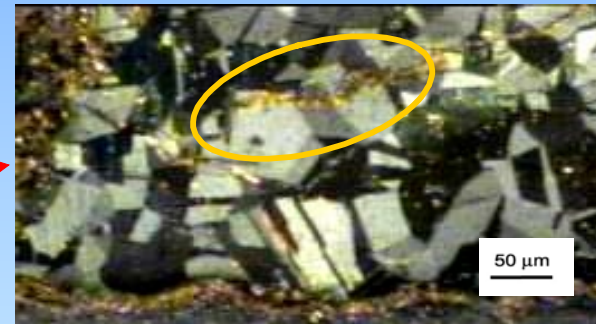
### Case 1: Non containment penetration

Transgranular Crack

The metallographic analysis has shown typical transgranular and branched cracks. As a conclusion, the failure of the pipe was due to Stress Corrosion Cracking (SCC) produced by the anions ( $\text{Cl}^-$ ) found as contamination in the ilmenite sand.

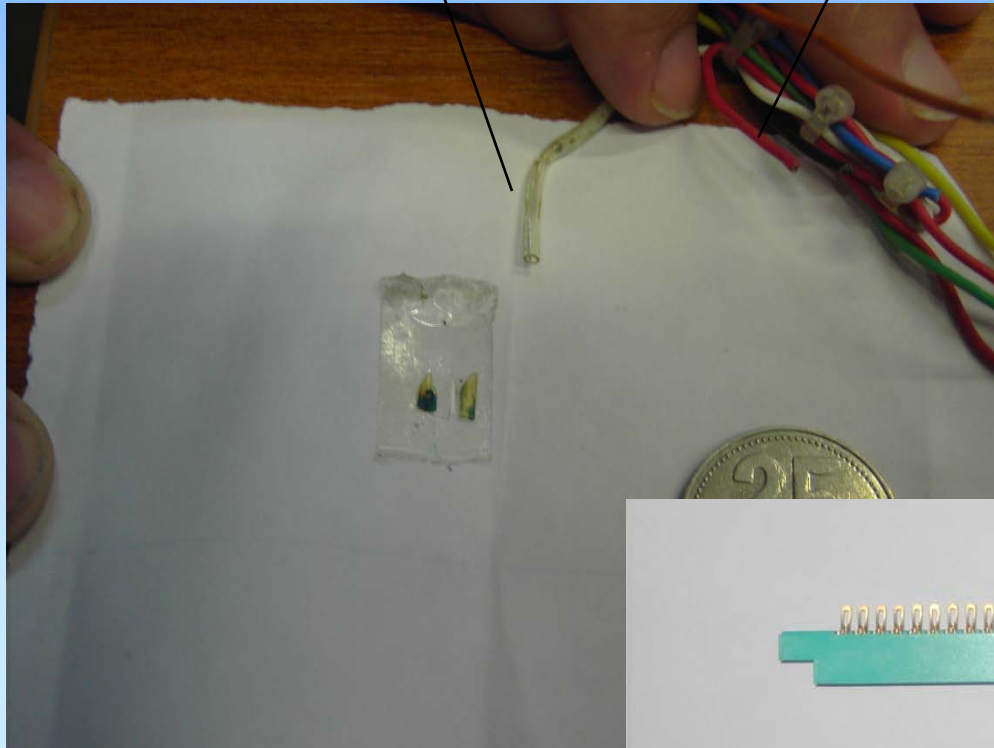
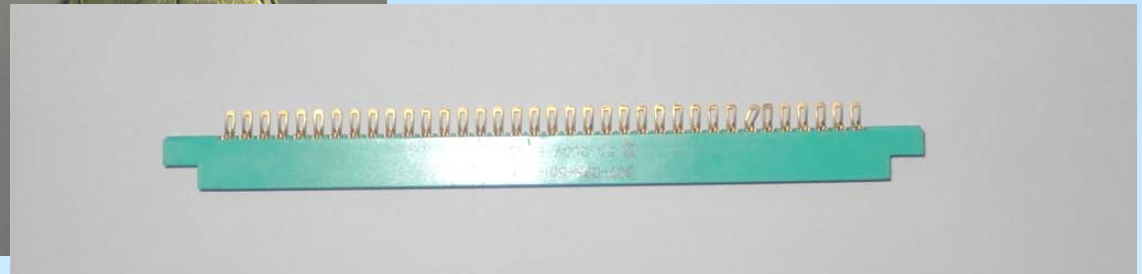
### Case 2: Corrosion in electronic devices

In a normal inspection of electronic equipment, several failures in welded connections were detected.

The failure analysis consisted in a characterization of failed connector and corrosion products.

- The welded connection was grinded at different depths in order to evaluate de crack size and morphology. Materials and corrosion product were characterized by FTIR, XRD, SEM and EDS
- Corrosion product found: Manly copper carbonate, and chlorine containing products.
- The failure could be related to chlorine evolution coming from the PVC splice-cover, and due to some transients in temperature and moisture.

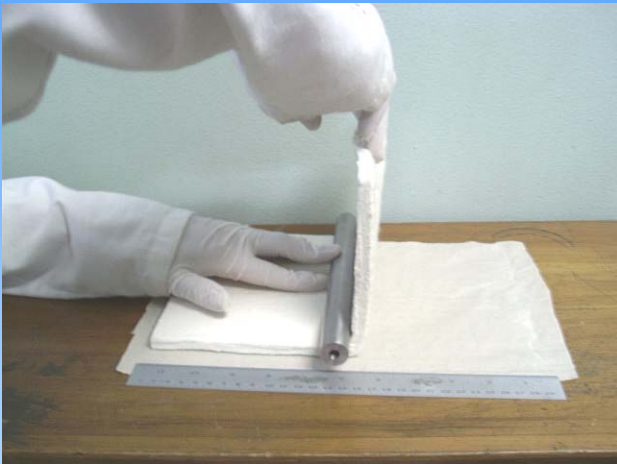
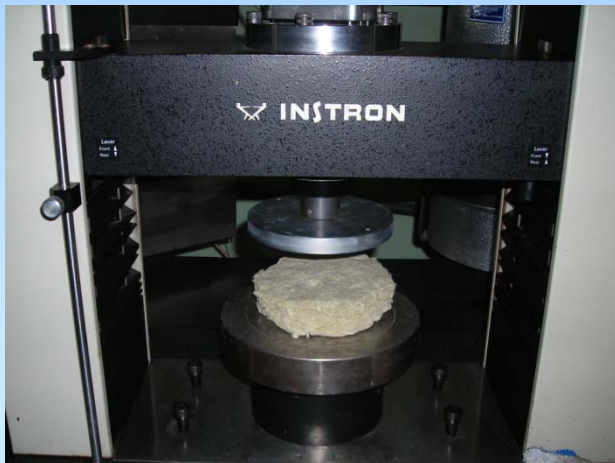
## Technical assistance: Suppliers qualification (ageing studies)

The PLIM division has made several tests to qualified materials and supplies for Argentinean NPPs, like electronic components, thermal insulation, etc

A new material based on a silica aerogel reinforced with a non-woven glass-fiber batting, was proposed to replace the conventional stone wool blanket. The PLIM department has studied the radiation damage and the possible changes in radiological activity after the exposure of both materials to neutrons.
