The Radiological Accident in Nueva Aldea

THE RADIOLOGICAL ACCIDENT
IN NUEVA ALDEA

INTERNATIONAL ATOMIC ENERGY AGENCY
VIENNA, 2009

A serious radiological accident occurred in Chile, on 14 December 2005, when at a cellulose plant under construction a radioactive source containing ^{192}Ir fell out of gamma radiography equipment unnoticed, and was later found and handled by three scaffolding workers. Under the Convention on Assistance in the Case of a Nuclear Accident or Radiological Emergency, the Chilean authorities requested assistance from the IAEA in terms of advice on the dose assessment and medical management of those involved in the accident.

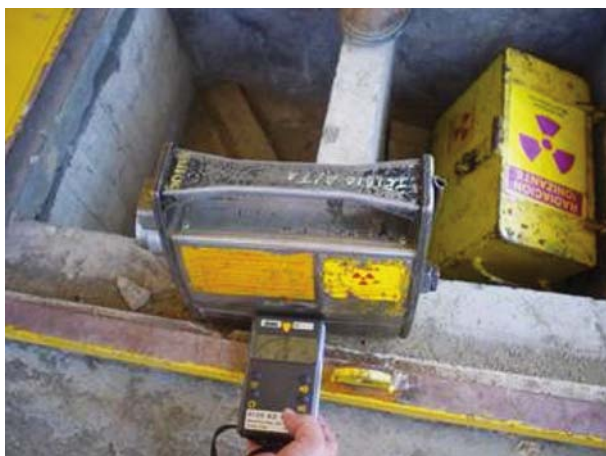
FIG. 2. Amersham Sentinel gamma radiography equipment, model 660, series 5657.

⁵ The source is a cylinder measuring 2.5 cm in length and 6.5 mm in diameter located in the pigtail with a total length of about 18 cm (pigtail plus the source plus the connection system).

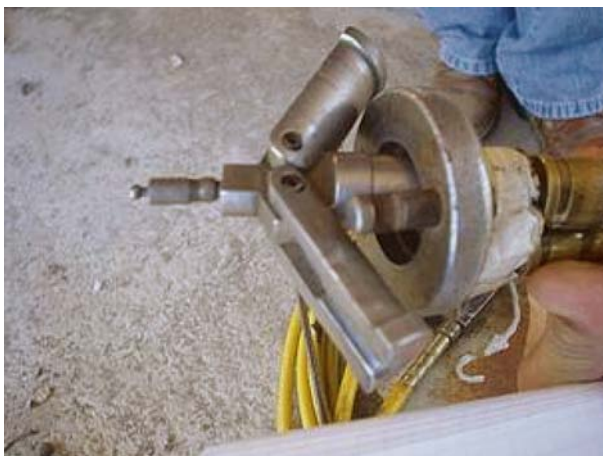
FIG. 4. A connector to the source and the projection exposure container (projector).

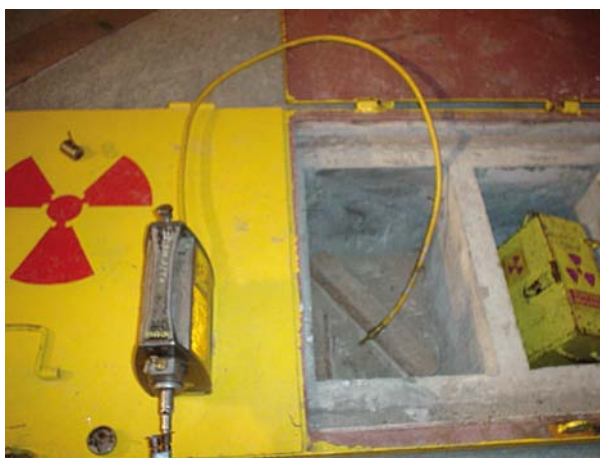
FIG. 5. A gamma radiography unit: the complete connection, including the guide tube.

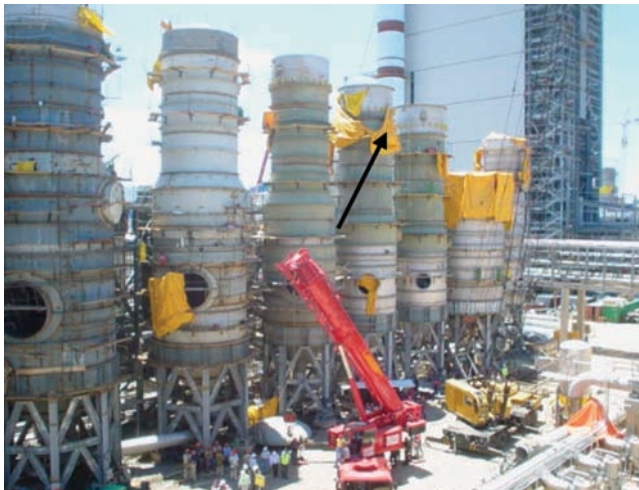
FIG. 6. Tower 3: the arrow shows the platform where radiographers were working on 14 December 2005 between 20:00 and 21:15.

On 14 December 2005 between 20:00 and 21:15 local time (in the following all times stated are local times), radiographer D and two radiography assistants, E and F, were performing radiography on the platform of tower 3 (about 22 m above the ground, see Fig. 6). After completing the fourth exposure, radiography assistant F collected the films and radiography assistant

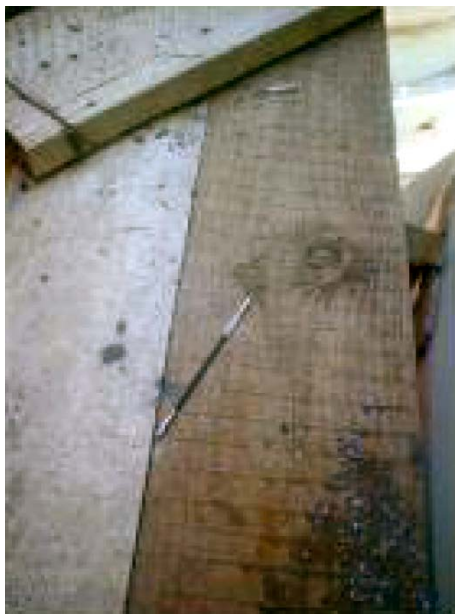
FIG. 7. A dummy source on the tower platform.

E dismantled the radiography equipment (taking 2–3 min)⁶. Radiographer D had a thermoluminescent dosimeter (TLD) and an alarm dosimeter, but the alarm dosimeter was turned off⁷. When radiography assistant E was disconnecting the source guide tube, the source fell out of the tube on to the tower platform unnoticed (Fig. 7).

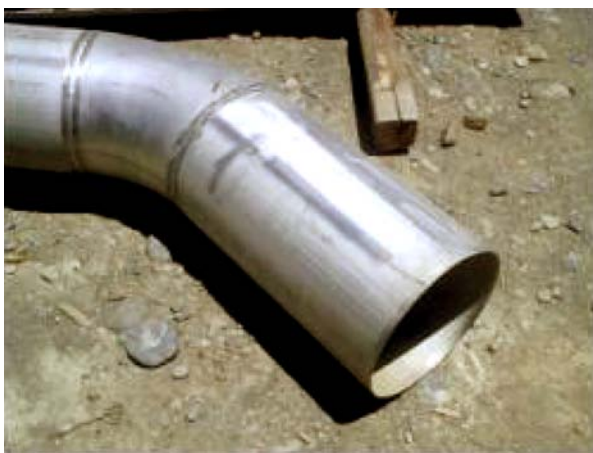
FIG. 8. The pipe that worker A threw the source into.

Two to four persons (workers A and G and possibly two other unidentified workers) were standing near the pipe (about 5 m from the pipe) when radiographer H passed by. They asked him if he recognized the object in the pipe. Radiographer H looked into the pipe, saw the small object, and took it out with his right hand to examine it. He immediately recognized that this was the source and threw it back into the pipe. He instructed the group to stay away and make sure that no one approached the pipe. He went to the office to report to his manager (manager I, the manager of the radiography company).

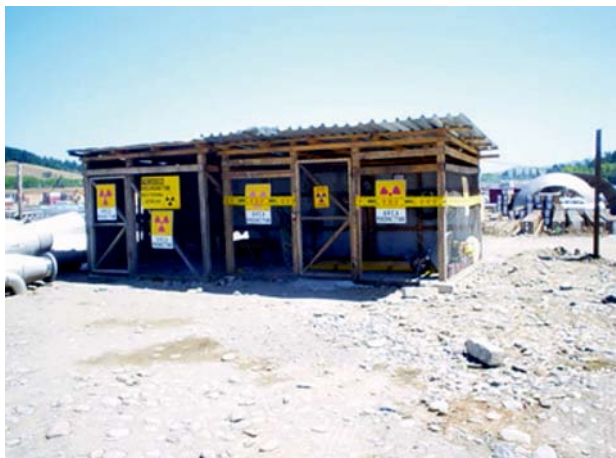
FIG. 9. The gamma radiography storage facility.

The gamma radiography storage facility is shown in Figs 9 and 10. Figure 11 shows the test carried out of the connection between the cable and the source. The connection complied with the requirements of the manufacturer as stipulated by the CCHEN.

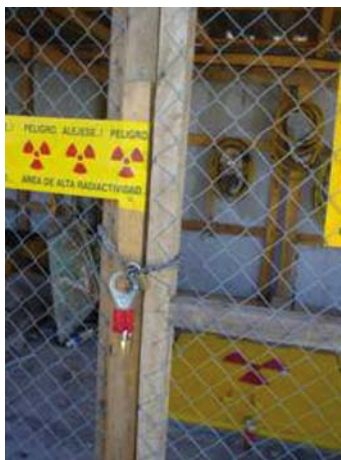
FIG. 10. Security details at the facility.

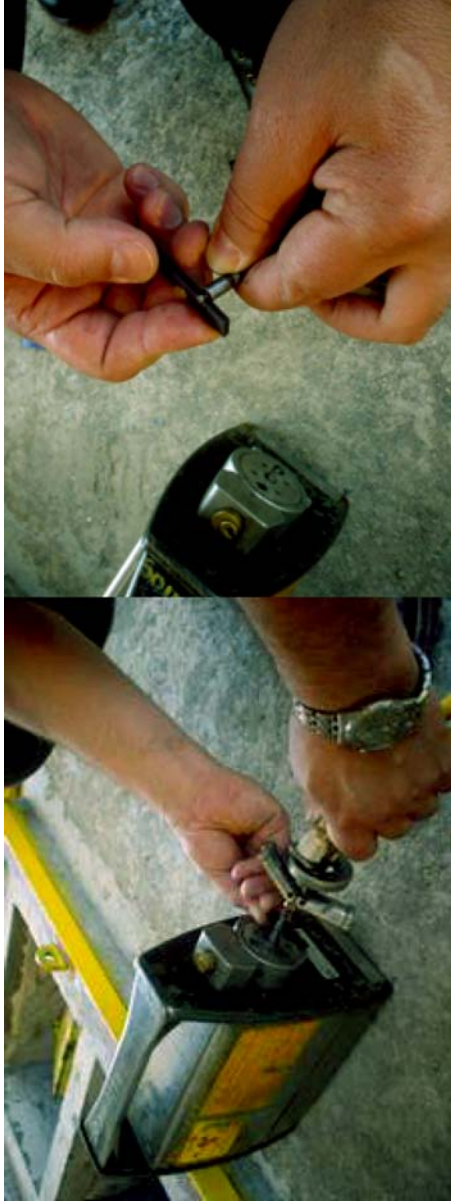
FIG. 11. Verification of the connection between the conductor cable and the source.

- (d) Inspected all Amersham 660 units and their accessories, verifying their condition. Where necessary, the equipment was repaired using original spare parts from the manufacturer.

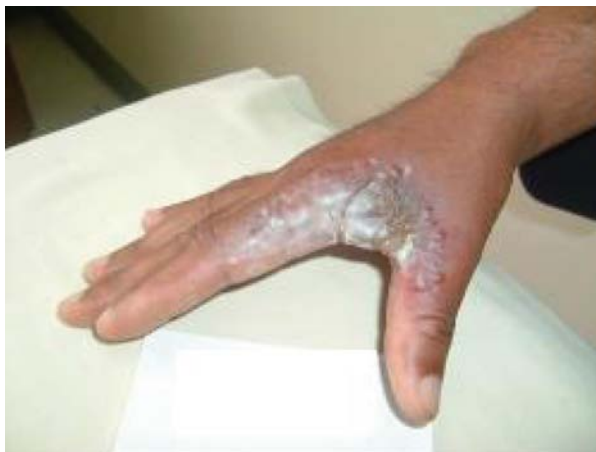
FIG. 20. Worker B: moist epithelitis with phlyctena on his right hand (9 January 2006).

On 2 January 2006, an erythema appeared in his right hand. The lesion evolved to moist epithelitis with phlyctena. On 16 January 2006, he was hospitalized again due to the erythema in his right hand and the need for a consultation with a plastic surgeon. The blister was treated on the following day. About a month after this treatment, the tissue was found to be epitelized and healed.

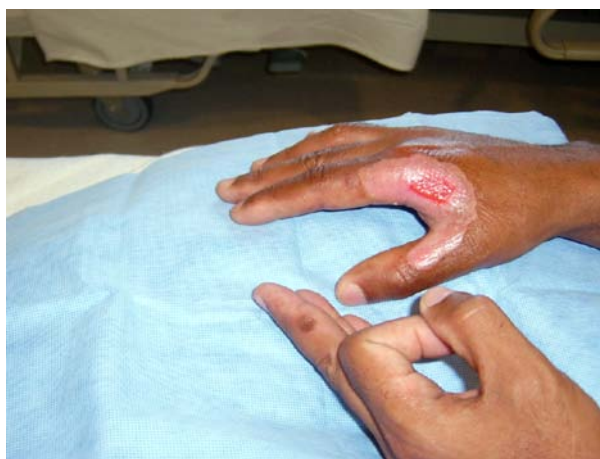
FIG. 21. Worker B: status of lesion on his right hand (17 January 2006).

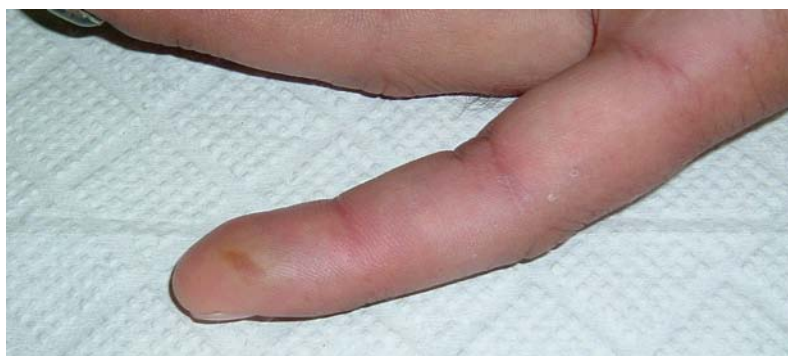
The spot on the index finger of the left hand of worker C is shown in Fig. 23.

FIG. 23. Worker C: pinpoint spot on the index finger of his left hand (11 January 2006).

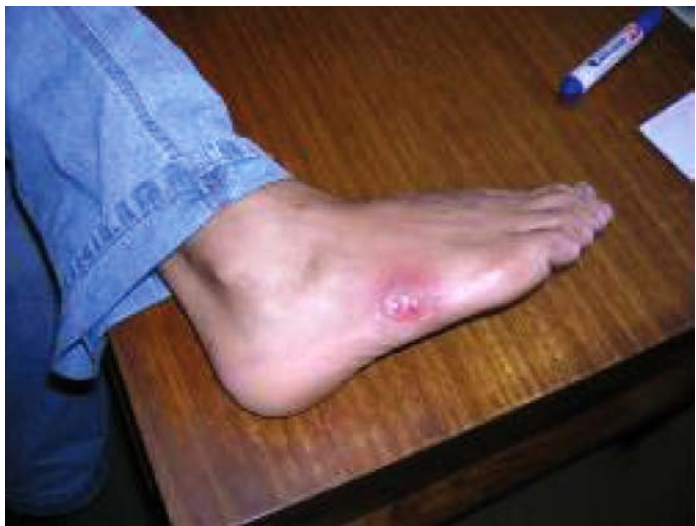
Figure 24 shows the right foot of radiography assistant E with the lesion before treatment, and Fig. 25 shows the lesion after treatment.

FIG. 24. Radiography assistant E: lesion on his right foot (11 January 2006).

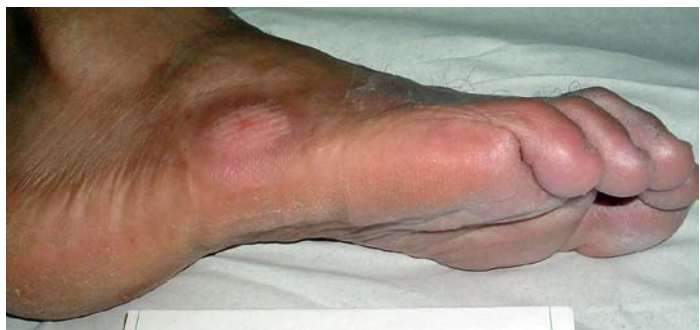
FIG. 25. Radiography assistant E: favourable evolution of the lesion (3 February 2006).

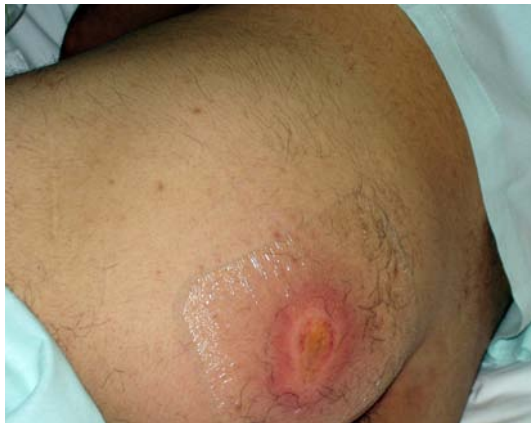
FIG. 26. Worker A: left buttock lesion (20 December 2005).

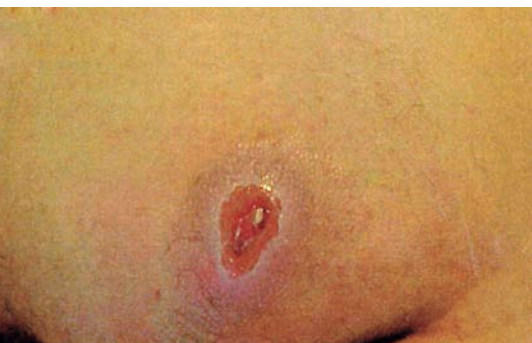
FIG. 27. Worker A: central necrosis in the left buttock (27 December 2005).

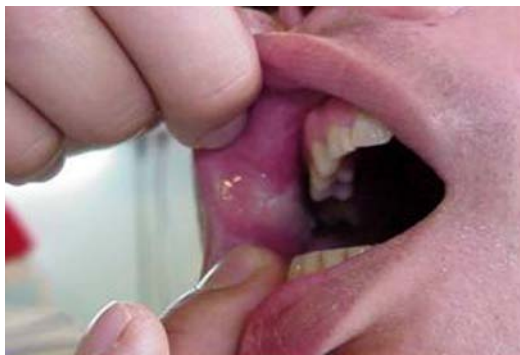
FIG. 28. Worker A: leukoplakia on the right hand side of the oral mucosa (26 December 2005).

The patient was successfully treated by intravenous application of 4 mg/d of Kepivance™ (Amgen, Thousand Oaks, California) for three days.

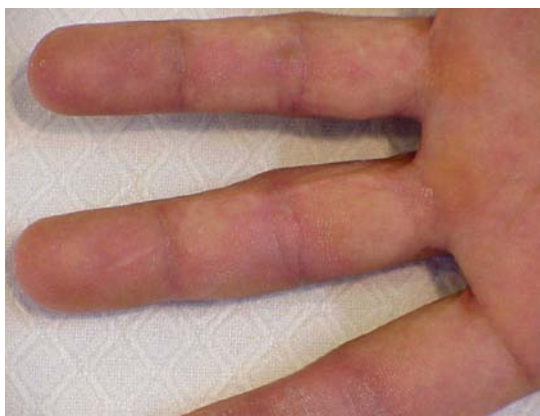
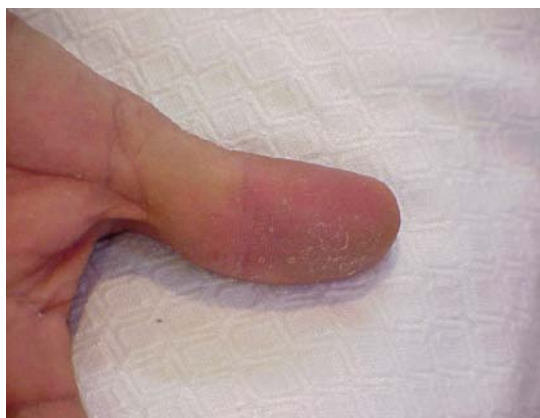
FIG. 29. Worker A: signs of dry epithelitis in the left hand (27 December 2005).

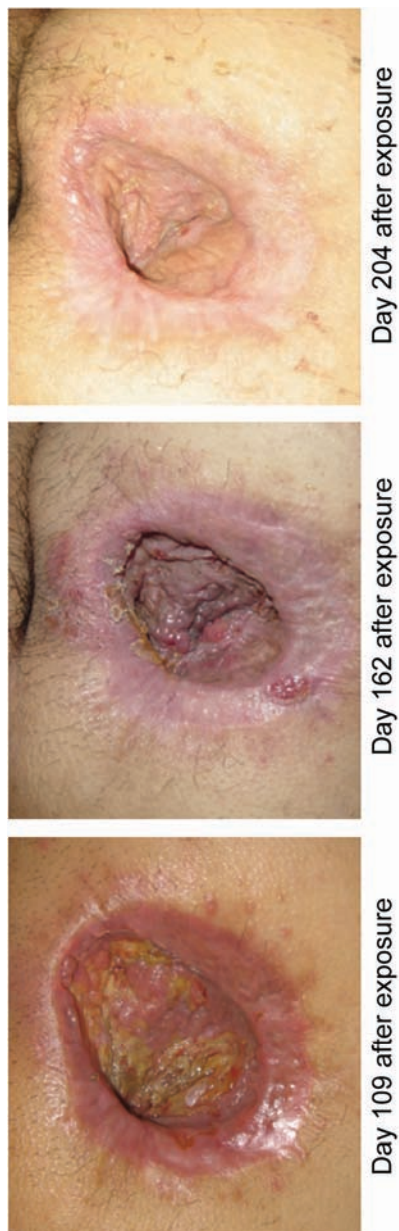
FIG. 36. Clinical evolution of the buttock necrosis after MSC therapy (courtesy: Hôpital d'instruction des armées Percy, CTSA, IRSN, France).

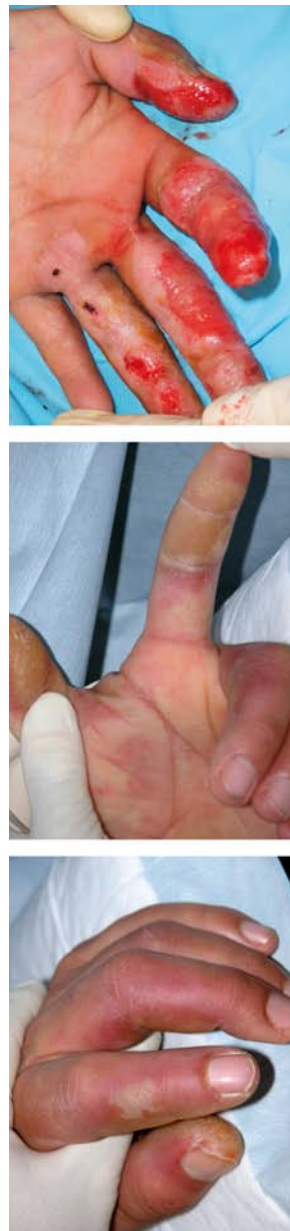
FIG. 37. Clinical evolution of the left hand of worker A (17 January 2006).

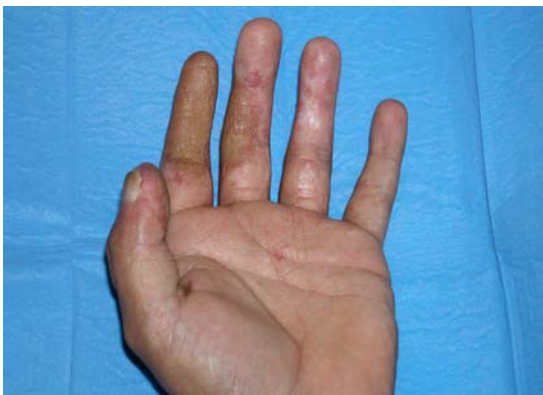
Figures 41 and 42 present the status of worker A's left and right hands when he arrived in France for the second time (October 2007).

FIG. 41. Status of the left hand of worker A (October 2007).

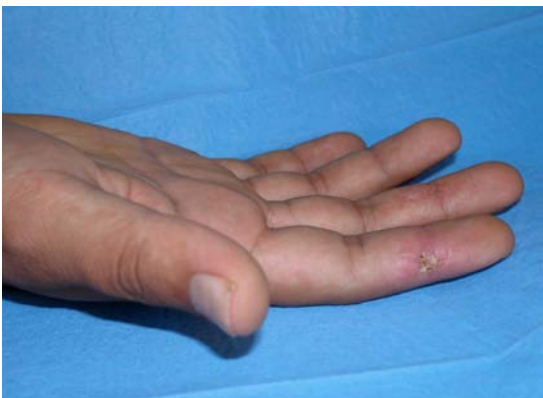
FIG. 42. Status of the right hand of worker A (October 2007).
