Experiences and Lessons Learned in Managing Severely Damaged Spent Fuel and Corium

Final Report of a Coordinated Research Project

IAEA-TECDOC-2085

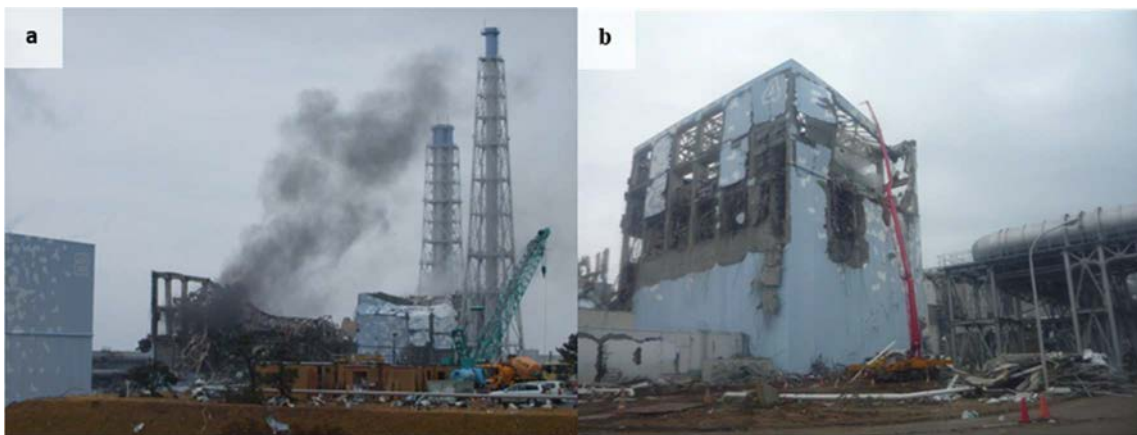
FIG. 20. Fukushima Daiichi NPP (a) Unit 3 and (b) Unit 4 after explosion (courtesy of TEPCO).

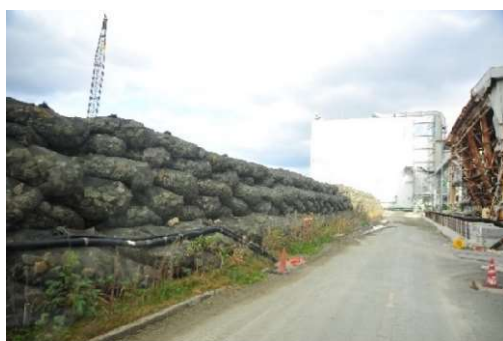
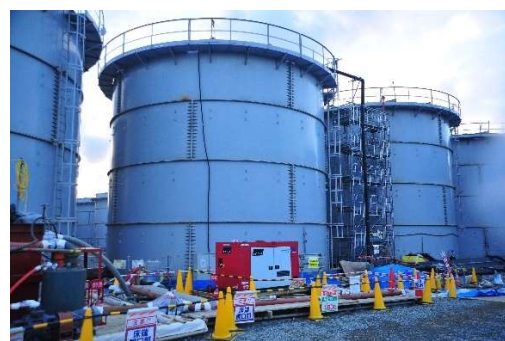
FIG. 22. (a) New sea barrier to secure site against a further tsunami, (b) New tanks for holding contaminated/treated water.

The combination of earthquake, accompanying tsunami and scale, in terms of the number of units involved, has made the decommissioning of 1F a complex task. Some of the initial operations have involved restoration of services, securing the site to a further tsunami (Fig. 22 (a)), removal of rubble/debris both on site and in the harbour, and building of tanks (Fig. 22 (b)) and cleanup systems to capture contaminated water.

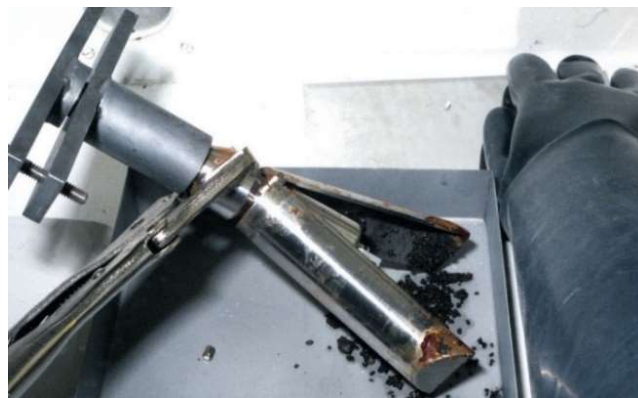
FIG. 24. Clamshell grab sampler with recovered material (courtesy of INL).

Eleven samples of loose material lying on the top of the melt were recovered before the reactor vessel head was removed. These grab samples provided indications of the highly varied nature of the loose debris. Material was acquired from the centre and midradius positions normally occupied by fuel assemblies H8 and E9. In the centre location, the sample tool was pushed into the loose debris to a depth of 77 cm from the top of the debris bed and to 94 cm at the midradius position. The sample tools included a clamshell device and a pointed penetrator with a cup into which loose material flowed. The samples were taken from the debris surface as well as at depths of 8 cm and 56 cm from the surface [78]. Figure 24 shows one type of sampler with granular material recovered.

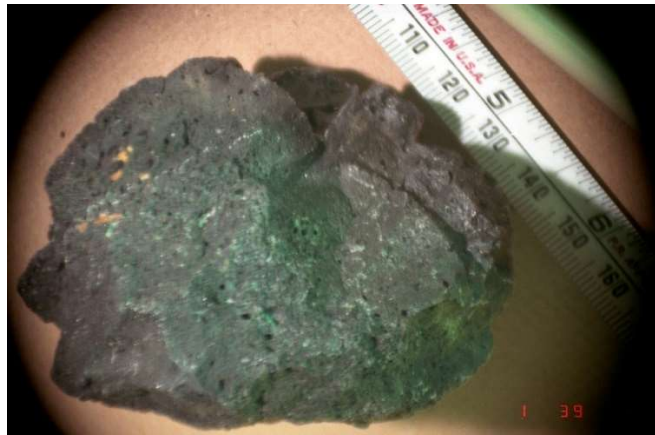
FIG. 25. Fuel piece retrieved from surface of the debris field in the centre of the core void (courtesy of INL).

pellets, pieces of cladding, porous material, metallic surfaces, and particles that included fuel, clad and structural material. An example of a fuel piece is shown in Fig. 25. Particles with dimensions between one and five thousand μm accounted for $\sim 90\%$ of the samples.

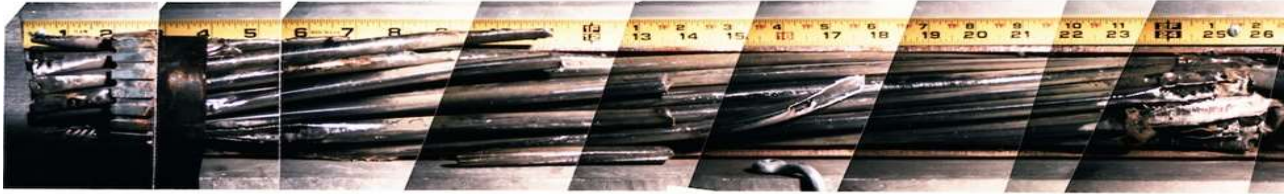
FIG. 38. Composite image of intact rods in core bore (courtesy of INL).

In those zones of the core where the lower sections of the fuel assemblies were largely intact, the core bore samples retained that configuration with some distortion due to the twisting action of the core bit passing through that material. A section of the intact rod structure is shown as a composite image in Fig. 38, and detailed views in Fig 39.

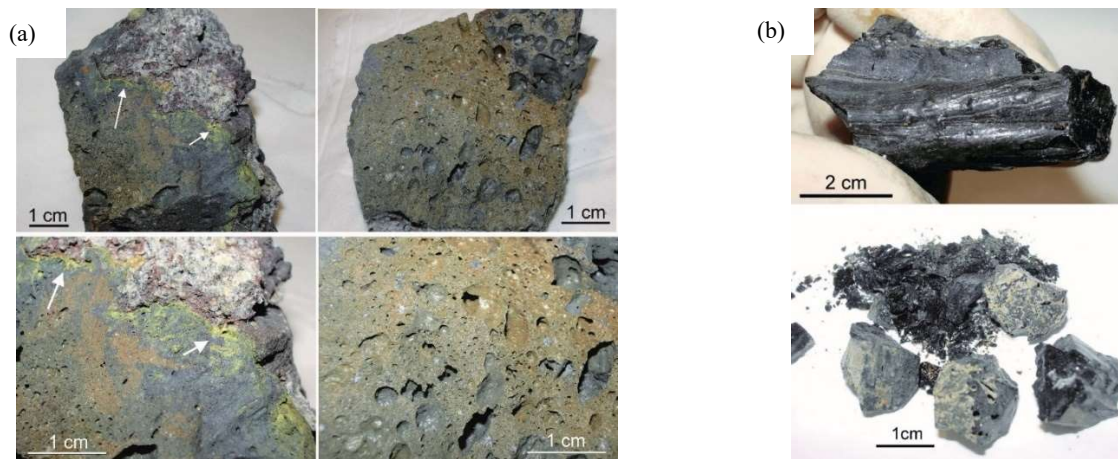
FIG. 45. (a) Sample of brown lava in contact with a piece of partially molten concrete from room No. 305/2. A secondary uranyl phase, indicated by arrows, was observed in 2011 along the interface between the lava and concrete. (b) Fragments of black lava from the ‘Elephant foot’ room No. 217/2. Sample observed to have fragmented in 2011 (reproduced from Ref. [35] with permission courtesy of B.E. Burakov, Ioffe Institute).

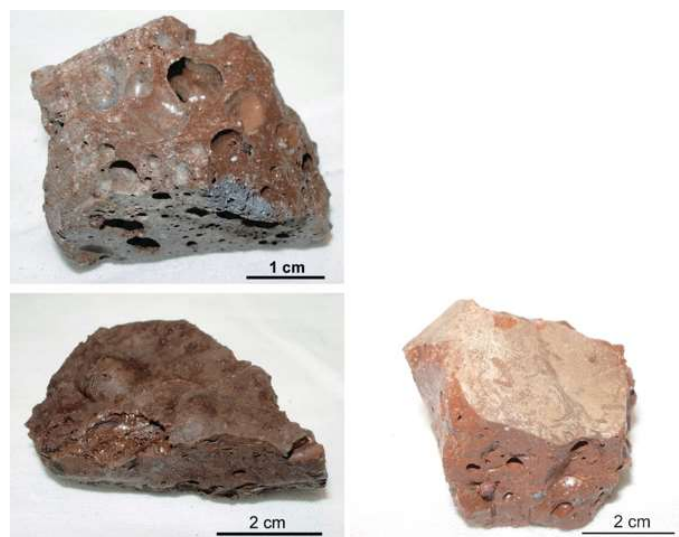
FIG. 46. Samples of brown lava from steam discharge corridor, room No. 210/7 (reproduced from Ref. [35] with permission courtesy of B.E. Burakov, Ioffe Institute).

A brief summary of the KRI collection is provided in Table 10. Examples of the samples retained at KRI are presented in Figs. 45–47. All samples have been stored in uncontrolled air at room temperature since 1990, and alteration was observed on the samples in 2011.

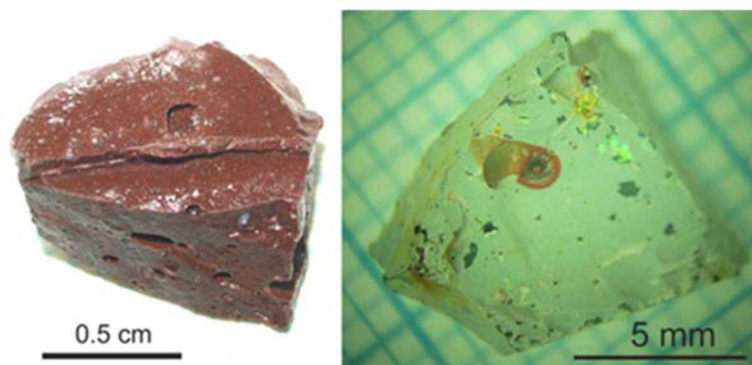
FIG. 57. Brown lava from steam discharge corridor used for alteration experiment: original sample (left) and after 1 year contact with distilled water at 423 K (right) [93] (courtesy of B.Yu. Zubekhina, KRI, and B.E. Burakov, Ioffe Institute).

After 1 year of contact in distilled water at 423 K, samples of lava and corium–metal interaction products were significantly altered in comparison with samples at 363 K (Figs 56 and 57). Different alteration processes took place on the surface of brown lava: formation of a gel on the surface of the sample, corrosion of metallic inclusions in lava matrix and oxidation of uranium in U bearing phases with formation of secondary uranyl minerals. At lower temperatures (298 and 363 K) dissolution of the glass like matrix of lava was not accompanied with a gel formation, in contrast to nuclear waste glasses [92].

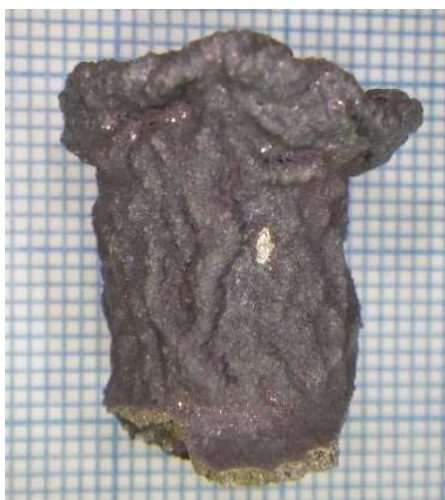
FIG. 65. Result of interaction of a fuel pellet placed in Zr + 1%Nb (E110) tube and heated at 2173 K for 10 min in vacuum, optical photograph taken on top of a 1 mm grid paper (courtesy of B.E. Burakov, Ioffe Institute).

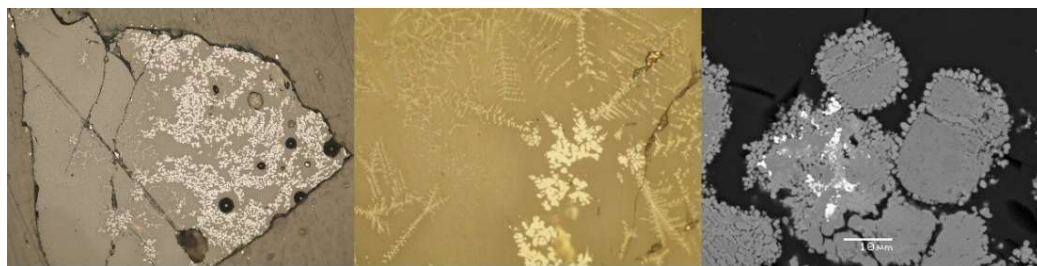
FIG. 68. ZrO_2 -based dendrites and spheres in the molten sample (courtesy of A. A. Shiryayev, A.N. Frumkin Institute of Physical Chemistry, and Electrochemistry).

The other half of the specimen was reacted with a mixture of K–Al–Si oxides and melted at 1673 K for 5 h in air. Samples mimicking black and brown ChNPP lava were obtained and subject to detailed examination (Figs. 67 and 68).

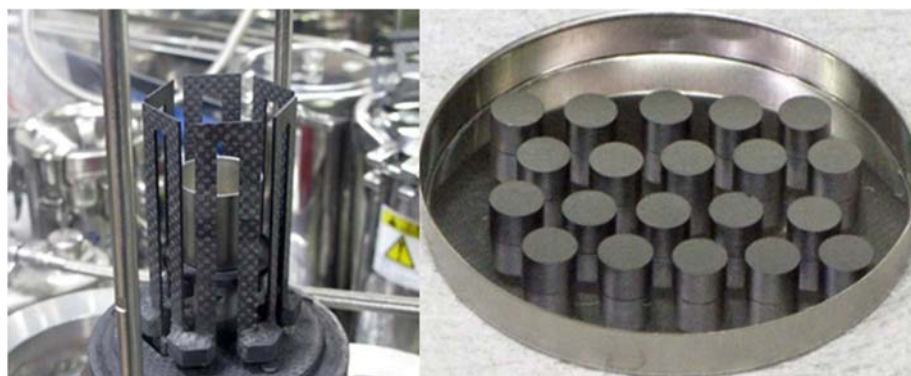
FIG. 69. Sintering heater unit (left), manufactured pellet with UO_2 , ZrO_2 mixture (right) (reproduced from Ref. [112] with permission courtesy of International Research Institute for Nuclear Decommissioning (IRID)).

Sintering is used in the fabrication of oxide fuel pellets. Powdered material components (such as UO_2 , Zr , ZrO_2 , etc.) are mixed and moulded into pellets. The pellets are sintered in an electric furnace at about 1973 to 2073 K, to produce simulated fuel debris (Fig. 69). UO_2 is eutectic with ZrO_2 to form a melt of $(\text{U}, \text{Zr})\text{O}_2$. Using this method, various fuel debris can be easily fabricated through changing the atmosphere and components.

- Same as fuel pellet fabrication;
- Mixing, crushing, pelletizing, sintering (Ar , $\sim 2000 \text{ K}$);
- Additive: Gd_2O_3 , Fe_2O_3 , Ca ;
- Oxygen potential control.

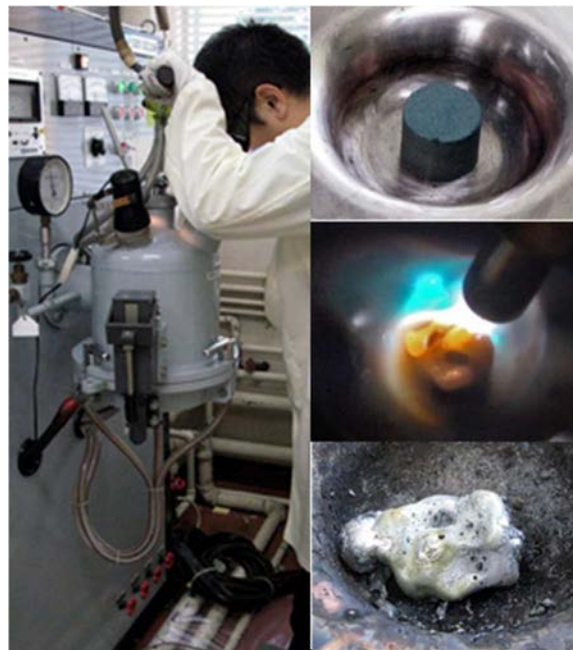
FIG. 70. Arc melting device (left), and sim-fuel debris pellet melted by arc melting (right) (reproduced from ref. [112] with permission courtesy of IRID).

In the arc melting method, an arc is formed between an electrode and the sample material, the material is heated by electron impact. The sample is melted at high temperature (>2000 273 K) in a short time. However, it needs inert gas atmosphere such as vacuum or Ar, and conductive materials for the material to melt. The sample can be completely melted and mixed with each component in this method (Fig. 70).

- Entirely uniform heating;
- Required metal rich conditions;
- Simulates core debris, MCCI products;
- ~ 5 g / sample.

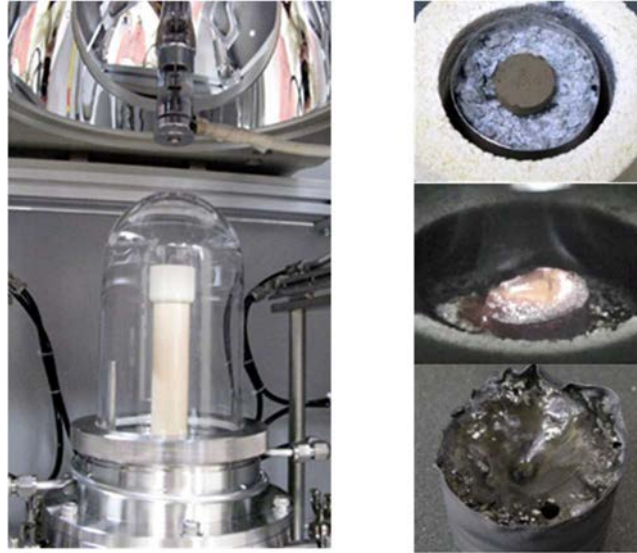
FIG. 71. Light collection heater device (left), and sim-debris pellet on concrete melted by Light collection method (right) (reproduced from Ref. [112] with permission courtesy of IRID).

During the condensed light heating method, the light of halogen heater is focused at one point by a condensing mirror and can heat the object in a short time (Fig. 71). By this method, not only metals but composite materials such as oxides can be melted.

- Concentrating light as a heat source;
- Erosion under thermal gradient conditions;
- Various atmospheres;
- Small scale MCCI, melting of (U, Zr)O₂.

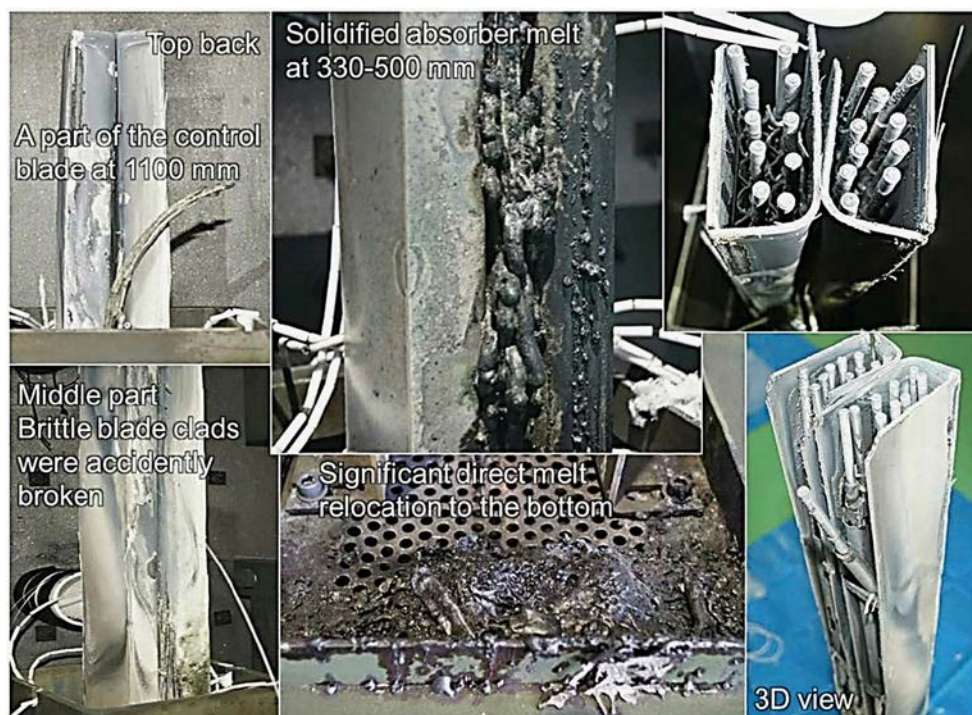
FIG. 78. Appearance of the post-test assembly of CLADS-MADE-01 test (reproduced from Ref. [115] with permission courtesy of Taylor & Francis Group).

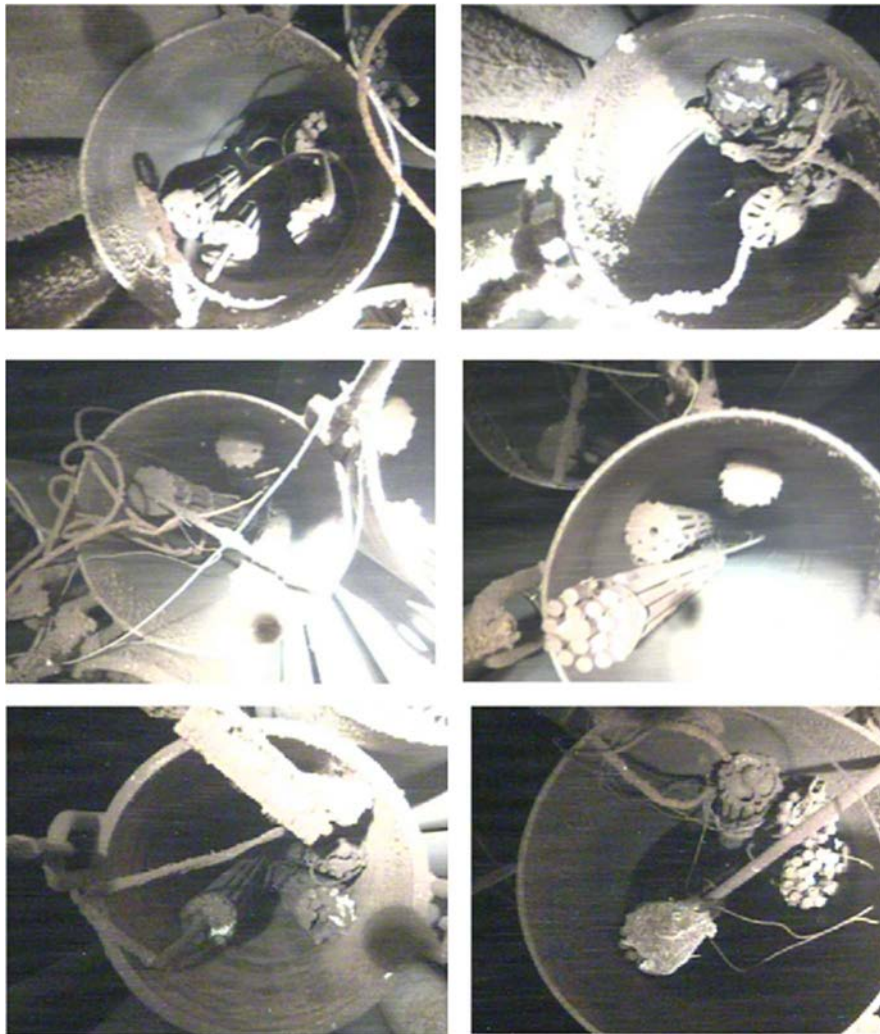
FIG. 90. Results of video inspection on the Unit 1 SDSF (courtesy of SSE ChNPP).

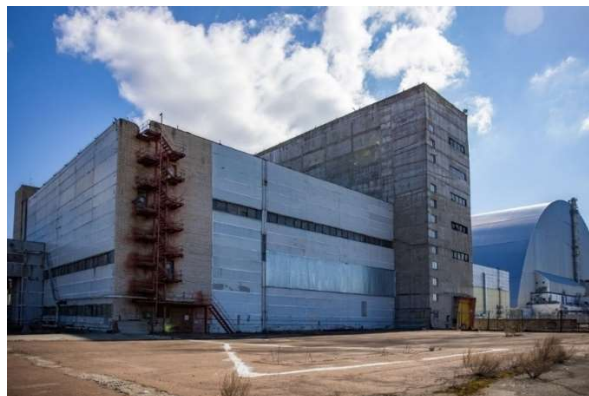
FIG. 97. Intermediate Spent Fuel Storage No.1 (courtesy of SSE ChNPP).

The ISF-1 (Fig. 97) is designed to receive, store and transport spent fuel assemblies (SFAs) to ISF-2.

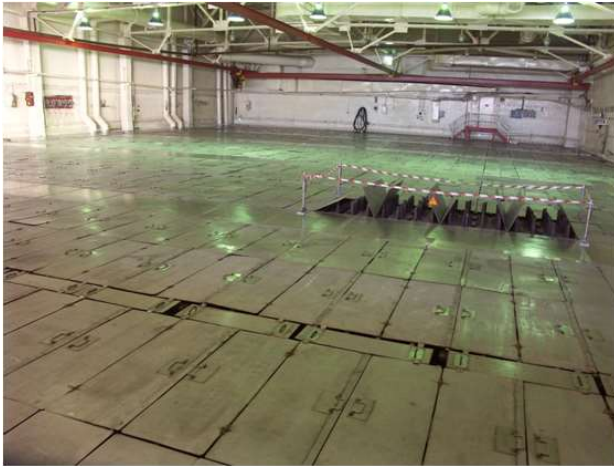
FIG. 98. (a) Intermediate Spent Fuel Storage No.1 spent fuel pool. (b). Canyon with USC (SCB) (courtesy of SSE ChNPP).

In ISF-1 the spent fuel is stored in five spent fuel pools (Fig. 98 (a)). There is a separate pool for transport casks and canyon.

To transfer SDSF from Units 1 and 2 to the ISF-1, it was necessary to make changes to the ISF-1 project and perform safety calculations. The canyon (Fig. 98 (b)) was designed for the storage (placement) of 29 USC (or SCB) with SDSF. The canyon consists of a reinforced concrete tank in which the walls and floor are lined with stainless steel and a rack for hanging SDSF in either a USC or SCB.

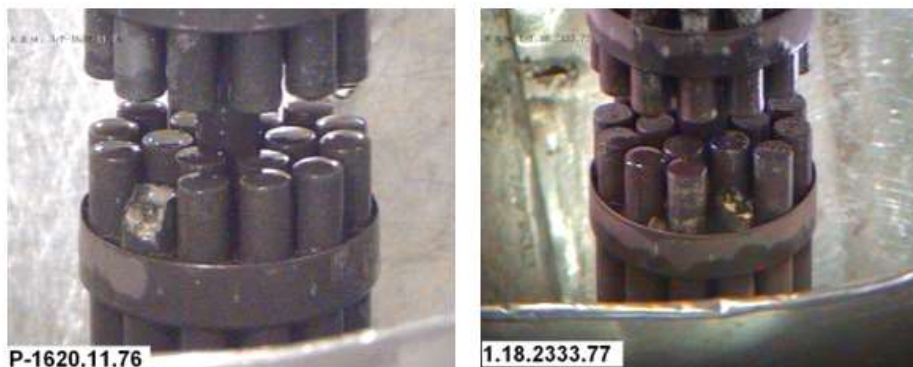
FIG. 100. Missing fuel rod plug (courtesy of SSE ChNPP).

Examples of VCS results are presented in Figs 99–101.

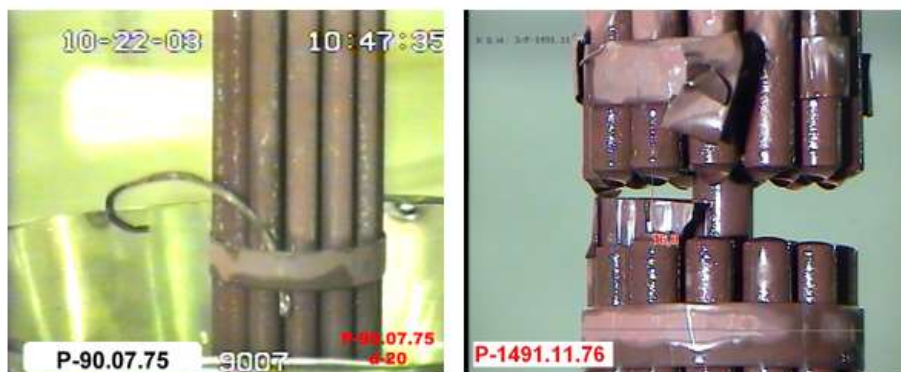
FIG. 101. Extraneous object in the SFA overall volume (courtesy of SSE ChNPP).

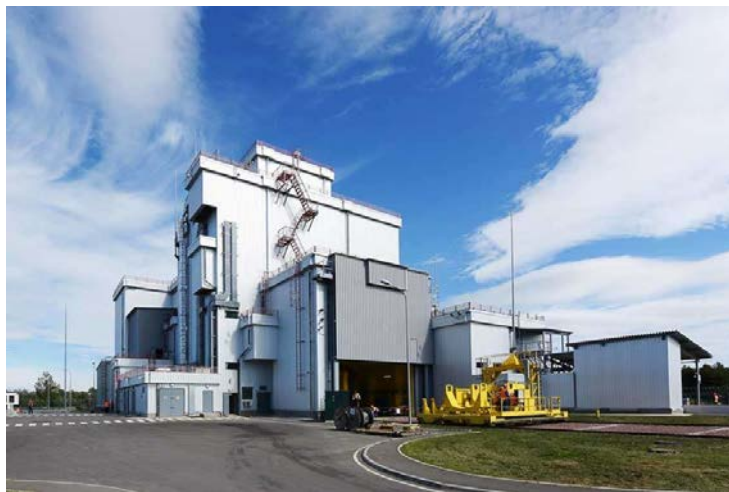
FIG. 102. Spent fuel processing facility (courtesy of SSE ChNPP).

The spent fuel processing facility (Fig. 102) is designed to receive, separate, and pack SFAs into canisters before exporting for storage, for up to 100 years.

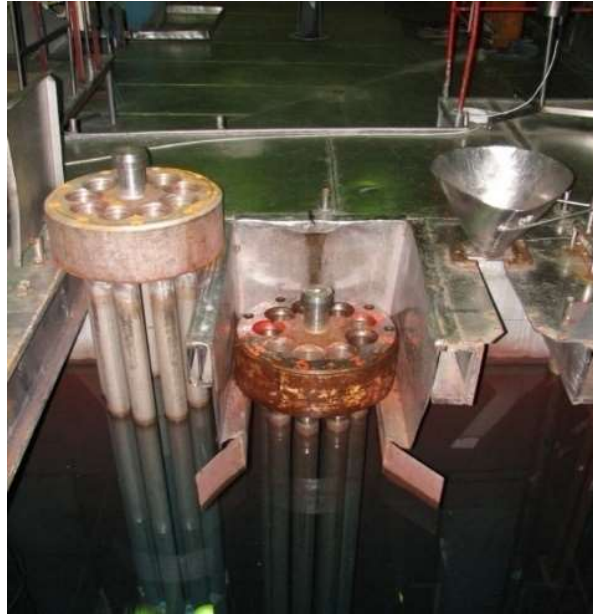
FIG. 103. Transport transfer basket (courtesy of SSE ChNPP).

- Receiving and shipment of TK–700 transfer wagon;
- Unloading of the transport transfer basket (Fig. 103) with SFA from TK–700 to the hot cell;
- Loading of the transport transfer basket with extension rods from hot cell to TK–700 (Fig. 104).

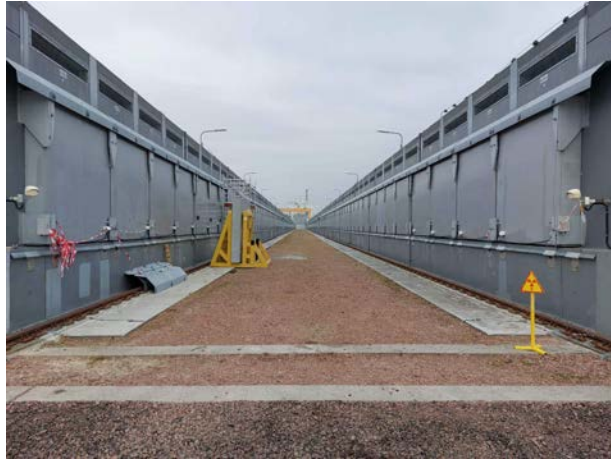
FIG. 110. Spent Fuel Storage Area (courtesy of SSE ChNPP).

The spent fuel storage area consists of 58 CSM \times 4 cells (232 cells in total) with a design basis of 100 years (Fig. 110).

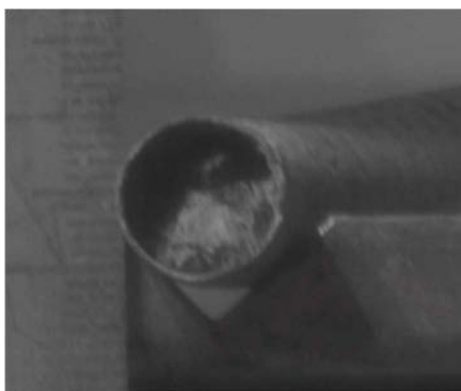
FIG. 116. Cut fuel pin with missing fuel (courtesy of NNL).

After weighing the fuel pin remnants, there was found to be a discrepancy between the mass of recorded and the mass of fuel expected within the can based on record. Inspection of the cut fuel sections indicated that in some cases substantial quantities of fuel were missing from the cut end of pins (Fig. 116).

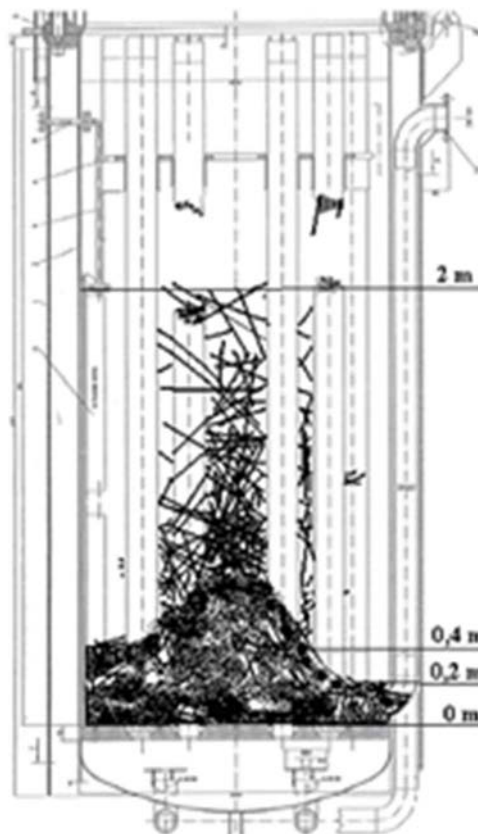
FIG. 130. The condition of damaged fuel in the cleaning tank (courtesy of Paks NPP).

- To investigate the cause of the accident, to understand the condition of the fuel and of the pit. The investigation showed the cause of the accident to be a design error since the removal of the residual heat was not properly ensured in all regimes. The tank contained more than 6 t of fuel, which was severely damaged in the centre, at the edges there was almost intact fuel (the status of the fuel is demonstrated in Fig. 130);
- To stabilize the fuel and to ensure safe condition of the damaged fuel and the units, including cooling, chemical treatment, and monitoring of main parameters (i.e., temperature, boron concentration and other chemical parameters, neutron flux and subcriticality, radiation, and potential releases).

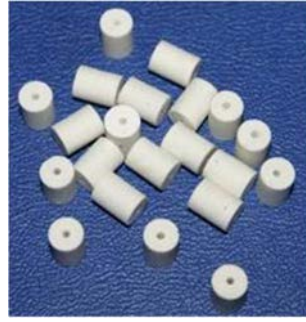
FIG. 138. Fuel pellet simulants using electro-technical casting porcelain (courtesy of Paks NPP).

On full scale experiments an electro–technical casting porcelain (ECP) was selected to simulate damaged SNF. The heat capacity per unit volume of ECP and UO₂ are close in values, i.e., the amount of heat required to heat ECP and UO₂, and consequently heating time are comparable. Thermal conductivity of ECP is 3 times less than the thermal conductivity of irradiated UO₂ that gives an opportunity to simulate UO₂ drying conservatively using ECP. Fuel pellet simulants fabricated using ECP are shown in Fig. 138.

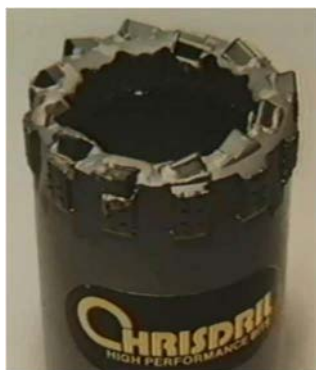
FIG. 185. Core sample core drill bit (courtesy of INL).

To accommodate materials ranging from metallic to ceramic, the core boring system that was used was based around a bit that used a combination of industrial diamond and tungsten carbide, silver soldered into the drill body. The drill bit type is shown in Fig. 185. This type of bit is hollow and creates a hole with a cylindrical centre core that is removed with the drill, resulting in an elevation representative section of the material it bores through. In this case, it is a sample core that was extracted by boring through the formerly melted reactor core.

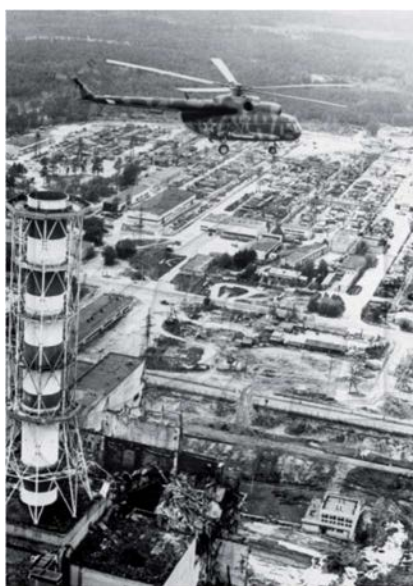
FIG. 199. Inspection of the destroyed ChNPP Unit 4 using helicopter (courtesy of Kurchatov Institute).

In the first days after the accident, high radiation levels and severe damage to the reactor and building hampered all attempts to find damaged fuel and corium at Unit 4. For this purpose, special detectors based on NaI (Tl) with a lead collimator were manufactured and installed on a helicopter (Fig. 199). When scanning from 200 m height it captured a field with a diameter of 30 m. In this way, the first map of radioactive sources was created over the damaged reactor, roofs of the on-site buildings and around the reactor site. In total, about 2000 measurements were made. The first measurements inside Unit 4 were made using radiometer Kirzhach-3 with a dose rate measurement limit of up to 30 Sv/h, however the dose rate near melted fuel locations quickly exceeded this limit. The method allowed the first lava accumulations like the one in room No. 217/2 ('Elephant's foot') to be discovered. Later, dehydrated pipelines were used for radiation measurements, which made it possible to find another accumulation of molten fuel in room No. 305/2. The location was also confirmed by temperature measurements (Chapter 1 of Ref. [49]).

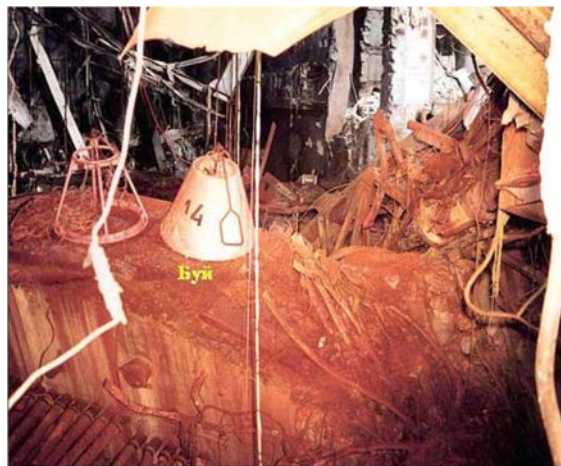
FIG. 201. One of the buoys installed on damaged reactor lid (scheme E) (courtesy of Kurchatov Institute).

- *Buoy programme*. The buoy was a truncated cone shaped 300 kg device, which had been installed directly into the reactor shaft using a helicopter or crane (Fig. 201). Each buoy was equipped with two sensors for measuring temperature and heat flux density, and it also had a gamma radiation detector and six anemometers in the upper part. The buoy cable was brought into a room with radiation background of 0.1–0.2 mSv/h where recording equipment was installed. In total, 15 buoys were installed with 160 different sensors and detectors.

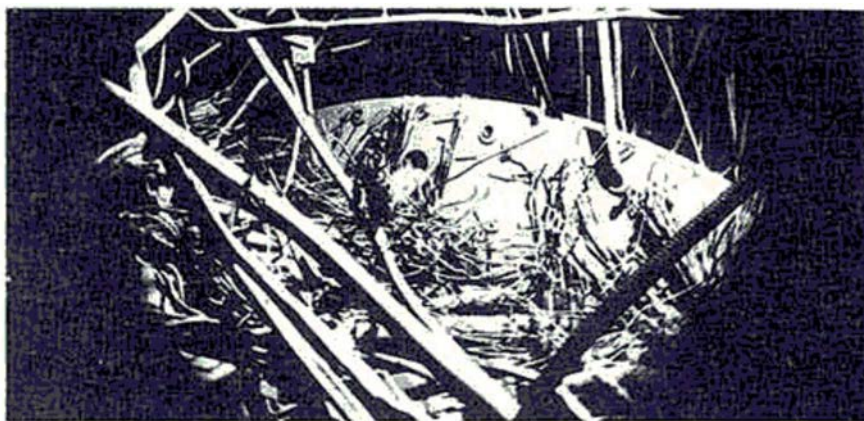
FIG. 202. Photo of the reactor shaft made by periscope through the borehole (courtesy of Kurchatov Institute).

Periscopes, portable photo and video cameras were used for visual inspection. The visual observation showed for the first time that the reactor shaft was almost empty (Fig. 202) and did not contain any fuel or graphite.

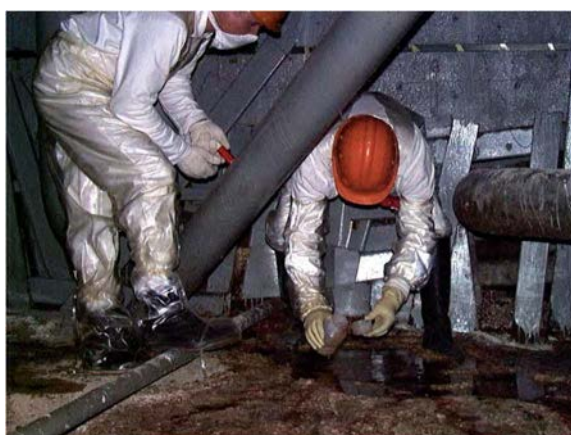
FIG. 203. Water sampling inside the Sarcophagus (courtesy of Kurchatov Institute).

Since the Sarcophagus was not hermetically sealed, and due to the use of dust suppressing solutions in some places inside the Sarcophagus, the molten fuel regularly interacted with water. Water samples were taken regularly by hand from the surface layer (Chapter 14 of Ref. [67]) (Fig. 203). After the decision was made in 1992 to transform the Sarcophagus into a new safe containment, detailed measurements of the dose rate, soil and groundwater contamination in the local area of the Sarcophagus were carried out (Chapter 15 of Ref. [67]).

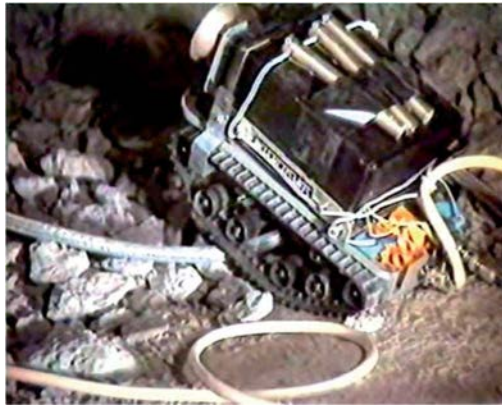
FIG. 204. Toy tank equipped with a dosimeter, temperature sensor and flashlight inside the Sarcophagus (courtesy of Kurchatov Institute).

However, some handmade robots were used inside Unit 4. For example, a self-propelled toy tank equipped with a dosimeter, temperature sensor, flashlight, and a 15 m cable (Fig. 204). Development, testing and improvement of robots continued during the operation of the Sarcophagus, where they were used to clean the air from aerosols and take samples of contaminated concrete [254].

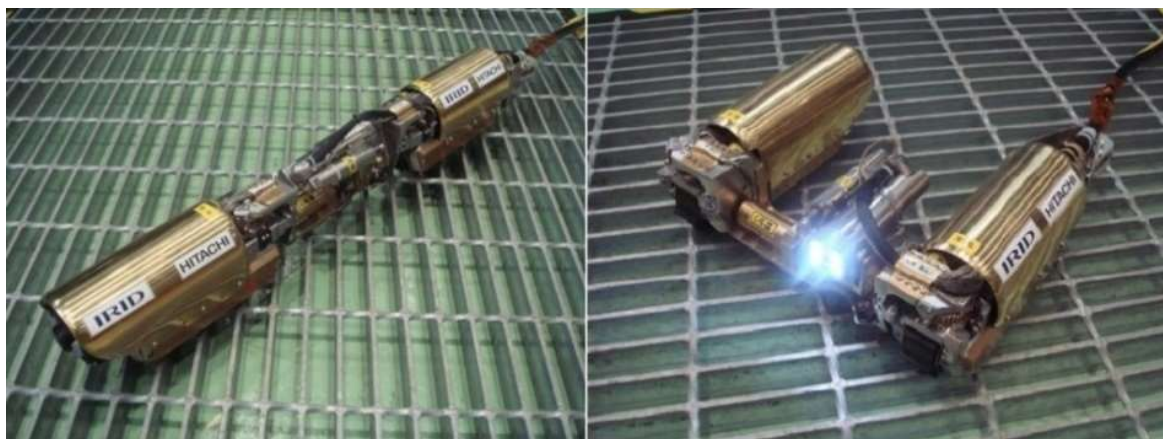
FIG. 206. PMORPH-1 (reproduced from Ref. [257] with permission courtesy of IRID).

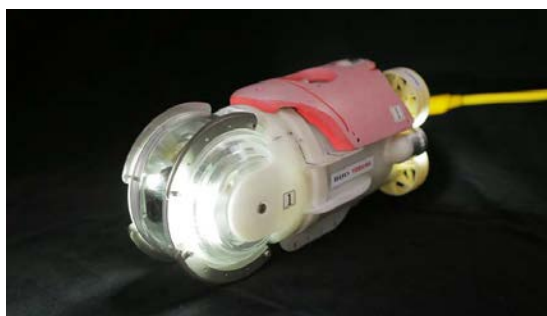
FIG. 215. Submersible inspection robot (reproduced from Ref. [265] with permission courtesy of IRID).

As the water level inside Unit 3 PCV is high, a submersible inspection robot was developed, shown in Fig. 215. It has five thrusters, four are for forward motion and one is for up/down motion. The robot can also pass through a narrow pipe (150 mm diameter) to enter the PCV. The size is approximately 130 mm (diameter) × approximately 300 mm (length), and weighs around 2 kg (in air), and neutral buoyancy (in water). It is equipped with two cameras, light emitting diodes (LED) lights, and a dosimeter. The robot operated in July 2017, entered the PCV through penetration X-53 and travelled into the RPV (Fig. 216).

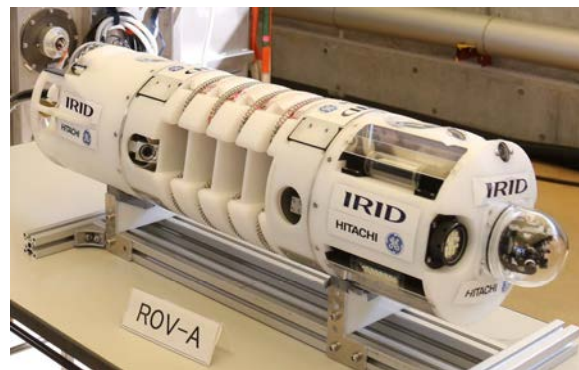
FIG. 217. Boat type access equipment with submersible functions (reproduced from Ref. [267] with permission courtesy of IRID).

Figure 217 shows a new boat type submarine. It has been developed to access and investigate the inside of Unit 1 PCV. This equipment has a total length of approximately 1 m, a cylindrical shape with a diameter of 25 cm, and various sensors to obtain information: A scanning type ultrasonic distance meter to acquire data on the shape of the sediments accumulated on the bottom of the PCV; A high power ultrasonic sensor to measure the thickness of the sediments; A radiation measuring instrument to understand the distribution of fuel debris etc.

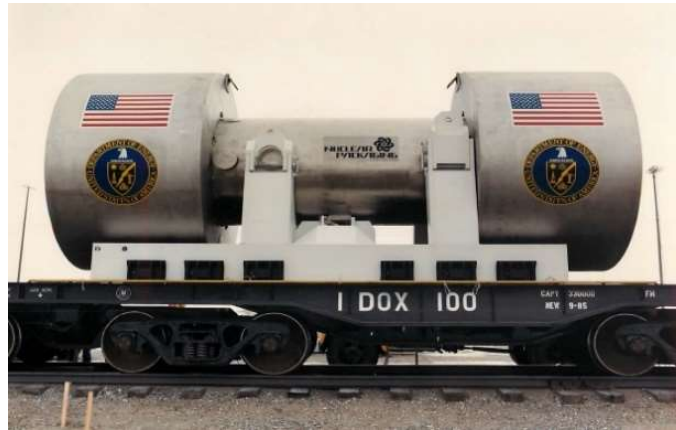
FIG. 228. NuPac 125-B cask on a rail car (courtesy of INL).

Seven canisters were fitted inside the cask, each having its own upper shield plug and upper and lower internal impact limiter. The casks were shipped cross country by rail as a dedicated shipment with as many as three rail cars, each cask on its own car. Figure 228 shows the cask with impact limiters in place.

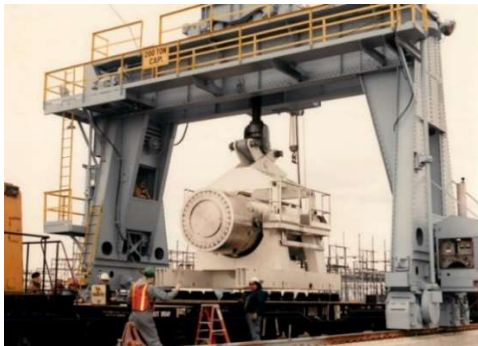
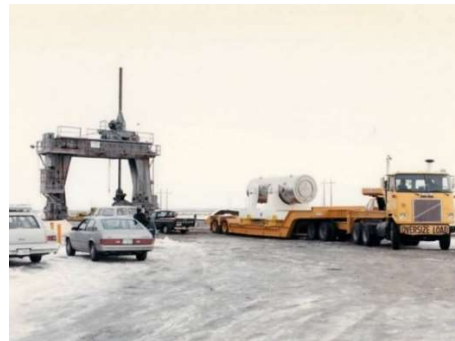
FIG. 229. Gantry crane removing 125-B Cask from rail car (left). 125-B cask on transport skid, loaded on trailer (right) (courtesy of INL).

When the casks reached INEL there was no rail spur available to complete the journey to the TAN-607 hot shop and pool system. This meant that the casks needed to be unloaded from the rail cars and transported by truck approximately 48 km from the rail terminal at the INEL Central Facilities Area to TAN; as shown in Fig. 229.

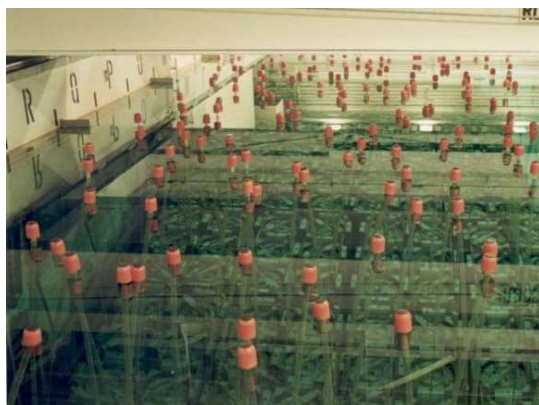
FIG. 232. TAN-607 pool, showing six pack racks and individual canister vent ports (orange caps divert water back into pool) (courtesy of INL).

Storage of canisters in the TAN-607 pool used the six pack array, with each canister having an individual vent tube extending above the pool surface. The canister internals, including debris, were isolated from the pool water. The canisters were backfilled with deionized water through the vent tube. During the early stages of storage, release of gas from radiolytic hydrogen production caused the water in the canister to be kinetically expelled through the vent tube. Following observation of

this phenomenon, the tops of the vent tubes were covered with plastic caps that diverted any expelled water back into the pool (see Fig. 232).

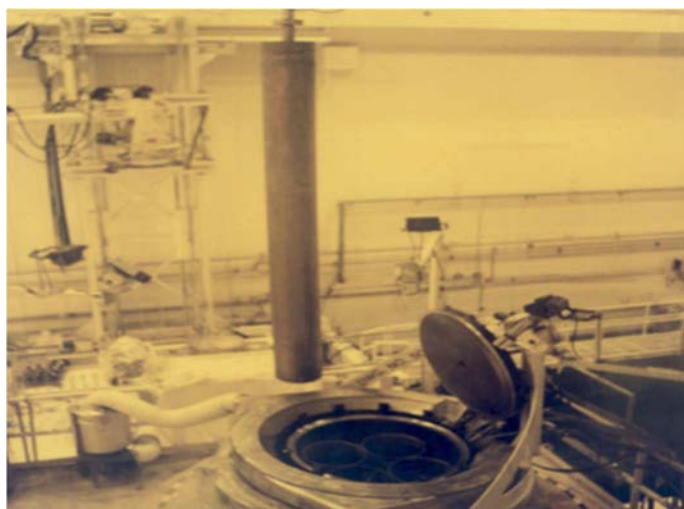
FIG. 236. Heated vacuum drying system installed in REA-2023 cask in TAN hot shop (courtesy of INL).

drying is an indication that the bulk water has been fully evaporated from among the particles of a granular system such as the fuel debris. The HVDS system included a condenser for water removal and separate pump for removable of incondensable gas. The system design included controls to prevent overtemperature conditions as well as to assure that flammable gas deflagration was not possible. The design allowed for intermittent purge capability, which was used periodically. The canister configuration in the HVDS was also analysed to assure subcriticality.

The original assumptions used by the INEL engineering group [276] were predicated on maintaining the drying temperature below that which would cause failure of the O ring on the fuel/debris canister head. When the drying and packaging contract was awarded to VECTRA, the decision was made only to take credit for the dry shielded canister (DSC) as the confinement barrier; no credit was taken for the fuel debris canister O ring, meaning that there was no need to run at a temperature <423 K. The four canister configuration in the HVDS is shown in Fig. 236.

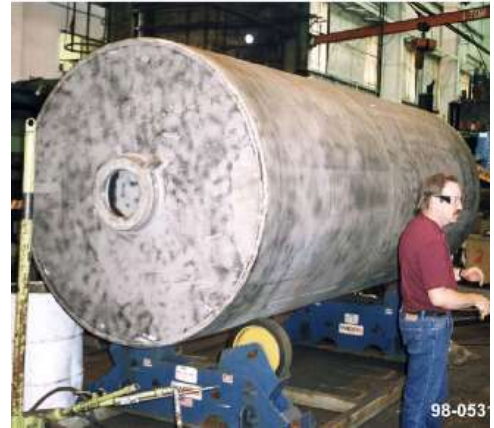
FIG. 237. (a) NUHOMS dry shielded canister schematic (reproduced from Ref. [277] with permission courtesy of INL). (b) Dry shielded canister during fabrication (courtesy of INL).

The NUHOMS-12T DSCs were fabricated from SA-517, Grade 70 mild steel. The DSC main shell is fabricated of 1.6 cm thick plate, rolled into a 170 cm diameter, 426 cm tall cylinder. The canister configuration is shown in Fig. 237 (a).

The DSC has a 2.54 cm thick welded top plate and a multiple piece bottom lid that incorporates a, 11.5 cm thick radiological shield plug and two 3.8 cm thick top cover plate that are welded to the shell to complete the final closure. The bottom end also incorporates a ring on which a hydraulic ram is attached that is used to push the DSC into place in the horizontal storage module (HSM) as well as retrieve it at the end of interim storage. The ring is visible in the fabrication photo, Fig. 237 (b).

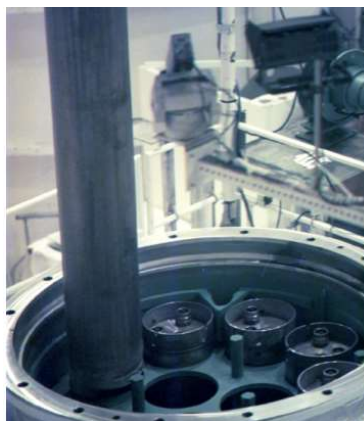
FIG. 238. Dried debris canisters being loaded into a DSC (courtesy of INL).

Dried canisters were then transferred to the NUHOMS-12T DSC in the TAN hot shop. The DSC was staged in the hot shop, positioned in the OS-197 onsite transfer cask with the lid off. The canister loading is shown in Fig. 238.

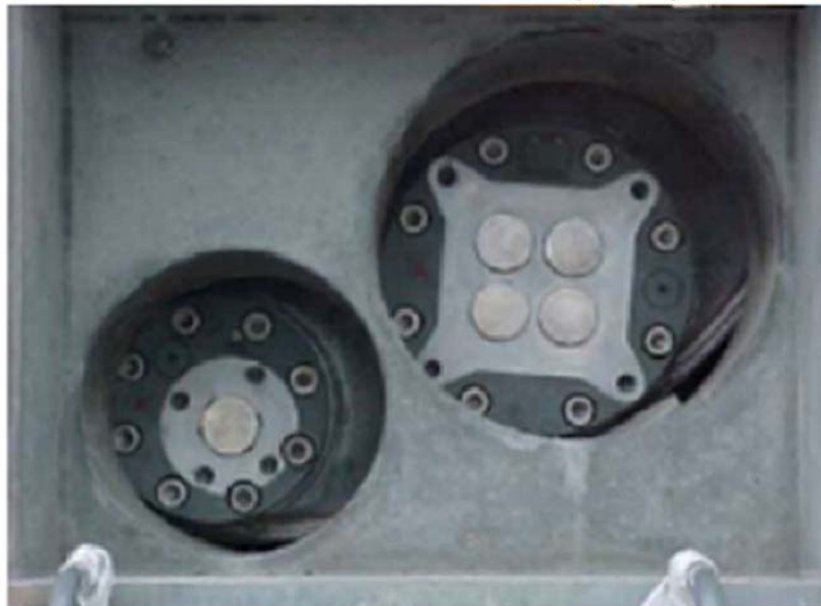
FIG. 242. Horizontal storage module cutaway diagram (top) and photograph showing purge vent and filter port (bottom) (reproduced from Ref. [277] with permission courtesy of INL).

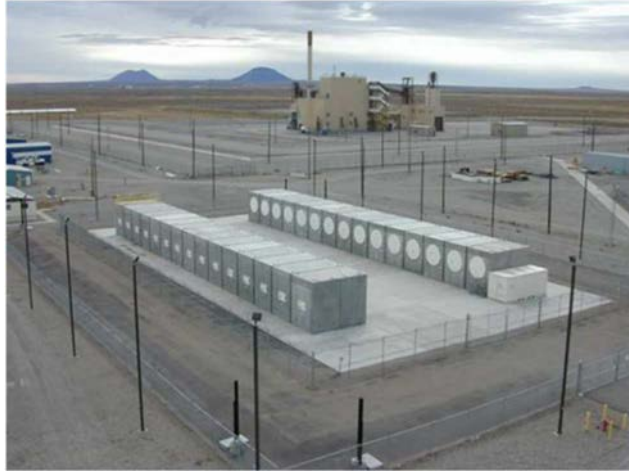
FIG. 243. CPP-1774 ISFSI with HSMs (courtesy of INL).

The resulting ISFSI, a two row HSM configuration, is shown in Fig. 243. There are thirty HSMs, of which 29 contain loaded DSCs. The intent is to provide an additional HSM if one of the DSCs should fail, and an additional position be necessary for any repackaged contents.

Apart from the freeze thaw effects of snowmelt on the bolt pockets that hold the HSM together, no significant degradation has been identified on the structure or systems. The bolt pocket damage was remedied by use of an epoxy filler and covering with stainless steel covers.

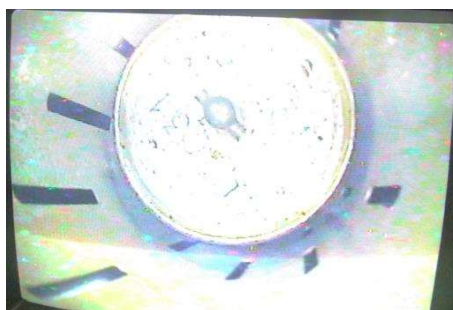
FIG. 247. Post irradiation examination can inside sheath (courtesy of NDA).

The PIE cans are small (nominally 13 cm in diameter and 0.5 m or 1m in length depending on pin length) compared with a typical fuel assembly (3–4 m length) so the cans are packed in a stack of three within a sheath (Fig. 247) in order to provide a package of suitable dimensions for handling and feeding to shear (to ensure firm gagging) and of suitable fuel mass to ensure an appropriate fuel batch size in the dissolver for feeding forward to the chemical separation area of plant.

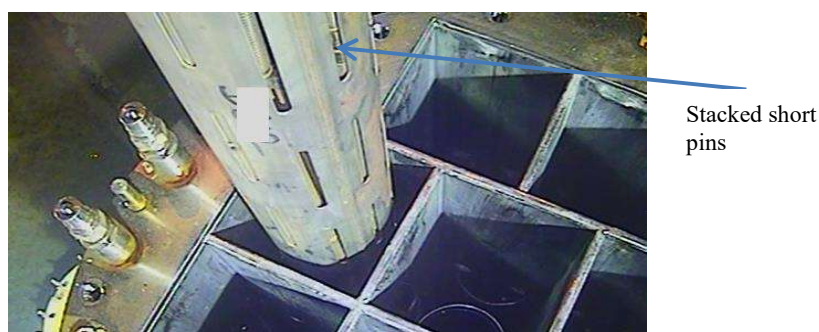
FIG. 248. Slotted PIE can with stacked short fuel pins (courtesy of NDA).

Post irradiation examination cans reprocessed in 2016 were all of nominal 1 m length but some contained the shorter length pins (0.5 m) stacked within the can (Fig. 248). This gave significant scope for movement of the shorter pins within the can and uncertainty over the pin end locations. For this reason, shear cut lengths were minimised to 25 mm in order to maximise shearing of the shorter pins – this is half the normal cut length employed for standard AGR fuel pins. This shorter cut length resulted in higher than usual volumes of fine material being generated in the decanters which created a degree of restriction when feeding forward to the waste container (which also contained the hulls). The ‘fines’ accumulation issue was successfully managed by additional flushing with acid to clear the decanter pipework.

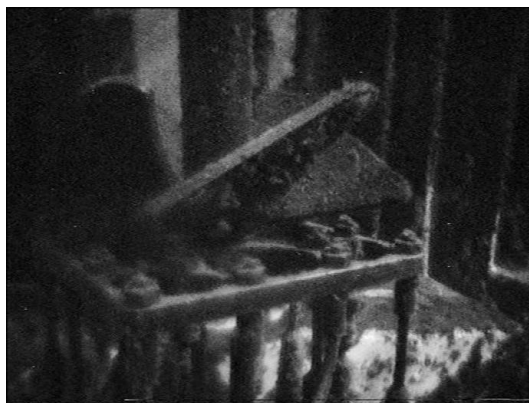
FIG. 251. PWR Burnable poison unit removed from fuel (courtesy of NDA).

Some types of PWR assembly were received with thimble plugs and burnable poison units (suspended in interstitial positions between the fuel rods on a 'spider' like assembly in the FA top, Fig. 251). These items were incompatible with the THORP process and specialist tools were developed to remove them prior to reprocessing.

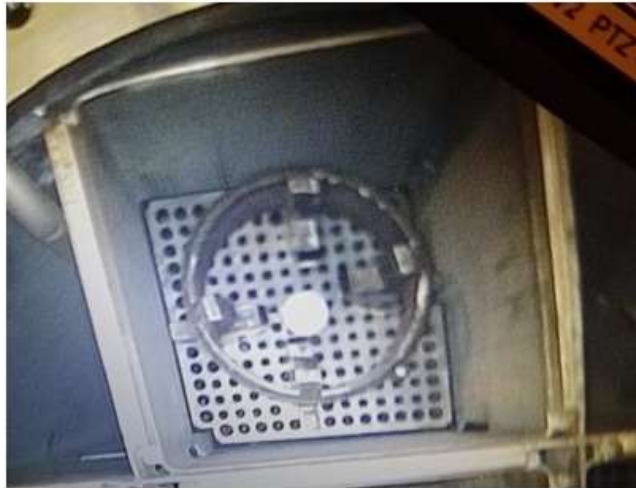
FIG. 252. View on inverted PWR assembly in MEB channel (replacement top nozzle) (courtesy of NDA).

One PWR assembly had been subjected to PIE which involved removal of the top nozzle and seven fuel pins. The incomplete assembly was then reconstituted using a new top plate with an integral tie-rod running the full length of the FA (Fig. 252). The new top plate/tie rod unit was designed so that the reconstituted assembly would have the same geometry as the original assembly. As these particular FAs were designed with lifting features on both the top and bottom nozzles the replacement top nozzle was made to a simpler design without a lifting feature, instead the assembly was turned around and placed upside down in the MEB channel to enable use of the bottom nozzle lifting feature. Taking this into account the FA was identified as fit for reprocessing with just the requirement for a new specific single use cutting pattern to accommodate the modified top nozzle when processed through shear.

A further example is of a PWR assembly that was part of a standard reprocessing campaign but had previously been the subject of PIE in which the top nozzle had been removed and a replacement fitted. It was found that the internal fittings of the replacement top nozzle interfered with the grab legs in Feed Pond and could not be grappled properly. In order to process this fuel at a later date an extension piece to the existing top nozzle was designed to fit over it to provide a lifting feature compatible with the fuel grab and tools to allow it to be fitted in situ. The extension piece results in an overall increase in the FA length thus reducing the clearance for subsequent handling operations therefore additional control supervision/ camera surveillance is required as a precaution during removal of this fuel from the MEB and transfer to shear (this assembly was subsequently successfully reprocessed).

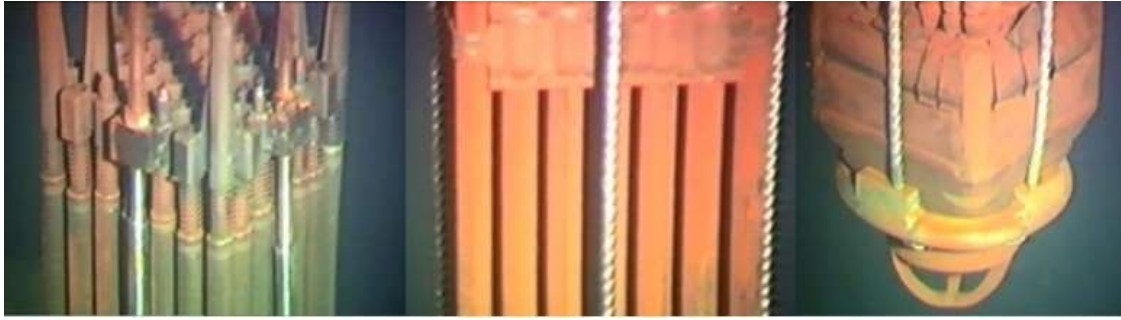
FIG. 253. Boiling water reactor wired assembly; top nozzle fittings, wires visible on three faces of assembly and base suspending ring (courtesy of NDA).

In a small number of cases BWR assemblies were received following a drop at reactor. One example is an assembly that was dropped at reactor and repaired before packaging for transport. Displaced fuel pins were sprung back into position, modified new top and bottom plates were fitted and the broken tie-rods were replaced with solid bars for strength. The repaired assembly was then sheathed to provide further support. A special canister was made to fit the central position of a modified MEB for transport of this assembly to Sellafield to prevent any movement of it during shipment. The sheathed assembly was successfully reprocessed in a campaign with other standard BWR assemblies from the same reactor. The only variation to standard procedure for reprocessing this assembly was to bypass the FPFM prior to shearing to avoid rotating it and thus prevent imposing additional mechanical stress on it. A further example is of an assembly which was dropped at reactor then wired up (Fig. 253) and transported to Sellafield. Four stainless steel wires were attached to a suspending ring under the bottom nozzle to support the fuel assembly weight. These wires were also fixed to a newly fitted top nozzle by nuts and bolts. With this arrangement the fuel assembly could be handled normally. A sheath was designed at Sellafield to fit over the assembly with holes at the top and base through which cutters could be applied to cut away the wires prior to reprocessing if required.
