Experiences and Lessons Learned in Managing Severely Damaged Spent Fuel and Corium

Final Report of a Coordinated Research Project

IAEA-TECDOC-2085

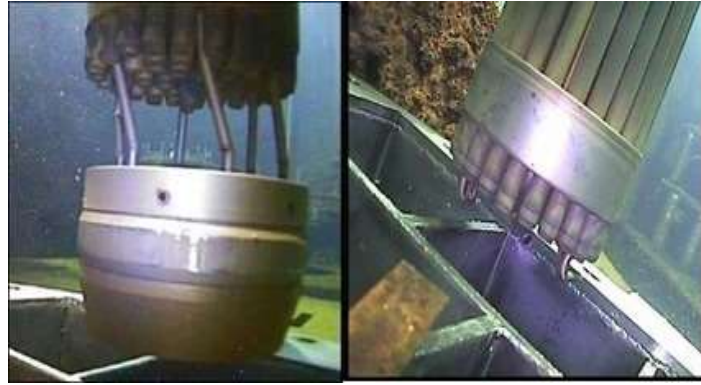
FIG. 254. Steam generating heavy water reactor assemblies with twisted or missing basal shrouds (courtesy of NDA).

A small number of assemblies from the prototype steam generating heavy water reactor (SGHWR) were found to have damaged or missing basal shrouds (non-fuel bearing) which presented both a shortened overall assembly length and a potential snagging issue for feeding to shear (Fig. 254). A further two SGHWR assemblies were each found to have a kinked fuel pin (or sparge tube) protruding outside the cross-sectional envelope of the assembly which also presented a potential snagging issue for feeding to shear. A sheath was designed to contain these assemblies to present a uniform package for shearing purposes and to prevent snagging. Figure 255 shows the sheath and a kinked pin assembly being loaded into the sheath with the protruding pin orientated to the corner. All of these damaged assemblies were successfully reprocessed in the sheaths. This sheath design was also used with additional inserts to batch smaller size PHWR assemblies for feeding to shear as described in Section 4.

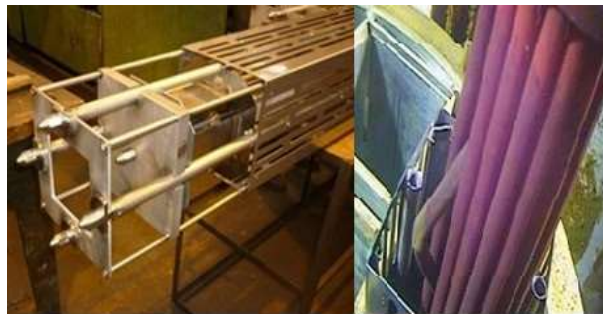
FIG. 255. Sheath designed to contain damaged SGHWR assemblies to facilitate shearing. Kinked pin orientated to corner of sheath (courtesy of NDA).
